## Profile/Photo Observation Report

Street:	<b>FLEMING ST &amp; E 13TH ST</b>	Flow Control:	<b>Not Controlled</b>
City:	<b>Hobart, IN</b>	Year Renewed:	
Location:	<b>Light Highway</b>	Tape/Media #:	
Purpose:	<b>Maintenance Related</b>	Dia/Height:	<b>12"</b>
Use:	<b>Sanitary</b>	Material:	<b>PVC</b>
Drain Area:	<b>NA</b>	Lining:	<b>Cured in Place</b>
Category:	<b>NA</b>		
Comment:	<b>Flow direction wrong.</b>

Location Details:		Direction of Survey:	<b>Downstream</b>
US MH:	<b>M-707-055</b>	DS MH:	<b>M-707-054</b>
		Total Length Surveyed (ft):	<b>267.2</b>

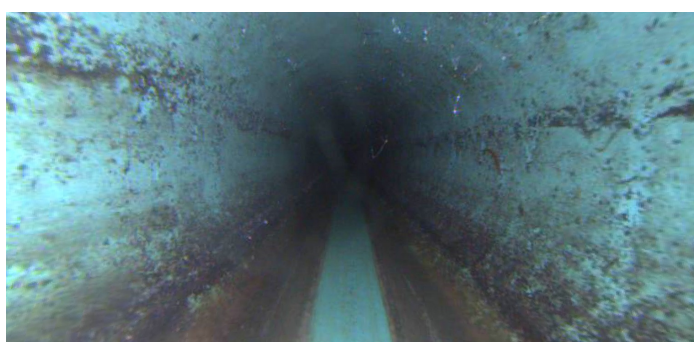
Code: **AMH**  
Description: **Manhole**

Distance (ft): **.0**  
Structural Grade: **0**  
O&M Grade: **0**  
Clock Start/From:  
Clock To:  
1st Value:  
2nd Value:  
Value Percent:  
Continuous Index:  
Within 8" of Joint: **NO**  
Remarks: **M-707-055**

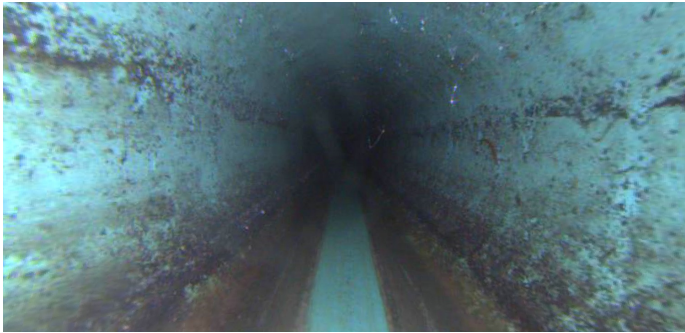
Code:	<b>MWL</b>
Description:	<b>Water Level</b>

Distance (ft):	<b>.0</b>
Structural Grade:	<b>0</b>
O&M Grade:	<b>0</b>
Clock Start/From:	
Clock To:	
1st Value:	
2nd Value:	
Value Percent:	<b>5.000</b>
Continuous Index:	
Within 8" of Joint:	<b>NO</b>
Remarks:

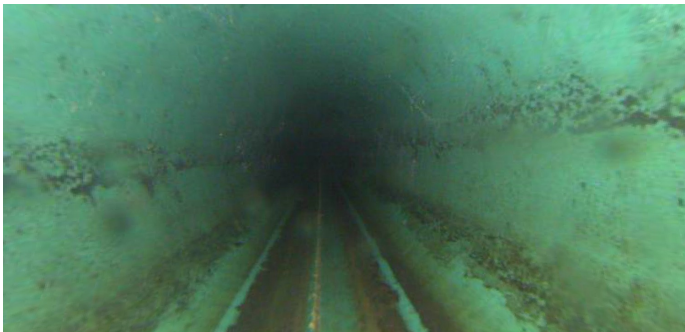
Code:	<b>MGO</b>
Description:	<b>General Observation</b>

Distance (ft):	<b>30.8</b>
Structural Grade:	<b>0</b>
O&M Grade:	<b>0</b>
Clock Start/From:	
Clock To:	
1st Value:	
2nd Value:	
Value Percent:	
Continuous Index:	
Within 8" of Joint:	<b>NO</b>
Remarks:	<b>REAR CAMERA</b>

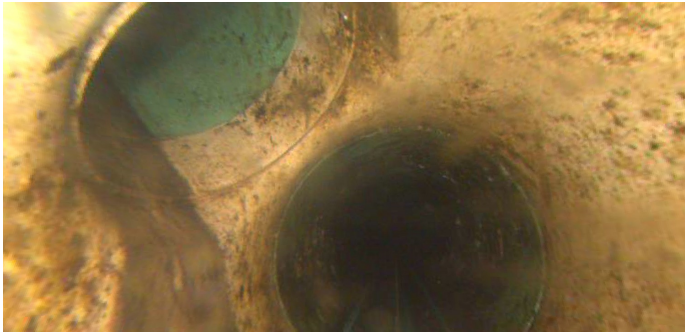
Code: **TFA**  
Description: **Tap Factory Active**

Distance (ft): **75.5**  
Structural Grade: **0**  
O&M Grade: **0**  
Clock Start/From: **1**  
Clock To:  
1st Value: **4.000**  
2nd Value:  
Value Percent:  
Continuous Index:  
Within 8" of Joint:  
Remarks:

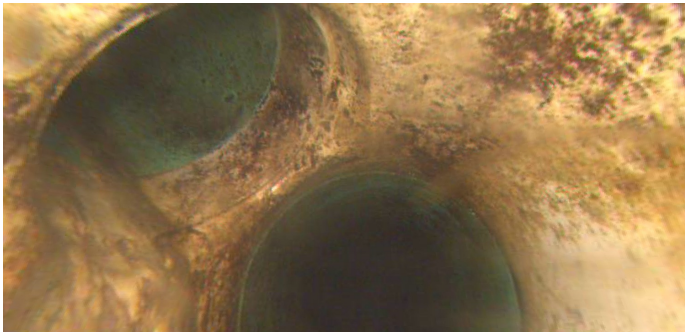
Code: **TF**  
Description: **Tap Factory**

Distance (ft): **149.2**  
Structural Grade: **0**  
O&M Grade: **0**  
Clock Start/From: **1**  
Clock To:  
1st Value: **4.000**  
2nd Value:  
Value Percent:  
Continuous Index:  
Within 8" of Joint:  
Remarks:

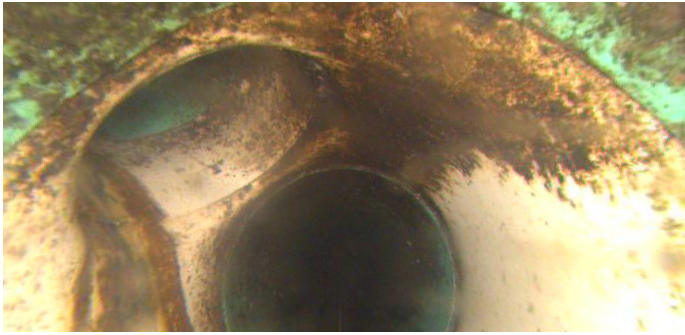
Code: **TF**  
Description: **Tap Factory**

Distance (ft): **184.8**  
Structural Grade: **0**  
O&M Grade: **0**  
Clock Start/From: **1**  
Clock To:  
1st Value: **4.000**  
2nd Value:  
Value Percent:  
Continuous Index:  
Within 8" of Joint:  
Remarks:

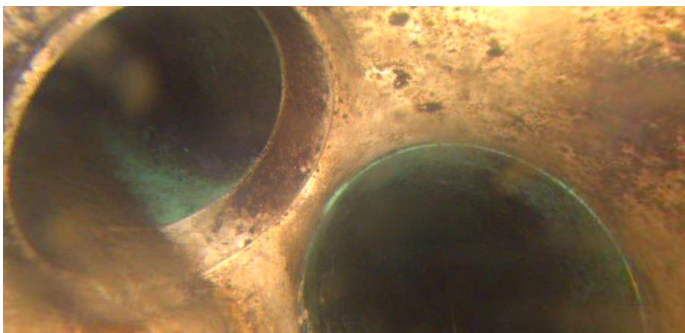
Code: **TF**  
Description: **Tap Factory**

Distance (ft): **263.6**  
Structural Grade: **0**  
O&M Grade: **0**  
Clock Start/From: **2**  
Clock To:  
1st Value: **4.000**  
2nd Value:  
Value Percent:  
Continuous Index:  
Within 8" of Joint:  
Remarks:

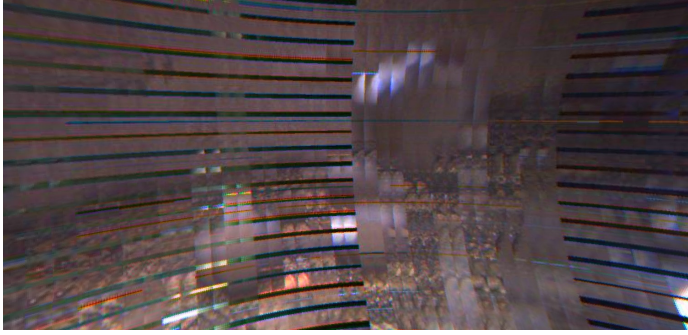
Code:	<b>AMH</b>
Description:	<b>Manhole</b>
Distance (ft):	<b>267.2</b>
Structural Grade:	<b>0</b>
O&M Grade:	<b>0</b>
Clock Start/From:	
Clock To:	
1st Value:	
2nd Value:	
Value Percent:	
Continuous Index:	
Within 8" of Joint:	<b>NO</b>
Remarks:	<b>M-707-054</b>
