Profile/Photo Observation Report

Date:	04/07/2018	Weather:		Coding:	PACP 6.0
Pipe Length (ft):	374.0	Owner:	NA	Pre Clean:	Not Known
P.O.#:		Surveyor:	Jen Costello	PSR:	P-707-057-058
Customer:		Clean Date:	01/01/1900	Shape:	C

Street:	E 12TH ST	Flow Control:	Not Controlled
City:	Hobart, IN	Year Renewed:	
Location:	Easement/Right of Way	Tape/Media #:	
Purpose:	Maintenance Related	Dia/Height:	8"
Use:	Sanitary	Material:	PVC
Drain Area:	NA	Lining:	Cured in Place
Category:	NA		
Comment:	Flow direction wrong.

Location Details:		Direction of Survey:	Downstream
US MH:	M-707-058	DS MH:	M-707-057
		Total Length Surveyed (ft):	366.1

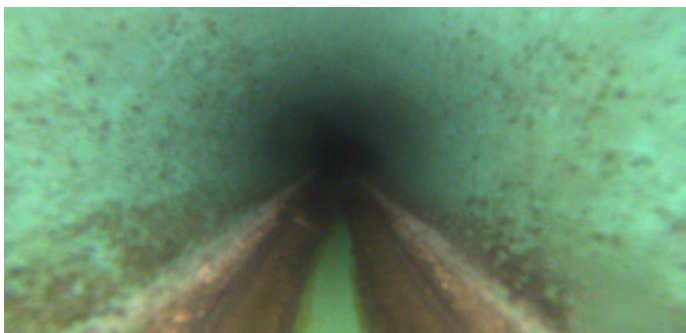
Code: **AMH**
Description: **Manhole**

Distance (ft): **.0**
Structural Grade: **0**
O&M Grade: **0**
Clock Start/From:
Clock To:
1st Value:
2nd Value:
Value Percent:
Continuous Index:
Within 8" of Joint: **NO**
Remarks: **M-707-058**

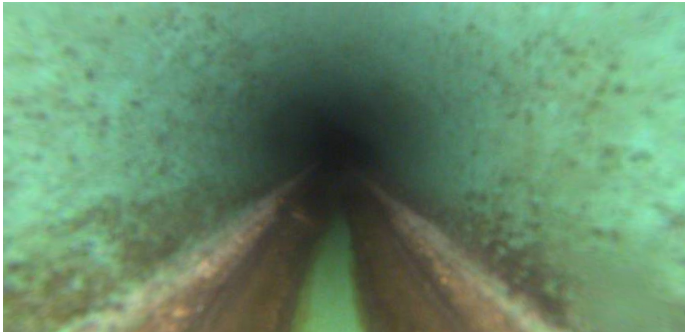
Code:	MWL
Description:	Water Level

Distance (ft):	.0
Structural Grade:	0
O&M Grade:	0
Clock Start/From:	
Clock To:	
1st Value:	
2nd Value:	
Value Percent:	5.000
Continuous Index:	
Within 8" of Joint:	NO
Remarks:

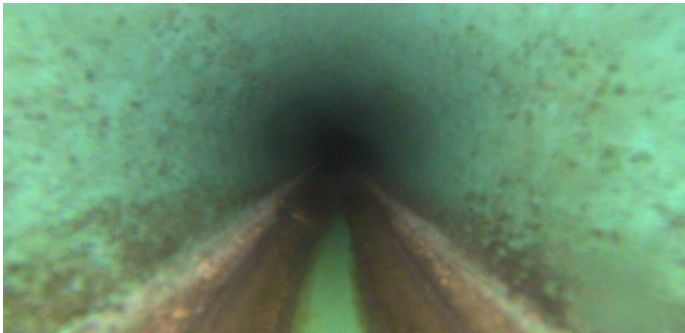
Code:	DAGS
Description:	Deposits Attached Grease

Distance (ft):	.0
Structural Grade:	0
O&M Grade:	2
Clock Start/From:	4
Clock To:	8
1st Value:	
2nd Value:	
Value Percent:	5.000
Continuous Index:	S01
Within 8" of Joint:	NO
Remarks:

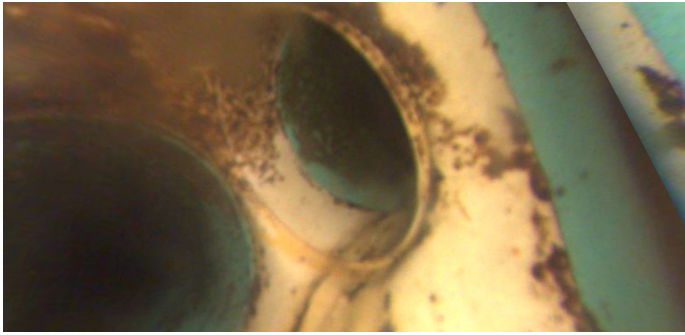
Code: **TF**
Description: **Tap Factory**

Distance (ft): **11.7**
Structural Grade: **0**
O&M Grade: **0**
Clock Start/From: **2**
Clock To:
1st Value: **4.000**
2nd Value:
Value Percent:
Continuous Index:
Within 8" of Joint:
Remarks:

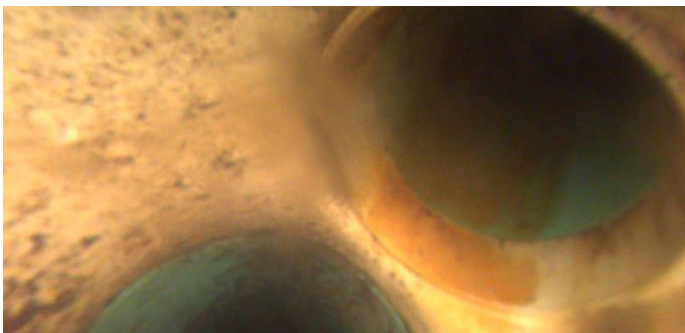
Code: **TF**
Description: **Tap Factory**

Distance (ft): **63.1**
Structural Grade: **0**
O&M Grade: **0**
Clock Start/From: **2**
Clock To:
1st Value: **4.000**
2nd Value:
Value Percent:
Continuous Index:
Within 8" of Joint:
Remarks:

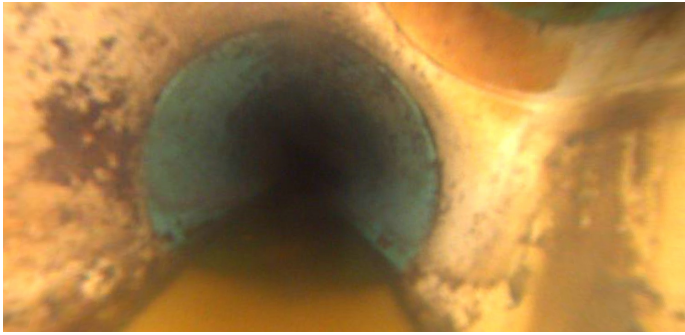
Code: **DAGS**
Description: **Deposits Attached Grease**

Distance (ft): **63.1**
Structural Grade: **0**
O&M Grade: **2**
Clock Start/From: **4**
Clock To: **8**
1st Value:
2nd Value:
Value Percent: **5.000**
Continuous Index: **F01**
Within 8" of Joint: **NO**
Remarks:

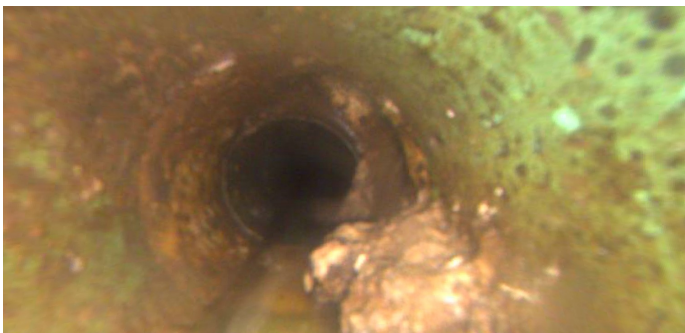
Code: **DAGS**
Description: **Deposits Attached Grease**

Distance (ft): **149.2**
Structural Grade: **0**
O&M Grade: **2**
Clock Start/From: **3**
Clock To: **5**
1st Value:
2nd Value:
Value Percent: **10.000**
Continuous Index:
Within 8" of Joint: **NO**
Remarks:

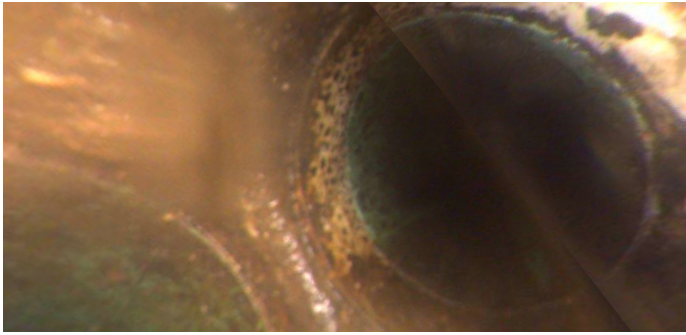
Code: **TF**
Description: **Tap Factory**

Distance (ft): **150.2**
Structural Grade: **0**
O&M Grade: **0**
Clock Start/From: **2**
Clock To:
1st Value: **4.000**
2nd Value:
Value Percent:
Continuous Index:
Within 8" of Joint:
Remarks:

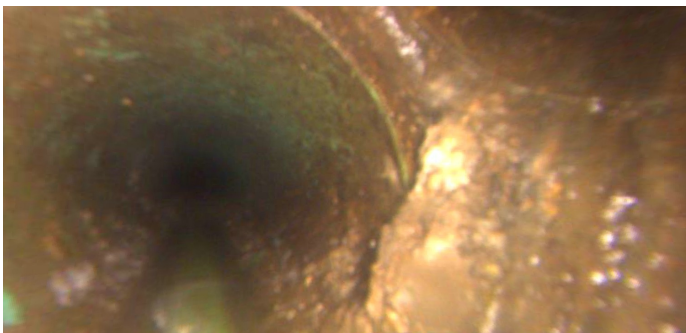
Code: **DAGS**
Description: **Deposits Attached Grease**

Distance (ft): **150.2**
Structural Grade: **0**
O&M Grade: **2**
Clock Start/From: **3**
Clock To: **5**
1st Value:
2nd Value:
Value Percent: **5.000**
Continuous Index:
Within 8" of Joint: **NO**
Remarks:

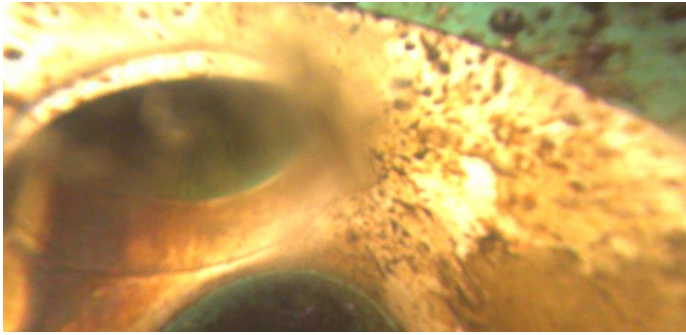
Code: **TF**
Description: **Tap Factory**

Distance (ft): **167.8**
Structural Grade: **0**
O&M Grade: **0**
Clock Start/From: **11**
Clock To:
1st Value: **4.000**
2nd Value:
Value Percent:
Continuous Index:
Within 8" of Joint:
Remarks:

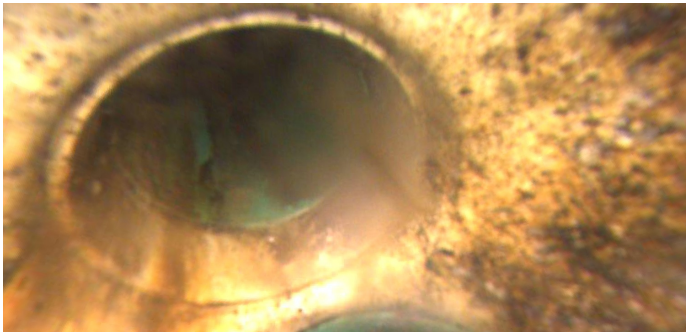
Code: **TF**
Description: **Tap Factory**

Distance (ft): **327.4**
Structural Grade: **0**
O&M Grade: **0**
Clock Start/From: **11**
Clock To:
1st Value: **4.000**
2nd Value:
Value Percent:
Continuous Index:
Within 8" of Joint:
Remarks:

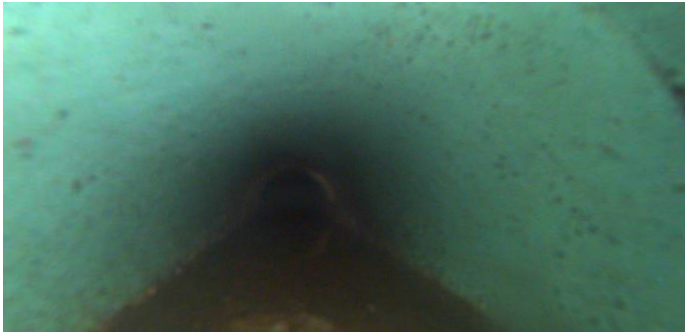
Code: **MWL**
Description: **Water Level**

Distance (ft): **338.9**
Structural Grade: **0**
O&M Grade: **0**
Clock Start/From:
Clock To:
1st Value:
2nd Value:
Value Percent: **20.000**
Continuous Index:
Within 8" of Joint: **NO**
Remarks:

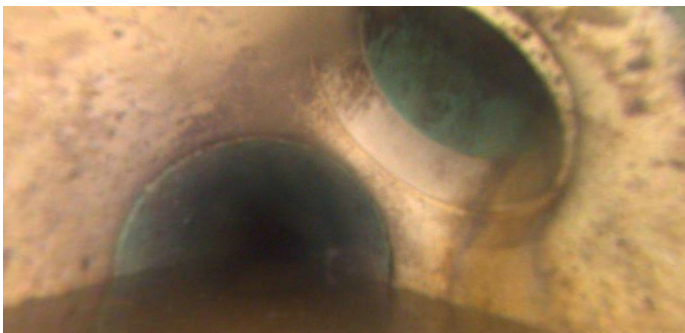
Code: **TF**
Description: **Tap Factory**

Distance (ft): **340.9**
Structural Grade: **0**
O&M Grade: **0**
Clock Start/From: **2**
Clock To:
1st Value: **4.000**
2nd Value:
Value Percent:
Continuous Index:
Within 8" of Joint:
Remarks:

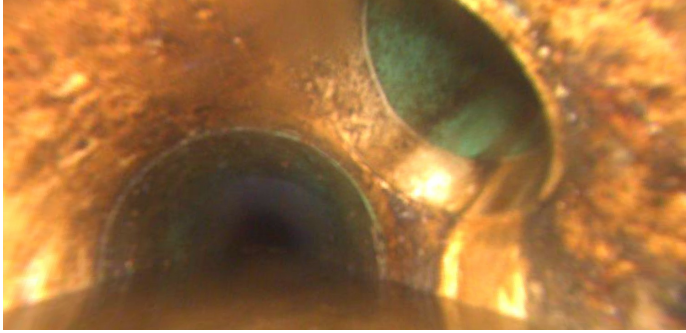
Code: **TF**
Description: **Tap Factory**

Distance (ft): **355.3**
Structural Grade: **0**
O&M Grade: **0**
Clock Start/From: **2**
Clock To:
1st Value: **4.000**
2nd Value:
Value Percent:
Continuous Index:
Within 8" of Joint:
Remarks:

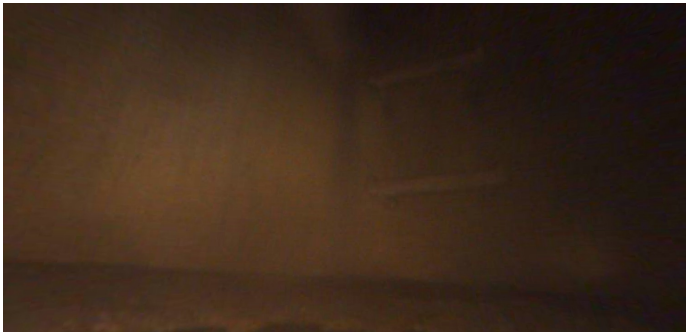
Code: **AMH**
Description: **Manhole**

Distance (ft): **366.1**
Structural Grade: **0**
O&M Grade: **0**
Clock Start/From:
Clock To:
1st Value:
2nd Value:
Value Percent:
Continuous Index:
Within 8" of Joint: **NO**
Remarks: **M-707-057**
