Profile/Photo Observation Report

Date:	04/07/2018	Weather:		Coding:	PACP 6.0
Pipe Length (ft):	374.0	Owner:	NA	Pre Clean:	Not Known
P.O.#:		Surveyor:	Jen Costello	PSR:	P-707-057-058
Customer:		Clean Date:	01/01/1900	Shape:	C

Street:	12th	Flow Control:	Not Controlled
City:	Hobart, IN	Year Renewed:	
Location:	Easement/Right of Way	Tape/Media #:	
Purpose:	Maintenance Related	Dia/Height:	8"
Use:	Sanitary	Material:	PVC
Drain Area:	NA	Lining:	Cured in Place
Category:	NA		
Comment:	Flow direction wrong.

Location Details:		Direction of Survey:	Downstream
US MH:	M-707-058	DS MH:	M-707-057
		Total Length Surveyed (ft):	366.1

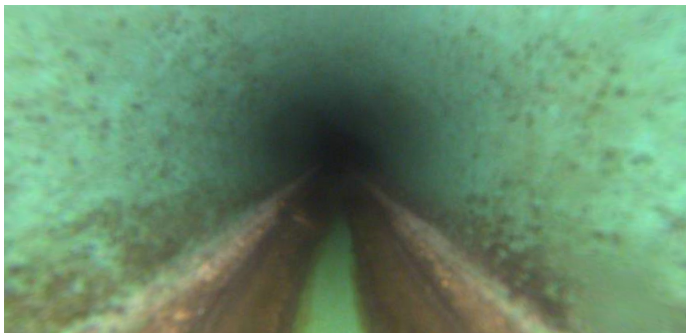
Code: **AMH**
Description: **Manhole**

Distance (ft): **.0**
Structural Grade: **0**
O&M Grade: **0**
Clock Start/From:
Clock To:
1st Value:
2nd Value:
Value Percent:
Continuous Index:
Within 8" of Joint: **NO**
Remarks: **M-707-058**

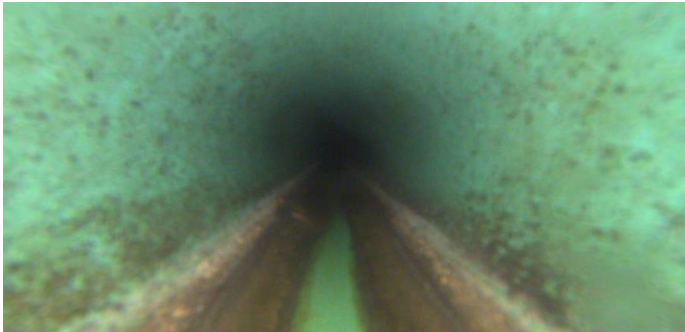
Code:	MWL
Description:	Water Level

Distance (ft):	.0
Structural Grade:	0
O&M Grade:	0
Clock Start/From:	
Clock To:	
1st Value:	
2nd Value:	
Value Percent:	5.000
Continuous Index:	
Within 8" of Joint:	NO
Remarks:

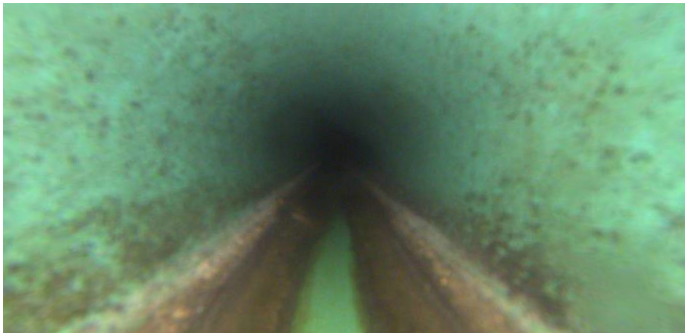
Code:	DAGS
Description:	Deposits Attached Grease

Distance (ft):	.0
Structural Grade:	0
O&M Grade:	2
Clock Start/From:	4
Clock To:	8
1st Value:	
2nd Value:	
Value Percent:	5.000
Continuous Index:	S01
Within 8" of Joint:	NO
Remarks:

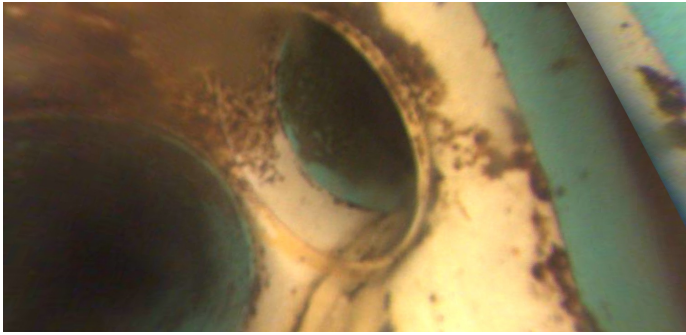
Code: **TF**
Description: **Tap Factory**

Distance (ft): **11.7**
Structural Grade: **0**
O&M Grade: **0**
Clock Start/From: **2**
Clock To:
1st Value: **4.000**
2nd Value:
Value Percent:
Continuous Index:
Within 8" of Joint:
Remarks:

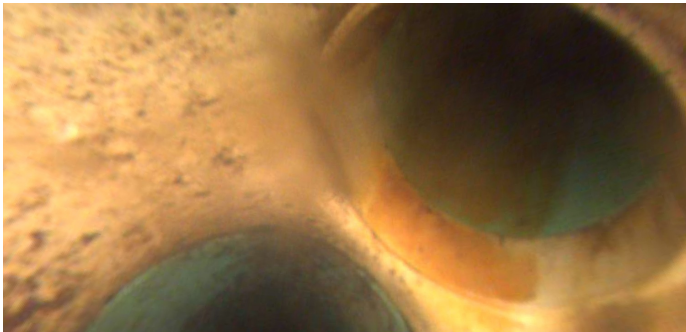
Code: **TF**
Description: **Tap Factory**

Distance (ft): **63.1**
Structural Grade: **0**
O&M Grade: **0**
Clock Start/From: **2**
Clock To:
1st Value: **4.000**
2nd Value:
Value Percent:
Continuous Index:
Within 8" of Joint:
Remarks:

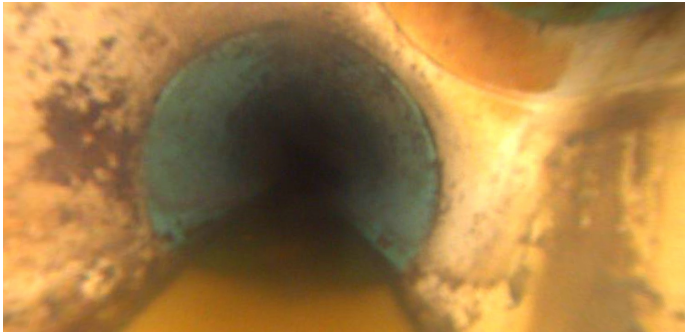
Code: **DAGS**
Description: **Deposits Attached Grease**

Distance (ft): **63.1**
Structural Grade: **0**
O&M Grade: **2**
Clock Start/From: **4**
Clock To: **8**
1st Value:
2nd Value:
Value Percent: **5.000**
Continuous Index: **F01**
Within 8" of Joint: **NO**
Remarks:

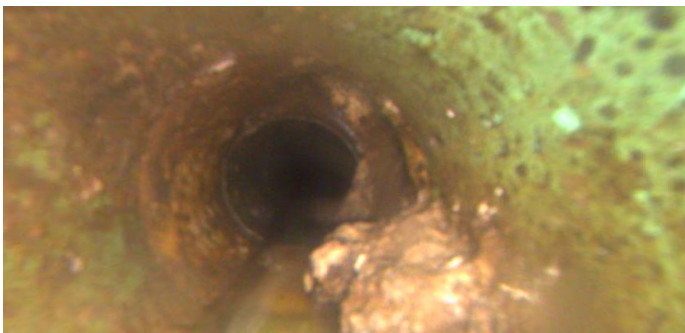
Code: **DAGS**
Description: **Deposits Attached Grease**

Distance (ft): **149.2**
Structural Grade: **0**
O&M Grade: **2**
Clock Start/From: **3**
Clock To: **5**
1st Value:
2nd Value:
Value Percent: **10.000**
Continuous Index:
Within 8" of Joint: **NO**
Remarks:

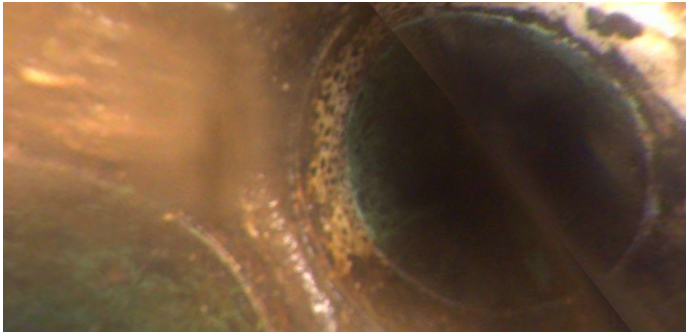
Code: **TF**
Description: **Tap Factory**

Distance (ft): **150.2**
Structural Grade: **0**
O&M Grade: **0**
Clock Start/From: **2**
Clock To:
1st Value: **4.000**
2nd Value:
Value Percent:
Continuous Index:
Within 8" of Joint:
Remarks:

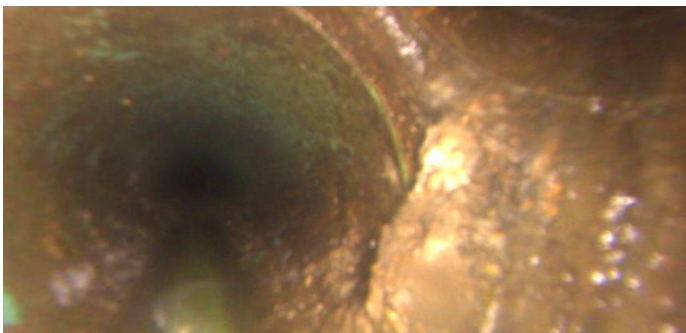
Code: **DAGS**
Description: **Deposits Attached Grease**

Distance (ft): **150.2**
Structural Grade: **0**
O&M Grade: **2**
Clock Start/From: **3**
Clock To: **5**
1st Value:
2nd Value:
Value Percent: **5.000**
Continuous Index:
Within 8" of Joint: **NO**
Remarks:

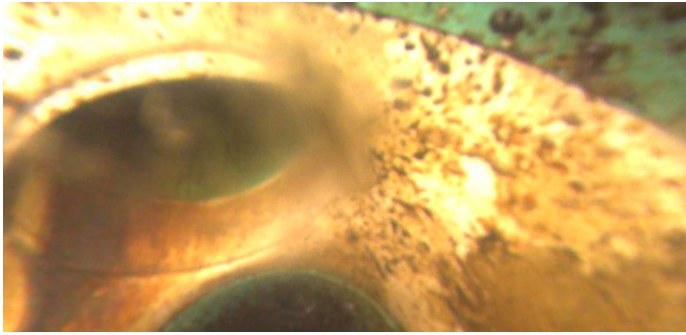
Code: **TF**
Description: **Tap Factory**

Distance (ft): **167.8**
Structural Grade: **0**
O&M Grade: **0**
Clock Start/From: **11**
Clock To:
1st Value: **4.000**
2nd Value:
Value Percent:
Continuous Index:
Within 8" of Joint:
Remarks:

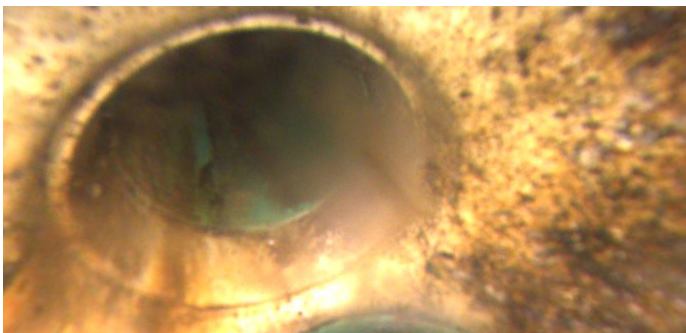
Code: **TF**
Description: **Tap Factory**

Distance (ft): **327.4**
Structural Grade: **0**
O&M Grade: **0**
Clock Start/From: **11**
Clock To:
1st Value: **4.000**
2nd Value:
Value Percent:
Continuous Index:
Within 8" of Joint:
Remarks:

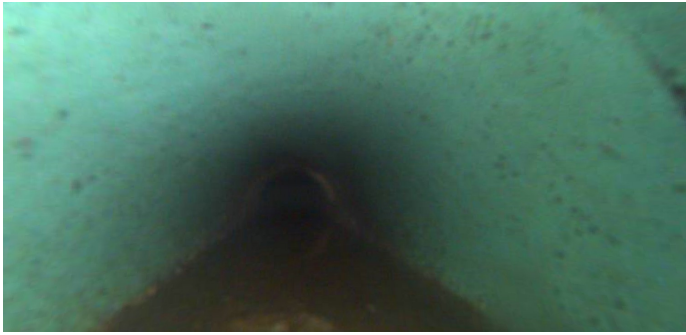
Code: **MWL**
Description: **Water Level**

Distance (ft): **338.9**
Structural Grade: **0**
O&M Grade: **0**
Clock Start/From:
Clock To:
1st Value:
2nd Value:
Value Percent: **20.000**
Continuous Index:
Within 8" of Joint: **NO**
Remarks:

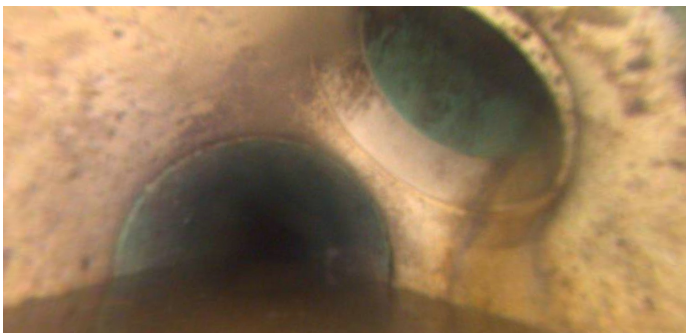
Code: **TF**
Description: **Tap Factory**

Distance (ft): **340.9**
Structural Grade: **0**
O&M Grade: **0**
Clock Start/From: **2**
Clock To:
1st Value: **4.000**
2nd Value:
Value Percent:
Continuous Index:
Within 8" of Joint:
Remarks:

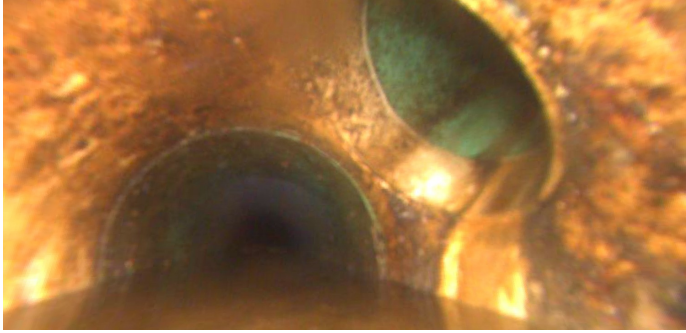
Code: **TF**
Description: **Tap Factory**

Distance (ft): **355.3**
Structural Grade: **0**
O&M Grade: **0**
Clock Start/From: **2**
Clock To:
1st Value: **4.000**
2nd Value:
Value Percent:
Continuous Index:
Within 8" of Joint:
Remarks:

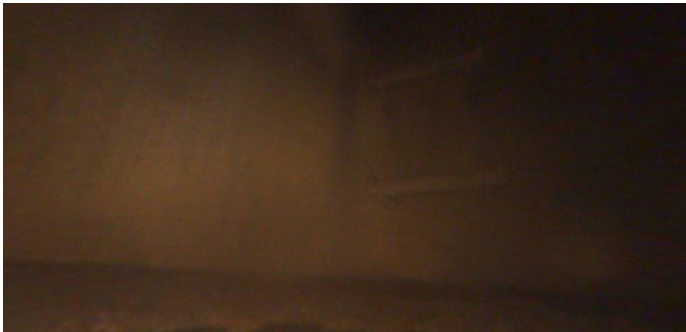
Code: **AMH**
Description: **Manhole**

Distance (ft): **366.1**
Structural Grade: **0**
O&M Grade: **0**
Clock Start/From:
Clock To:
1st Value:
2nd Value:
Value Percent:
Continuous Index:
Within 8" of Joint: **NO**
Remarks: **M-707-057**
