Profile/Photo Observation Report

Date:	04/07/2018	Weather:		Coding:	PACP 6.0
Pipe Length (ft):	332.9	Owner:	NA	Pre Clean:	Not Known
P.O.#:		Surveyor:	Jen Costello	PSR:	P-707-058-059
Customer:		Clean Date:	01/01/1900	Shape:	C

Street:	12th	Flow Control:	Not Controlled
City:	Hobart, IN	Year Renewed:	
Location:	Easement/Right of Way	Tape/Media #:	
Purpose:	Maintenance Related	Dia/Height:	8"
Use:	Sanitary	Material:	PVC
Drain Area:	NA	Lining:	Cured in Place
Category:	NA		
Comment:	Flow direction wrong.

Location Details:		Direction of Survey:	Upstream
US MH:	M-707-059	DS MH:	M-707-058
		Total Length Surveyed (ft):	327.3

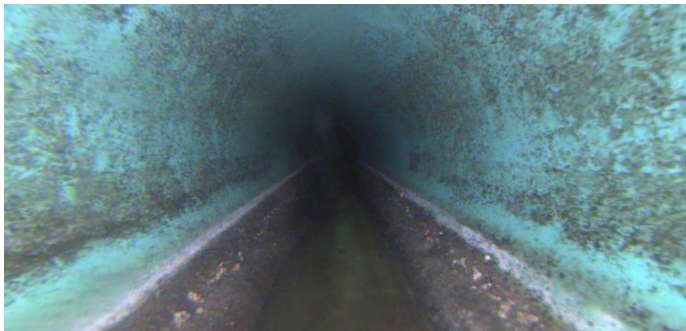
Code: **AMH**
Description: **Manhole**

Distance (ft): **.0**
Structural Grade: **0**
O&M Grade: **0**
Clock Start/From:
Clock To:
1st Value:
2nd Value:
Value Percent:
Continuous Index:
Within 8" of Joint: **NO**
Remarks: **M-707-058**

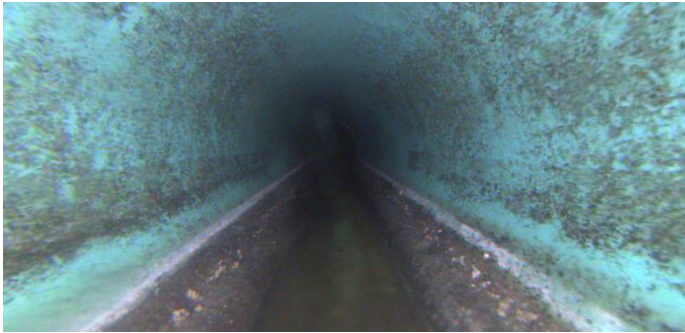
Code:	MWL
Description:	Water Level

Distance (ft):	.0
Structural Grade:	0
O&M Grade:	0
Clock Start/From:	
Clock To:	
1st Value:	
2nd Value:	
Value Percent:	5.000
Continuous Index:	
Within 8" of Joint:	NO
Remarks:

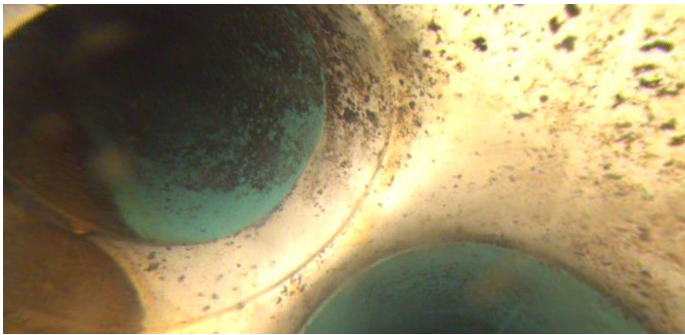
Code:	TF
Description:	Tap Factory

Distance (ft):	5.3
Structural Grade:	0
O&M Grade:	0
Clock Start/From:	2
Clock To:	
1st Value:	4.000
2nd Value:	
Value Percent:	
Continuous Index:	
Within 8" of Joint:	
Remarks:

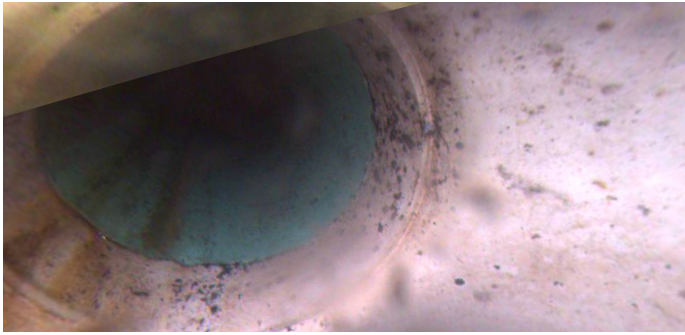
Code: **TF**
Description: **Tap Factory**

Distance (ft): **15.3**
Structural Grade: **0**
O&M Grade: **0**
Clock Start/From: **11**
Clock To:
1st Value: **4.000**
2nd Value:
Value Percent:
Continuous Index:
Within 8" of Joint:
Remarks:

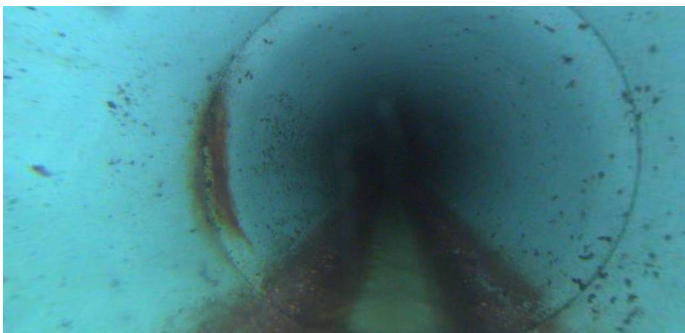
Code: **IS**
Description: **Infil Stain**

Distance (ft): **87.0**
Structural Grade: **0**
O&M Grade: **0**
Clock Start/From: **8**
Clock To: **9**
1st Value:
2nd Value:
Value Percent:
Continuous Index:
Within 8" of Joint: **YES**
Remarks:

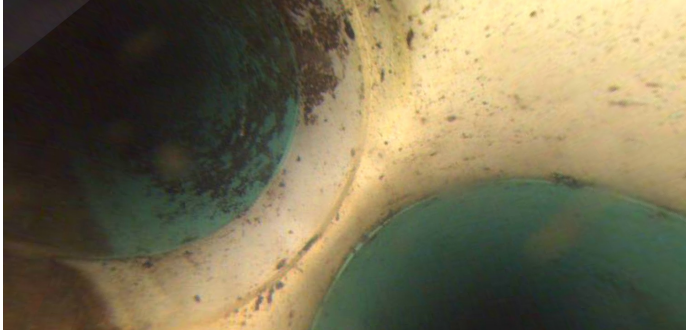
Code: **TF**
Description: **Tap Factory**

Distance (ft): **107.1**
Structural Grade: **0**
O&M Grade: **0**
Clock Start/From: **2**
Clock To:
1st Value: **4.000**
2nd Value:
Value Percent:
Continuous Index:
Within 8" of Joint:
Remarks:

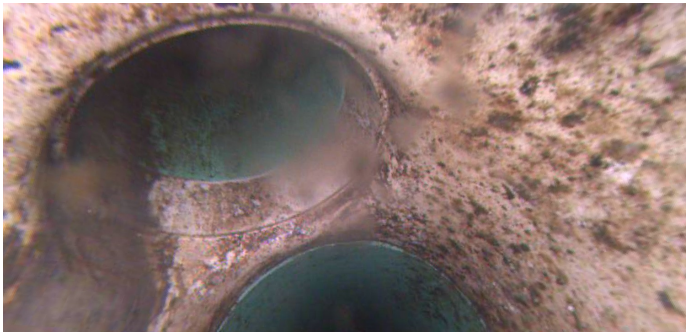
Code: **TF**
Description: **Tap Factory**

Distance (ft): **128.9**
Structural Grade: **0**
O&M Grade: **0**
Clock Start/From: **11**
Clock To:
1st Value: **4.000**
2nd Value:
Value Percent:
Continuous Index:
Within 8" of Joint:
Remarks:

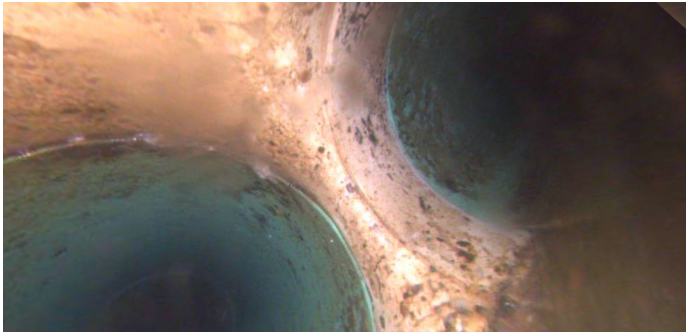
Code: **TFA**
Description: **Tap Factory Active**

Distance (ft): **162.6**
Structural Grade: **0**
O&M Grade: **0**
Clock Start/From: **2**
Clock To:
1st Value: **4.000**
2nd Value:
Value Percent:
Continuous Index:
Within 8" of Joint:
Remarks:

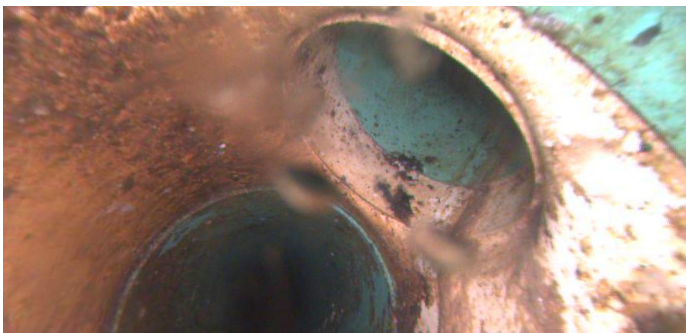
Code: **TF**
Description: **Tap Factory**

Distance (ft): **218.1**
Structural Grade: **0**
O&M Grade: **0**
Clock Start/From: **2**
Clock To:
1st Value: **4.000**
2nd Value:
Value Percent:
Continuous Index:
Within 8" of Joint:
Remarks:

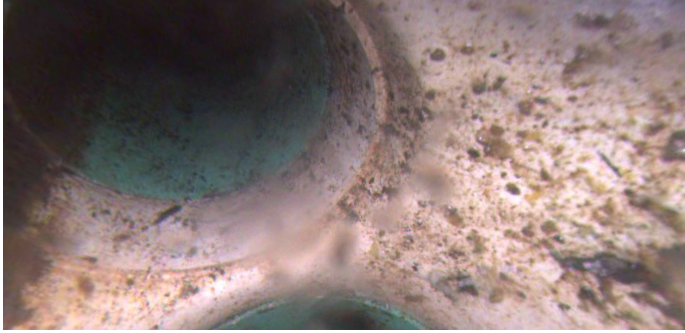
Code: **TF**
Description: **Tap Factory**

Distance (ft): **228.4**
Structural Grade: **0**
O&M Grade: **0**
Clock Start/From: **1**
Clock To:
1st Value: **4.000**
2nd Value:
Value Percent:
Continuous Index:
Within 8" of Joint:
Remarks:

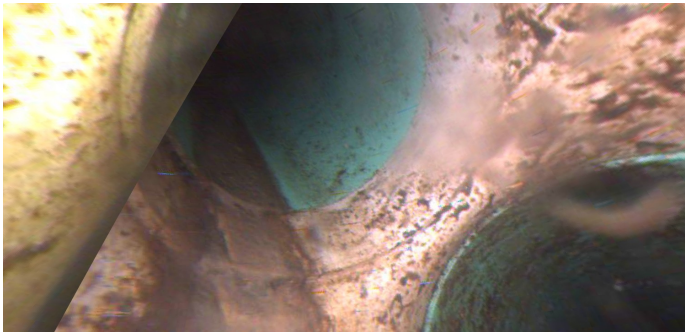
Code: **TF**
Description: **Tap Factory**

Distance (ft): **233.4**
Structural Grade: **0**
O&M Grade: **0**
Clock Start/From: **10**
Clock To:
1st Value: **4.000**
2nd Value:
Value Percent:
Continuous Index:
Within 8" of Joint:
Remarks:

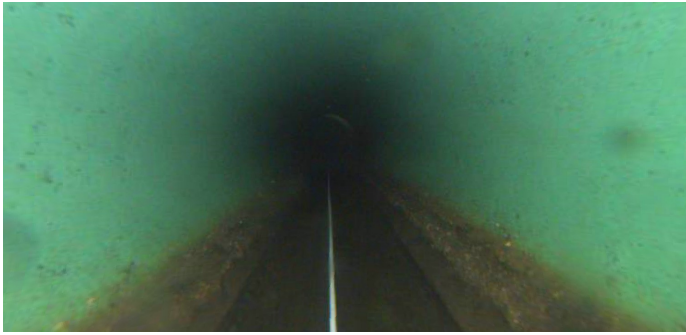
Code: **MGO**
Description: **General Observation**

Distance (ft): **237.7**
Structural Grade: **0**
O&M Grade: **0**
Clock Start/From:
Clock To:
1st Value:
2nd Value:
Value Percent:
Continuous Index:
Within 8" of Joint: **NO**
Remarks: **rear camera**

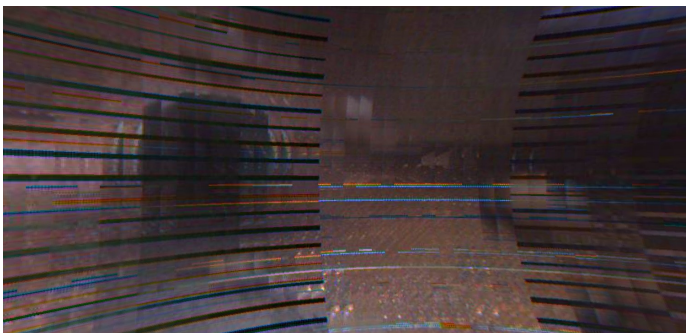
Code: **AMH**
Description: **Manhole**

Distance (ft): **327.3**
Structural Grade: **0**
O&M Grade: **0**
Clock Start/From:
Clock To:
1st Value:
2nd Value:
Value Percent:
Continuous Index:
Within 8" of Joint: **NO**
Remarks: **M-707-059**
