Profile/Photo Observation Report

Street:	E 12TH ST & S LAKE PARK AVE	Flow Control:	Not Controlled
City:	Hobart, IN	Year Renewed:	
Location:	Yard	Tape/Media #:	
Purpose:	Routine Assessment	Dia/Height:	8"
Use:	Sanitary	Material:	PVC
Drain Area:	NA	Lining:	
Category:	NA		
Comment:	Flow direction marked wrong.

Location Details:		Direction of Survey:	Downstream
US MH:	M-707-061	DS MH:	M-707-060
		Total Length Surveyed (ft):	297.1

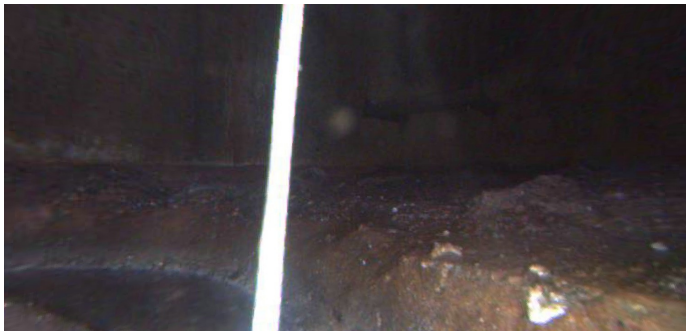
Code: **AMH**
Description: **Manhole**

Distance (ft): **.0**
Structural Grade: **0**
O&M Grade: **0**
Clock Start/From:
Clock To:
1st Value:
2nd Value:
Value Percent:
Continuous Index:
Within 8" of Joint: **NO**
Remarks: **M-707-061**

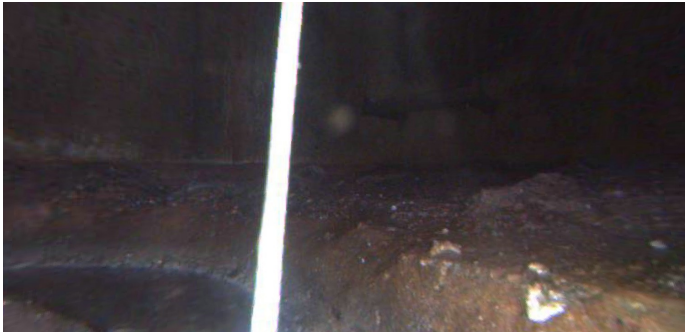
Code:	MWL
Description:	Water Level

Distance (ft):	.0
Structural Grade:	0
O&M Grade:	0
Clock Start/From:	
Clock To:	
1st Value:	
2nd Value:	
Value Percent:	10.000
Continuous Index:	
Within 8" of Joint:	NO
Remarks:

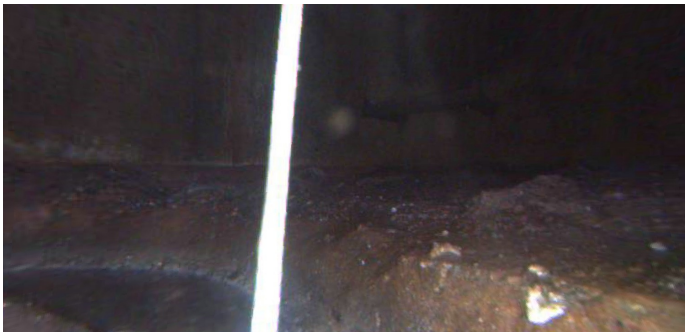
Code:	MGO
Description:	General Observation

Distance (ft):	.0
Structural Grade:	0
O&M Grade:	0
Clock Start/From:	
Clock To:	
1st Value:	
2nd Value:	
Value Percent:	
Continuous Index:	
Within 8" of Joint:	NO
Remarks:	REAR CAMERA

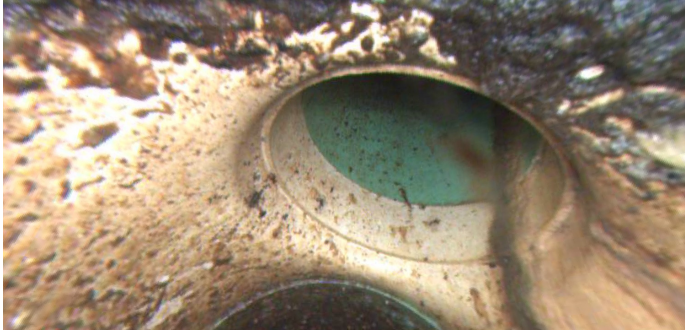
Code: **TF**
Description: **Tap Factory**

Distance (ft): **64.4**
Structural Grade: **0**
O&M Grade: **0**
Clock Start/From: **12**
Clock To:
1st Value: **4.000**
2nd Value:
Value Percent:
Continuous Index:
Within 8" of Joint:
Remarks:

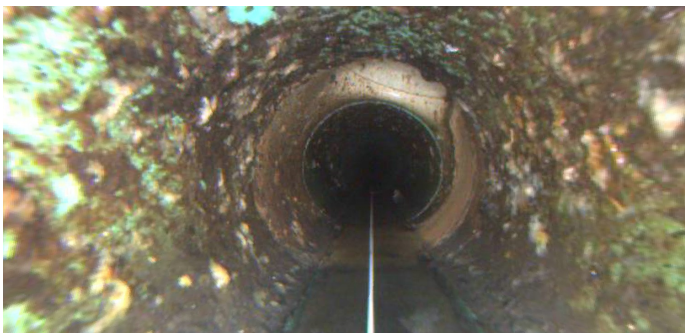
Code: **DAGS**
Description: **Deposits Attached Grease**

Distance (ft): **65.1**
Structural Grade: **0**
O&M Grade: **2**
Clock Start/From: **8**
Clock To: **4**
1st Value:
2nd Value:
Value Percent: **5.000**
Continuous Index:
Within 8" of Joint: **NO**
Remarks:

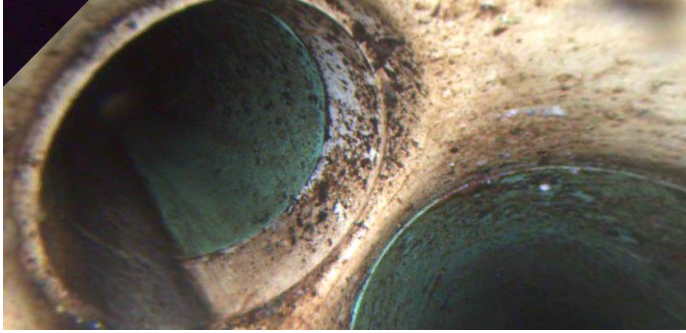
Code: **TF**
Description: **Tap Factory**

Distance (ft): **91.6**
Structural Grade: **0**
O&M Grade: **0**
Clock Start/From: **2**
Clock To:
1st Value: **4.000**
2nd Value:
Value Percent:
Continuous Index:
Within 8" of Joint:
Remarks:

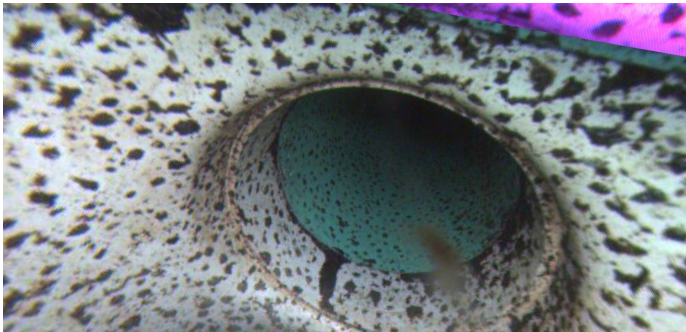
Code: **TF**
Description: **Tap Factory**

Distance (ft): **213.3**
Structural Grade: **0**
O&M Grade: **0**
Clock Start/From: **11**
Clock To:
1st Value: **4.000**
2nd Value:
Value Percent:
Continuous Index:
Within 8" of Joint:
Remarks:

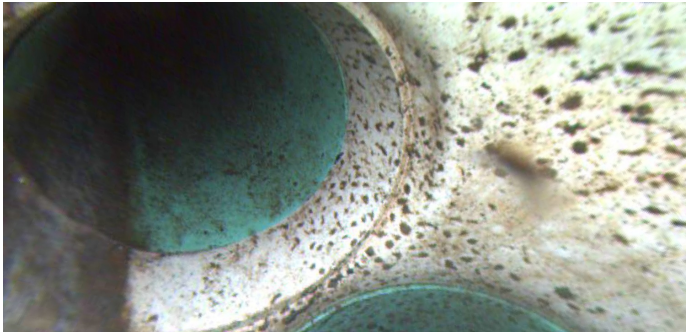
Code: **TF**
Description: **Tap Factory**

Distance (ft): **230.9**
Structural Grade: **0**
O&M Grade: **0**
Clock Start/From: **1**
Clock To:
1st Value: **4.000**
2nd Value:
Value Percent:
Continuous Index:
Within 8" of Joint:
Remarks:

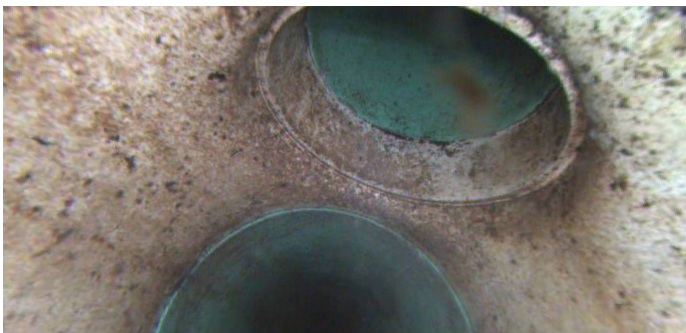
Code: **TF**
Description: **Tap Factory**

Distance (ft): **279.3**
Structural Grade: **0**
O&M Grade: **0**
Clock Start/From: **11**
Clock To:
1st Value: **4.000**
2nd Value:
Value Percent:
Continuous Index:
Within 8" of Joint:
Remarks:

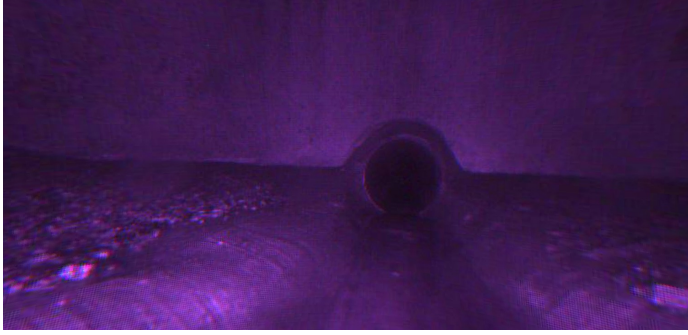
Code:	AMH
Description:	Manhole
Distance (ft):	297.1
Structural Grade:	0
O&M Grade:	0
Clock Start/From:	
Clock To:	
1st Value:	
2nd Value:	
Value Percent:	
Continuous Index:	
Within 8" of Joint:	NO
Remarks:	M-707-060
