Profile/Photo Observation Report

Street:	FOXCROFT STREET	Flow Control:	Not Controlled
City:	Hobart, IN	Year Renewed:	
Location:	Yard	Tape/Media #:	
Purpose:	Routine Assessment	Dia/Height:	8"
Use:	Sanitary	Material:	PVC
Drain Area:	NA	Lining:	
Category:	NA		
Comment:	Flow direction marked wrong.

Location Details:		Direction of Survey:	Downstream
US MH:	M-707-061	DS MH:	M-707-060
		Total Length Surveyed (ft):	297.1

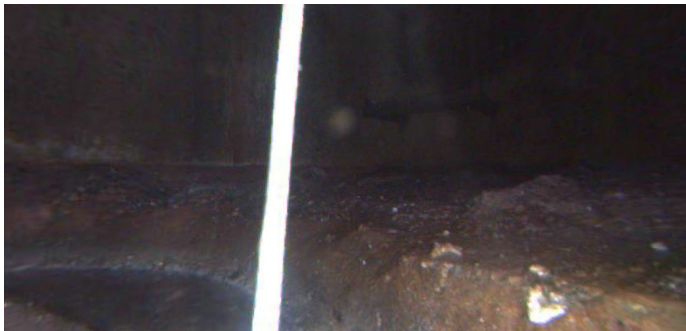
Code: **AMH**
Description: **Manhole**

Distance (ft): **.0**
Structural Grade: **0**
O&M Grade: **0**
Clock Start/From:
Clock To:
1st Value:
2nd Value:
Value Percent:
Continuous Index:
Within 8" of Joint: **NO**
Remarks: **M-707-061**

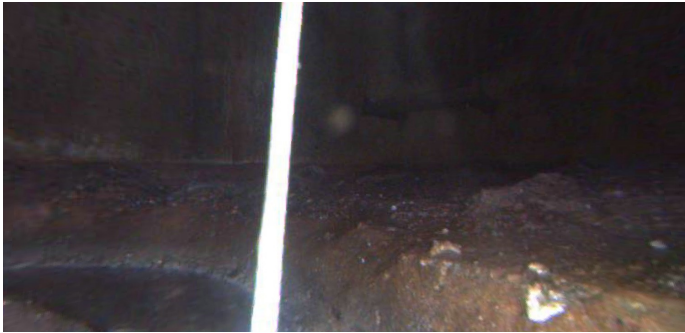
Code:	MWL
Description:	Water Level

Distance (ft):	.0
Structural Grade:	0
O&M Grade:	0
Clock Start/From:	
Clock To:	
1st Value:	
2nd Value:	
Value Percent:	10.000
Continuous Index:	
Within 8" of Joint:	NO
Remarks:

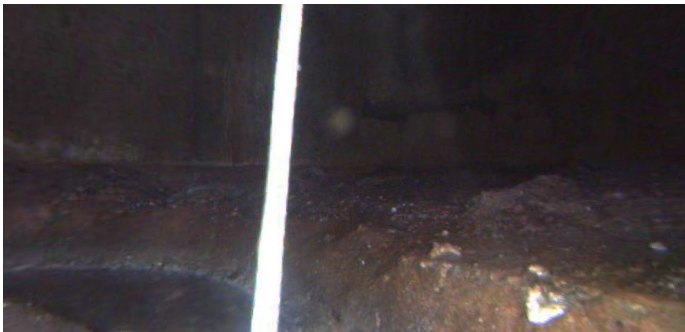
Code:	MGO
Description:	General Observation

Distance (ft):	.0
Structural Grade:	0
O&M Grade:	0
Clock Start/From:	
Clock To:	
1st Value:	
2nd Value:	
Value Percent:	
Continuous Index:	
Within 8" of Joint:	NO
Remarks:	REAR CAMERA

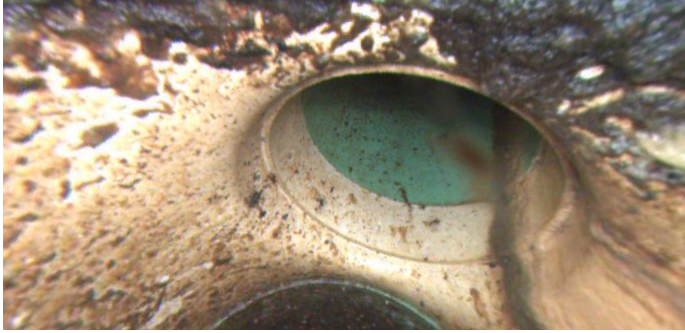
Code: **TF**
Description: **Tap Factory**

Distance (ft): **64.4**
Structural Grade: **0**
O&M Grade: **0**
Clock Start/From: **12**
Clock To:
1st Value: **4.000**
2nd Value:
Value Percent:
Continuous Index:
Within 8" of Joint:
Remarks:

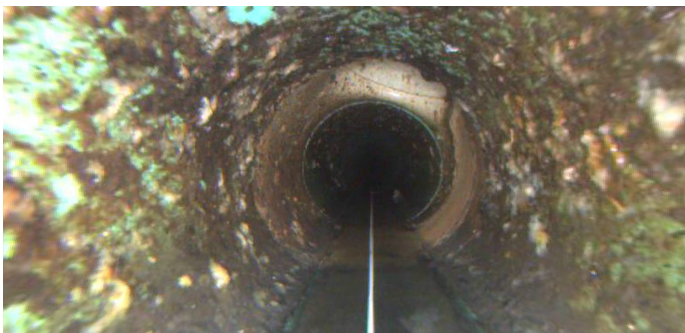
Code: **DAGS**
Description: **Deposits Attached Grease**

Distance (ft): **65.1**
Structural Grade: **0**
O&M Grade: **2**
Clock Start/From: **8**
Clock To: **4**
1st Value:
2nd Value:
Value Percent: **5.000**
Continuous Index:
Within 8" of Joint: **NO**
Remarks:

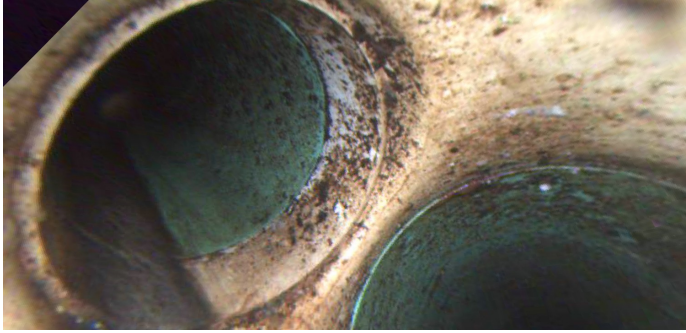
Code: **TF**
Description: **Tap Factory**

Distance (ft): **91.6**
Structural Grade: **0**
O&M Grade: **0**
Clock Start/From: **2**
Clock To:
1st Value: **4.000**
2nd Value:
Value Percent:
Continuous Index:
Within 8" of Joint:
Remarks:

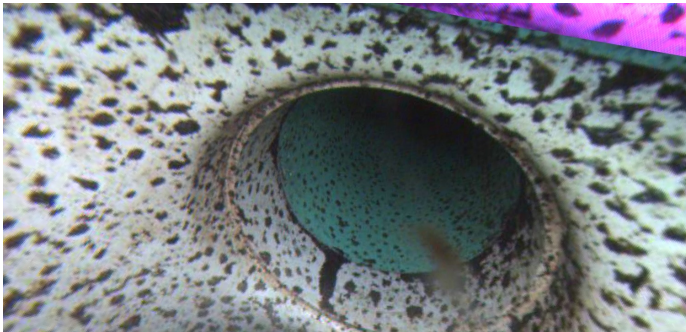
Code: **TF**
Description: **Tap Factory**

Distance (ft): **213.3**
Structural Grade: **0**
O&M Grade: **0**
Clock Start/From: **11**
Clock To:
1st Value: **4.000**
2nd Value:
Value Percent:
Continuous Index:
Within 8" of Joint:
Remarks:

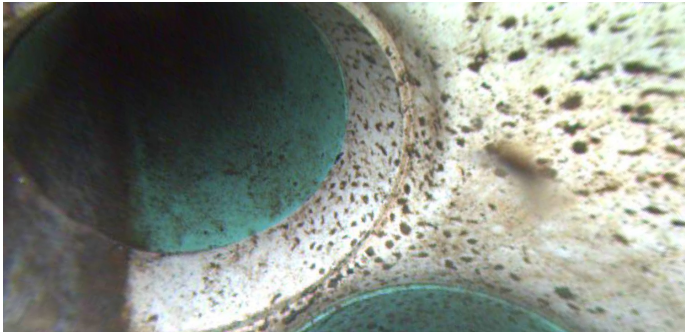
Code: **TF**
Description: **Tap Factory**

Distance (ft): **230.9**
Structural Grade: **0**
O&M Grade: **0**
Clock Start/From: **1**
Clock To:
1st Value: **4.000**
2nd Value:
Value Percent:
Continuous Index:
Within 8" of Joint:
Remarks:

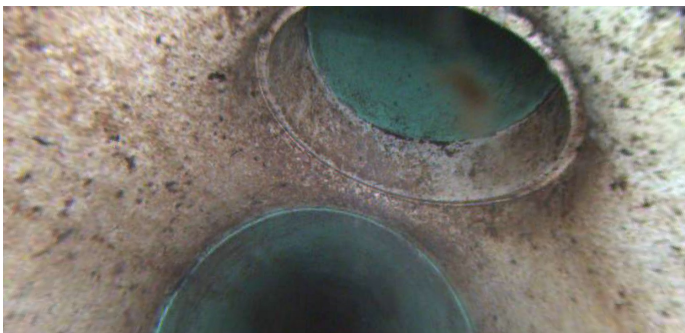
Code: **TF**
Description: **Tap Factory**

Distance (ft): **279.3**
Structural Grade: **0**
O&M Grade: **0**
Clock Start/From: **11**
Clock To:
1st Value: **4.000**
2nd Value:
Value Percent:
Continuous Index:
Within 8" of Joint:
Remarks:

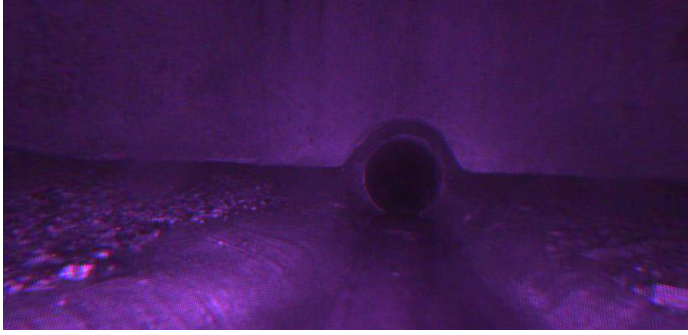
Code:	AMH
Description:	Manhole
Distance (ft):	297.1
Structural Grade:	0
O&M Grade:	0
Clock Start/From:	
Clock To:	
1st Value:	
2nd Value:	
Value Percent:	
Continuous Index:	
Within 8" of Joint:	NO
Remarks:	M-707-060
