Profile/Photo Observation Report

Street:	E 12TH ST & S LAKE PARK AVE	Flow Control:	Not Controlled
City:	Hobart, IN	Year Renewed:	
Location:	Yard	Tape/Media #:	
Purpose:	Routine Assessment	Dia/Height:	8"
Use:	Sanitary	Material:	PVC
Drain Area:	NA	Lining:	
Category:	NA		
Comment:

Location Details:		Direction of Survey:	Upstream
US MH:	M-707-061	DS MH:	M-707-062
		Total Length Surveyed (ft):	111.1

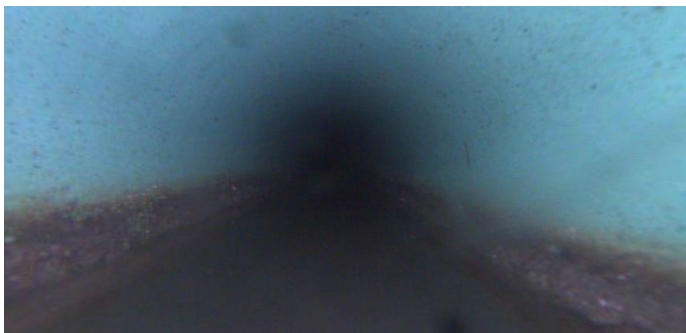
Code: **AMH**
Description: **Manhole**

Distance (ft): **.0**
Structural Grade: **0**
O&M Grade: **0**
Clock Start/From:
Clock To:
1st Value:
2nd Value:
Value Percent:
Continuous Index:
Within 8" of Joint: **NO**
Remarks: **M-707-062**

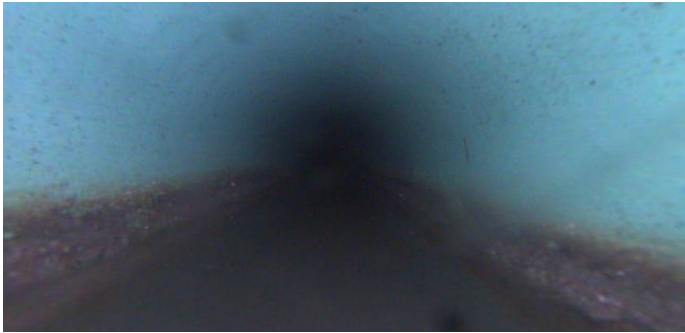
Code:	MWL
Description:	Water Level

Distance (ft):	.0
Structural Grade:	0
O&M Grade:	0
Clock Start/From:	
Clock To:	
1st Value:	
2nd Value:	
Value Percent:	20.000
Continuous Index:	
Within 8" of Joint:	NO
Remarks:

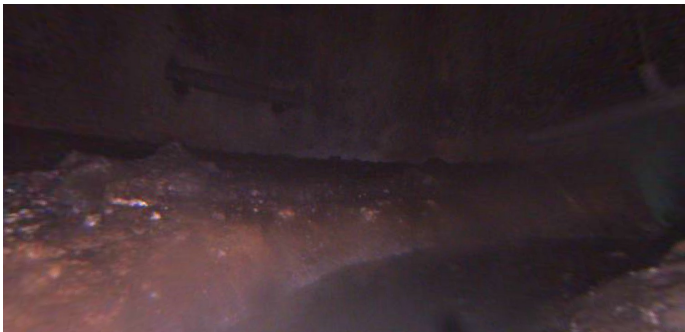
Code:	AMH
Description:	Manhole

Distance (ft):	111.1
Structural Grade:	0
O&M Grade:	0
Clock Start/From:	
Clock To:	
1st Value:	
2nd Value:	
Value Percent:	
Continuous Index:	
Within 8" of Joint:	NO
Remarks:	M-707-061
