# Profile/Photo Observation Report

Street:	<b>FOXCROFT STREET</b>	Flow Control:	<b>Not Controlled</b>
City:	<b>Hobart, IN</b>	Year Renewed:	
Location:	<b>Yard</b>	Tape/Media #:	
Purpose:	<b>Routine Assessment</b>	Dia/Height:	<b>8"</b>
Use:	<b>Sanitary</b>	Material:	<b>PVC</b>
Drain Area:	<b>NA</b>	Lining:	
Category:	<b>NA</b>		
Comment:			
Location Details:		Direction of Survey:	<b>Upstream</b>
US MH:	<b>M-707-061</b>	DS MH:	<b>M-707-062</b>
		Total Length Surveyed (ft):	<b>111.1</b>

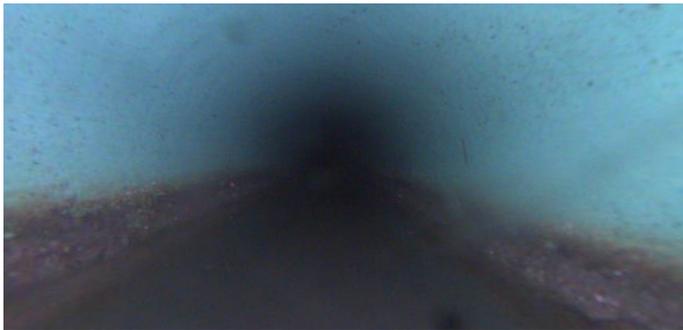
Code: **AMH**  
Description: **Manhole**

Distance (ft): **.0**  
Structural Grade: **0**  
O&M Grade: **0**  
Clock Start/From:  
Clock To:  
1st Value:  
2nd Value:  
Value Percent:  
Continuous Index:  
Within 8" of Joint: **NO**  
Remarks: **M-707-062**

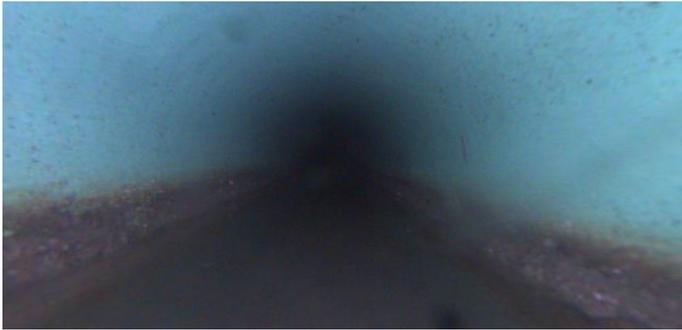
Code: **MWL**  
Description: **Water Level**

Distance (ft): **.0**  
Structural Grade: **0**  
O&M Grade: **0**  
Clock Start/From:  
Clock To:  
1st Value:  
2nd Value:  
Value Percent: **20.000**  
Continuous Index:  
Within 8" of Joint: **NO**  
Remarks:

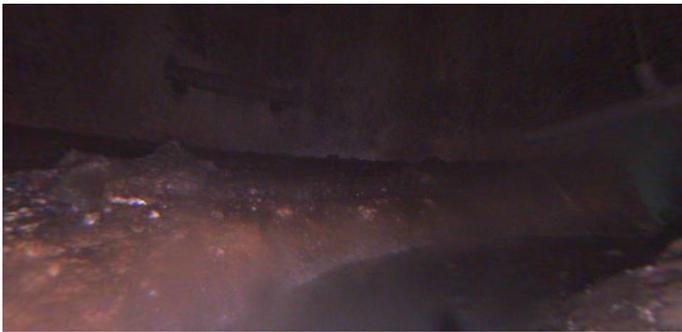
Code: **AMH**  
Description: **Manhole**

Distance (ft): **111.1**  
Structural Grade: **0**  
O&M Grade: **0**  
Clock Start/From:  
Clock To:  
1st Value:  
2nd Value:  
Value Percent:  
Continuous Index:  
Within 8" of Joint: **NO**  
Remarks: **M-707-061**
