# Profile/Photo Observation Report

Street:	<b>S LAKE PARK AVE</b>	Flow Control:	<b>Not Controlled</b>
City:	<b>Hobart, IN</b>	Year Renewed:	
Location:	<b>Yard</b>	Tape/Media #:	
Purpose:	<b>Routine Assessment</b>	Dia/Height:	<b>10"</b>
Use:	<b>Sanitary</b>	Material:	<b>PVC</b>
Drain Area:	<b>NA</b>	Lining:	
Category:	<b>NA</b>		
Comment:			
Location Details:		Direction of Survey:	<b>Downstream</b>
US MH:	<b>M-707-062</b>	DS MH:	<b>M-607-006</b>
		Total Length Surveyed (ft):	<b>348.4</b>

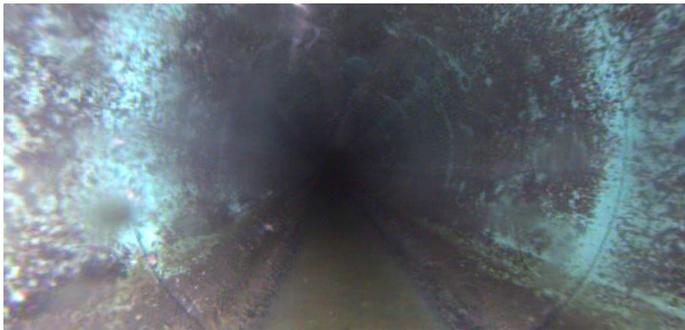
Code: **AMH**  
 Description: **Manhole**  
 Distance (ft): **.0**  
 Structural Grade: **0**  
 O&M Grade: **0**  
 Clock Start/From:  
 Clock To:  
 1st Value:  
 2nd Value:  
 Value Percent:  
 Continuous Index:  
 Within 8" of Joint: **NO**  
 Remarks: **M-707-062**

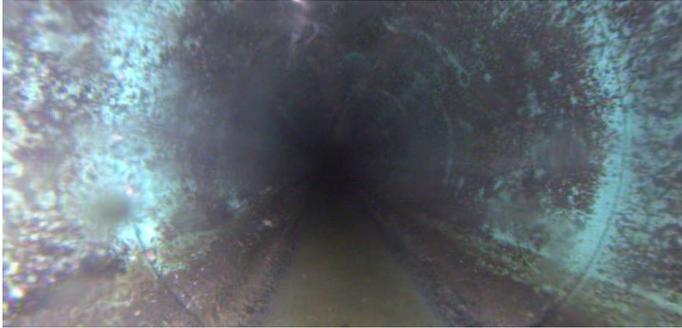
Code: **MWL**  
Description: **Water Level**

Distance (ft): **.0**  
Structural Grade: **0**  
O&M Grade: **0**  
Clock Start/From:  
Clock To:  
1st Value:  
2nd Value:  
Value Percent: **5.000**  
Continuous Index:  
Within 8" of Joint: **NO**  
Remarks:

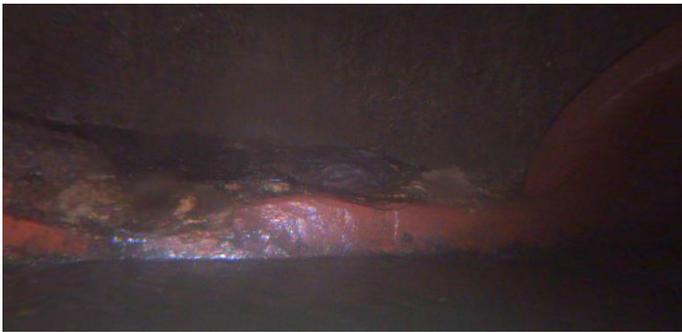
Code: **AMH**  
Description: **Manhole**

Distance (ft): **348.4**  
Structural Grade: **0**  
O&M Grade: **0**  
Clock Start/From:  
Clock To:  
1st Value:  
2nd Value:  
Value Percent:  
Continuous Index:  
Within 8" of Joint: **NO**  
Remarks: **M-607-006**
