## Profile/Photo Observation Report

Street:	<b>FOXCROFT STREET</b>	Flow Control:	<b>Not Controlled</b>
City:	<b>Hobart, IN</b>	Year Renewed:	
Location:	<b>Yard</b>	Tape/Media #:	
Purpose:	<b>Routine Assessment</b>	Dia/Height:	<b>10"</b>
Use:	<b>Sanitary</b>	Material:	<b>PVC</b>
Drain Area:	<b>NA</b>	Lining:	
Category:	<b>NA</b>		
Comment:

Location Details:		Direction of Survey:	<b>Downstream</b>
US MH:	<b>M-707-062</b>	DS MH:	<b>M-607-006</b>
		Total Length Surveyed (ft):	<b>348.4</b>

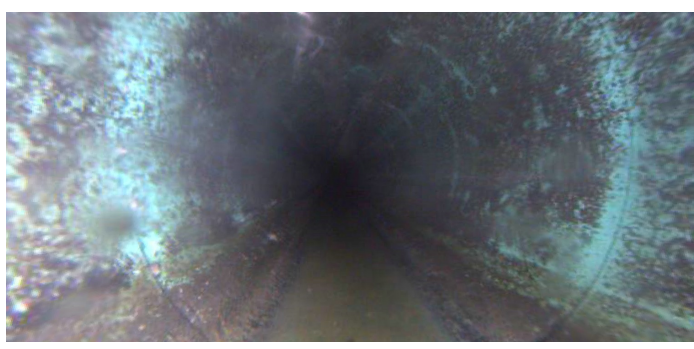
Code: **AMH**  
Description: **Manhole**

Distance (ft): **.0**  
Structural Grade: **0**  
O&M Grade: **0**  
Clock Start/From:  
Clock To:  
1st Value:  
2nd Value:  
Value Percent:  
Continuous Index:  
Within 8" of Joint: **NO**  
Remarks: **M-707-062**

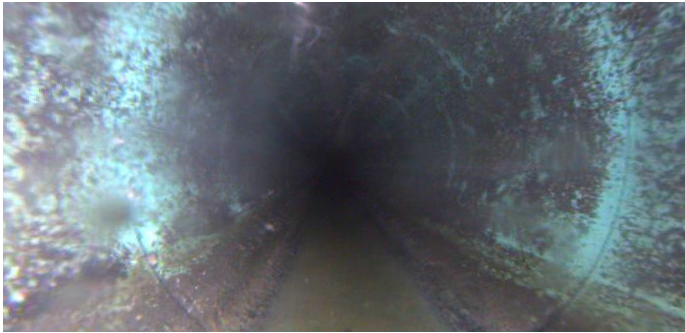
Code:	<b>MWL</b>
Description:	<b>Water Level</b>

Distance (ft):	<b>.0</b>
Structural Grade:	<b>0</b>
O&M Grade:	<b>0</b>
Clock Start/From:	
Clock To:	
1st Value:	
2nd Value:	
Value Percent:	<b>5.000</b>
Continuous Index:	
Within 8" of Joint:	<b>NO</b>
Remarks:

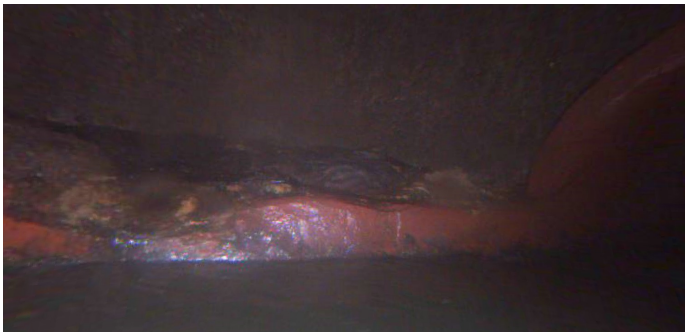
Code:	<b>AMH</b>
Description:	<b>Manhole</b>

Distance (ft):	<b>348.4</b>
Structural Grade:	<b>0</b>
O&M Grade:	<b>0</b>
Clock Start/From:	
Clock To:	
1st Value:	
2nd Value:	
Value Percent:	
Continuous Index:	
Within 8" of Joint:	<b>NO</b>
Remarks:	<b>M-607-006</b>
