Profile/Photo Observation Report

Date:	04/04/2018	Weather:		Coding:	PACP 6.0
Pipe Length (ft):	376.0	Owner:	NA	Pre Clean:	No Pre-Cleaning
P.O.#:		Surveyor:	Jen Costello	PSR:	P-707-053-062
Customer:		Clean Date:	01/01/1900	Shape:	C

Street:	S LAKE PARK AVE & E 13TH ST	Flow Control:	Not Controlled
City:	Hobart, IN	Year Renewed:	
Location:	Yard	Tape/Media #:	
Purpose:	Routine Assessment	Dia/Height:	8"
Use:	Sanitary	Material:	PVC
Drain Area:	NA	Lining:	
Category:	NA		
Comment:	Flow direction is marked wrong.		
Location Details:		Direction of Survey:	Downstream
US MH:	M-707-062	DS MH:	M-707-053
		Total Length Surveyed (ft):	369.2

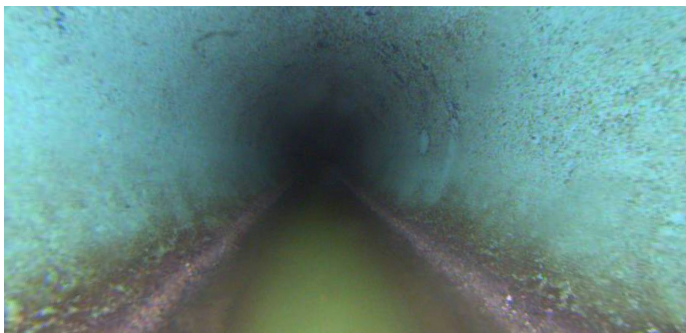
Code: **AMH**
Description: **Manhole**

Distance (ft): **.0**
Structural Grade: **0**
O&M Grade: **0**
Clock Start/From:
Clock To:
1st Value:
2nd Value:
Value Percent:
Continuous Index:
Within 8" of Joint: **NO**
Remarks: **M-707-062**

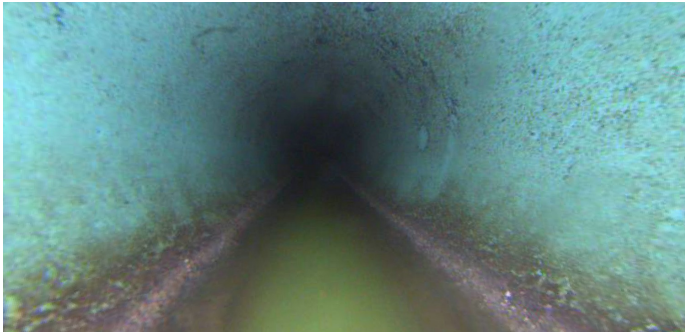
Code:	MWL
Description:	Water Level

Distance (ft):	.0
Structural Grade:	0
O&M Grade:	0
Clock Start/From:	
Clock To:	
1st Value:	
2nd Value:	
Value Percent:	5.000
Continuous Index:	
Within 8" of Joint:	NO
Remarks:

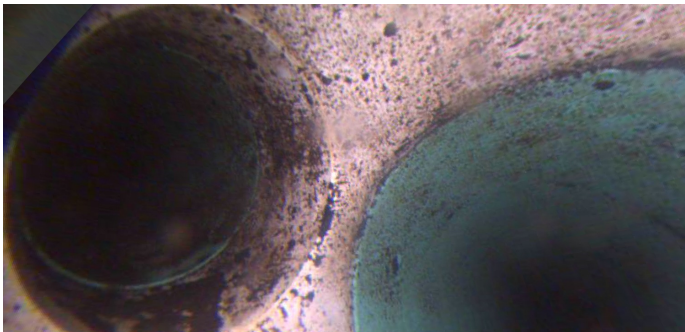
Code:	TF
Description:	Tap Factory

Distance (ft):	9.8
Structural Grade:	0
O&M Grade:	0
Clock Start/From:	10
Clock To:	
1st Value:	4.000
2nd Value:	
Value Percent:	
Continuous Index:	
Within 8" of Joint:	
Remarks:

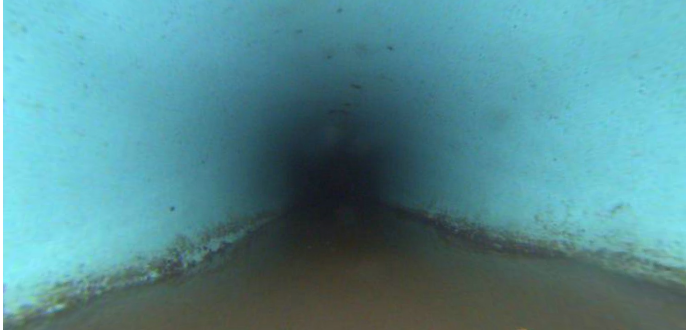
Code: **MWL**
Description: **Water Level**

Distance (ft): **29.0**
Structural Grade: **0**
O&M Grade: **0**
Clock Start/From:
Clock To:
1st Value:
2nd Value:
Value Percent: **30.000**
Continuous Index:
Within 8" of Joint: **NO**
Remarks:

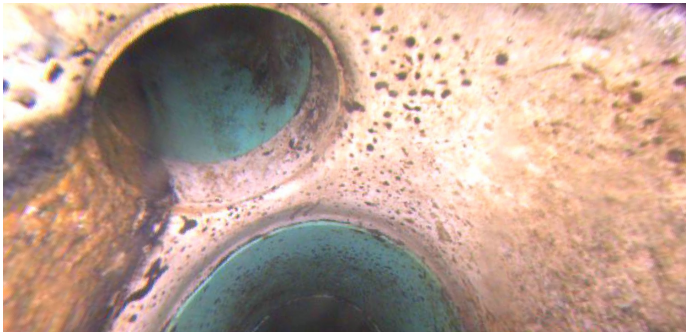
Code: **TF**
Description: **Tap Factory**

Distance (ft): **134.8**
Structural Grade: **0**
O&M Grade: **0**
Clock Start/From: **11**
Clock To:
1st Value: **4.000**
2nd Value:
Value Percent:
Continuous Index:
Within 8" of Joint:
Remarks:

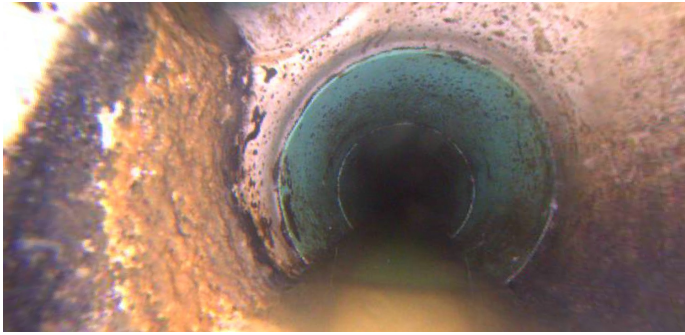
Code: **DAGS**
Description: **Deposits Attached Grease**

Distance (ft): **134.8**
Structural Grade: **0**
O&M Grade: **2**
Clock Start/From: **7**
Clock To: **11**
1st Value:
2nd Value:
Value Percent: **5.000**
Continuous Index:
Within 8" of Joint: **NO**
Remarks:

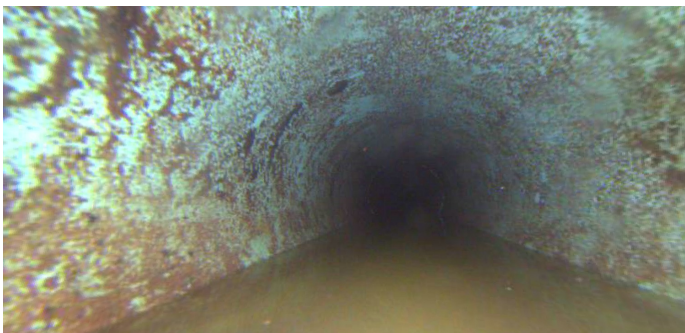
Code: **MWL**
Description: **Water Level**

Distance (ft): **233.7**
Structural Grade: **0**
O&M Grade: **0**
Clock Start/From:
Clock To:
1st Value:
2nd Value:
Value Percent: **30.000**
Continuous Index:
Within 8" of Joint: **NO**
Remarks:

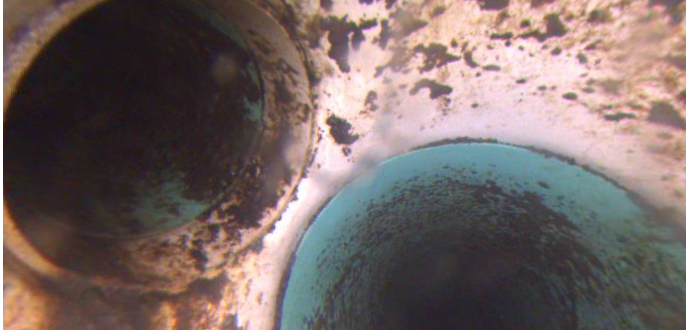
Code: **TF**
Description: **Tap Factory**

Distance (ft): **266.5**
Structural Grade: **0**
O&M Grade: **0**
Clock Start/From: **10**
Clock To:
1st Value: **4.000**
2nd Value:
Value Percent:
Continuous Index:
Within 8" of Joint:
Remarks:

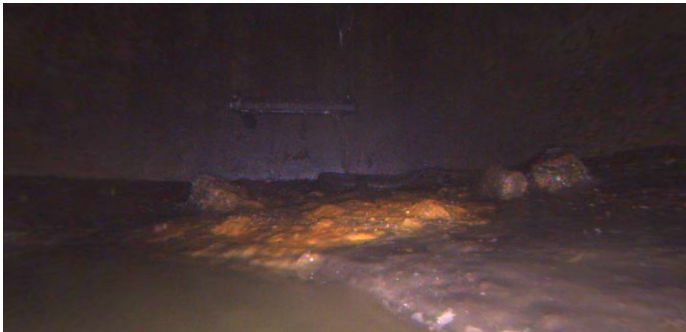
Code: **AMH**
Description: **Manhole**

Distance (ft): **369.2**
Structural Grade: **0**
O&M Grade: **0**
Clock Start/From:
Clock To:
1st Value:
2nd Value:
Value Percent:
Continuous Index:
Within 8" of Joint: **NO**
Remarks: **M-707-053**
