Profile/Photo Observation Report

Date:	04/04/2018	Weather:		Coding:	PACP 6.0
Pipe Length (ft):	376.0	Owner:	NA	Pre Clean:	No Pre-Cleaning
P.O.#:		Surveyor:	Jen Costello	PSR:	P-707-053-062
Customer:		Clean Date:	01/01/1900	Shape:	C

Street:	FOXCROFT STREET	Flow Control:	Not Controlled
City:	Hobart, IN	Year Renewed:	
Location:	Yard	Tape/Media #:	
Purpose:	Routine Assessment	Dia/Height:	8"
Use:	Sanitary	Material:	PVC
Drain Area:	NA	Lining:	
Category:	NA		
Comment:	Flow direction is marked wrong.

Location Details:		Direction of Survey:	Downstream
US MH:	M-707-062	DS MH:	M-707-053
		Total Length Surveyed (ft):	369.2

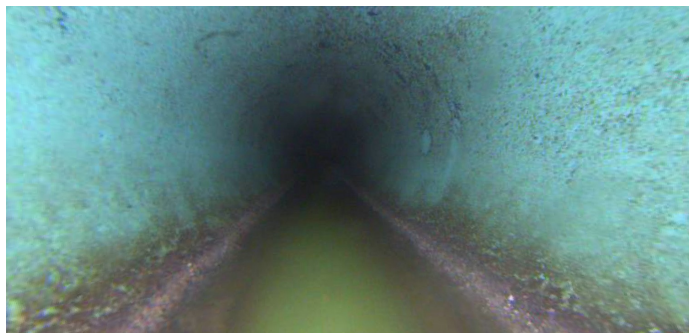
Code: **AMH**
 Description: **Manhole**

Distance (ft): **.0**
 Structural Grade: **0**
 O&M Grade: **0**
 Clock Start/From:
 Clock To:
 1st Value:
 2nd Value:
 Value Percent:
 Continuous Index:
 Within 8" of Joint: **NO**
 Remarks: **M-707-062**

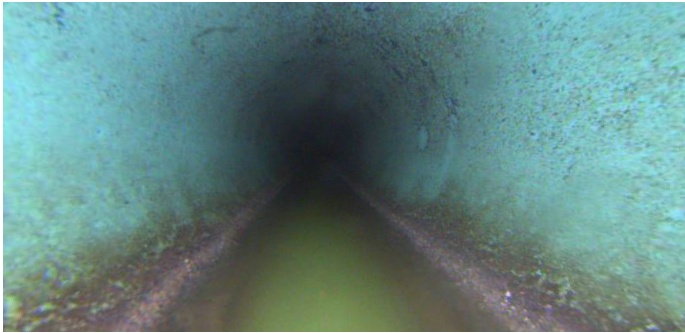
Code:	MWL
Description:	Water Level

Distance (ft):	.0
Structural Grade:	0
O&M Grade:	0
Clock Start/From:	
Clock To:	
1st Value:	
2nd Value:	
Value Percent:	5.000
Continuous Index:	
Within 8" of Joint:	NO
Remarks:

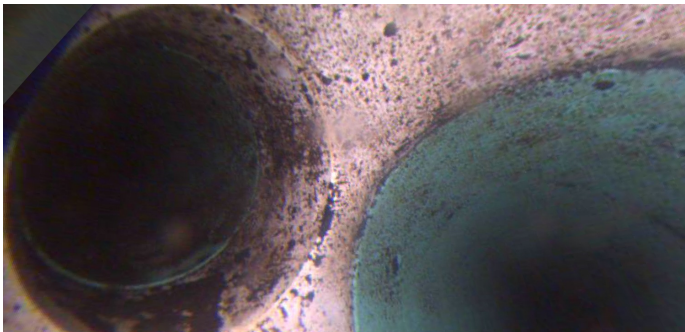
Code:	TF
Description:	Tap Factory

Distance (ft):	9.8
Structural Grade:	0
O&M Grade:	0
Clock Start/From:	10
Clock To:	
1st Value:	4.000
2nd Value:	
Value Percent:	
Continuous Index:	
Within 8" of Joint:	
Remarks:

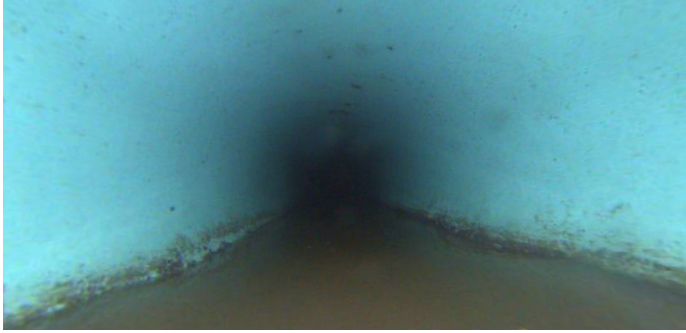
Code: **MWL**
Description: **Water Level**

Distance (ft): **29.0**
Structural Grade: **0**
O&M Grade: **0**
Clock Start/From:
Clock To:
1st Value:
2nd Value:
Value Percent: **30.000**
Continuous Index:
Within 8" of Joint: **NO**
Remarks:

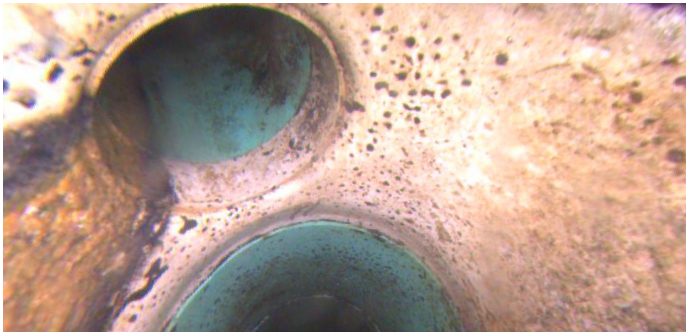
Code: **TF**
Description: **Tap Factory**

Distance (ft): **134.8**
Structural Grade: **0**
O&M Grade: **0**
Clock Start/From: **11**
Clock To:
1st Value: **4.000**
2nd Value:
Value Percent:
Continuous Index:
Within 8" of Joint:
Remarks:

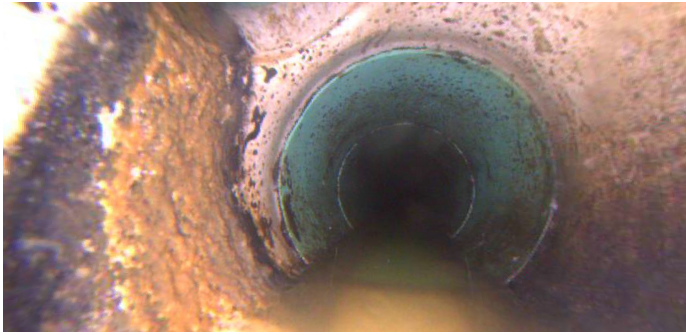
Code: **DAGS**
Description: **Deposits Attached Grease**

Distance (ft): **134.8**
Structural Grade: **0**
O&M Grade: **2**
Clock Start/From: **7**
Clock To: **11**
1st Value:
2nd Value:
Value Percent: **5.000**
Continuous Index:
Within 8" of Joint: **NO**
Remarks:

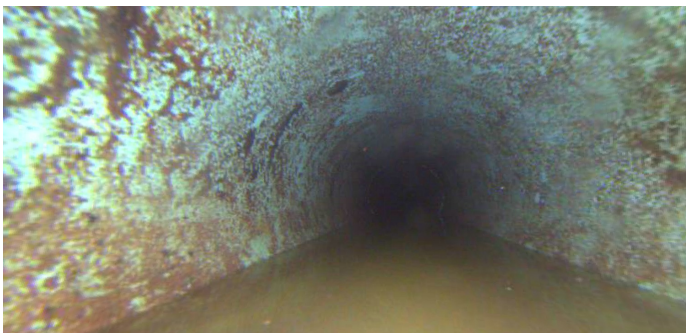
Code: **MWL**
Description: **Water Level**

Distance (ft): **233.7**
Structural Grade: **0**
O&M Grade: **0**
Clock Start/From:
Clock To:
1st Value:
2nd Value:
Value Percent: **30.000**
Continuous Index:
Within 8" of Joint: **NO**
Remarks:

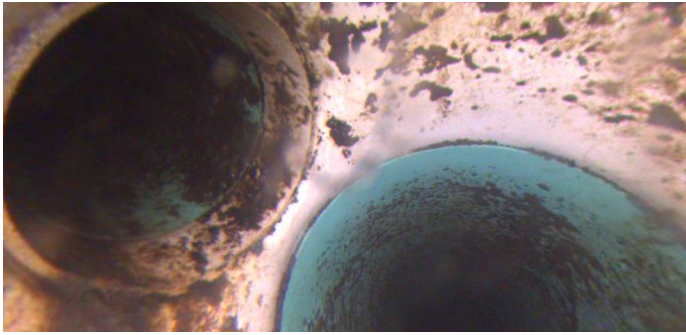
Code: **TF**
Description: **Tap Factory**

Distance (ft): **266.5**
Structural Grade: **0**
O&M Grade: **0**
Clock Start/From: **10**
Clock To:
1st Value: **4.000**
2nd Value:
Value Percent:
Continuous Index:
Within 8" of Joint:
Remarks:

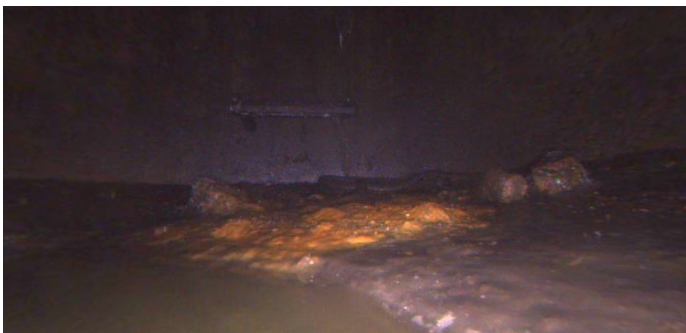
Code: **AMH**
Description: **Manhole**

Distance (ft): **369.2**
Structural Grade: **0**
O&M Grade: **0**
Clock Start/From:
Clock To:
1st Value:
2nd Value:
Value Percent:
Continuous Index:
Within 8" of Joint: **NO**
Remarks: **M-707-053**
