## Profile/Photo Observation Report

Street:	<b>E 11TH ST &amp; E 11TH PL</b>	Flow Control:	<b>Not Controlled</b>
City:	<b>Hobart, IN</b>	Year Renewed:	
Location:	<b>Light Highway</b>	Tape/Media #:	
Purpose:	<b>Maintenance Related</b>	Dia/Height:	<b>12"</b>
Use:	<b>Sanitary</b>	Material:	<b>VCP</b>
Drain Area:	<b>NA</b>	Lining:	<b>Cured in Place</b>
Category:	<b>NA</b>		
Comment:	<b>blk silt and debris at 21'.</b>		
Location Details:		Direction of Survey:	<b>Downstream</b>
US MH:	<b>M-707-063</b>	DS MH:	<b>M-707-071</b>
		Total Length Surveyed (ft):	<b>23.1</b>

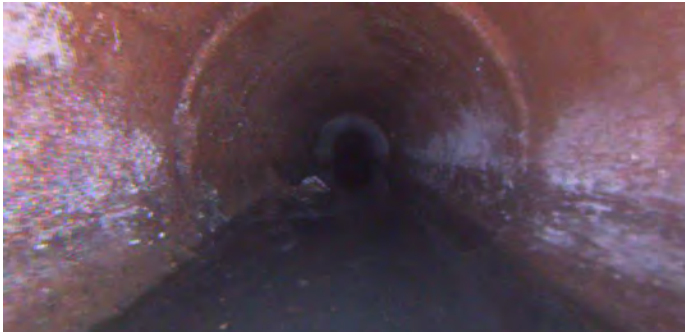
Code:	<b>MWL</b>
Description:	<b>Water Level</b>

Distance (ft):	<b>.0</b>
Structural Grade:	<b>0</b>
O&M Grade:	<b>0</b>
Clock Start/From:	
Clock To:	
1st Value:	
2nd Value:	
Value Percent:	<b>5.000</b>
Continuous Index:	
Within 8" of Joint:	<b>NO</b>
Remarks:

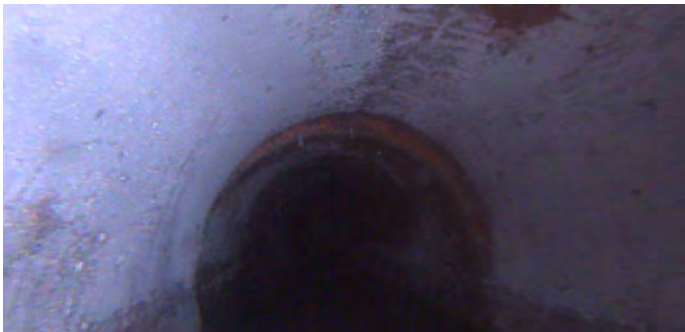
Code:	<b>RFJ</b>
Description:	<b>Roots Fine Joint</b>

Distance (ft):	<b>6.8</b>
Structural Grade:	<b>0</b>
O&M Grade:	<b>1</b>
Clock Start/From:	<b>11</b>
Clock To:	<b>12</b>
1st Value:	
2nd Value:	
Value Percent:	
Continuous Index:	
Within 8" of Joint:	<b>YES</b>
Remarks:

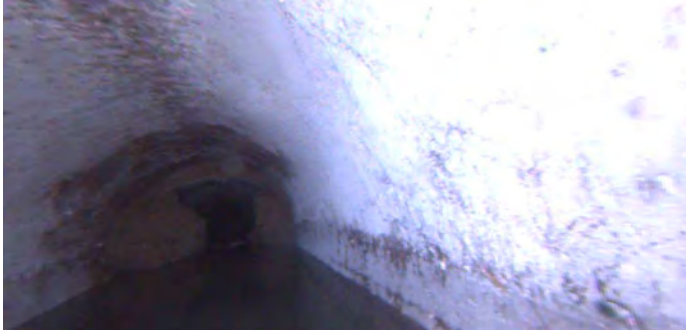
Code: **RBJ**  
Description: **Roots Ball Joint**

Distance (ft): **14.3**  
Structural Grade: **0**  
O&M Grade: **4**  
Clock Start/From: **7**  
Clock To: **5**  
1st Value:  
2nd Value:  
Value Percent: **65.000**  
Continuous Index: **S01**  
Within 8" of Joint: **YES**  
Remarks:

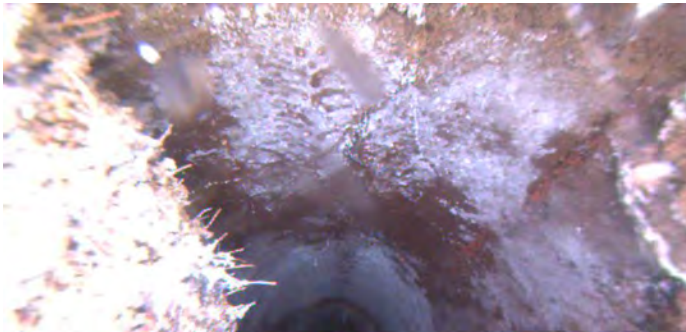
Code: **FL**  
Description: **Fracture Longitudinal**

Distance (ft): **16.5**  
Structural Grade: **3**  
O&M Grade: **0**  
Clock Start/From: **1**  
Clock To:  
1st Value:  
2nd Value:  
Value Percent:  
Continuous Index:  
Within 8" of Joint:  
Remarks:

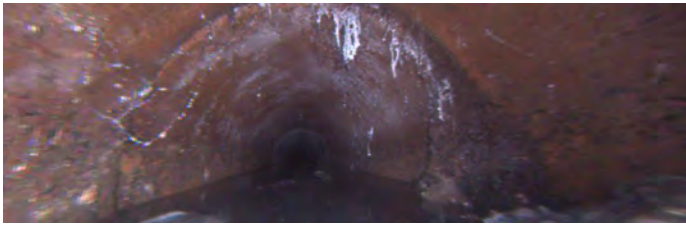
Code: **RBJ**  
Description: **Roots Ball Joint**

Distance (ft): **21.9**  
Structural Grade: **0**  
O&M Grade: **4**  
Clock Start/From: **7**  
Clock To: **5**  
1st Value:  
2nd Value:  
Value Percent: **65.000**  
Continuous Index: **F01**  
Within 8" of Joint: **YES**  
Remarks:

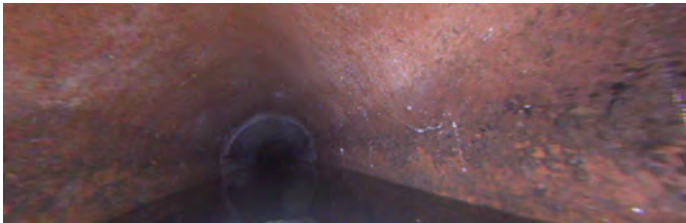
Code: **MSA**  
Description: **Abandoned Survey**

Distance (ft): **23.1**  
Structural Grade: **0**  
O&M Grade: **0**  
Clock Start/From:  
Clock To:  
1st Value:  
2nd Value:  
Value Percent:  
Continuous Index:  
Within 8" of Joint: **NO**  
Remarks: **camera stopped**
