## Profile/Photo Observation Report

Date:	<b>04/15/2018</b>	Weather:		Coding:	<b>PACP 6.0</b>
Pipe Length (ft):	<b>182.0</b>	Owner:	<b>NA</b>	Pre Clean:	<b>Not Known</b>
P.O.#:		Surveyor:	<b>Selasie Honu</b>	PSR:	<b>P-707-071-063</b>
Customer:		Clean Date:	<b>01/01/1900</b>	Shape:	<b>C</b>

Street:	<b>Capitol</b>	Flow Control:	<b>Not Controlled</b>
City:	<b>Hobart, IN</b>	Year Renewed:	
Location:	<b>Light Highway</b>	Tape/Media #:	
Purpose:	<b>Maintenance Related</b>	Dia/Height:	<b>12"</b>
Use:	<b>Sanitary</b>	Material:	<b>VCP</b>
Drain Area:	<b>NA</b>	Lining:	<b>Cured in Place</b>
Category:	<b>NA</b>		
Comment:	<b>blk silt and debris at 21'.</b>

Location Details:		Direction of Survey:	<b>Downstream</b>
US MH:	<b>M-707-063</b>	DS MH:	<b>M-707-071</b>
		Total Length Surveyed (ft):	<b>23.1</b>

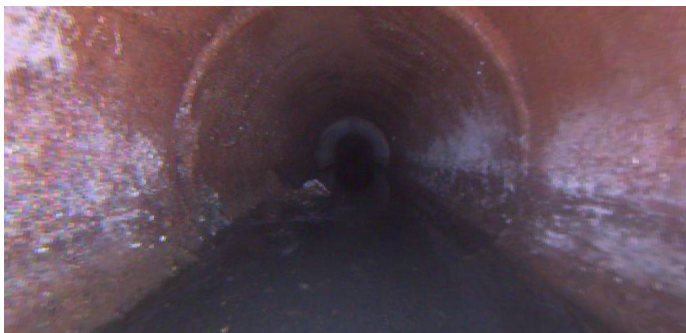
Code: **AMH**  
Description: **Manhole**

Distance (ft): **.0**  
Structural Grade: **0**  
O&M Grade: **0**  
Clock Start/From:  
Clock To:  
1st Value:  
2nd Value:  
Value Percent:  
Continuous Index:  
Within 8" of Joint: **NO**  
Remarks: **M-707-063**

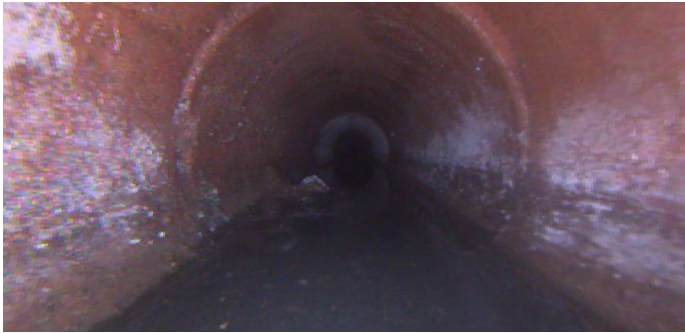
Code:	<b>MWL</b>
Description:	<b>Water Level</b>

Distance (ft):	<b>.0</b>
Structural Grade:	<b>0</b>
O&M Grade:	<b>0</b>
Clock Start/From:	
Clock To:	
1st Value:	
2nd Value:	
Value Percent:	<b>5.000</b>
Continuous Index:	
Within 8" of Joint:	<b>NO</b>
Remarks:

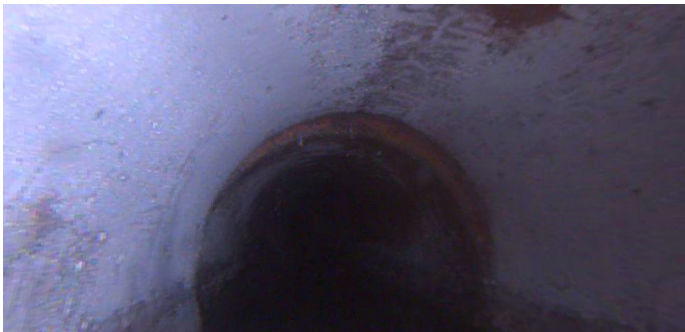
Code:	<b>RFJ</b>
Description:	<b>Roots Fine Joint</b>

Distance (ft):	<b>6.8</b>
Structural Grade:	<b>0</b>
O&M Grade:	<b>1</b>
Clock Start/From:	<b>11</b>
Clock To:	<b>12</b>
1st Value:	
2nd Value:	
Value Percent:	
Continuous Index:	
Within 8" of Joint:	<b>YES</b>
Remarks:

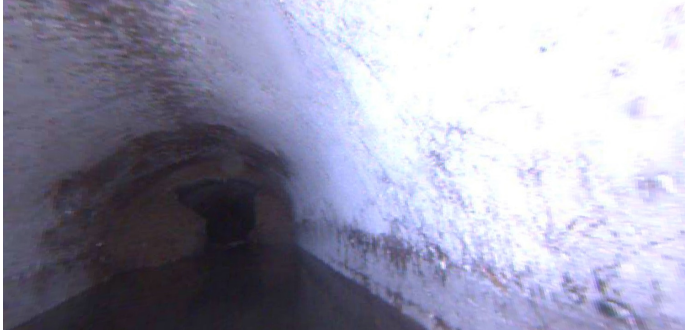
Code: **RBJ**  
Description: **Roots Ball Joint**

Distance (ft): **14.3**  
Structural Grade: **0**  
O&M Grade: **4**  
Clock Start/From: **7**  
Clock To: **5**  
1st Value:  
2nd Value:  
Value Percent: **65.000**  
Continuous Index: **S01**  
Within 8" of Joint: **YES**  
Remarks:

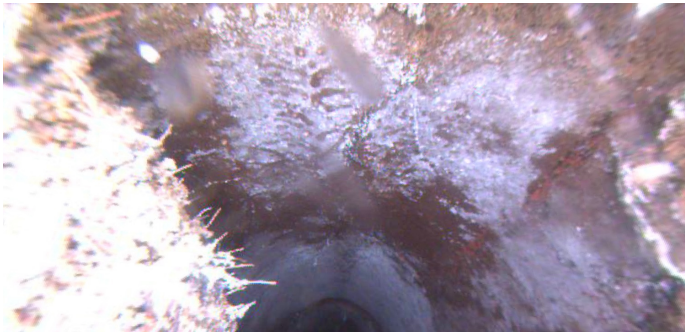
Code: **FL**  
Description: **Fracture Longitudinal**

Distance (ft): **16.5**  
Structural Grade: **3**  
O&M Grade: **0**  
Clock Start/From: **1**  
Clock To:  
1st Value:  
2nd Value:  
Value Percent:  
Continuous Index:  
Within 8" of Joint:  
Remarks:

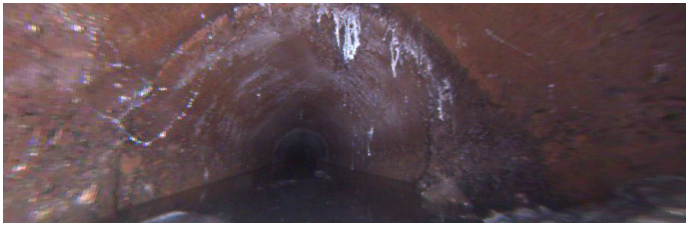
Code: **RBJ**  
Description: **Roots Ball Joint**

Distance (ft): **21.9**  
Structural Grade: **0**  
O&M Grade: **4**  
Clock Start/From: **7**  
Clock To: **5**  
1st Value:  
2nd Value:  
Value Percent: **65.000**  
Continuous Index: **F01**  
Within 8" of Joint: **YES**  
Remarks:

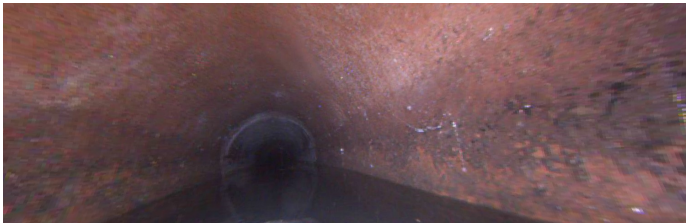
Code: **MSA**  
Description: **Abandoned Survey**

Distance (ft): **23.1**  
Structural Grade: **0**  
O&M Grade: **0**  
Clock Start/From:  
Clock To:  
1st Value:  
2nd Value:  
Value Percent:  
Continuous Index:  
Within 8" of Joint: **NO**  
Remarks: **camera stopped**
