Profile/Photo Observation Report

Date:	02/17/2022	Weather:		Coding:	PACP 7.0
Pipe Length (ft):	181.1	Owner:	City of Hobart	Pre Clean:	Heavy Cleaning
P.O.#:	YES502259	Surveyor:	S. Bucklin	PSR:	P-707-071-063
Customer:	City of Hobart	Clean Date:	02/15/2022	Shape:	C

Street:	East 11th Place	Flow Control:	Not Controlled
City:	Hobart, IN	Year Renewed:	
Location:	Local rural streets with light traffic, t	Tape/Media #:	
Purpose:	Routine Assessment	Dia/Height:	12"
Use:	Sanitary Sewage Pipe	Material:	VCP
Drain Area:		Lining:	None
Category:	NA		
Comment:			
Location Details:		Direction of Survey:	Downstream
US MH:	M-707-063	DS MH:	M-707-071
		Total Length Surveyed (ft):	181.1

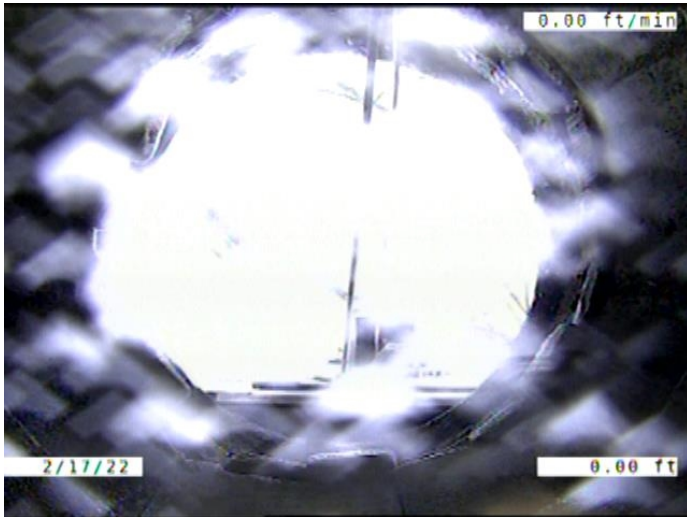
Code: **AMH**
 Description: **Manhole**

Distance (ft): **.0**
 Structural Grade: **0**
 O&M Grade: **0**
 Clock Start/From:
 Clock To:
 1st Value:
 2nd Value:
 Value Percent:
 Continuous Index:
 Within 8" of Joint: **NO**
 Remarks: **M-707-063**

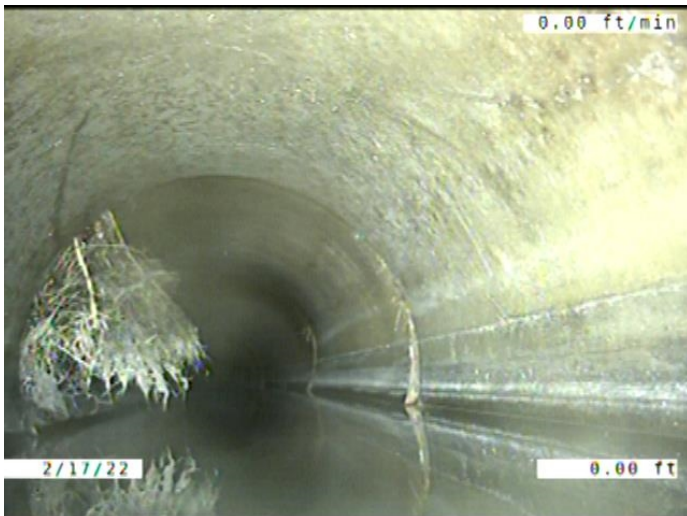
Code: **MWL**
 Description: **Miscellaneous Water Level**

Distance (ft): **.0**
 Structural Grade: **0**
 O&M Grade: **0**
 Clock Start/From:
 Clock To:
 1st Value:
 2nd Value:
 Value Percent: **15.000**
 Continuous Index:
 Within 8" of Joint: **NO**
 Remarks:

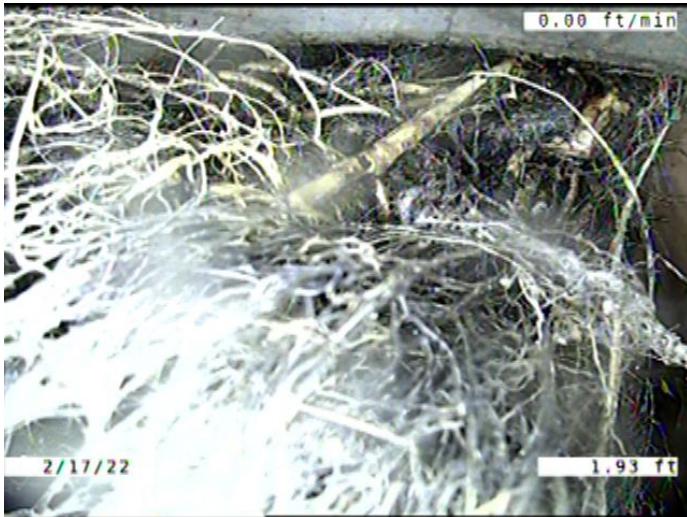
Code: **RMJ**
 Description: **Roots Medium Joint**

Distance (ft): **1.9**
 Structural Grade: **0**
 O&M Grade: **3**
 Clock Start/From: **9**
 Clock To: **3**
 1st Value:
 2nd Value:
 Value Percent: **15.000**
 Continuous Index:
 Within 8" of Joint: **YES**
 Remarks:

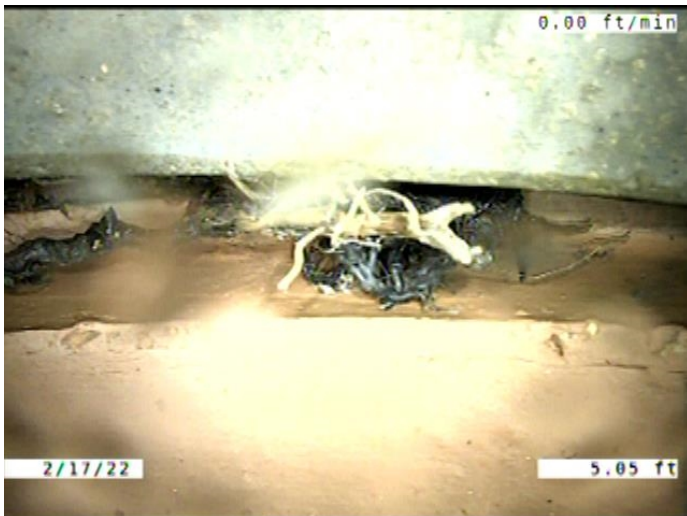
Code: **RFJ**
 Description: **Roots Fine Joint**

Distance (ft): **5.0**
 Structural Grade: **0**
 O&M Grade: **1**
 Clock Start/From: **9**
 Clock To: **3**
 1st Value:
 2nd Value:
 Value Percent:
 Continuous Index:
 Within 8" of Joint: **YES**
 Remarks:

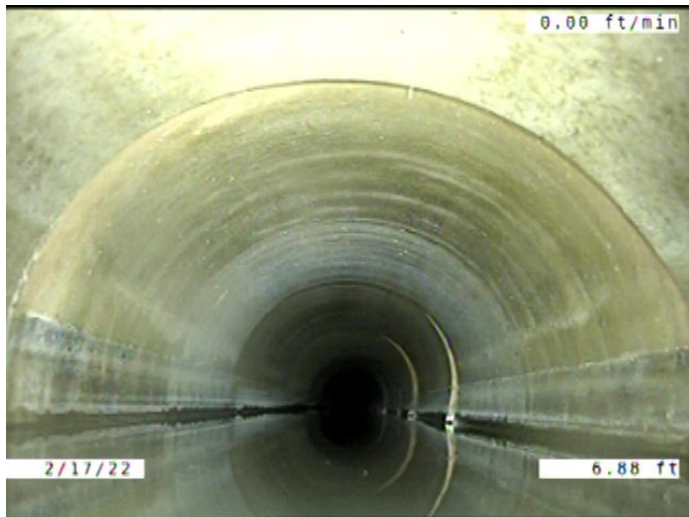
Code: **MWLS**
 Description: **Miscellaneous Water Level Sag**

Distance (ft): **6.9**
 Structural Grade: **2**
 O&M Grade: **0**
 Clock Start/From:
 Clock To:
 1st Value:
 2nd Value:
 Value Percent: **30.000**
 Continuous Index: **S01**
 Within 8" of Joint: **NO**
 Remarks:

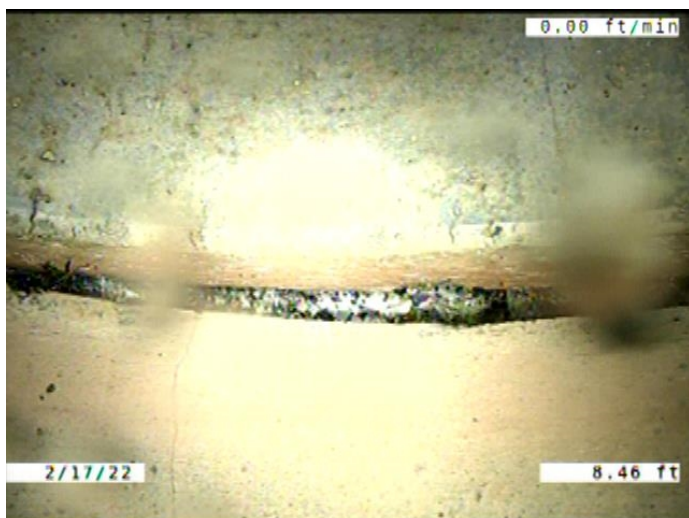
Code: **JOM**
 Description: **Joint Offset Medium**

Distance (ft): **8.5**
 Structural Grade: **3**
 O&M Grade: **0**
 Clock Start/From:
 Clock To:
 1st Value:
 2nd Value:
 Value Percent:
 Continuous Index:
 Within 8" of Joint: **NO**
 Remarks:

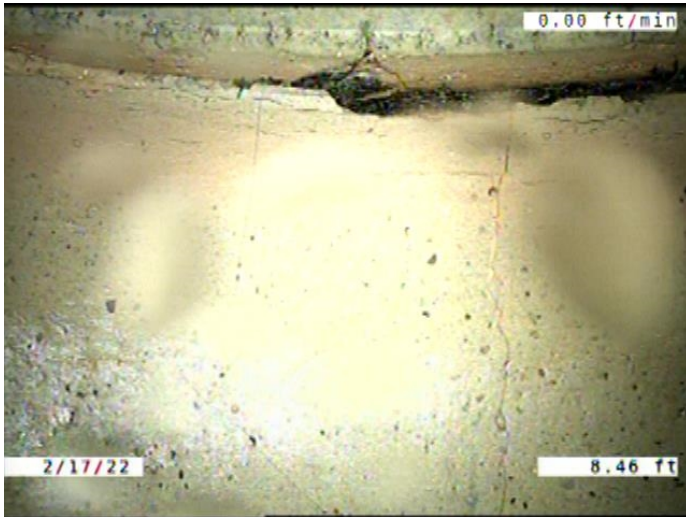
Code: **CM**
 Description: **Crack Multiple**

Distance (ft): **8.5**
 Structural Grade: **3**
 O&M Grade: **0**
 Clock Start/From: **9**
 Clock To: **3**
 1st Value:
 2nd Value:
 Value Percent:
 Continuous Index:
 Within 8" of Joint: **YES**
 Remarks:

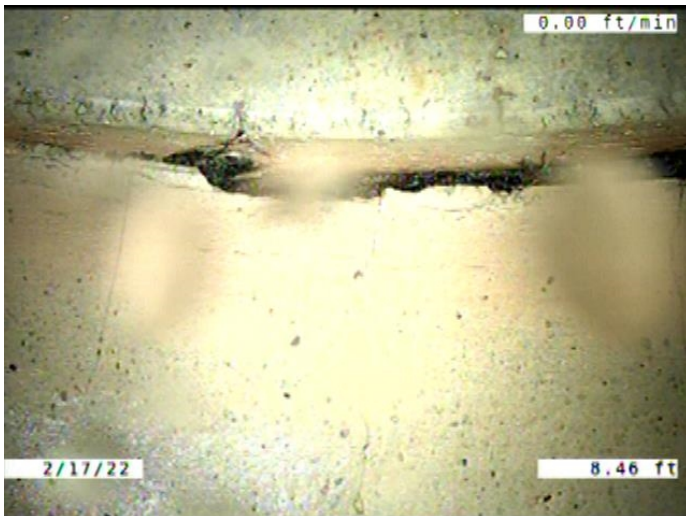
Code: **RFJ**
 Description: **Roots Fine Joint**

Distance (ft): **8.5**
 Structural Grade: **0**
 O&M Grade: **1**
 Clock Start/From: **12**
 Clock To: **2**
 1st Value:
 2nd Value:
 Value Percent:
 Continuous Index:
 Within 8" of Joint: **YES**
 Remarks:

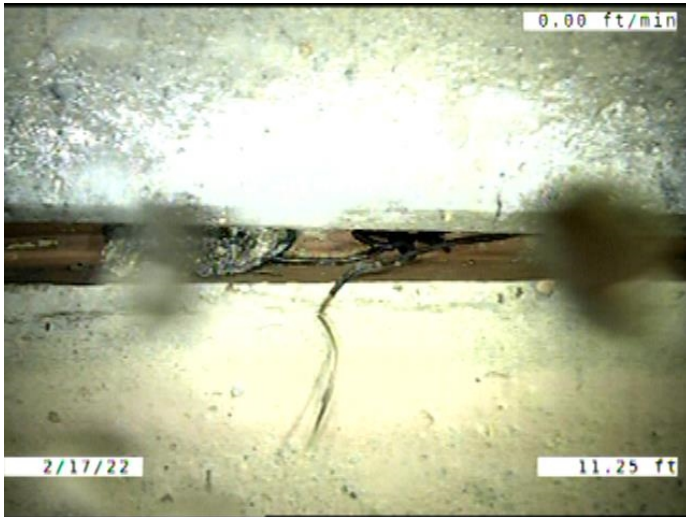
Code: **RFJ**
Description: **Roots Fine Joint**

Distance (ft): **11.3**
Structural Grade: **0**
O&M Grade: **1**
Clock Start/From: **11**
Clock To: **3**
1st Value:
2nd Value:
Value Percent:
Continuous Index:
Within 8" of Joint: **YES**
Remarks:

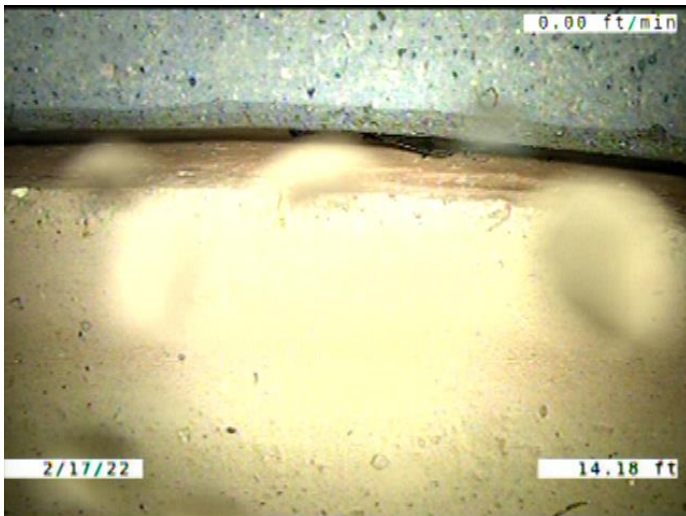
Code: **JOM**
Description: **Joint Offset Medium**

Distance (ft): **14.2**
Structural Grade: **3**
O&M Grade: **0**
Clock Start/From:
Clock To:
1st Value:
2nd Value:
Value Percent:
Continuous Index:
Within 8" of Joint: **NO**
Remarks:

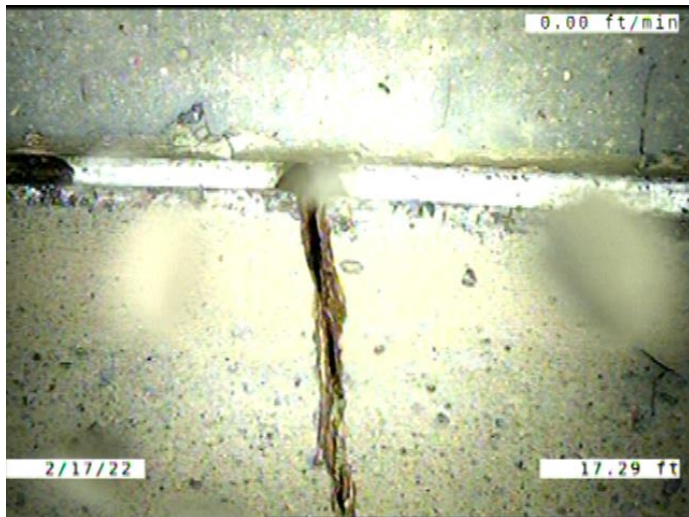
Code: **B**
 Description: **Broken**

Distance (ft): **17.3**
 Structural Grade: **4**
 O&M Grade: **0**
 Clock Start/From: **9**
 Clock To: **3**
 1st Value:
 2nd Value:
 Value Percent:
 Continuous Index:
 Within 8" of Joint: **YES**
 Remarks:

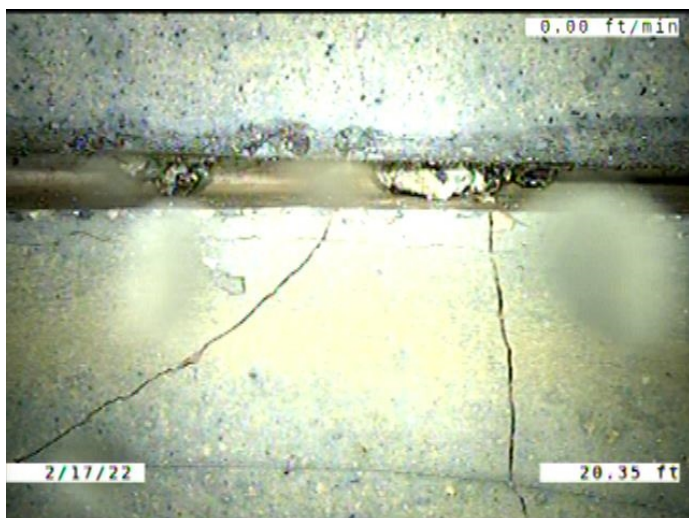
Code: **FM**
 Description: **Fracture Multiple**

Distance (ft): **20.4**
 Structural Grade: **4**
 O&M Grade: **0**
 Clock Start/From: **11**
 Clock To: **2**
 1st Value:
 2nd Value:
 Value Percent:
 Continuous Index:
 Within 8" of Joint: **YES**
 Remarks:

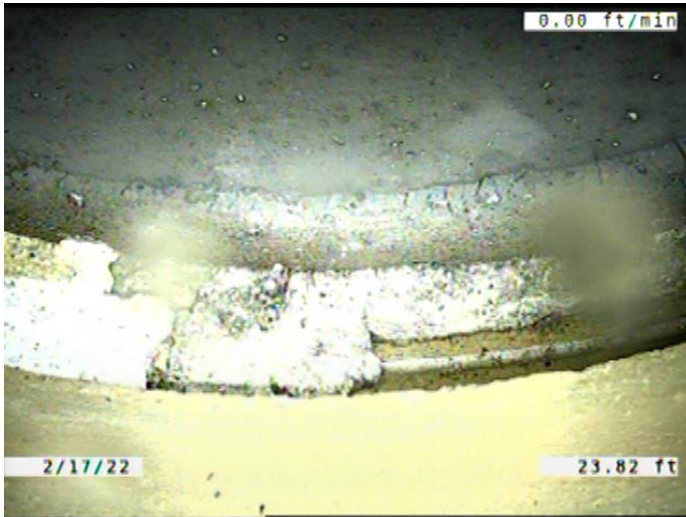
Code: **JAM**
 Description: **Joint Angular Medium**

Distance (ft): **23.8**
 Structural Grade: **3**
 O&M Grade: **0**
 Clock Start/From:
 Clock To:
 1st Value:
 2nd Value:
 Value Percent:
 Continuous Index:
 Within 8" of Joint: **NO**
 Remarks:

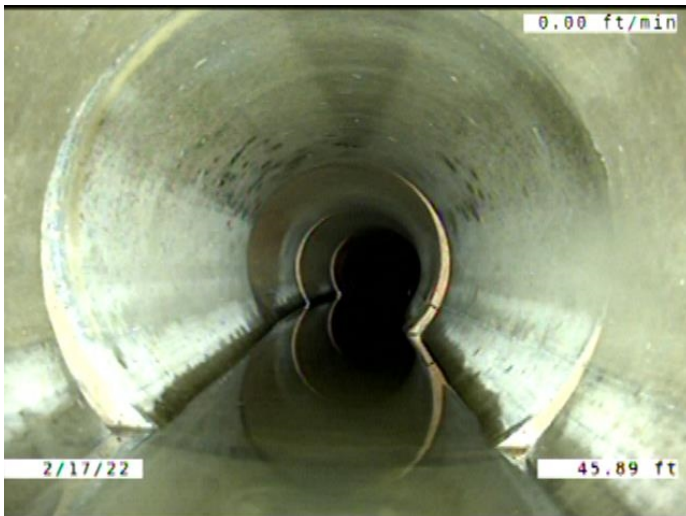
Code: **MWLS**
 Description: **Miscellaneous Water Level Sag**

Distance (ft): **45.9**
 Structural Grade: **2**
 O&M Grade: **0**
 Clock Start/From:
 Clock To:
 1st Value:
 2nd Value:
 Value Percent: **30.000**
 Continuous Index: **F01**
 Within 8" of Joint: **NO**
 Remarks:

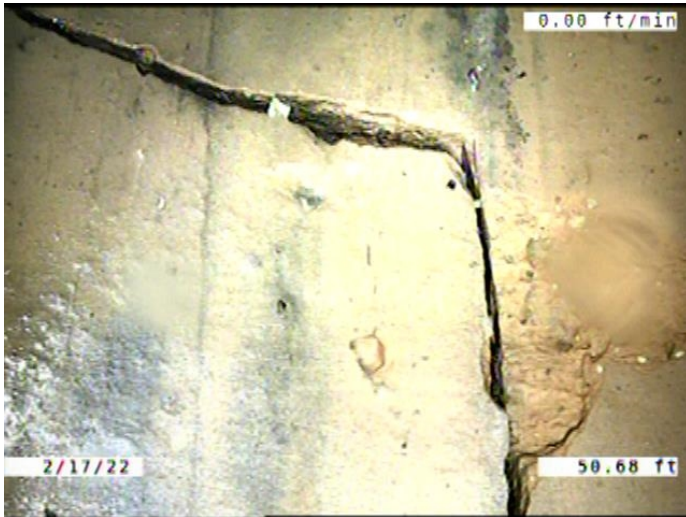
Code: **B**
Description: **Broken**

Distance (ft): **50.7**
Structural Grade: **4**
O&M Grade: **0**
Clock Start/From: **4**
Clock To: **10**
1st Value:
2nd Value:
Value Percent:
Continuous Index:
Within 8" of Joint: **YES**
Remarks:

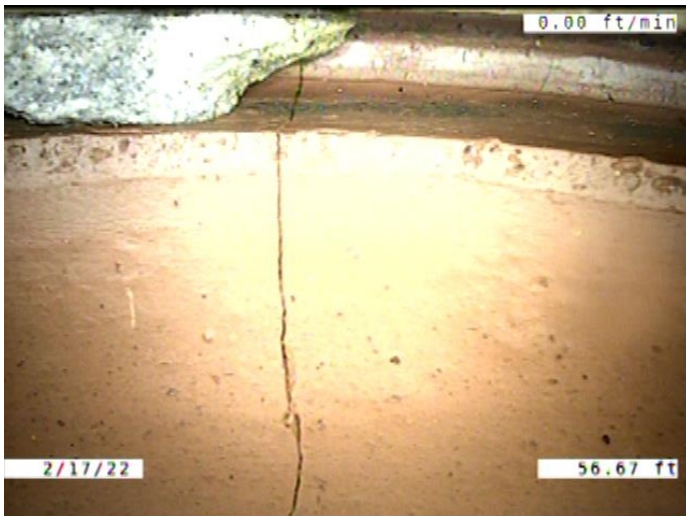
Code: **FM**
Description: **Fracture Multiple**

Distance (ft): **56.7**
Structural Grade: **4**
O&M Grade: **0**
Clock Start/From: **9**
Clock To: **3**
1st Value:
2nd Value:
Value Percent:
Continuous Index: **S02**
Within 8" of Joint: **YES**
Remarks:

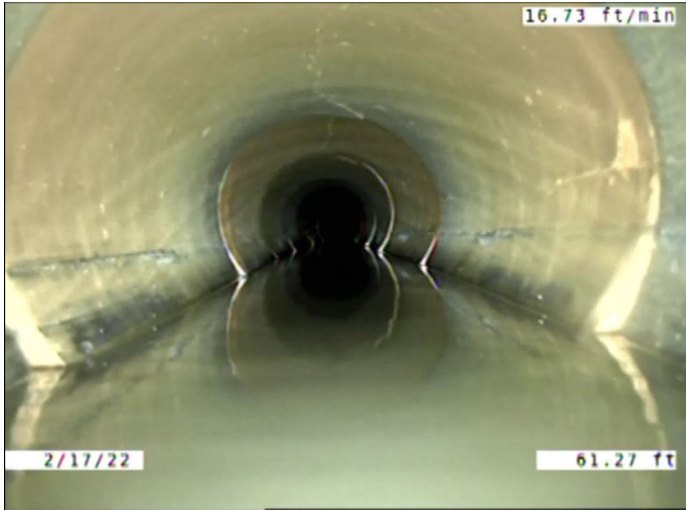
Code: **SSS**
Description: **Surface Damage Surface Spalling**

Distance (ft): **61.3**
Structural Grade: **2**
O&M Grade: **0**
Clock Start/From: **3**
Clock To:
1st Value:
2nd Value:
Value Percent:
Continuous Index:
Within 8" of Joint: **YES**
Remarks:

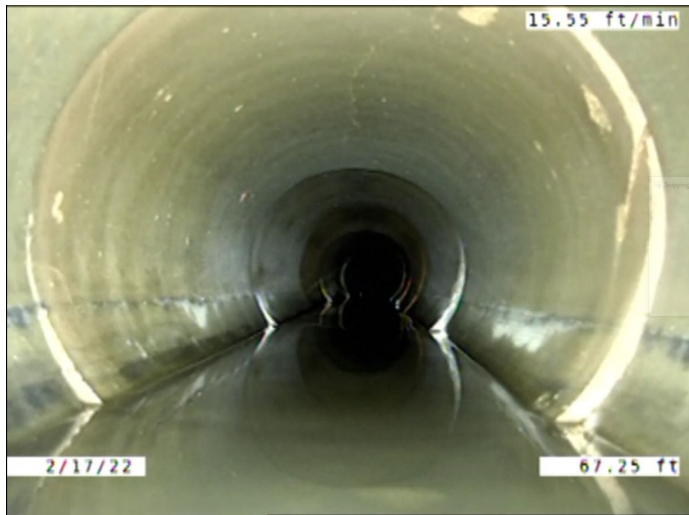
Code: **B**
 Description: **Broken**

Distance (ft): **67.3**
 Structural Grade: **4**
 O&M Grade: **0**
 Clock Start/From: **3**
 Clock To:
 1st Value:
 2nd Value:
 Value Percent:
 Continuous Index:
 Within 8" of Joint: **YES**
 Remarks:

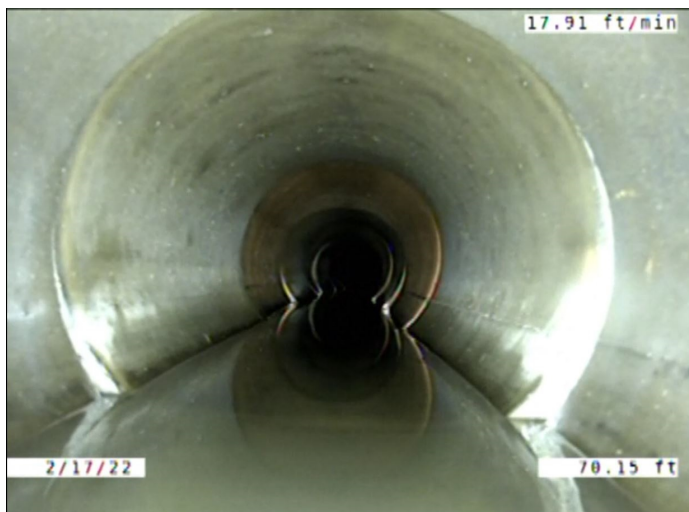
Code: **FM**
 Description: **Fracture Multiple**

Distance (ft): **70.2**
 Structural Grade: **4**
 O&M Grade: **0**
 Clock Start/From: **9**
 Clock To: **3**
 1st Value:
 2nd Value:
 Value Percent:
 Continuous Index: **F02**
 Within 8" of Joint: **YES**
 Remarks:

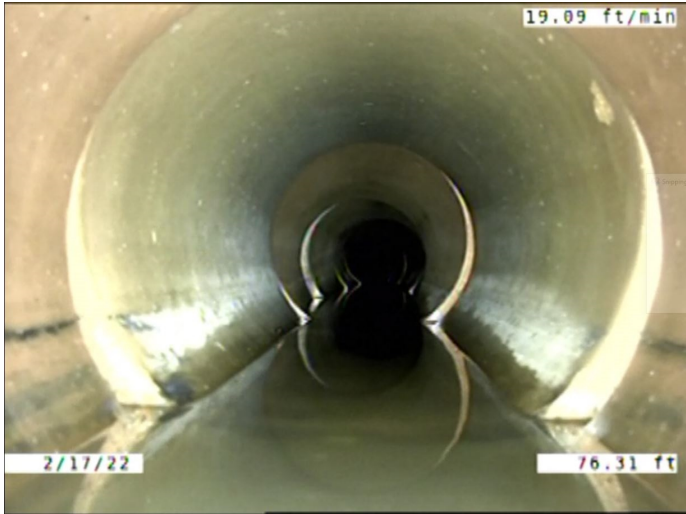
Code: **SSS**
Description: **Surface Damage Surface Spalling**

Distance (ft): **76.3**
Structural Grade: **2**
O&M Grade: **0**
Clock Start/From: **2**
Clock To:
1st Value:
2nd Value:
Value Percent:
Continuous Index:
Within 8" of Joint: **YES**
Remarks:

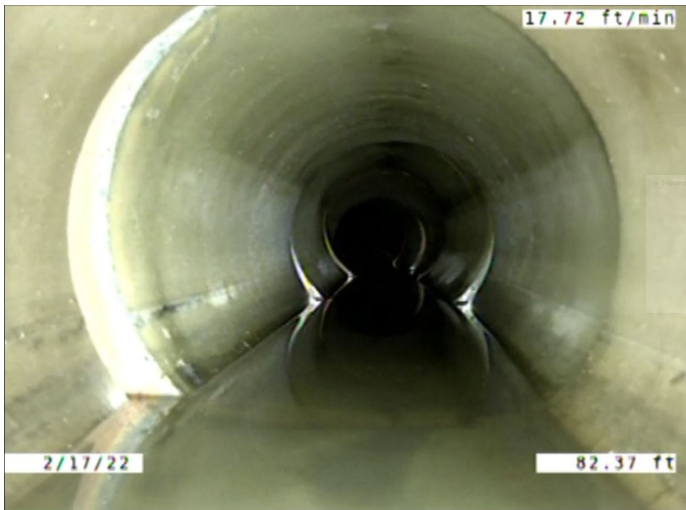
Code: **CC**
Description: **Crack Circumferential**

Distance (ft): **82.4**
Structural Grade: **1**
O&M Grade: **0**
Clock Start/From: **10**
Clock To: **11**
1st Value:
2nd Value:
Value Percent:
Continuous Index:
Within 8" of Joint: **YES**
Remarks:

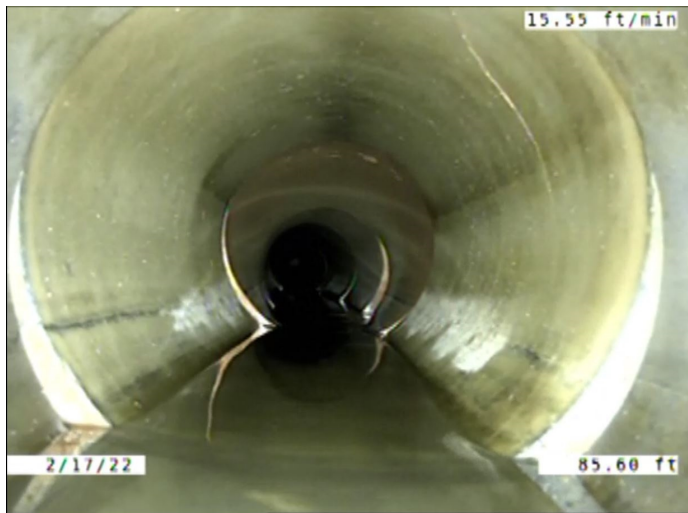
Code: **CC**
 Description: **Crack Circumferential**

Distance (ft): **85.6**
 Structural Grade: **1**
 O&M Grade: **0**
 Clock Start/From: **1**
 Clock To: **3**
 1st Value:
 2nd Value:
 Value Percent:
 Continuous Index:
 Within 8" of Joint: **YES**
 Remarks:

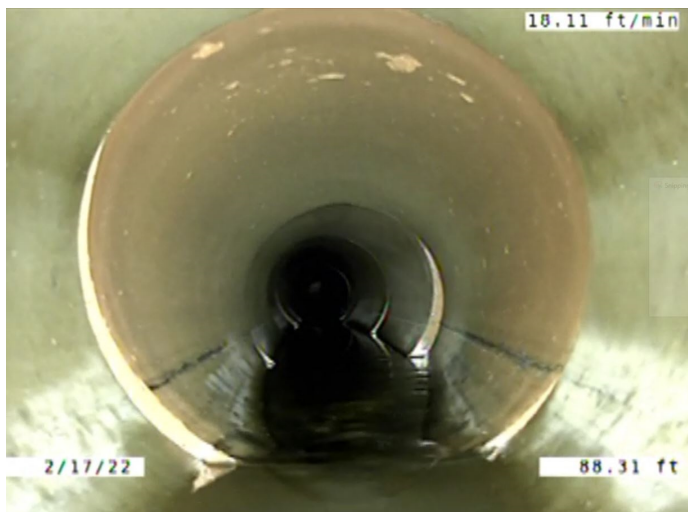
Code: **SSS**
 Description: **Surface Damage Surface Spalling**

Distance (ft): **88.3**
 Structural Grade: **2**
 O&M Grade: **0**
 Clock Start/From: **11**
 Clock To: **1**
 1st Value:
 2nd Value:
 Value Percent:
 Continuous Index:
 Within 8" of Joint: **YES**
 Remarks:

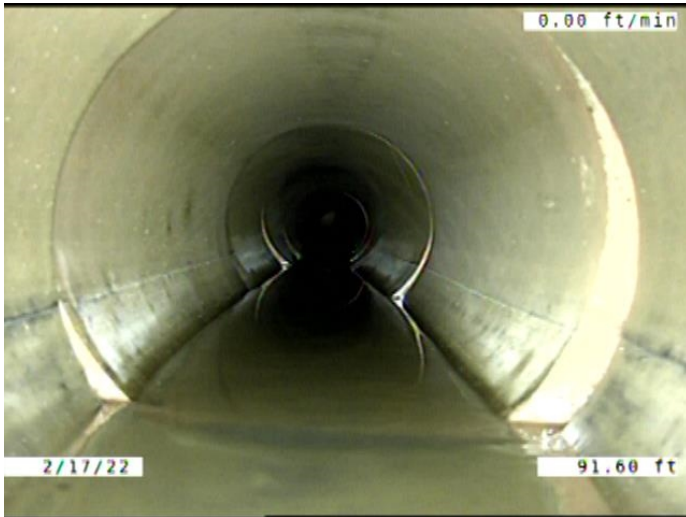
Code: **MWLS**
 Description: **Miscellaneous Water Level Sag**

Distance (ft): **91.6**
 Structural Grade: **2**
 O&M Grade: **0**
 Clock Start/From:
 Clock To:
 1st Value:
 2nd Value:
 Value Percent: **10.000**
 Continuous Index:
 Within 8" of Joint: **NO**
 Remarks:

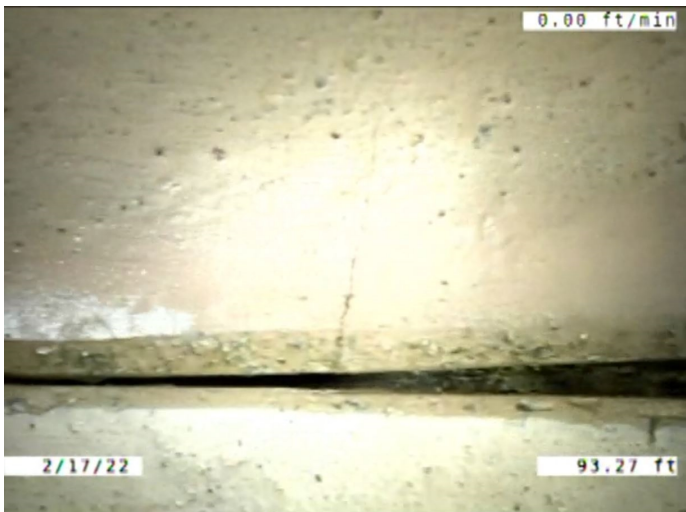
Code: **CM**
 Description: **Crack Multiple**

Distance (ft): **93.3**
 Structural Grade: **3**
 O&M Grade: **0**
 Clock Start/From: **9**
 Clock To: **11**
 1st Value:
 2nd Value:
 Value Percent:
 Continuous Index:
 Within 8" of Joint: **YES**
 Remarks:

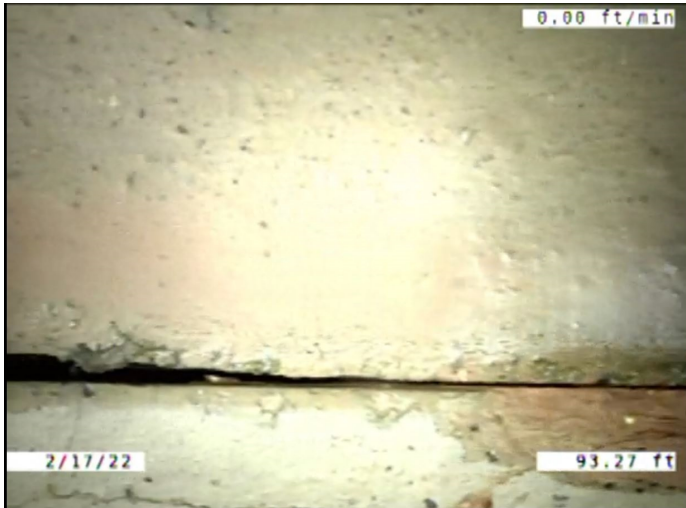
Code: **SSS**
Description: **Surface Damage Surface Spalling**

Distance (ft): **93.3**
Structural Grade: **2**
O&M Grade: **0**
Clock Start/From: **10**
Clock To:
1st Value:
2nd Value:
Value Percent:
Continuous Index:
Within 8" of Joint: **YES**
Remarks:

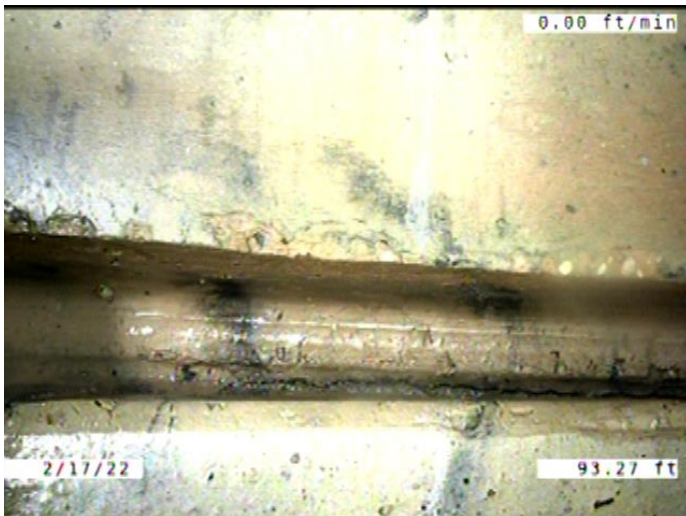
Code: **JAM**
Description: **Joint Angular Medium**

Distance (ft): **93.3**
Structural Grade: **3**
O&M Grade: **0**
Clock Start/From:
Clock To:
1st Value:
2nd Value:
Value Percent:
Continuous Index:
Within 8" of Joint: **NO**
Remarks:

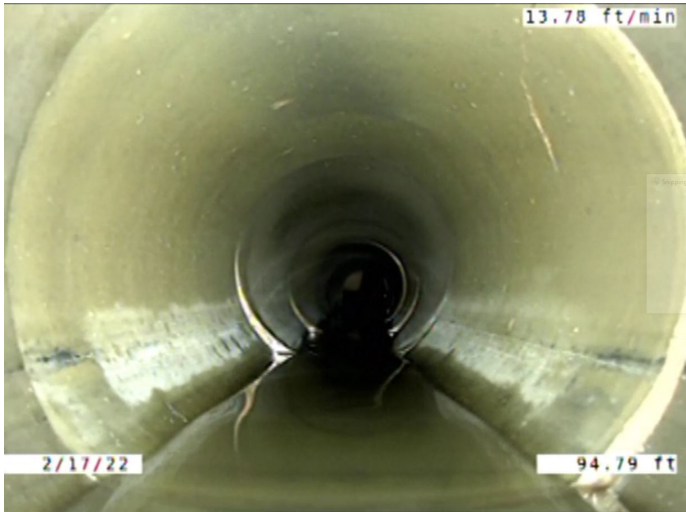
Code: **CS**
 Description: **Crack Spiral**

Distance (ft): **94.8**
 Structural Grade: **2**
 O&M Grade: **0**
 Clock Start/From: **1**
 Clock To: **2**
 1st Value:
 2nd Value:
 Value Percent:
 Continuous Index:
 Within 8" of Joint: **YES**
 Remarks:

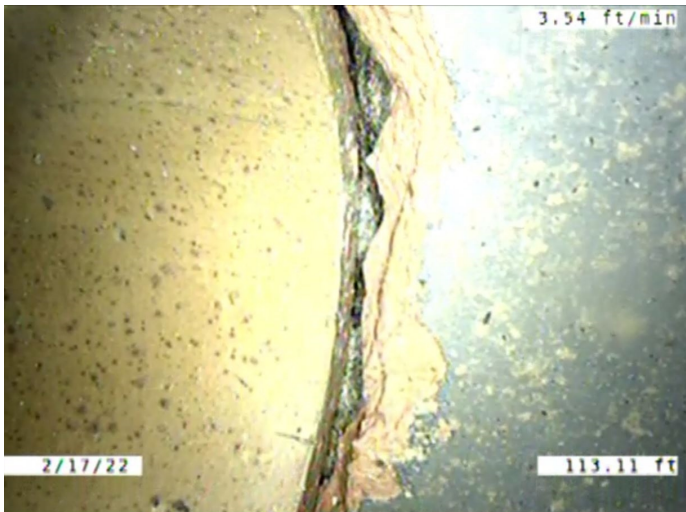
Code: **SSS**
 Description: **Surface Damage Surface Spalling**

Distance (ft): **113.1**
 Structural Grade: **2**
 O&M Grade: **0**
 Clock Start/From: **10**
 Clock To: **12**
 1st Value:
 2nd Value:
 Value Percent:
 Continuous Index:
 Within 8" of Joint: **NO**
 Remarks:

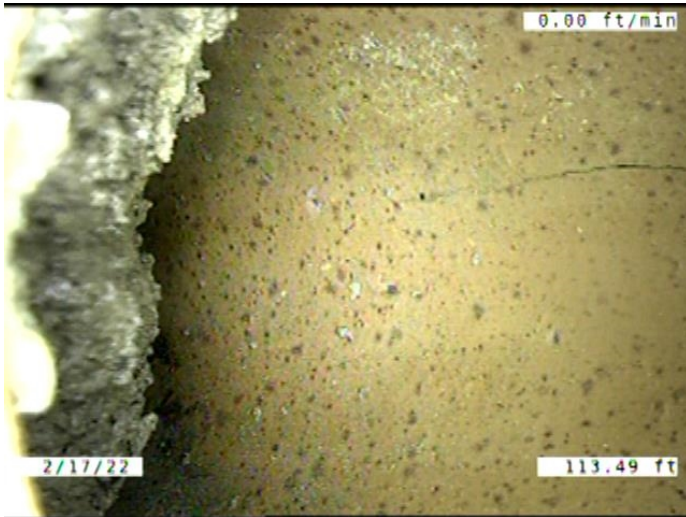
Code: **TBI**
 Description: **Tap Break-in Intruding**

Distance (ft): **113.5**
 Structural Grade: **0**
 O&M Grade: **2**
 Clock Start/From: **11**
 Clock To:
 1st Value: **4.000**
 2nd Value: **5.000**
 Value Percent:
 Continuous Index:
 Within 8" of Joint: **YES**
 Remarks:

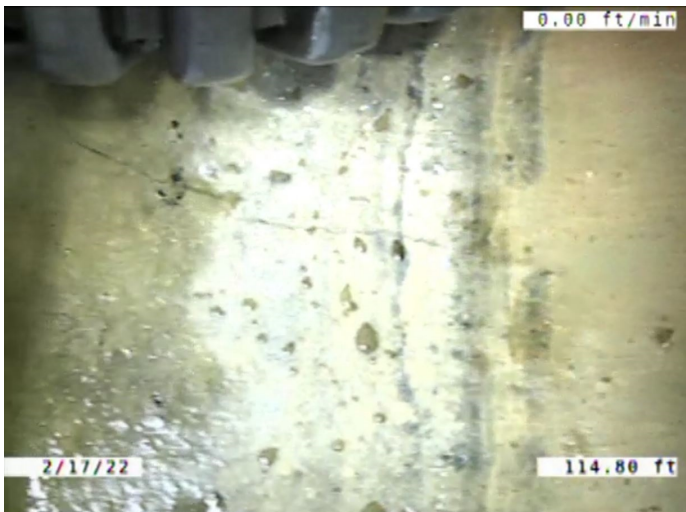
Code: **CC**
 Description: **Crack Circumferential**

Distance (ft): **114.8**
 Structural Grade: **1**
 O&M Grade: **0**
 Clock Start/From: **7**
 Clock To: **1**
 1st Value:
 2nd Value:
 Value Percent:
 Continuous Index:
 Within 8" of Joint: **NO**
 Remarks:

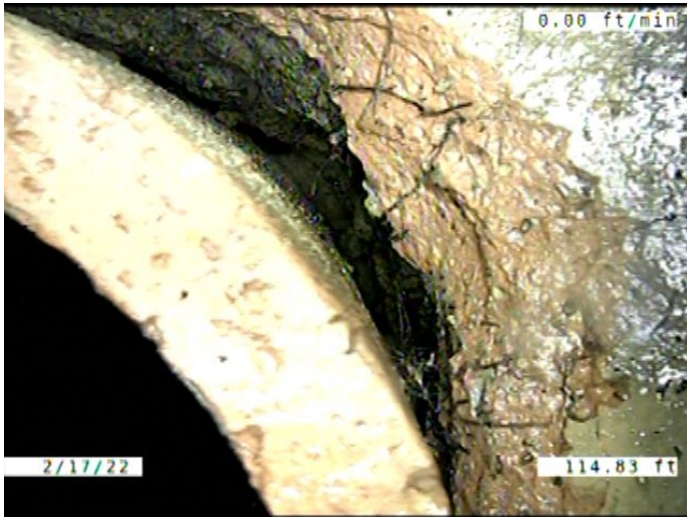
Code: **BSV**
 Description: **Broken Soil Visible**

Distance (ft): **114.8**
 Structural Grade: **5**
 O&M Grade: **0**
 Clock Start/From: **12**
 Clock To: **12**
 1st Value:
 2nd Value:
 Value Percent:
 Continuous Index:
 Within 8" of Joint: **YES**
 Remarks:

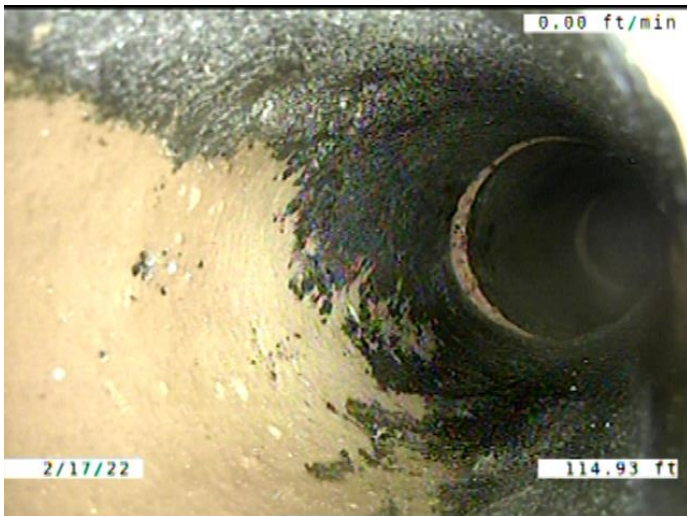
Code: **TBI**
 Description: **Tap Break-in Intruding**

Distance (ft): **114.9**
 Structural Grade: **0**
 O&M Grade: **2**
 Clock Start/From: **2**
 Clock To:
 1st Value: **4.000**
 2nd Value: **2.000**
 Value Percent:
 Continuous Index:
 Within 8" of Joint: **YES**
 Remarks:

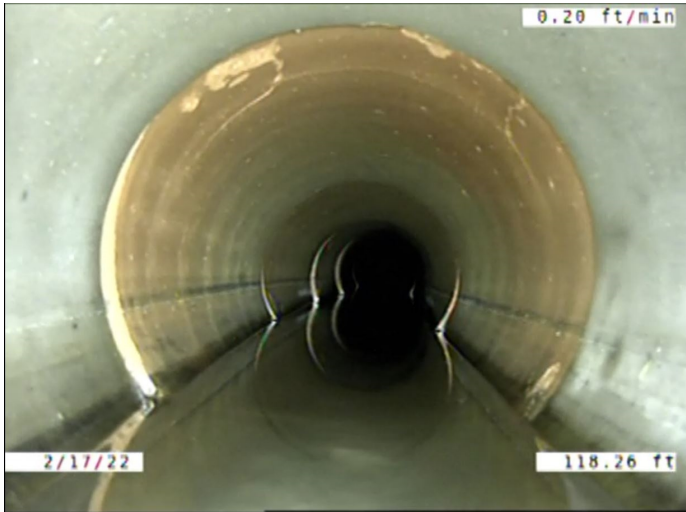
Code: **CS**
Description: **Crack Spiral**

Distance (ft): **118.3**
Structural Grade: **2**
O&M Grade: **0**
Clock Start/From: **10**
Clock To: **11**
1st Value:
2nd Value:
Value Percent:
Continuous Index:
Within 8" of Joint: **YES**
Remarks:

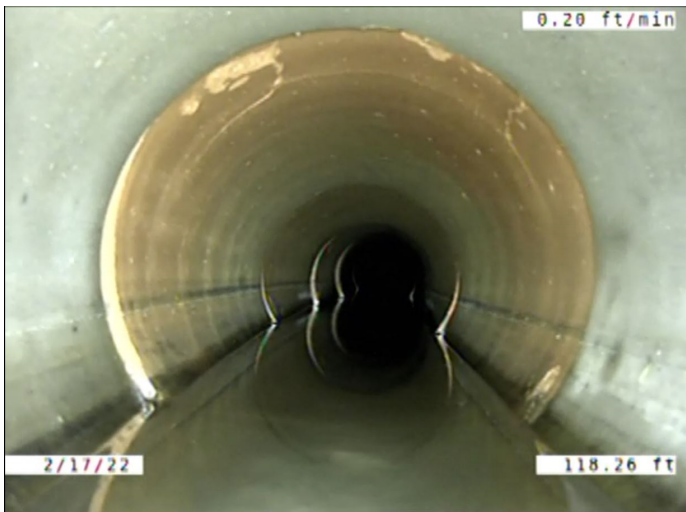
Code: **CS**
Description: **Crack Spiral**

Distance (ft): **118.3**
Structural Grade: **2**
O&M Grade: **0**
Clock Start/From: **2**
Clock To: **3**
1st Value:
2nd Value:
Value Percent:
Continuous Index:
Within 8" of Joint: **YES**
Remarks:

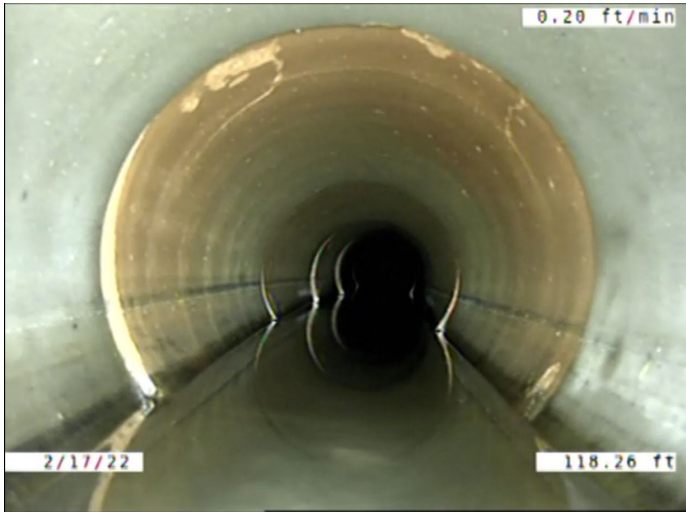
Code: **SSS**
Description: **Surface Damage Surface Spalling**

Distance (ft): **118.3**
Structural Grade: **2**
O&M Grade: **0**
Clock Start/From: **10**
Clock To: **2**
1st Value:
2nd Value:
Value Percent:
Continuous Index:
Within 8" of Joint: **YES**
Remarks:

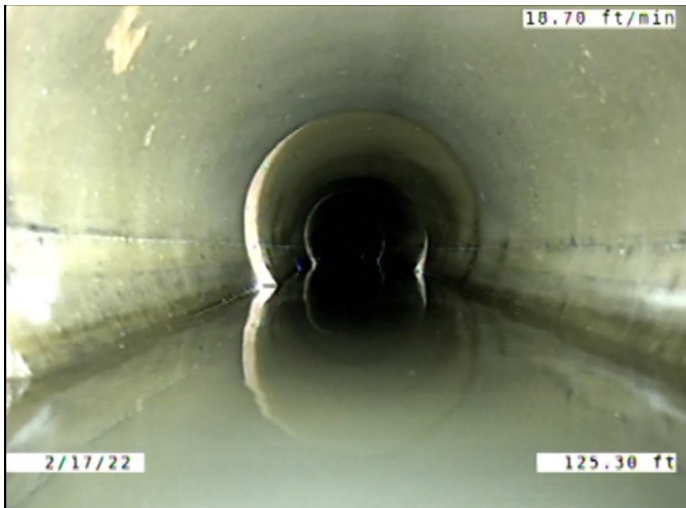
Code: **SSS**
Description: **Surface Damage Surface Spalling**

Distance (ft): **125.3**
Structural Grade: **2**
O&M Grade: **0**
Clock Start/From: **10**
Clock To:
1st Value:
2nd Value:
Value Percent:
Continuous Index:
Within 8" of Joint: **NO**
Remarks:

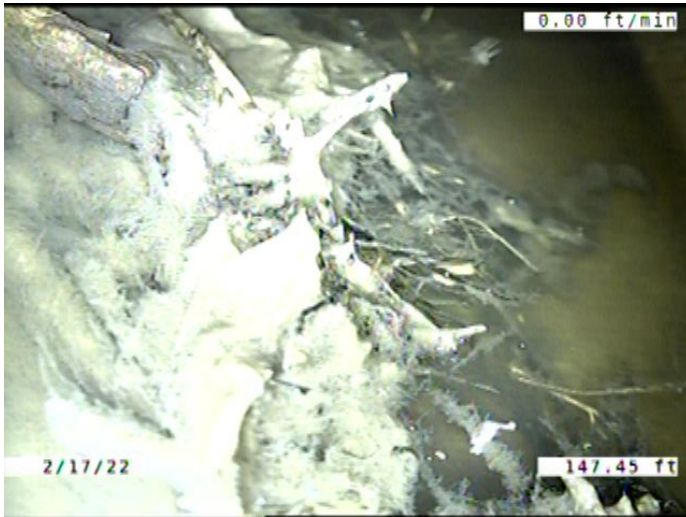
Code:	OBZ
Description:	Obstruction Other
Distance (ft):	147.4
Structural Grade:	0
O&M Grade:	2
Clock Start/From:	4
Clock To:	6
1st Value:	
2nd Value:	
Value Percent:	5.000
Continuous Index:	
Within 8" of Joint:	YES
Remarks:	RAGS AND ROOTS THAT HAVE BEEN CUT

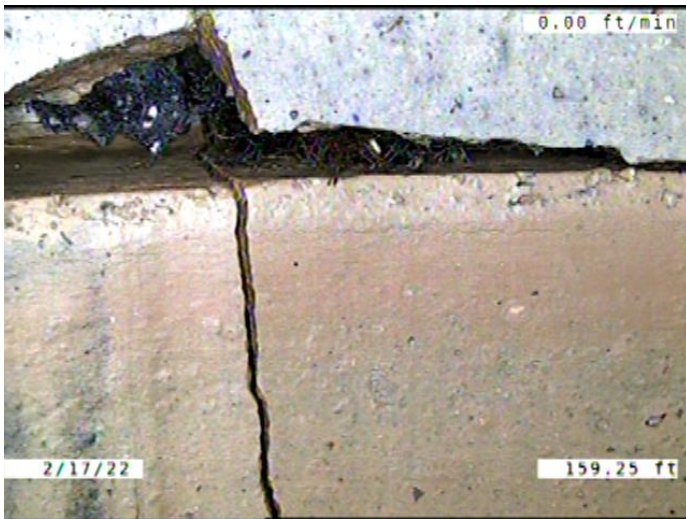
Code:	RFJ
Description:	Roots Fine Joint
Distance (ft):	159.2
Structural Grade:	0
O&M Grade:	1
Clock Start/From:	9
Clock To:	10
1st Value:	
2nd Value:	
Value Percent:	
Continuous Index:	
Within 8" of Joint:	YES
Remarks:

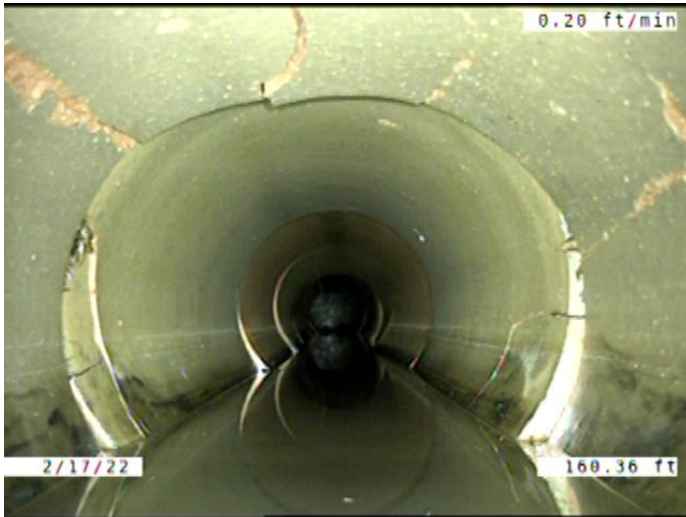
Code: **DR**
 Description: **Deformed Rigid**

Distance (ft): **160.4**
 Structural Grade: **4**
 O&M Grade: **0**
 Clock Start/From:
 Clock To:
 1st Value:
 2nd Value:
 Value Percent: **5.000**
 Continuous Index:
 Within 8" of Joint: **NO**
 Remarks:

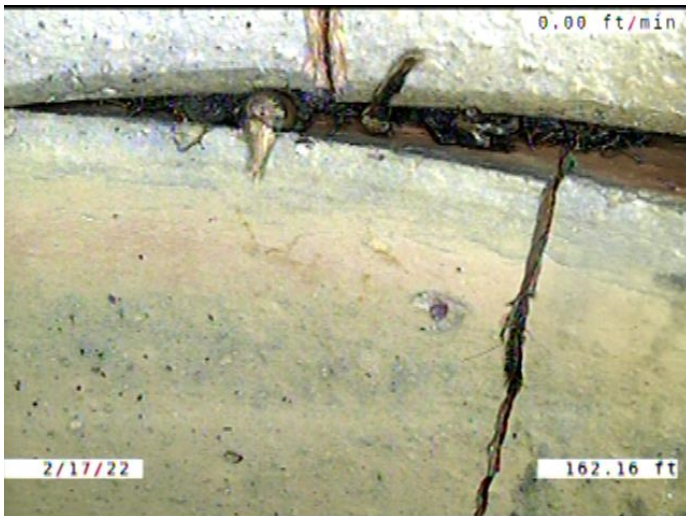
Code: **RFB**
 Description: **Roots Fine Barrel**

Distance (ft): **162.2**
 Structural Grade: **0**
 O&M Grade: **2**
 Clock Start/From: **2**
 Clock To: **3**
 1st Value:
 2nd Value:
 Value Percent:
 Continuous Index:
 Within 8" of Joint: **NO**
 Remarks:

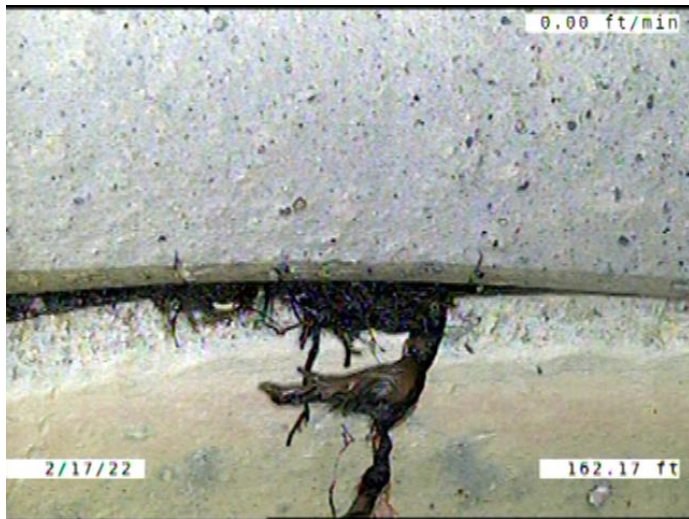
Code: **RFB**
 Description: **Roots Fine Barrel**

Distance (ft): **162.2**
 Structural Grade: **0**
 O&M Grade: **2**
 Clock Start/From: **9**
 Clock To: **10**
 1st Value:
 2nd Value:
 Value Percent:
 Continuous Index:
 Within 8" of Joint: **NO**
 Remarks:

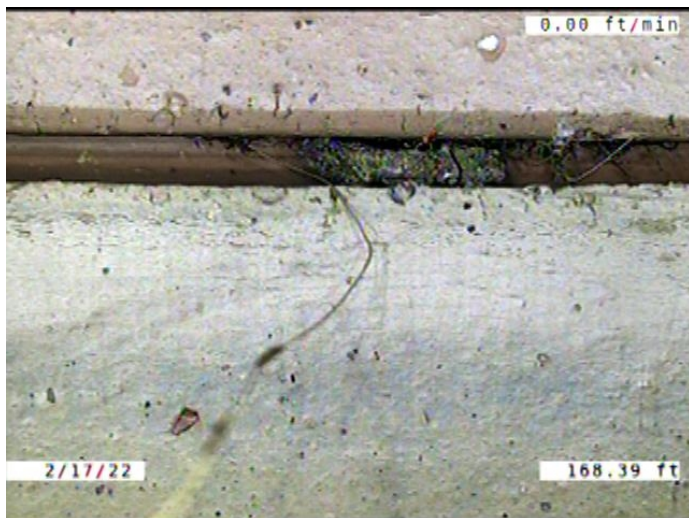
Code: **RFJ**
 Description: **Roots Fine Joint**

Distance (ft): **168.4**
 Structural Grade: **0**
 O&M Grade: **1**
 Clock Start/From: **12**
 Clock To:
 1st Value:
 2nd Value:
 Value Percent:
 Continuous Index:
 Within 8" of Joint: **YES**
 Remarks:

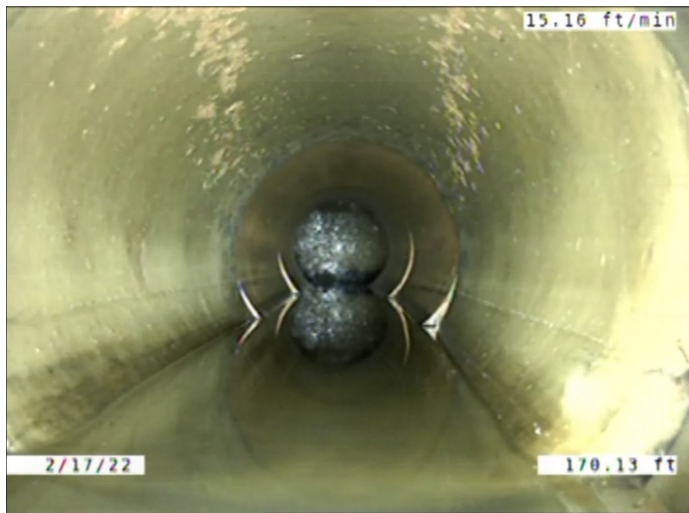
Code: **SSS**
 Description: **Surface Damage Surface Spalling**

Distance (ft): **170.1**
 Structural Grade: **2**
 O&M Grade: **0**
 Clock Start/From: **10**
 Clock To: **2**
 1st Value:
 2nd Value:
 Value Percent:
 Continuous Index:
 Within 8" of Joint: **YES**
 Remarks:

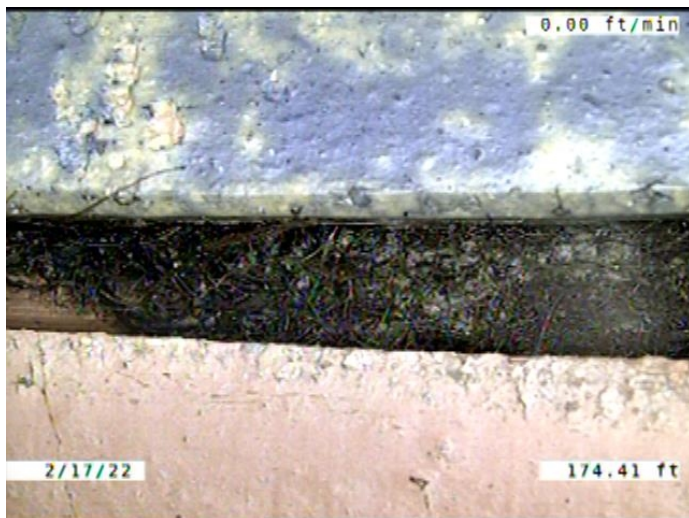
Code: **RFJ**
 Description: **Roots Fine Joint**

Distance (ft): **174.4**
 Structural Grade: **0**
 O&M Grade: **1**
 Clock Start/From: **1**
 Clock To: **4**
 1st Value:
 2nd Value:
 Value Percent:
 Continuous Index:
 Within 8" of Joint: **YES**
 Remarks:

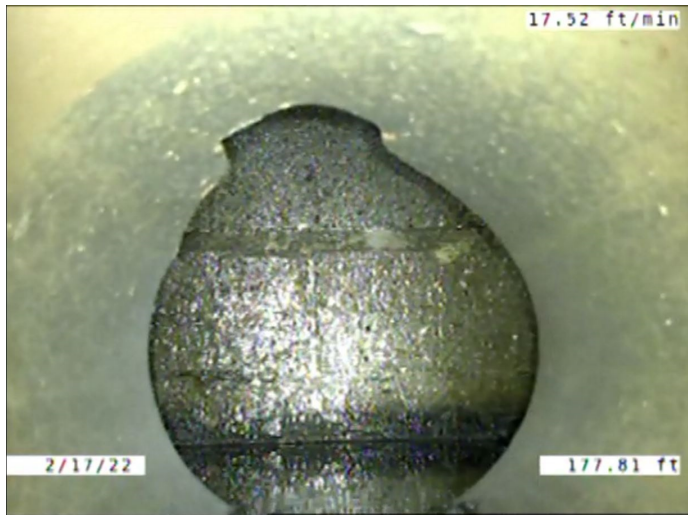
Code: **SMW**
 Description: **Surface Damage Missing Wall**

Distance (ft): **177.8**
 Structural Grade: **5**
 O&M Grade: **0**
 Clock Start/From: **11**
 Clock To: **12**
 1st Value:
 2nd Value:
 Value Percent:
 Continuous Index:
 Within 8" of Joint: **NO**
 Remarks:

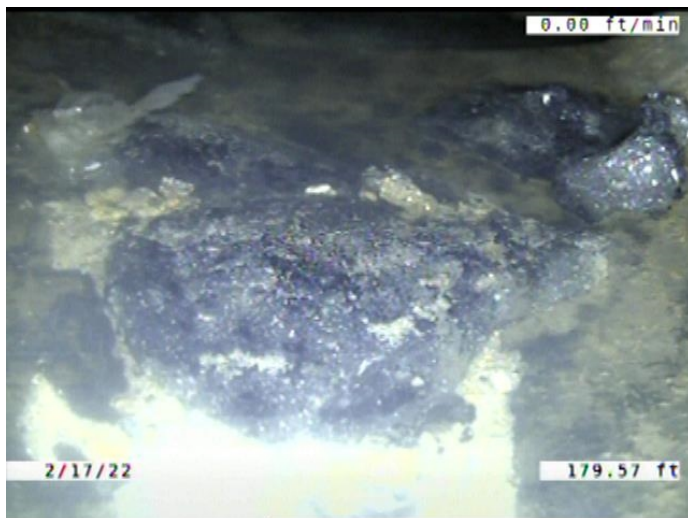
Code: **DSC**
 Description: **Deposits Settled Hard/Compacted**

Distance (ft): **179.6**
 Structural Grade: **0**
 O&M Grade: **2**
 Clock Start/From: **5**
 Clock To: **7**
 1st Value:
 2nd Value:
 Value Percent: **5.000**
 Continuous Index:
 Within 8" of Joint: **YES**
 Remarks:

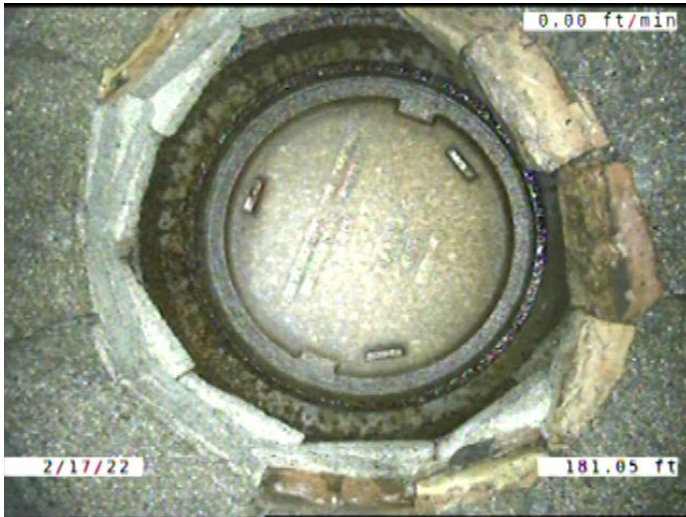
Code:	AMH
Description:	Manhole
Distance (ft):	181.1
Structural Grade:	0
O&M Grade:	0
Clock Start/From:	
Clock To:	
1st Value:	
2nd Value:	
Value Percent:	
Continuous Index:	
Within 8" of Joint:	NO
Remarks:	M-707-071
