Profile/Photo Observation Report

Date:	04/10/2018	Weather:		Coding:	PACP 6.0
Pipe Length (ft):	93.7	Owner:	NA	Pre Clean:	Not Known
P.O.#:		Surveyor:	Jen Costello	PSR:	P-707-065-064
Customer:		Clean Date:	01/01/1900	Shape:	C

Street:	E 11TH PL	Flow Control:	Not Controlled
City:	Hobart, IN	Year Renewed:	
Location:	Light Highway	Tape/Media #:	
Purpose:	Maintenance Related	Dia/Height:	10"
Use:	Sanitary	Material:	VCP
Drain Area:	NA	Lining:	Cured in Place
Category:	NA		
Comment:	debris pile at 5'.flow incorrect.		
Location Details:		Direction of Survey:	Upstream
US MH:	M-707-064	DS MH:	M-707-065
		Total Length Surveyed (ft):	6.5

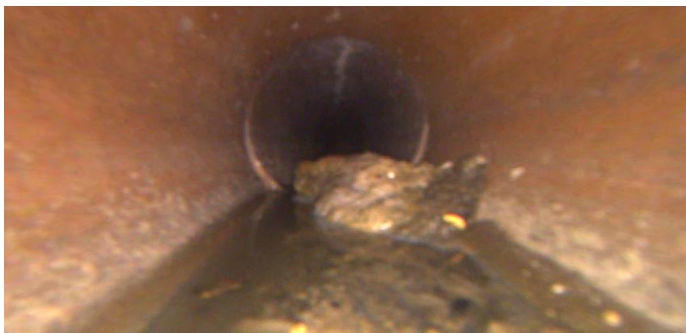
Code: **AMH**
Description: **Manhole**

Distance (ft): **.0**
Structural Grade: **0**
O&M Grade: **0**
Clock Start/From:
Clock To:
1st Value:
2nd Value:
Value Percent:
Continuous Index:
Within 8" of Joint: **NO**
Remarks: **M-707-065**

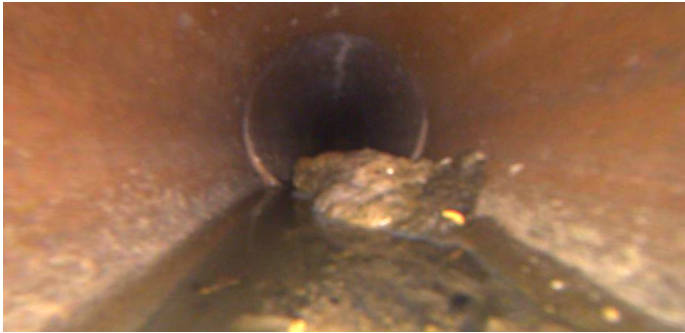
Code:	MWL
Description:	Water Level

Distance (ft):	.0
Structural Grade:	0
O&M Grade:	0
Clock Start/From:	
Clock To:	
1st Value:	
2nd Value:	
Value Percent:	20.000
Continuous Index:	
Within 8" of Joint:	NO
Remarks:

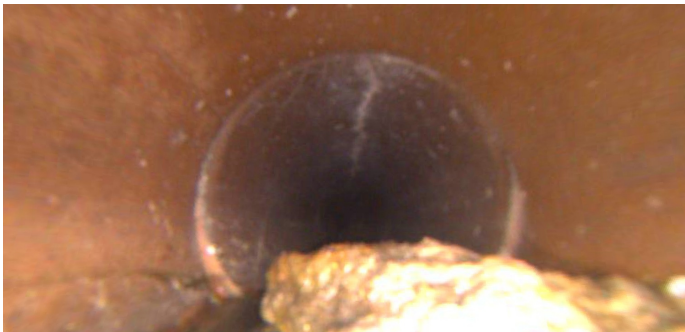
Code:	FM
Description:	Fracture Multiple

Distance (ft):	1.7
Structural Grade:	4
O&M Grade:	0
Clock Start/From:	8
Clock To:	12
1st Value:	
2nd Value:	
Value Percent:	
Continuous Index:	
Within 8" of Joint:	YES
Remarks:

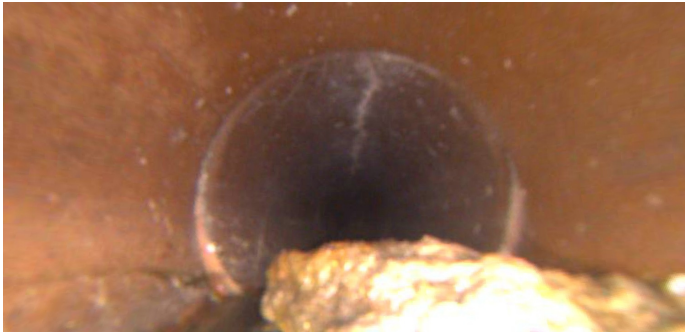
Code: **OBZ**
Description: **Obstacle Other**

Distance (ft): **1.7**
Structural Grade: **0**
O&M Grade: **3**
Clock Start/From: **4**
Clock To: **8**
1st Value:
2nd Value:
Value Percent: **20.000**
Continuous Index:
Within 8" of Joint: **NO**
Remarks: **GREASE**
