Profile/Photo Observation Report

Date:	04/10/2018	Weather:		Coding:	PACP 6.0
Pipe Length (ft):	93.7	Owner:	NA	Pre Clean:	Not Known
P.O.#:		Surveyor:	Jen Costello	PSR:	P-707-065-064
Customer:		Clean Date:	01/01/1900	Shape:	C

Street:	Capitol	Flow Control:	Not Controlled
City:	Hobart, IN	Year Renewed:	
Location:	Light Highway	Tape/Media #:	
Purpose:	Maintenance Related	Dia/Height:	10"
Use:	Sanitary	Material:	VCP
Drain Area:	NA	Lining:	Cured in Place
Category:	NA		
Comment:	debris pile at 5'.flow incorrect.		
Location Details:		Direction of Survey:	Upstream
US MH:	M-707-064	DS MH:	M-707-065
		Total Length Surveyed (ft):	6.5

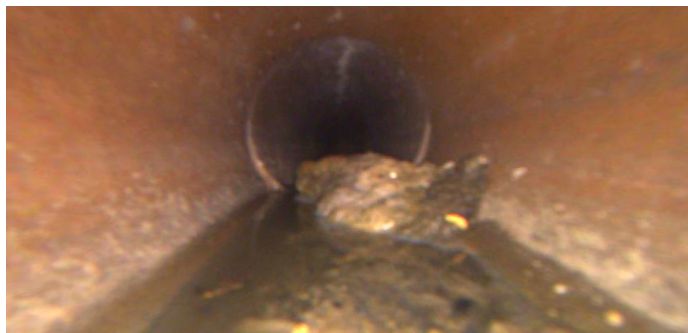
Code: **AMH**
Description: **Manhole**

Distance (ft): **.0**
Structural Grade: **0**
O&M Grade: **0**
Clock Start/From:
Clock To:
1st Value:
2nd Value:
Value Percent:
Continuous Index:
Within 8" of Joint: **NO**
Remarks: **M-707-065**

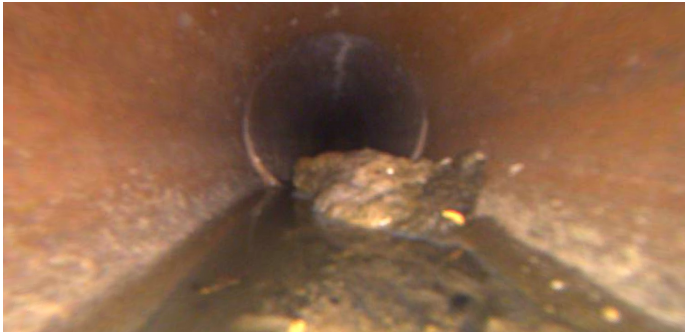
Code:	MWL
Description:	Water Level

Distance (ft):	.0
Structural Grade:	0
O&M Grade:	0
Clock Start/From:	
Clock To:	
1st Value:	
2nd Value:	
Value Percent:	20.000
Continuous Index:	
Within 8" of Joint:	NO
Remarks:

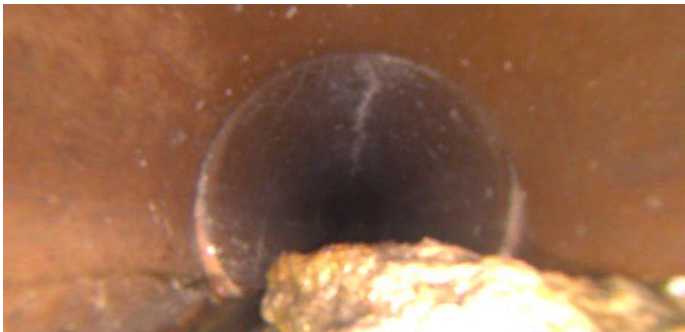
Code:	FM
Description:	Fracture Multiple

Distance (ft):	1.7
Structural Grade:	4
O&M Grade:	0
Clock Start/From:	8
Clock To:	12
1st Value:	
2nd Value:	
Value Percent:	
Continuous Index:	
Within 8" of Joint:	YES
Remarks:

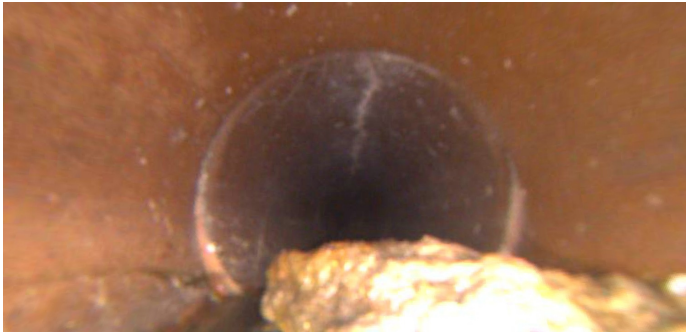
Code: **OBZ**
Description: **Obstacle Other**

Distance (ft): **1.7**
Structural Grade: **0**
O&M Grade: **3**
Clock Start/From: **4**
Clock To: **8**
1st Value:
2nd Value:
Value Percent: **20.000**
Continuous Index:
Within 8" of Joint: **NO**
Remarks: **GREASE**
