Profile/Photo Observation Report

Street:	E 11TH PL	Flow Control:	Not Controlled
City:	Hobart, IN	Year Renewed:	
Location:	Light Highway	Tape/Media #:	
Purpose:	Maintenance Related	Dia/Height:	10"
Use:	Sanitary	Material:	VCP
Drain Area:	NA	Lining:	Cured in Place
Category:	NA		
Comment:	broken vcp in bell, flow incorrect.		
Location Details:		Direction of Survey:	Downstream
US MH:	M-707-065	DS MH:	M-707-066
		Total Length Surveyed (ft):	2.5

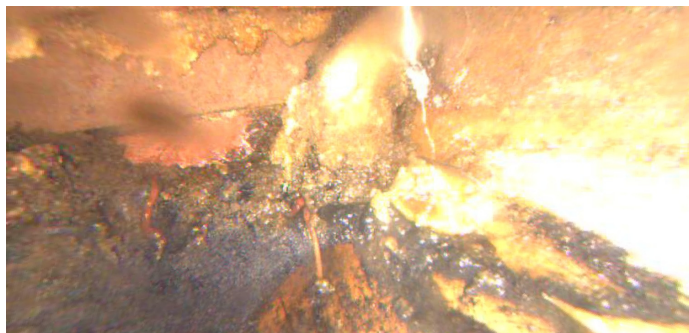
Code: **AMH**
Description: **Manhole**

Distance (ft): **.0**
Structural Grade: **0**
O&M Grade: **0**
Clock Start/From:
Clock To:
1st Value:
2nd Value:
Value Percent:
Continuous Index:
Within 8" of Joint: **NO**
Remarks: **M-707-065**

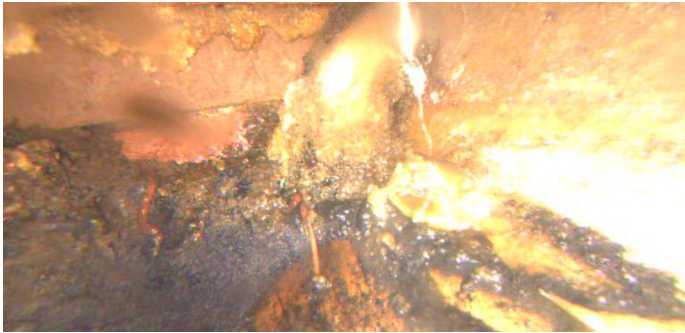
Code:	MWL
Description:	Water Level

Distance (ft):	.0
Structural Grade:	0
O&M Grade:	0
Clock Start/From:	
Clock To:	
1st Value:	
2nd Value:	
Value Percent:	0.000
Continuous Index:	
Within 8" of Joint:	NO
Remarks:
