Profile/Photo Observation Report

Street:	Capitol	Flow Control:	Not Controlled
City:	Hobart, IN	Year Renewed:	
Location:	Light Highway	Tape/Media #:	
Purpose:	Maintenance Related	Dia/Height:	10"
Use:	Sanitary	Material:	VCP
Drain Area:	NA	Lining:	Cured in Place
Category:	NA		
Comment:	broken vcp in bell, flow incorrect.		
Location Details:		Direction of Survey:	Downstream
US MH:	M-707-065	DS MH:	M-707-066
		Total Length Surveyed (ft):	2.5

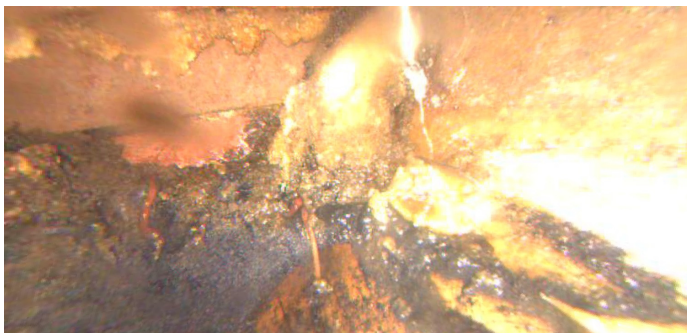
Code: **AMH**
Description: **Manhole**

Distance (ft): **.0**
Structural Grade: **0**
O&M Grade: **0**
Clock Start/From:
Clock To:
1st Value:
2nd Value:
Value Percent:
Continuous Index:
Within 8" of Joint: **NO**
Remarks: **M-707-065**

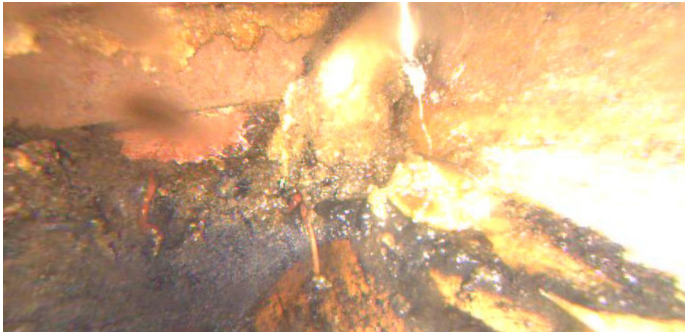
Code:	MWL
Description:	Water Level

Distance (ft):	.0
Structural Grade:	0
O&M Grade:	0
Clock Start/From:	
Clock To:	
1st Value:	
2nd Value:	
Value Percent:	0.000
Continuous Index:	
Within 8" of Joint:	NO
Remarks:
