## Profile/Photo Observation Report

Street:	<b>10th Street</b>	Flow Control:	
City:	<b>Hobart, IN</b>	Year Renewed:	
Location:	<b>Light Highway</b>	Tape/Media #:	<b>940</b>
Purpose:	<b>Routine Assessment</b>	Dia/Height:	<b>12"</b>
Use:	<b>Sanitary</b>	Material:	<b>CP</b>
Drain Area:		Lining:	
Category:	<b>NA</b>		
Comment:

Location Details:		Direction of Survey:	<b>Upstream</b>
US MH:	<b>M-707-69</b>	DS MH:	<b>M-707-68</b>
		Total Length Surveyed (ft):	<b>13.7</b>

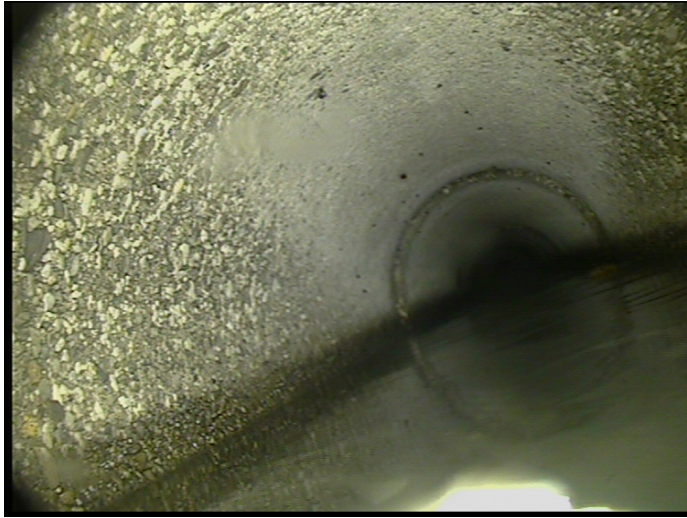
Code: **MWL**  
Description: **Water Level**

Distance (ft): **.0**  
Structural Grade: **0**  
O&M Grade: **0**  
Clock Start/From:  
Clock To:  
1st Value:  
2nd Value:  
Value Percent: **25.000**  
Continuous Index:  
Within 8" of Joint: **NO**  
Remarks:

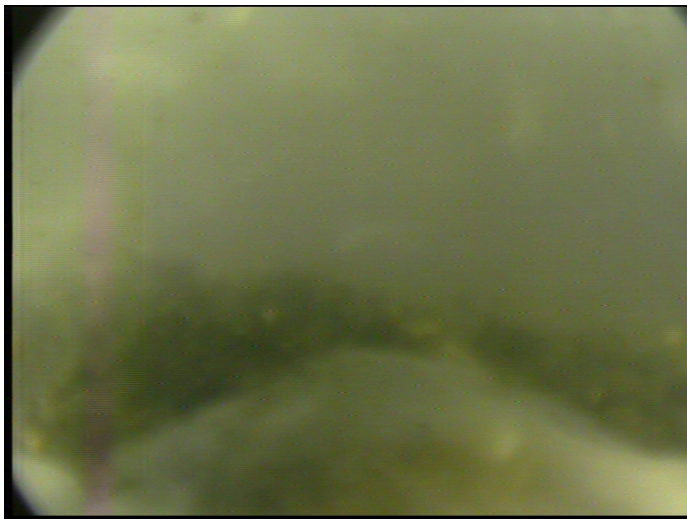
Code: **DSF**  
Description: **Deposits Settled Fine**

Distance (ft): **7.7**  
Structural Grade: **0**  
O&M Grade: **3**  
Clock Start/From: **4**  
Clock To: **8**  
1st Value:  
2nd Value:  
Value Percent: **15.000**  
Continuous Index: **S01**  
Within 8" of Joint: **YES**  
Remarks:

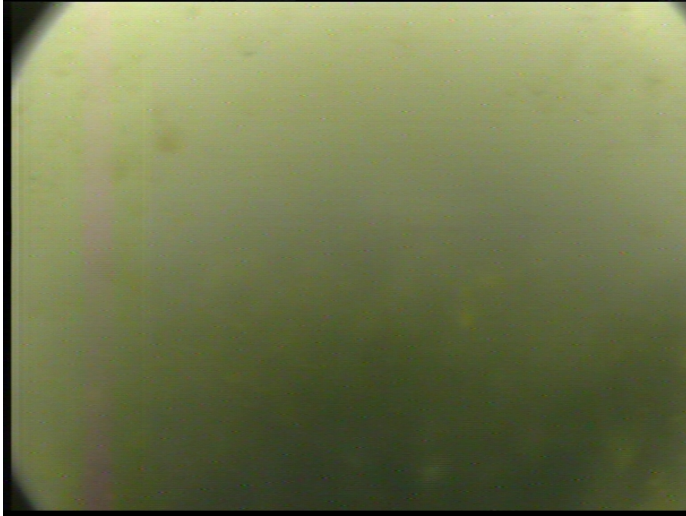
Code: **DSF**  
Description: **Deposits Settled Fine**

Distance (ft): **13.1**  
Structural Grade: **0**  
O&M Grade: **3**  
Clock Start/From: **4**  
Clock To: **8**  
1st Value:  
2nd Value:  
Value Percent: **15.000**  
Continuous Index: **F01**  
Within 8" of Joint: **NO**  
Remarks:

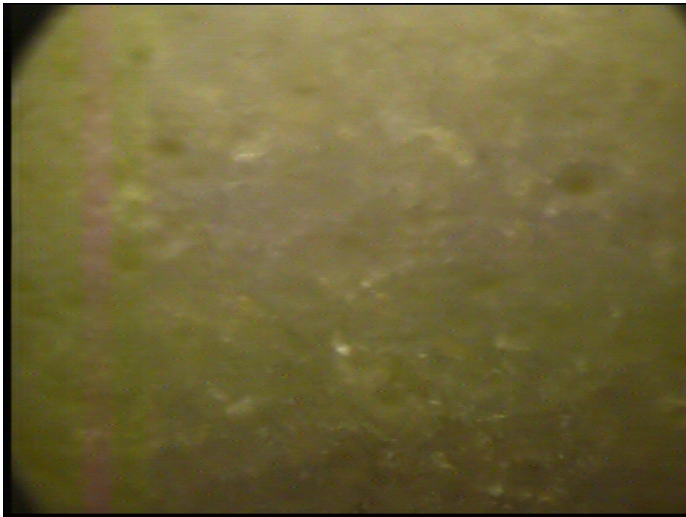
Code: **MSA**  
Description: **Abandoned Survey**

Distance (ft): **13.1**  
Structural Grade: **0**  
O&M Grade: **0**  
Clock Start/From:  
Clock To:  
1st Value:  
2nd Value:  
Value Percent:  
Continuous Index:  
Within 8" of Joint: **NO**  
Remarks: **sediment**
