Profile/Photo Observation Report

Date:	02/17/2022	Weather:		Coding:	PACP 7.0
Pipe Length (ft):	214.9	Owner:	City of Hobart	Pre Clean:	Heavy Cleaning
P.O.#:	YES502259	Surveyor:	S. Bucklin	PSR:	P-707-064-071
Customer:	City of Hobart	Clean Date:	02/15/2022	Shape:	C

Street:	East 11th Place	Flow Control:	Not Controlled
City:	Hobart, IN	Year Renewed:	
Location:	Local rural streets with light traffic, t	Tape/Media #:	
Purpose:	Routine Assessment	Dia/Height:	12"
Use:	Sanitary Sewage Pipe	Material:	VCP
Drain Area:		Lining:	None
Category:	NA		
Comment:			
Location Details:		Direction of Survey:	Upstream
US MH:	M-707-071	DS MH:	M-707-064
		Total Length Surveyed (ft):	214.9

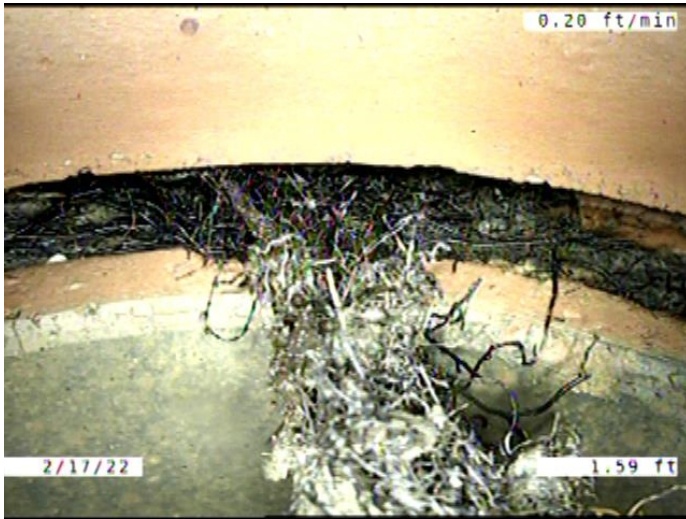
Code: **RMJ**
 Description: **Roots Medium Joint**

Distance (ft): **1.6**
 Structural Grade: **0**
 O&M Grade: **3**
 Clock Start/From: **9**
 Clock To: **3**
 1st Value:
 2nd Value:
 Value Percent: **5.000**
 Continuous Index:
 Within 8" of Joint: **YES**
 Remarks:

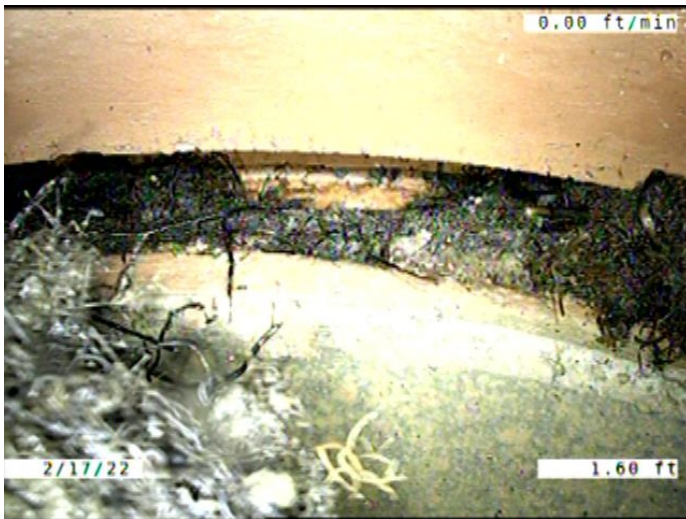
Code: **JOM**
 Description: **Joint Offset Medium**

Distance (ft): **1.6**
 Structural Grade: **3**
 O&M Grade: **0**
 Clock Start/From:
 Clock To:
 1st Value:
 2nd Value:
 Value Percent:
 Continuous Index:
 Within 8" of Joint: **NO**
 Remarks:

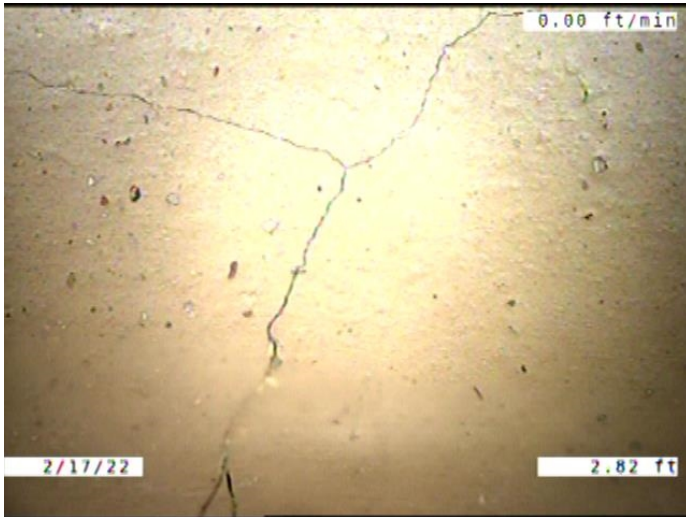
Code: **CM**
 Description: **Crack Multiple**

Distance (ft): **2.8**
 Structural Grade: **3**
 O&M Grade: **0**
 Clock Start/From: **11**
 Clock To: **1**
 1st Value:
 2nd Value:
 Value Percent:
 Continuous Index:
 Within 8" of Joint: **YES**
 Remarks:

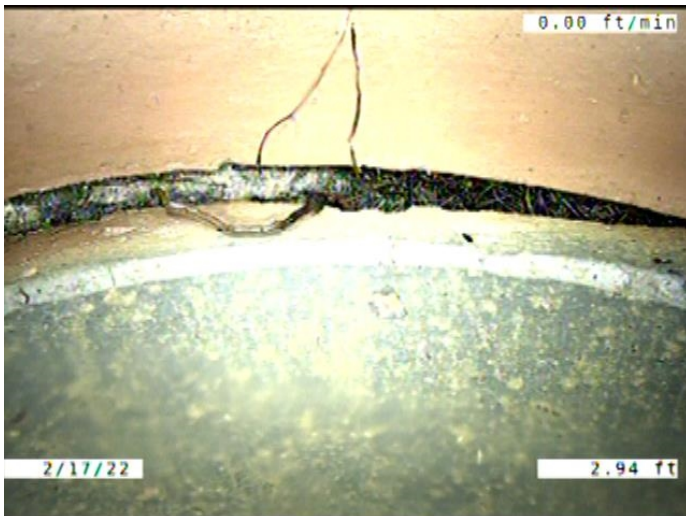
Code: **RFJ**
 Description: **Roots Fine Joint**

Distance (ft): **2.9**
 Structural Grade: **0**
 O&M Grade: **1**
 Clock Start/From: **11**
 Clock To: **12**
 1st Value:
 2nd Value:
 Value Percent:
 Continuous Index:
 Within 8" of Joint: **YES**
 Remarks:

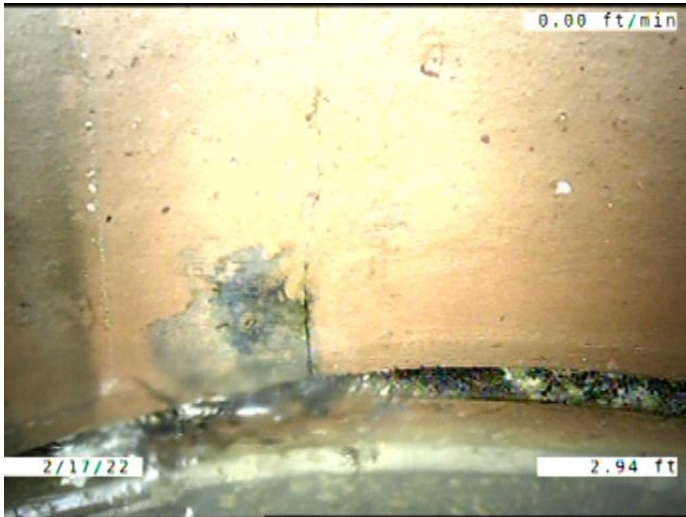
Code: **CL**
Description: **Crack Longitudinal**

Distance (ft): **2.9**
Structural Grade: **2**
O&M Grade: **0**
Clock Start/From: **10**
Clock To:
1st Value:
2nd Value:
Value Percent:
Continuous Index:
Within 8" of Joint: **YES**
Remarks:

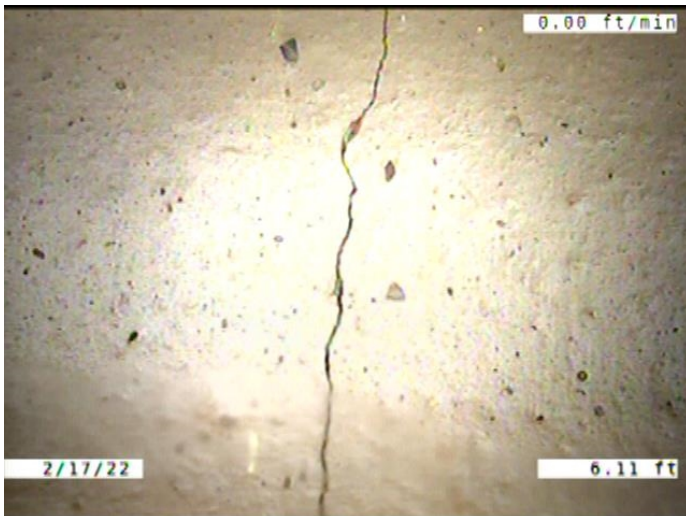
Code: **CL**
Description: **Crack Longitudinal**

Distance (ft): **6.1**
Structural Grade: **2**
O&M Grade: **0**
Clock Start/From: **1**
Clock To:
1st Value:
2nd Value:
Value Percent:
Continuous Index:
Within 8" of Joint: **YES**
Remarks:

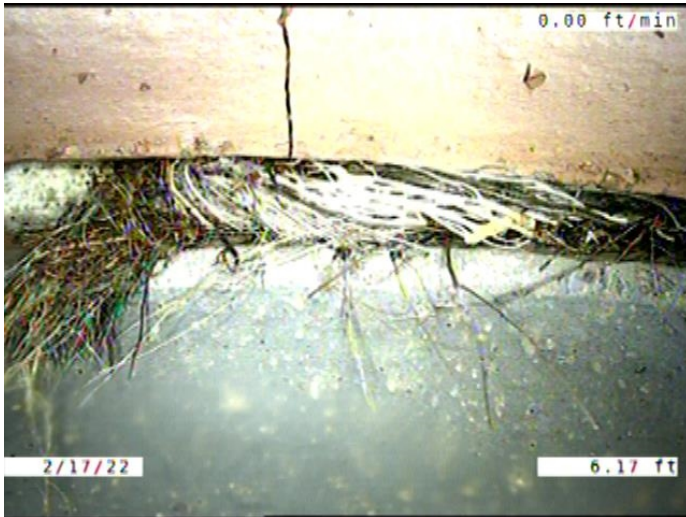
Code: **RFJ**
 Description: **Roots Fine Joint**

Distance (ft): **6.2**
 Structural Grade: **0**
 O&M Grade: **1**
 Clock Start/From: **1**
 Clock To: **3**
 1st Value:
 2nd Value:
 Value Percent:
 Continuous Index:
 Within 8" of Joint: **YES**
 Remarks:

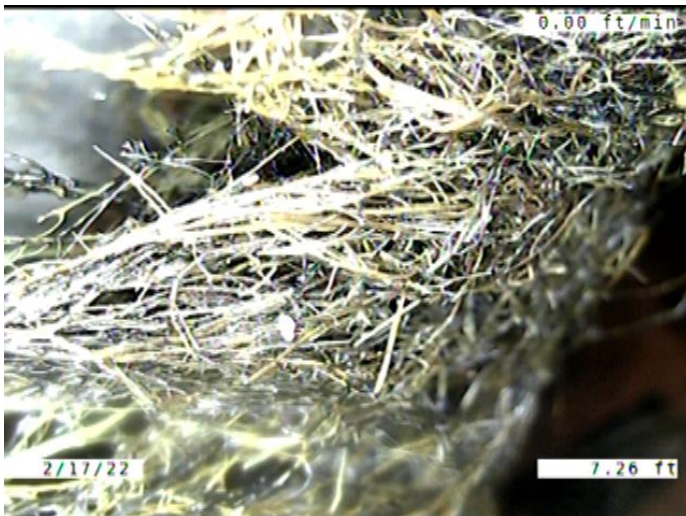
Code: **RML**
 Description: **Roots Medium Lateral**

Distance (ft): **7.3**
 Structural Grade: **0**
 O&M Grade: **3**
 Clock Start/From: **10**
 Clock To:
 1st Value:
 2nd Value:
 Value Percent: **10.000**
 Continuous Index:
 Within 8" of Joint: **NO**
 Remarks:

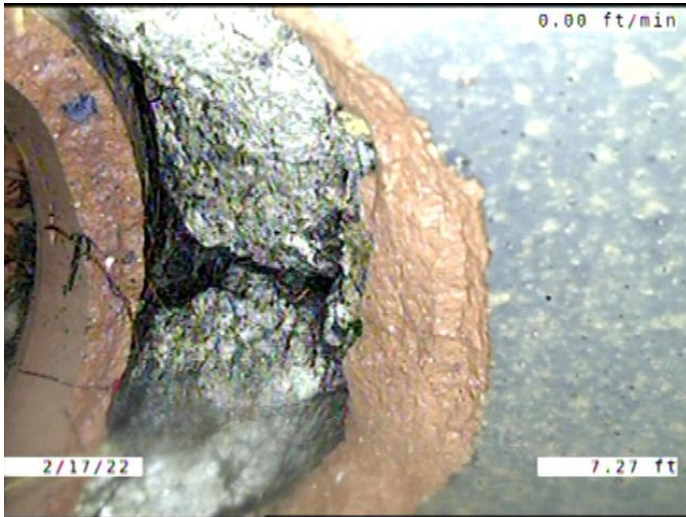
Code: **SSS**
 Description: **Surface Damage Surface Spalling**

Distance (ft): **7.3**
 Structural Grade: **2**
 O&M Grade: **0**
 Clock Start/From: **9**
 Clock To: **12**
 1st Value:
 2nd Value:
 Value Percent:
 Continuous Index:
 Within 8" of Joint: **NO**
 Remarks:

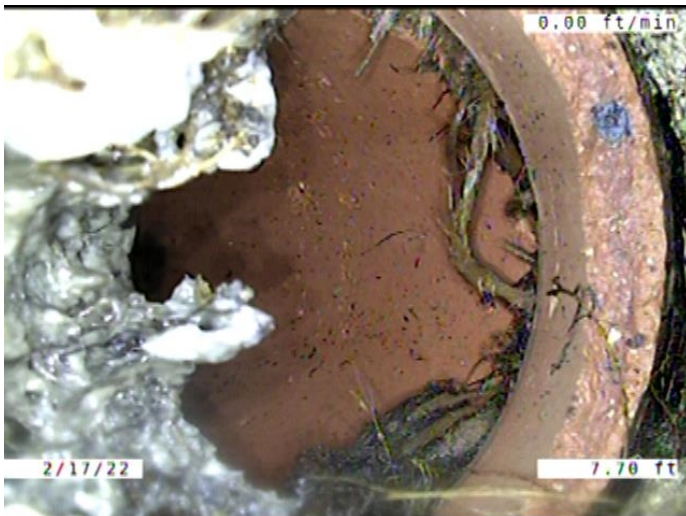
Code: **TBI**
 Description: **Tap Break-in Intruding**

Distance (ft): **7.7**
 Structural Grade: **0**
 O&M Grade: **2**
 Clock Start/From: **11**
 Clock To:
 1st Value: **4.000**
 2nd Value: **2.000**
 Value Percent:
 Continuous Index:
 Within 8" of Joint: **YES**
 Remarks:

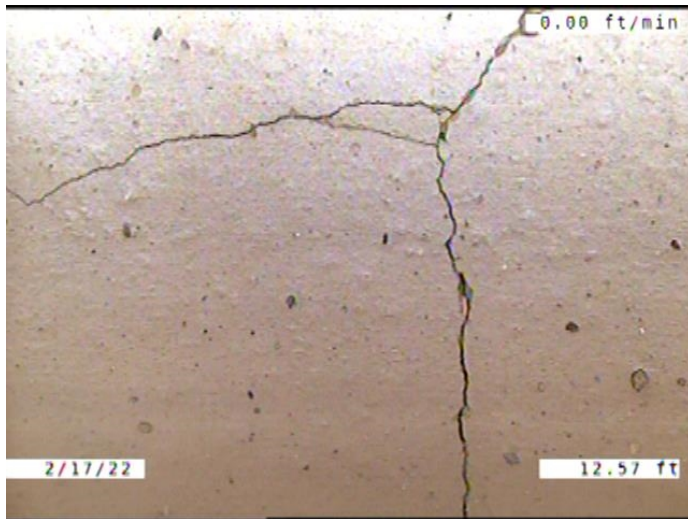
Code: **FM**
 Description: **Fracture Multiple**

Distance (ft): **12.6**
 Structural Grade: **4**
 O&M Grade: **0**
 Clock Start/From: **10**
 Clock To: **2**
 1st Value:
 2nd Value:
 Value Percent:
 Continuous Index:
 Within 8" of Joint: **YES**
 Remarks:

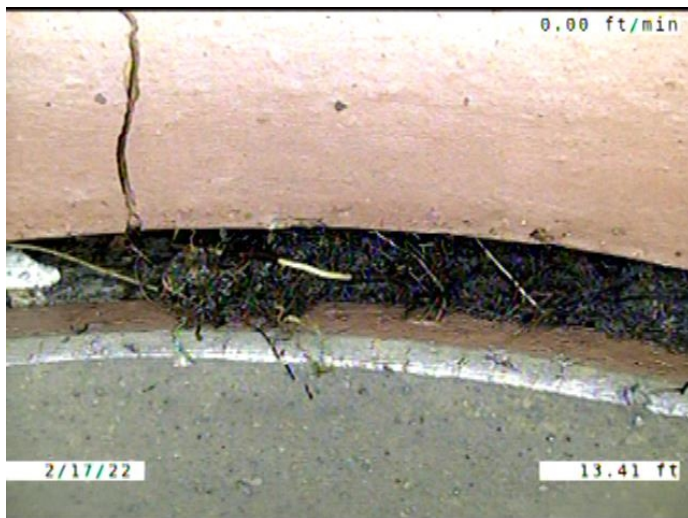
Code: **RFJ**
 Description: **Roots Fine Joint**

Distance (ft): **13.4**
 Structural Grade: **0**
 O&M Grade: **1**
 Clock Start/From: **9**
 Clock To: **3**
 1st Value:
 2nd Value:
 Value Percent:
 Continuous Index:
 Within 8" of Joint: **YES**
 Remarks:

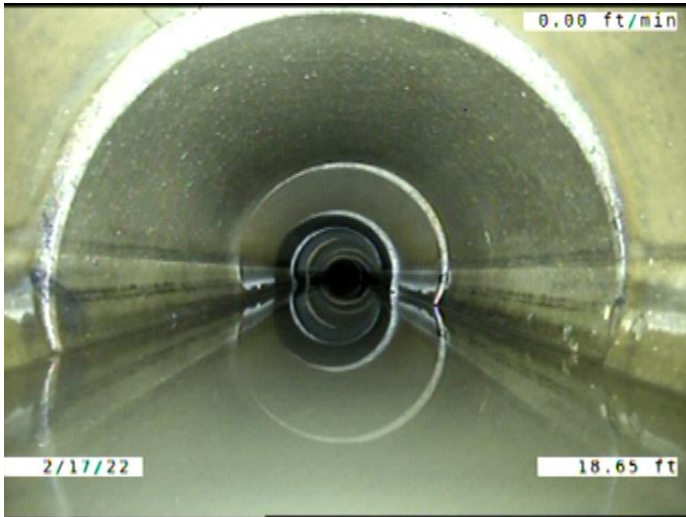
Code: **MWLS**
 Description: **Miscellaneous Water Level Sag**

Distance (ft): **18.6**
 Structural Grade: **2**
 O&M Grade: **0**
 Clock Start/From:
 Clock To:
 1st Value:
 2nd Value:
 Value Percent: **30.000**
 Continuous Index: **S01**
 Within 8" of Joint: **NO**
 Remarks:

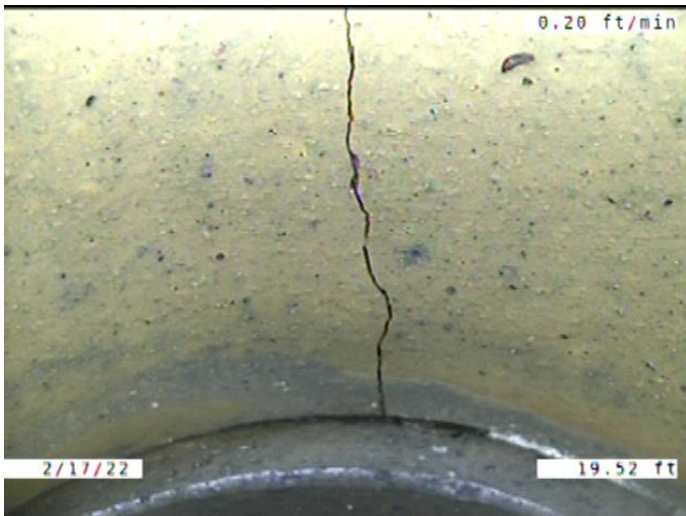
Code: **CL**
 Description: **Crack Longitudinal**

Distance (ft): **19.5**
 Structural Grade: **2**
 O&M Grade: **0**
 Clock Start/From: **11**
 Clock To:
 1st Value:
 2nd Value:
 Value Percent:
 Continuous Index:
 Within 8" of Joint: **YES**
 Remarks:

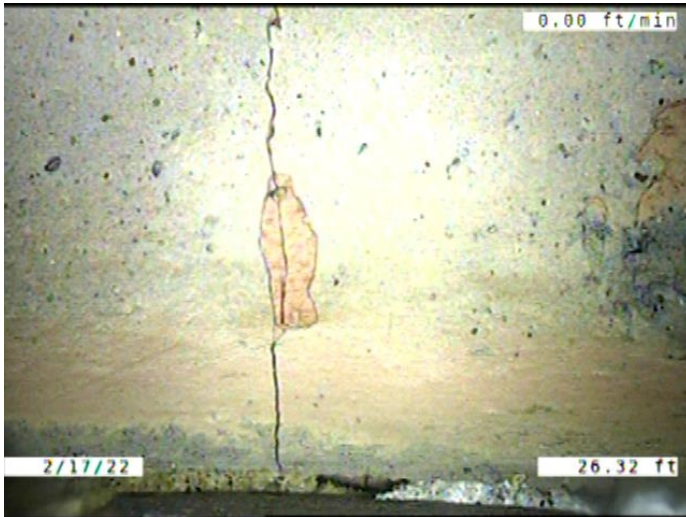
Code: **CL**
Description: **Crack Longitudinal**

Distance (ft): **26.3**
Structural Grade: **2**
O&M Grade: **0**
Clock Start/From: **12**
Clock To:
1st Value:
2nd Value:
Value Percent:
Continuous Index:
Within 8" of Joint: **YES**
Remarks:

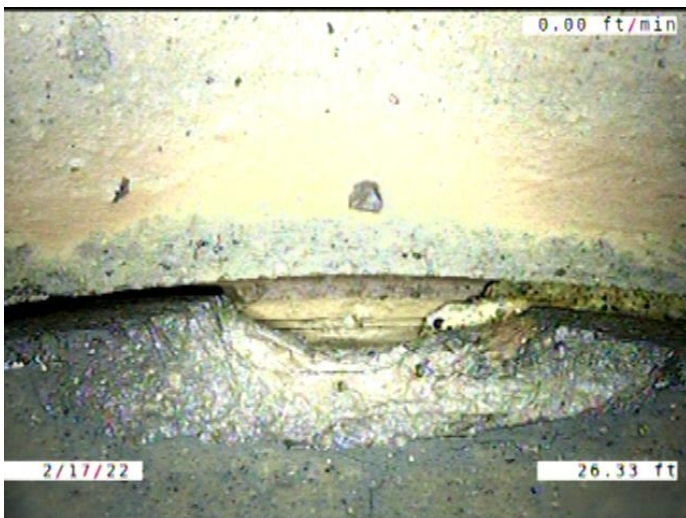
Code: **SZ**
Description: **Surface Damage Other**

Distance (ft): **26.3**
Structural Grade: **0**
O&M Grade: **0**
Clock Start/From: **11**
Clock To:
1st Value:
2nd Value:
Value Percent:
Continuous Index:
Within 8" of Joint: **YES**
Remarks: **A PIECE CHIPPED AWAY FROM THE JOINT**

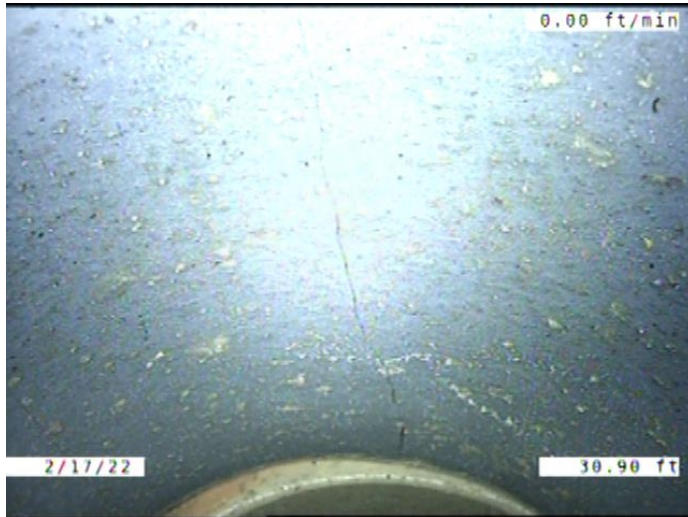
Code: **CS**
 Description: **Crack Spiral**

Distance (ft): **30.9**
 Structural Grade: **2**
 O&M Grade: **0**
 Clock Start/From: **11**
 Clock To: **1**
 1st Value:
 2nd Value:
 Value Percent:
 Continuous Index:
 Within 8" of Joint: **YES**
 Remarks:

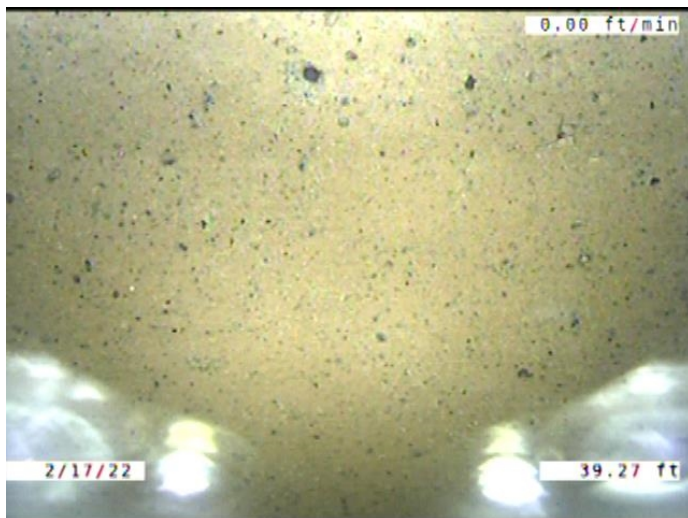
Code: **MCU**
 Description: **Miscellaneous Camera Underwater**

Distance (ft): **39.3**
 Structural Grade: **0**
 O&M Grade: **4**
 Clock Start/From:
 Clock To:
 1st Value:
 2nd Value:
 Value Percent:
 Continuous Index:
 Within 8" of Joint: **NO**
 Remarks: **Out at 40.9**

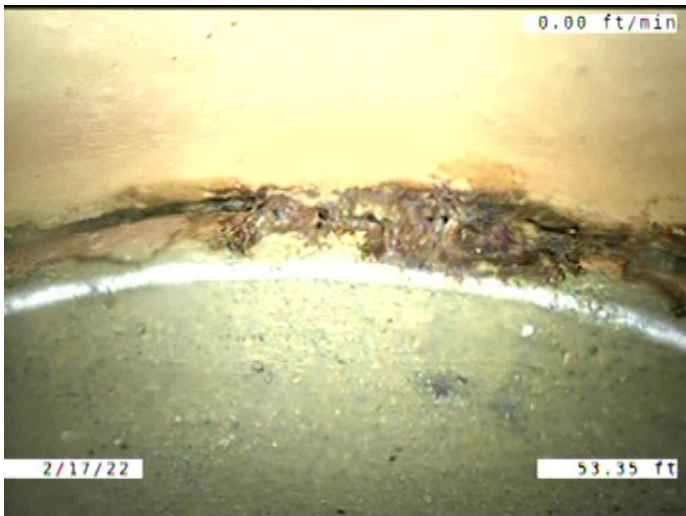
Code: **DAE**
 Description: **Deposits Attached Encrustation**

Distance (ft): **53.3**
 Structural Grade: **0**
 O&M Grade: **2**
 Clock Start/From: **10**
 Clock To: **2**
 1st Value:
 2nd Value:
 Value Percent: **5.000**
 Continuous Index:
 Within 8" of Joint: **YES**
 Remarks:

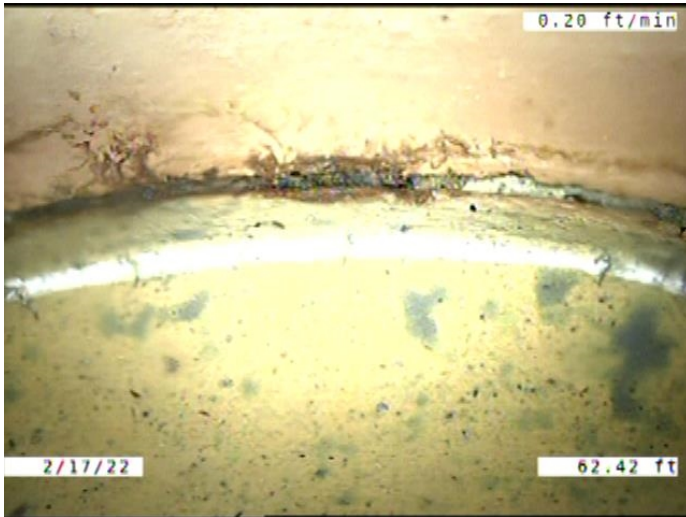
Code: **DAE**
 Description: **Deposits Attached Encrustation**

Distance (ft): **62.4**
 Structural Grade: **0**
 O&M Grade: **2**
 Clock Start/From: **9**
 Clock To: **3**
 1st Value:
 2nd Value:
 Value Percent: **5.000**
 Continuous Index: **S02**
 Within 8" of Joint: **YES**
 Remarks:

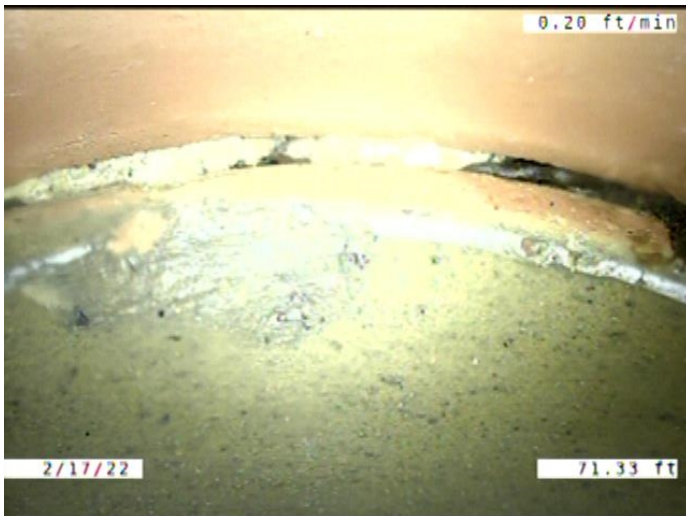
Code: **SSS**
 Description: **Surface Damage Surface Spalling**

Distance (ft): **71.3**
 Structural Grade: **2**
 O&M Grade: **0**
 Clock Start/From: **12**
 Clock To:
 1st Value:
 2nd Value:
 Value Percent:
 Continuous Index:
 Within 8" of Joint: **YES**
 Remarks:

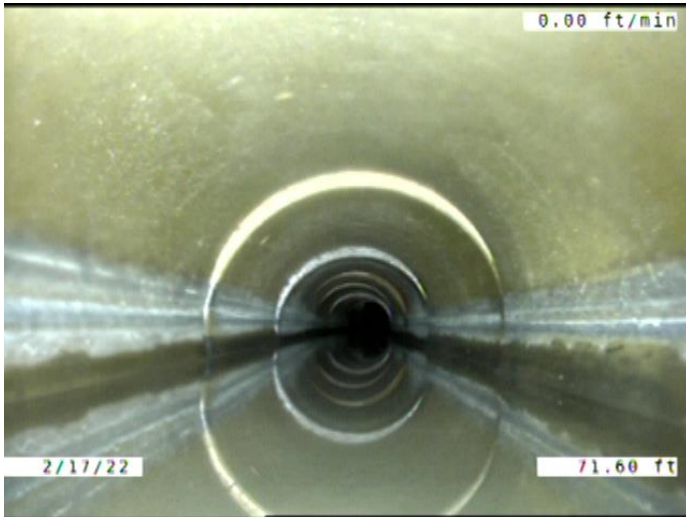
Code: **MWLS**
Description: **Miscellaneous Water Level Sag**

Distance (ft): **71.6**
Structural Grade: **2**
O&M Grade: **0**
Clock Start/From:
Clock To:
1st Value:
2nd Value:
Value Percent: **30.000**
Continuous Index: **F01**
Within 8" of Joint: **NO**
Remarks:

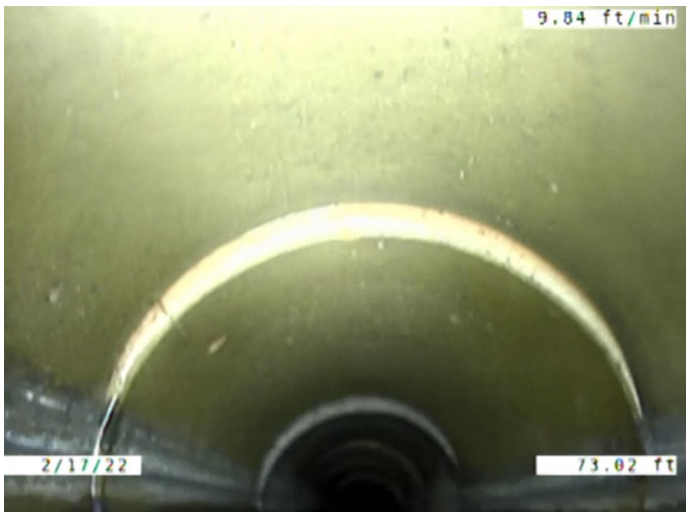
Code: **FL**
Description: **Fracture Longitudinal**

Distance (ft): **73.0**
Structural Grade: **3**
O&M Grade: **0**
Clock Start/From: **10**
Clock To:
1st Value:
2nd Value:
Value Percent:
Continuous Index:
Within 8" of Joint: **YES**
Remarks:

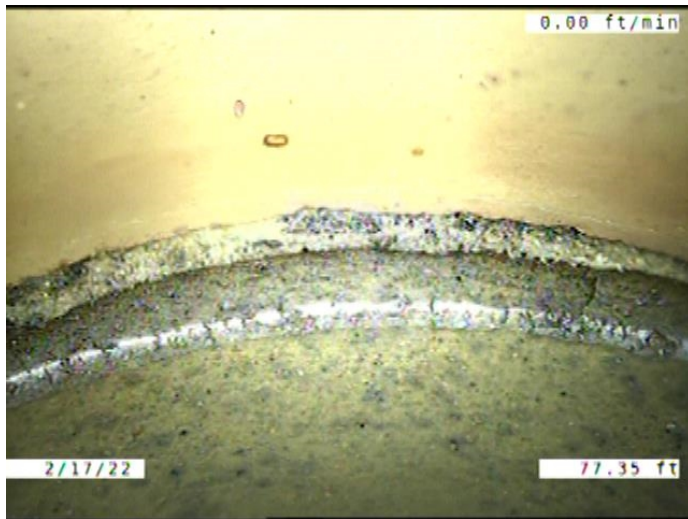
Code: **JOM**
 Description: **Joint Offset Medium**

Distance (ft): **77.3**
 Structural Grade: **3**
 O&M Grade: **0**
 Clock Start/From:
 Clock To:
 1st Value:
 2nd Value:
 Value Percent:
 Continuous Index:
 Within 8" of Joint: **NO**
 Remarks:

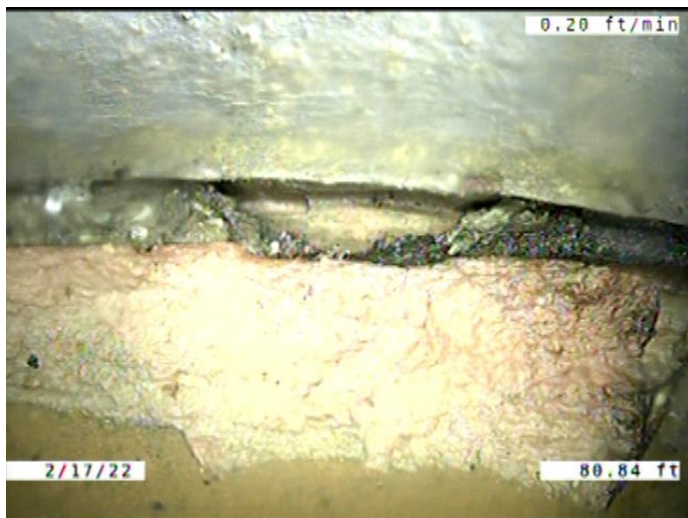
Code: **SZ**
 Description: **Surface Damage Other**

Distance (ft): **80.8**
 Structural Grade: **0**
 O&M Grade: **0**
 Clock Start/From: **12**
 Clock To: **3**
 1st Value:
 2nd Value:
 Value Percent:
 Continuous Index:
 Within 8" of Joint: **YES**
 Remarks: **A PIECE CHIPPED AWAY FROM THE JOINT**

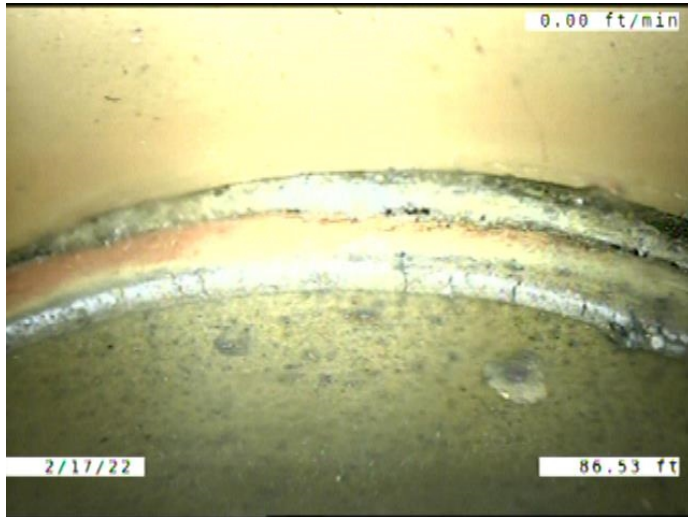
Code: **JOM**
 Description: **Joint Offset Medium**

Distance (ft): **86.5**
 Structural Grade: **3**
 O&M Grade: **0**
 Clock Start/From:
 Clock To:
 1st Value:
 2nd Value:
 Value Percent:
 Continuous Index:
 Within 8" of Joint: **NO**
 Remarks:

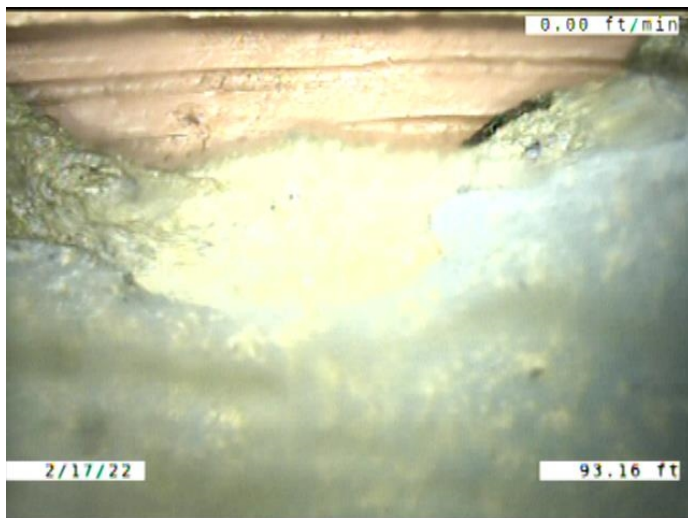
Code: **SZ**
 Description: **Surface Damage Other**

Distance (ft): **93.2**
 Structural Grade: **0**
 O&M Grade: **0**
 Clock Start/From: **9**
 Clock To: **11**
 1st Value:
 2nd Value:
 Value Percent:
 Continuous Index:
 Within 8" of Joint: **YES**
 Remarks: **A PIECE CHIPPED AWAY FROM THE JOINT**

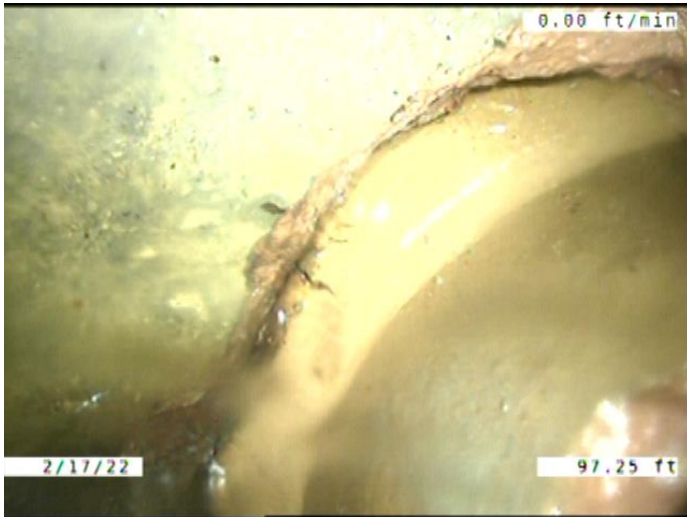
Code: **SSS**
 Description: **Surface Damage Surface Spalling**

Distance (ft): **97.2**
 Structural Grade: **2**
 O&M Grade: **0**
 Clock Start/From: **10**
 Clock To: **12**
 1st Value:
 2nd Value:
 Value Percent:
 Continuous Index:
 Within 8" of Joint: **YES**
 Remarks:

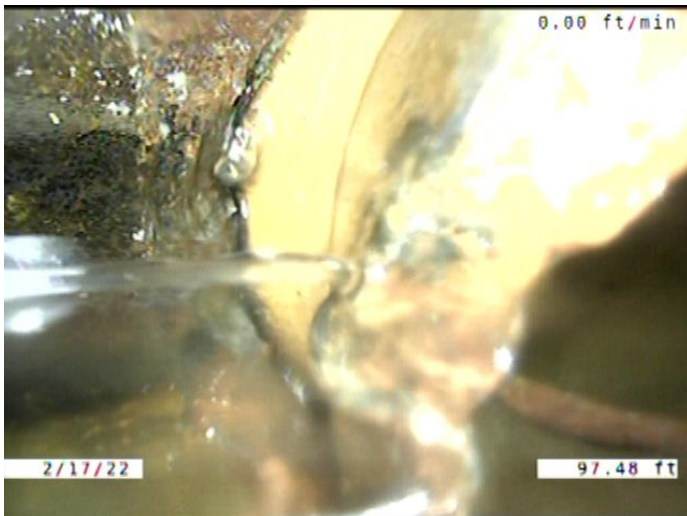
Code: **IRC**
 Description: **Infiltration Runner Connection**

Distance (ft): **97.5**
 Structural Grade: **0**
 O&M Grade: **4**
 Clock Start/From: **10**
 Clock To:
 1st Value:
 2nd Value:
 Value Percent:
 Continuous Index:
 Within 8" of Joint: **YES**
 Remarks:

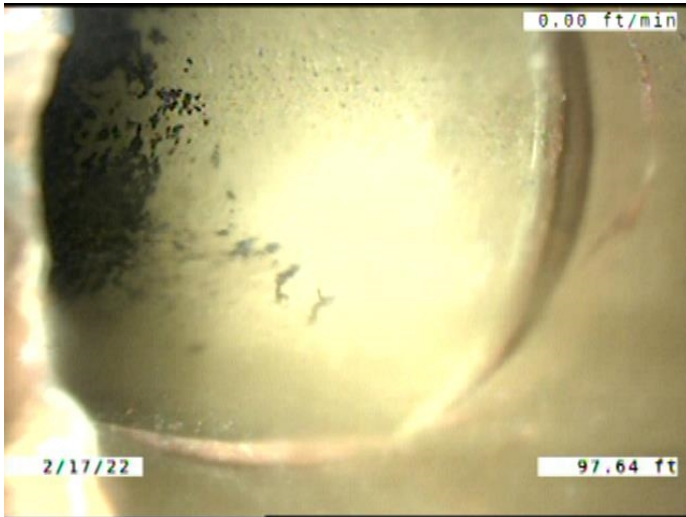
Code: **TBI**
 Description: **Tap Break-in Intruding**

Distance (ft): **97.6**
 Structural Grade: **0**
 O&M Grade: **2**
 Clock Start/From: **11**
 Clock To:
 1st Value: **4.000**
 2nd Value: **3.000**
 Value Percent:
 Continuous Index:
 Within 8" of Joint: **YES**
 Remarks: **Active**

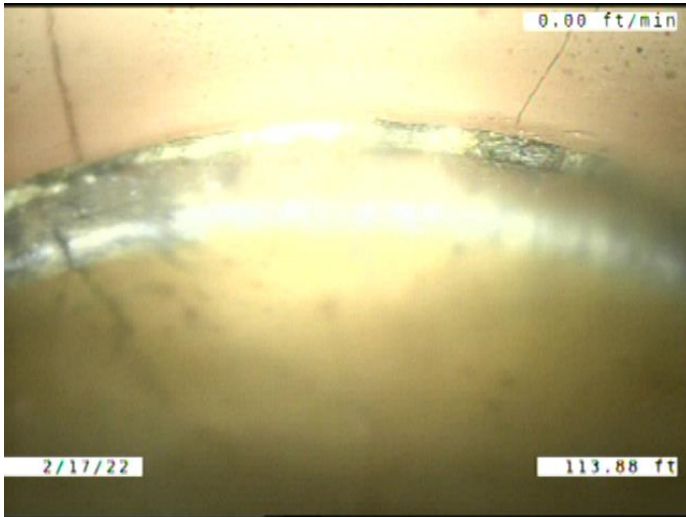
Code: **JOMD**
Description: **Joint Offset Medium Defective**

Distance (ft): **113.9**
Structural Grade: **3**
O&M Grade: **0**
Clock Start/From:
Clock To:
1st Value:
2nd Value:
Value Percent:
Continuous Index:
Within 8" of Joint: **NO**
Remarks:

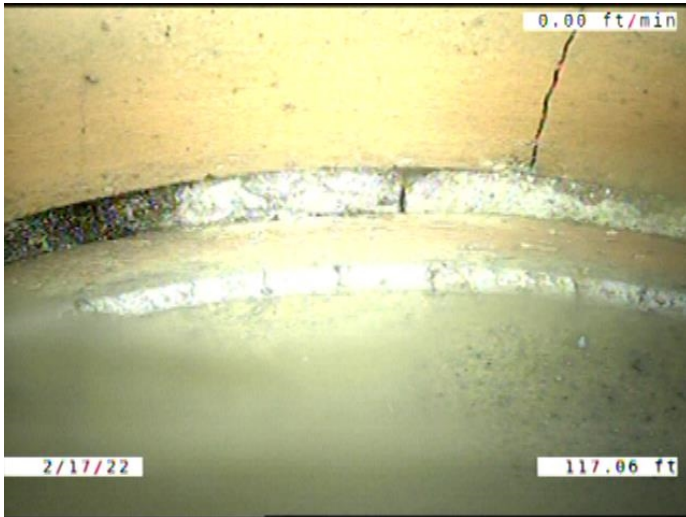
Code: **JOM**
 Description: **Joint Offset Medium**

Distance (ft): **117.1**
 Structural Grade: **3**
 O&M Grade: **0**
 Clock Start/From:
 Clock To:
 1st Value:
 2nd Value:
 Value Percent:
 Continuous Index:
 Within 8" of Joint: **NO**
 Remarks:

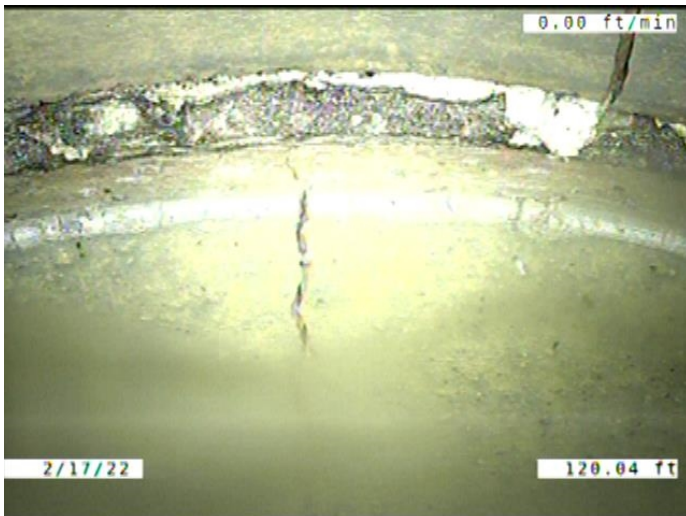
Code: **JOMD**
 Description: **Joint Offset Medium Defective**

Distance (ft): **120.0**
 Structural Grade: **3**
 O&M Grade: **0**
 Clock Start/From:
 Clock To:
 1st Value:
 2nd Value:
 Value Percent:
 Continuous Index:
 Within 8" of Joint: **NO**
 Remarks:

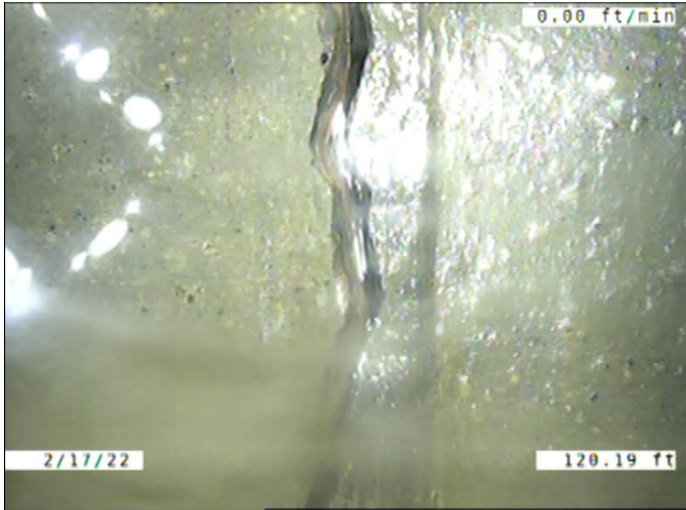
Code: **B**
Description: **Broken**

Distance (ft): **120.2**
Structural Grade: **4**
O&M Grade: **0**
Clock Start/From: **5**
Clock To: **7**
1st Value:
2nd Value:
Value Percent:
Continuous Index:
Within 8" of Joint: **YES**
Remarks:

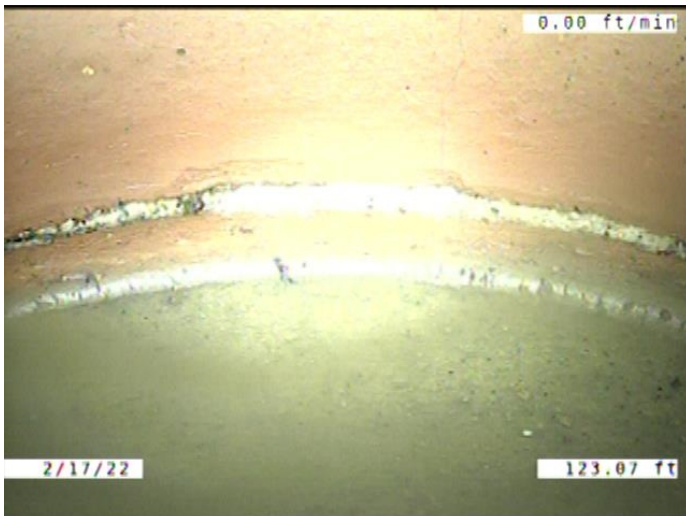
Code: **JOMD**
Description: **Joint Offset Medium Defective**

Distance (ft): **123.1**
Structural Grade: **3**
O&M Grade: **0**
Clock Start/From:
Clock To:
1st Value:
2nd Value:
Value Percent:
Continuous Index:
Within 8" of Joint: **NO**
Remarks:

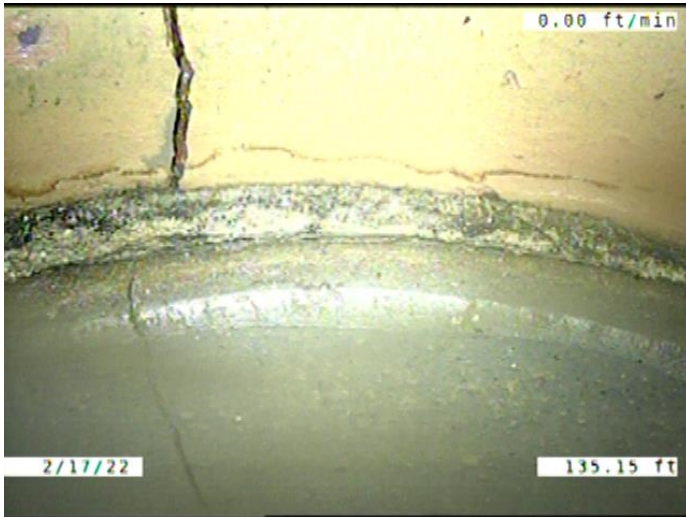
Code: **JOMD**
Description: **Joint Offset Medium Defective**

Distance (ft): **135.1**
Structural Grade: **3**
O&M Grade: **0**
Clock Start/From:
Clock To:
1st Value:
2nd Value:
Value Percent:
Continuous Index:
Within 8" of Joint: **NO**
Remarks:

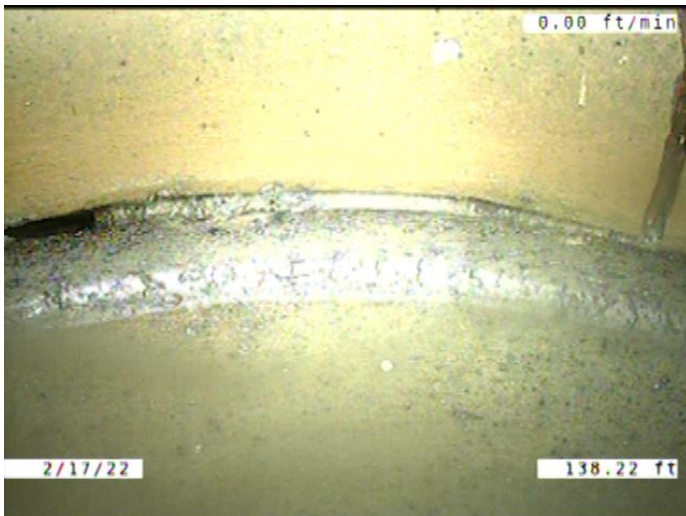
Code: **JOMD**
Description: **Joint Offset Medium Defective**

Distance (ft): **138.2**
Structural Grade: **3**
O&M Grade: **0**
Clock Start/From:
Clock To:
1st Value:
2nd Value:
Value Percent:
Continuous Index: **S05**
Within 8" of Joint: **NO**
Remarks:

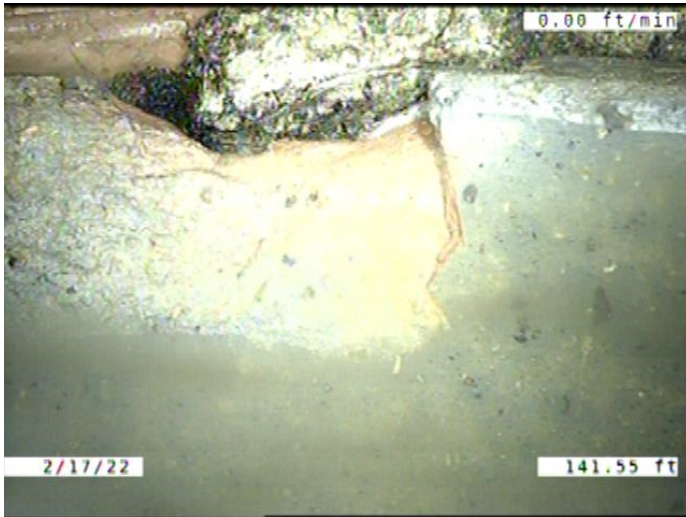
Code:	SZ
Description:	Surface Damage Other
Distance (ft):	141.5
Structural Grade:	0
O&M Grade:	0
Clock Start/From:	10
Clock To:	11
1st Value:	
2nd Value:	
Value Percent:	
Continuous Index:	
Within 8" of Joint:	YES
Remarks:	A PIECE CHIPPED AWAY FROM THE JOINT

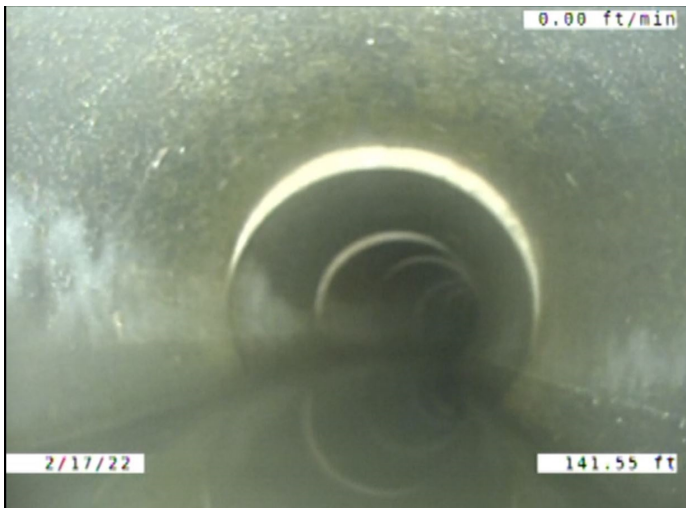
Code:	FM
Description:	Fracture Multiple
Distance (ft):	141.6
Structural Grade:	4
O&M Grade:	0
Clock Start/From:	12
Clock To:	12
1st Value:	
2nd Value:	
Value Percent:	
Continuous Index:	F04
Within 8" of Joint:	YES
Remarks:	Wandering

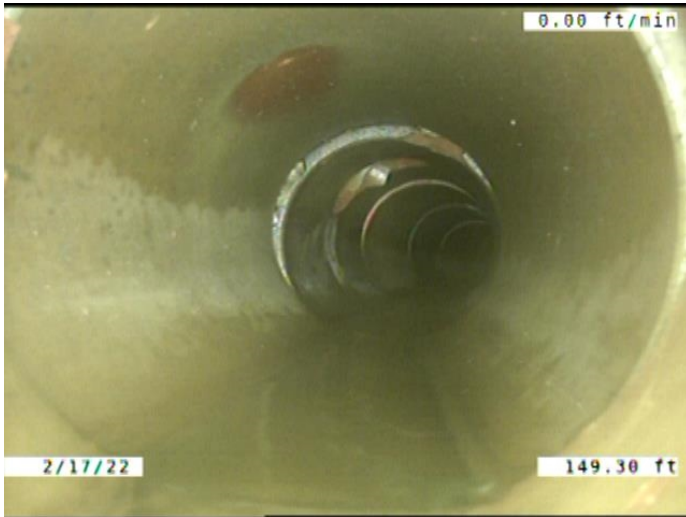
Code: **LR**
 Description: **Line Right**

Distance (ft): **149.3**
 Structural Grade: **0**
 O&M Grade: **2**
 Clock Start/From:
 Clock To:
 1st Value:
 2nd Value:
 Value Percent: **15.000**
 Continuous Index:
 Within 8" of Joint: **NO**
 Remarks:

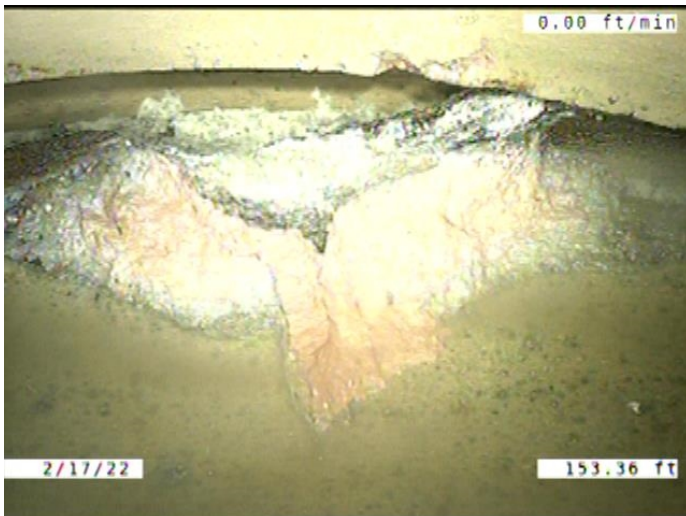
Code: **SZ**
 Description: **Surface Damage Other**

Distance (ft): **153.4**
 Structural Grade: **0**
 O&M Grade: **0**
 Clock Start/From: **12**
 Clock To: **1**
 1st Value:
 2nd Value:
 Value Percent:
 Continuous Index:
 Within 8" of Joint: **YES**
 Remarks: **A PIECE CHIPPED AWAY FROM THE JOINT**

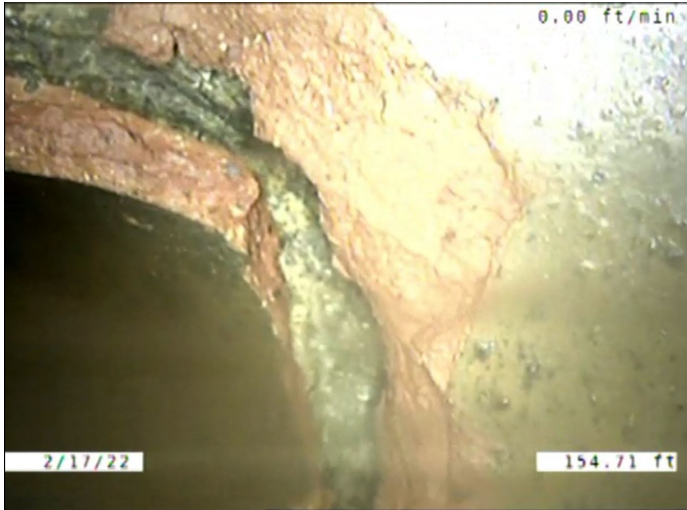
Code: **SSS**
Description: **Surface Damage Surface Spalling**

Distance (ft): **154.7**
Structural Grade: **2**
O&M Grade: **0**
Clock Start/From: **10**
Clock To: **12**
1st Value:
2nd Value:
Value Percent:
Continuous Index:
Within 8" of Joint: **NO**
Remarks:

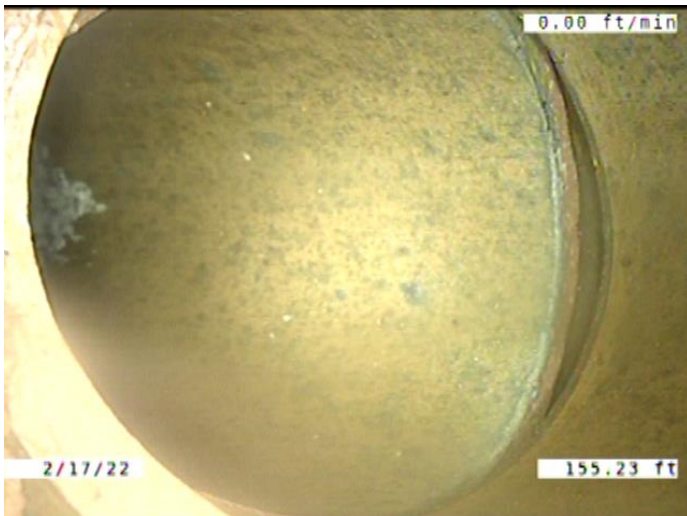
Code: **TBI**
Description: **Tap Break-in Intruding**

Distance (ft): **155.2**
Structural Grade: **0**
O&M Grade: **2**
Clock Start/From: **11**
Clock To:
1st Value: **4.000**
2nd Value: **1.000**
Value Percent:
Continuous Index:
Within 8" of Joint: **YES**
Remarks:

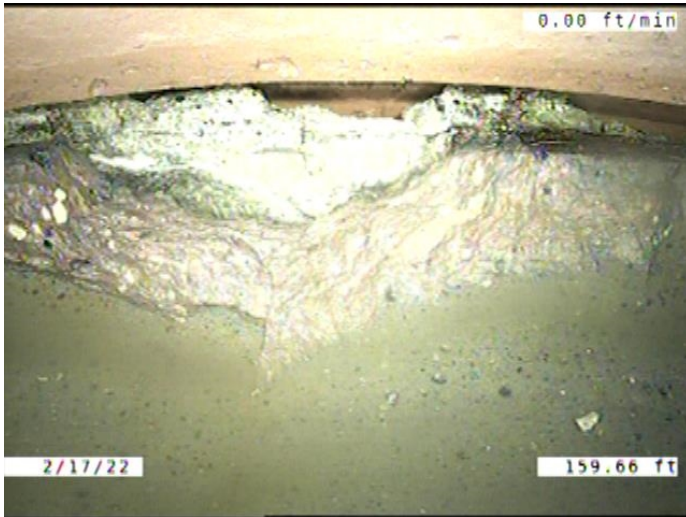
Code: **SZ**
Description: **Surface Damage Other**

Distance (ft): **159.7**
Structural Grade: **0**
O&M Grade: **0**
Clock Start/From: **12**
Clock To:
1st Value:
2nd Value:
Value Percent:
Continuous Index:
Within 8" of Joint: **YES**
Remarks: **A PIECE CHIPPED AWAY FROM THE JOINT.**

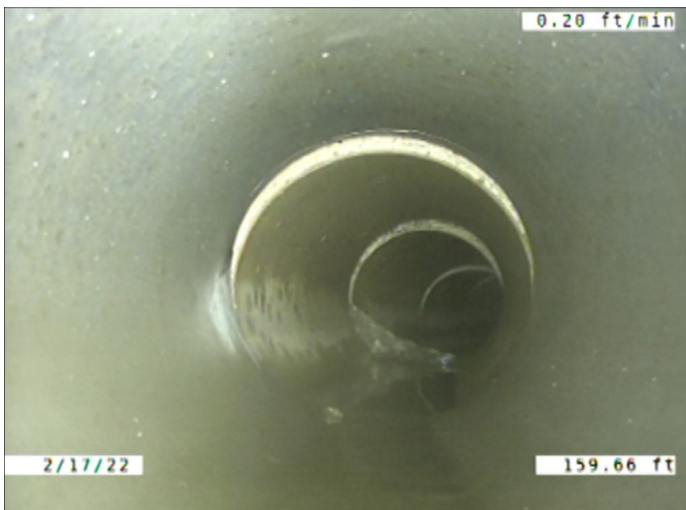
Code: **LR**
Description: **Line Right**

Distance (ft): **159.7**
Structural Grade: **0**
O&M Grade: **2**
Clock Start/From:
Clock To:
1st Value:
2nd Value:
Value Percent: **15.000**
Continuous Index: **S06**
Within 8" of Joint: **NO**
Remarks:

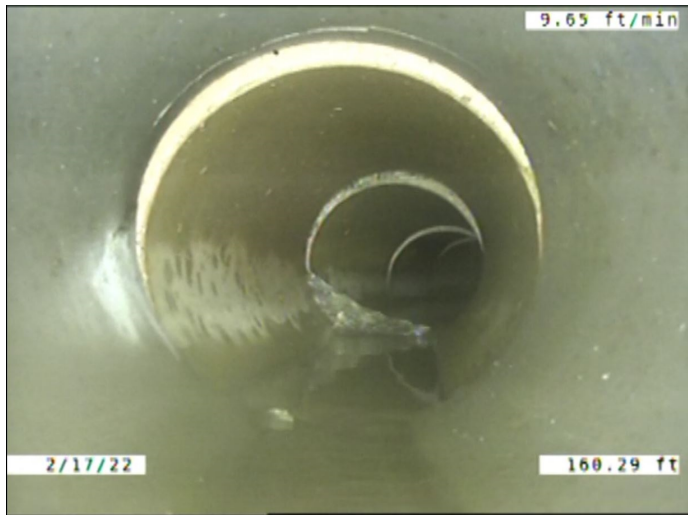
Code: **CC**
 Description: **Crack Circumferential**

Distance (ft): **160.3**
 Structural Grade: **1**
 O&M Grade: **0**
 Clock Start/From: **10**
 Clock To: **1**
 1st Value:
 2nd Value:
 Value Percent:
 Continuous Index:
 Within 8" of Joint: **YES**
 Remarks:

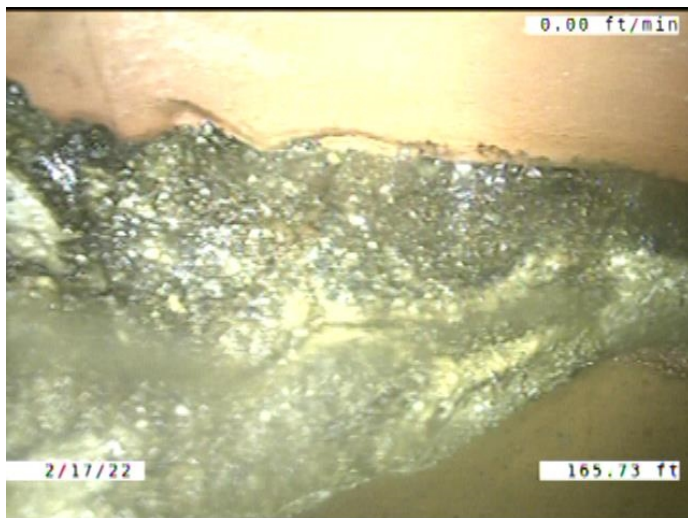
Code: **ISGT**
 Description: **Intruding Sealing Material Grout**

Distance (ft): **165.7**
 Structural Grade: **0**
 O&M Grade: **2**
 Clock Start/From: **6**
 Clock To: **11**
 1st Value:
 2nd Value:
 Value Percent: **10.000**
 Continuous Index:
 Within 8" of Joint: **NO**
 Remarks:

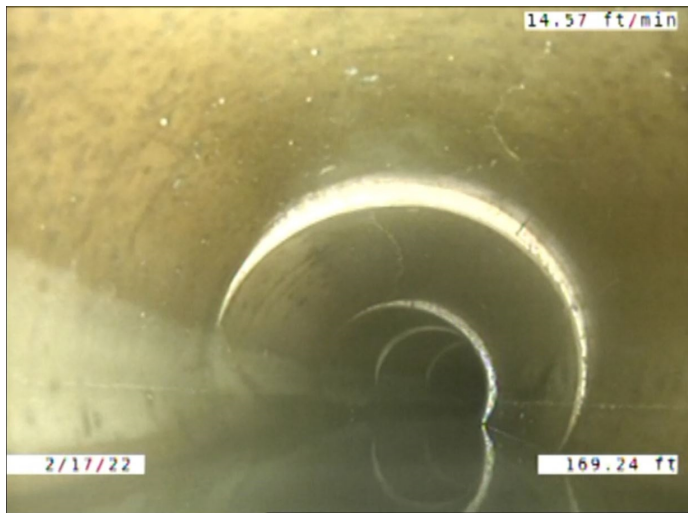
Code: **FM**
 Description: **Fracture Multiple**

Distance (ft): **169.2**
 Structural Grade: **4**
 O&M Grade: **0**
 Clock Start/From: **11**
 Clock To: **1**
 1st Value:
 2nd Value:
 Value Percent:
 Continuous Index: **S07**
 Within 8" of Joint: **YES**
 Remarks:

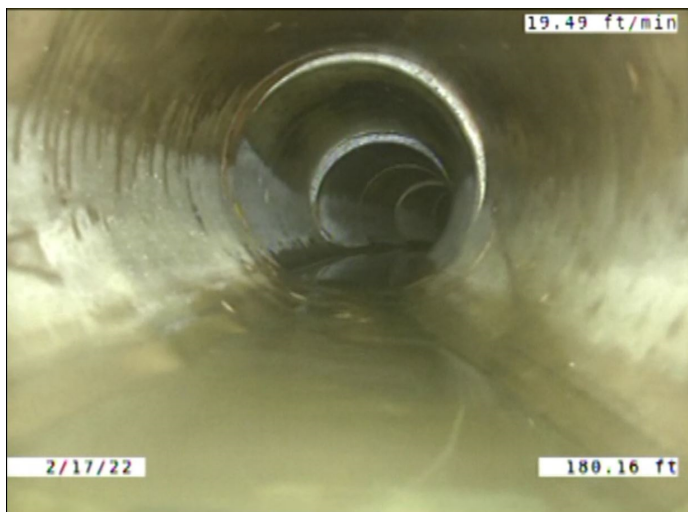
Code: **FM**
 Description: **Fracture Multiple**

Distance (ft): **180.2**
 Structural Grade: **4**
 O&M Grade: **0**
 Clock Start/From: **11**
 Clock To: **1**
 1st Value:
 2nd Value:
 Value Percent:
 Continuous Index: **F07**
 Within 8" of Joint: **YES**
 Remarks:

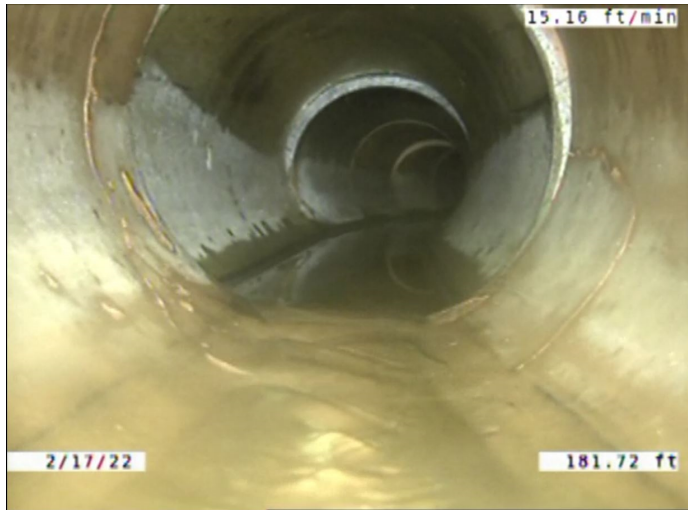
Code: **CM**
 Description: **Crack Multiple**

Distance (ft): **181.7**
 Structural Grade: **3**
 O&M Grade: **0**
 Clock Start/From: **3**
 Clock To: **11**
 1st Value:
 2nd Value:
 Value Percent:
 Continuous Index:
 Within 8" of Joint: **YES**
 Remarks:

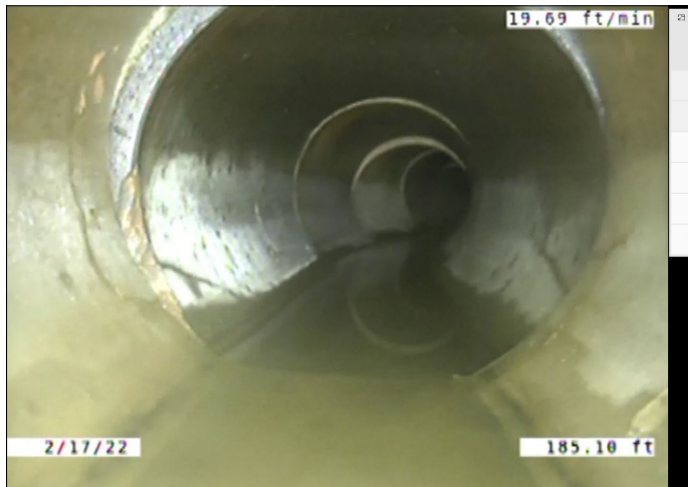
Code: **CM**
 Description: **Crack Multiple**

Distance (ft): **185.1**
 Structural Grade: **3**
 O&M Grade: **0**
 Clock Start/From: **8**
 Clock To: **4**
 1st Value:
 2nd Value:
 Value Percent:
 Continuous Index: **S08**
 Within 8" of Joint: **YES**
 Remarks: **Wandering**

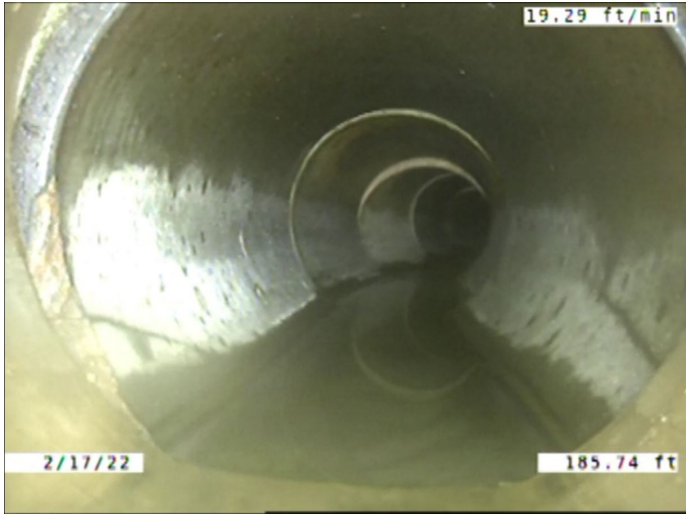
Code: **SSS**
Description: **Surface Damage Surface Spalling**

Distance (ft): **185.7**
Structural Grade: **2**
O&M Grade: **0**
Clock Start/From: **8**
Clock To: **9**
1st Value:
2nd Value:
Value Percent:
Continuous Index:
Within 8" of Joint: **YES**
Remarks:

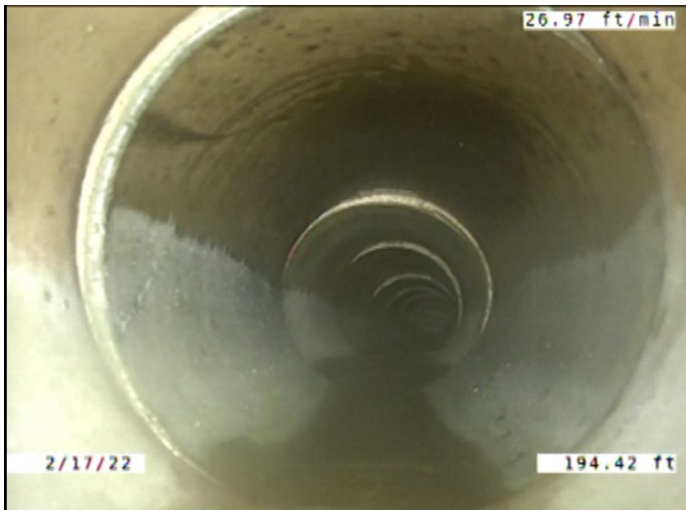
Code: **CM**
Description: **Crack Multiple**

Distance (ft): **194.4**
Structural Grade: **3**
O&M Grade: **0**
Clock Start/From: **8**
Clock To: **4**
1st Value:
2nd Value:
Value Percent:
Continuous Index: **F08**
Within 8" of Joint: **YES**
Remarks: **Wandering**
