Profile/Photo Observation Report

Date:	02/17/2022	Weather:		Coding:	PACP 7.0
Pipe Length (ft):	214.9	Owner:	City of Hobart	Pre Clean:	Heavy Cleaning
P.O.#:	YES502259	Surveyor:	S. Bucklin	PSR:	P-707-064-071
Customer:	City of Hobart	Clean Date:	02/15/2022	Shape:	C

Street:	East 11th Place	Flow Control:	Not Controlled
City:	Hobart, IN	Year Renewed:	
Location:	Local rural streets with light traffic, t	Tape/Media #:	
Purpose:	Routine Assessment	Dia/Height:	12"
Use:	Sanitary Sewage Pipe	Material:	VCP
Drain Area:		Lining:	None
Category:	NA		
Comment:			
Location Details:		Direction of Survey:	Upstream
US MH:	M-707-071	DS MH:	M-707-064
		Total Length Surveyed (ft):	214.9

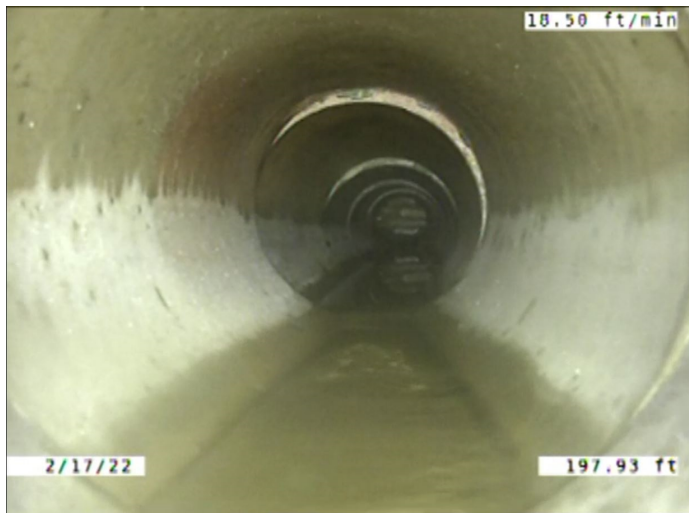
Code: **LR**
Description: **Line Right**

Distance (ft): **197.9**
Structural Grade: **0**
O&M Grade: **2**
Clock Start/From:
Clock To:
1st Value:
2nd Value:
Value Percent: **15.000**
Continuous Index: **F06**
Within 8" of Joint: **NO**
Remarks:

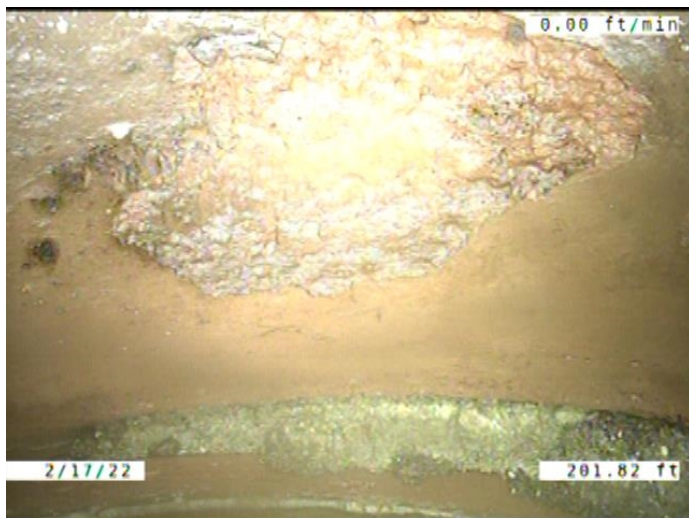
Code: **SSS**
Description: **Surface Damage Surface Spalling**

Distance (ft): **201.8**
Structural Grade: **2**
O&M Grade: **0**
Clock Start/From: **11**
Clock To:
1st Value:
2nd Value:
Value Percent:
Continuous Index:
Within 8" of Joint: **YES**
Remarks:

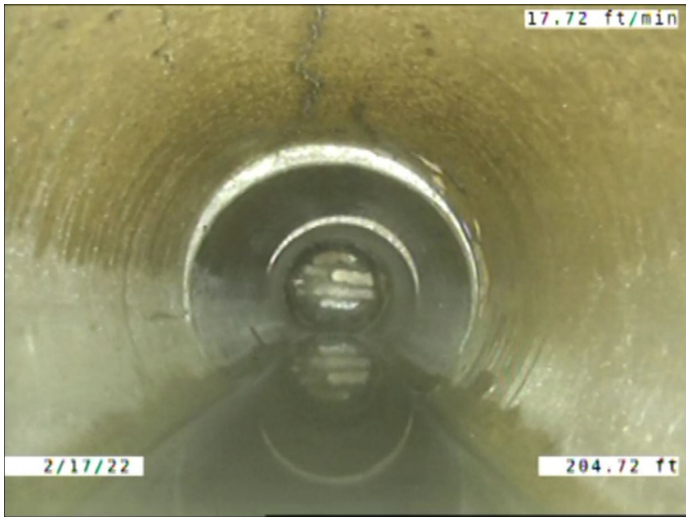
Code: **CM**
 Description: **Crack Multiple**

Distance (ft): **204.7**
 Structural Grade: **3**
 O&M Grade: **0**
 Clock Start/From: **9**
 Clock To: **1**
 1st Value:
 2nd Value:
 Value Percent:
 Continuous Index:
 Within 8" of Joint: **YES**
 Remarks:

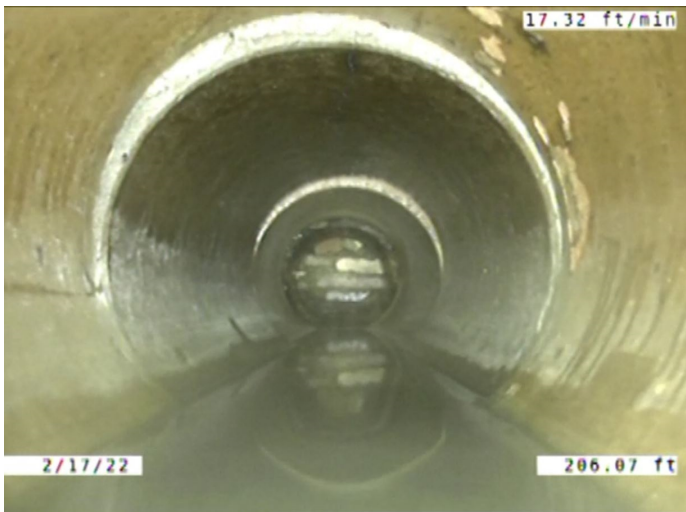
Code: **SSS**
 Description: **Surface Damage Surface Spalling**

Distance (ft): **206.1**
 Structural Grade: **2**
 O&M Grade: **0**
 Clock Start/From: **1**
 Clock To: **3**
 1st Value:
 2nd Value:
 Value Percent:
 Continuous Index:
 Within 8" of Joint: **YES**
 Remarks:

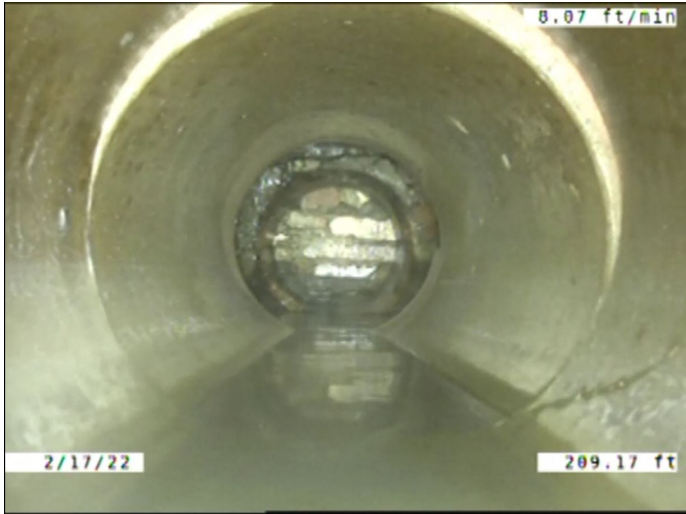
Code: **CS**
Description: **Crack Spiral**

Distance (ft): **209.2**
Structural Grade: **2**
O&M Grade: **0**
Clock Start/From: **4**
Clock To: **5**
1st Value:
2nd Value:
Value Percent:
Continuous Index:
Within 8" of Joint: **YES**
Remarks:

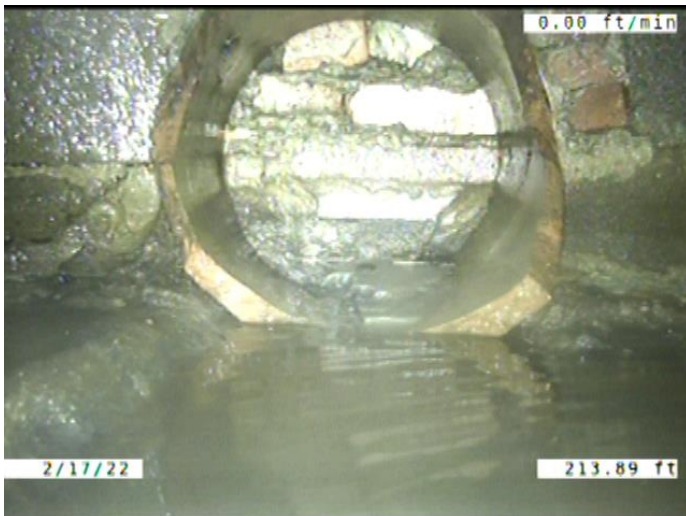
Code: **DAE**
Description: **Deposits Attached Encrustation**

Distance (ft): **213.9**
Structural Grade: **0**
O&M Grade: **2**
Clock Start/From: **9**
Clock To: **3**
1st Value:
2nd Value:
Value Percent: **5.000**
Continuous Index: **F02**
Within 8" of Joint: **YES**
Remarks:

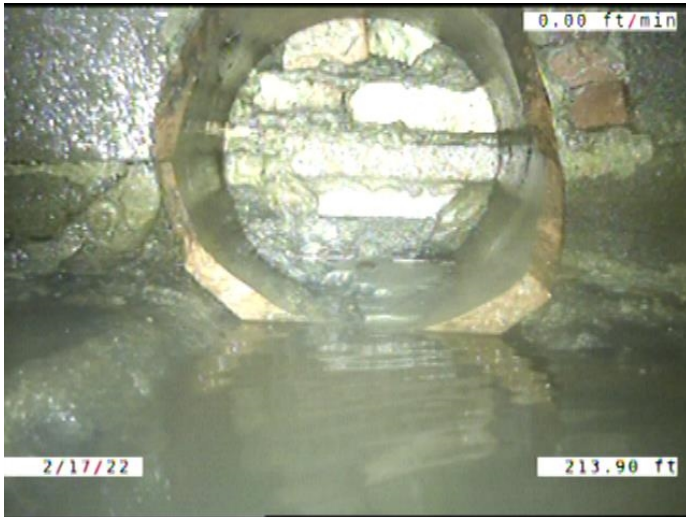
Code: **JOMD**
 Description: **Joint Offset Medium Defective**

Distance (ft): **213.9**
 Structural Grade: **3**
 O&M Grade: **0**
 Clock Start/From:
 Clock To:
 1st Value:
 2nd Value:
 Value Percent:
 Continuous Index: **F05**
 Within 8" of Joint: **NO**
 Remarks:
