Profile/Photo Observation Report

| Street: | East 11th Place | Flow Control: | Not Controlled |
| Purpose: | Routine Assessment | Dia/Height: | 10" |
| US MH: | M-707-072 | DS MH: | M-707-071 |

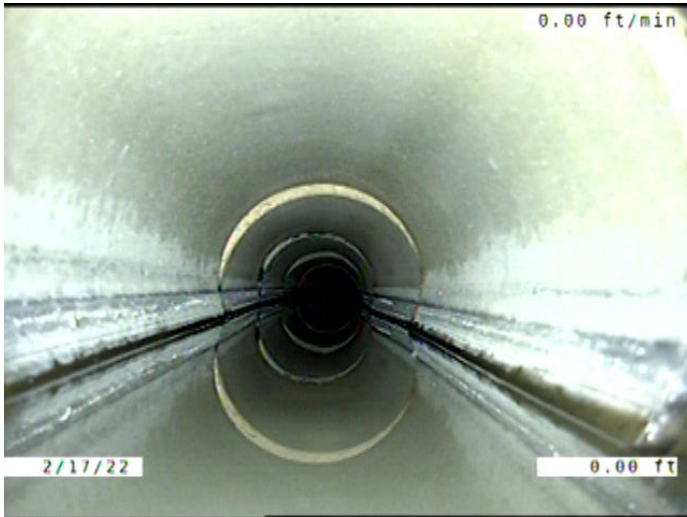
Code: **MWL**
 Description: **Miscellaneous Water Level**

Distance (ft): **.0**
 Structural Grade: **0**
 O&M Grade: **0**
 Clock Start/From:
 Clock To:
 1st Value:
 2nd Value:
 Value Percent: **15.000**
 Continuous Index:
 Within 8" of Joint: **NO**
 Remarks:

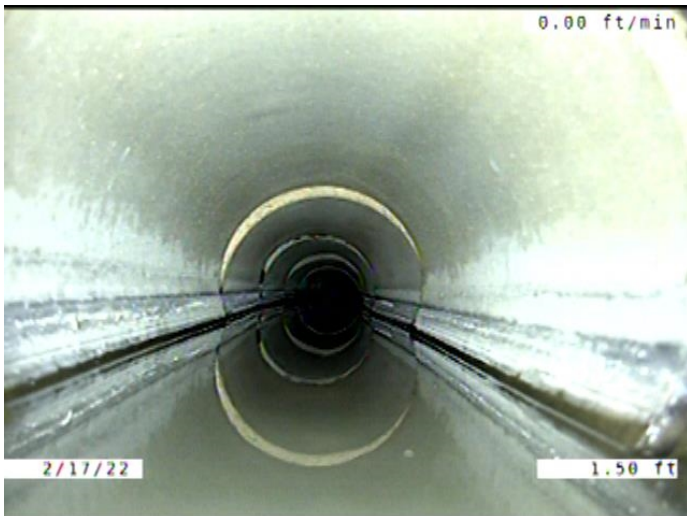
Code: **MGO**
 Description: **Miscellaneous General Observation**

Distance (ft): **1.5**
 Structural Grade: **0**
 O&M Grade: **0**
 Clock Start/From:
 Clock To:
 1st Value:
 2nd Value:
 Value Percent:
 Continuous Index:
 Within 8" of Joint: **NO**
 Remarks: **TIGHT ACCESS IN THE MANHOLE DUE TO ROOTS. ALSO PIPE IS BROKEN AT**

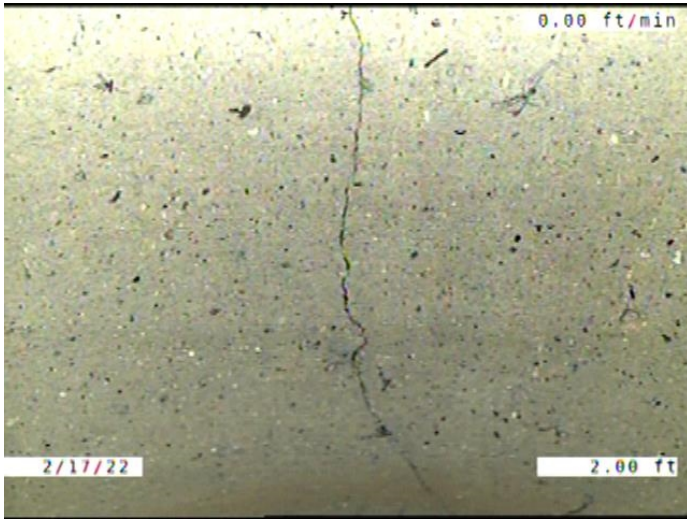
Code: **CS**
Description: **Crack Spiral**

Distance (ft): **2.0**
Structural Grade: **2**
O&M Grade: **0**
Clock Start/From: **11**
Clock To: **12**
1st Value:
2nd Value:
Value Percent:
Continuous Index:
Within 8" of Joint: **YES**
Remarks:

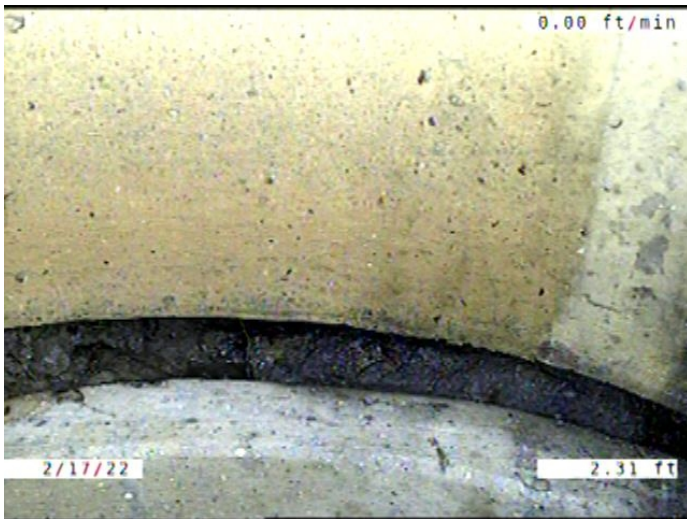
Code: **JOM**
Description: **Joint Offset Medium**

Distance (ft): **2.3**
Structural Grade: **3**
O&M Grade: **0**
Clock Start/From:
Clock To:
1st Value:
2nd Value:
Value Percent:
Continuous Index: **S01**
Within 8" of Joint: **NO**
Remarks:

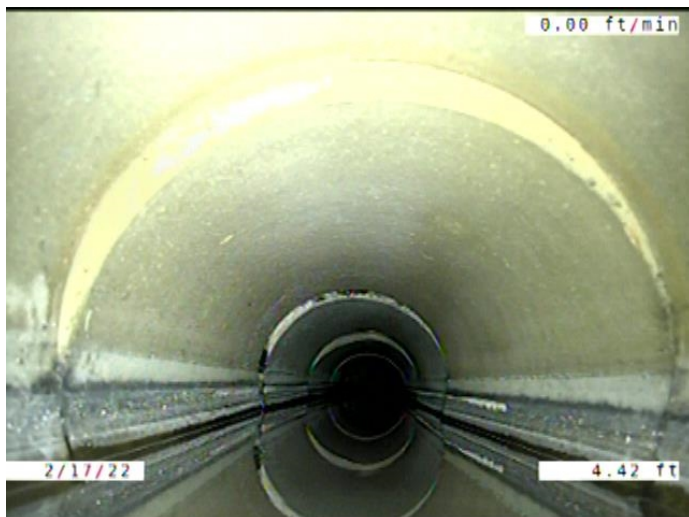
Code: **MWLS**
 Description: **Miscellaneous Water Level Sag**

Distance (ft): **4.4**
 Structural Grade: **2**
 O&M Grade: **0**
 Clock Start/From:
 Clock To:
 1st Value:
 2nd Value:
 Value Percent: **20.000**
 Continuous Index: **S02**
 Within 8" of Joint: **NO**
 Remarks:

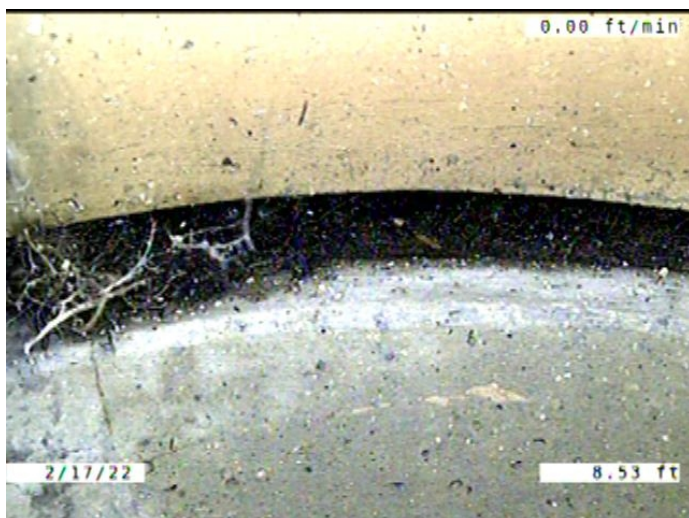
Code: **RFJ**
 Description: **Roots Fine Joint**

Distance (ft): **8.5**
 Structural Grade: **0**
 O&M Grade: **1**
 Clock Start/From: **10**
 Clock To: **2**
 1st Value:
 2nd Value:
 Value Percent:
 Continuous Index:
 Within 8" of Joint: **YES**
 Remarks:

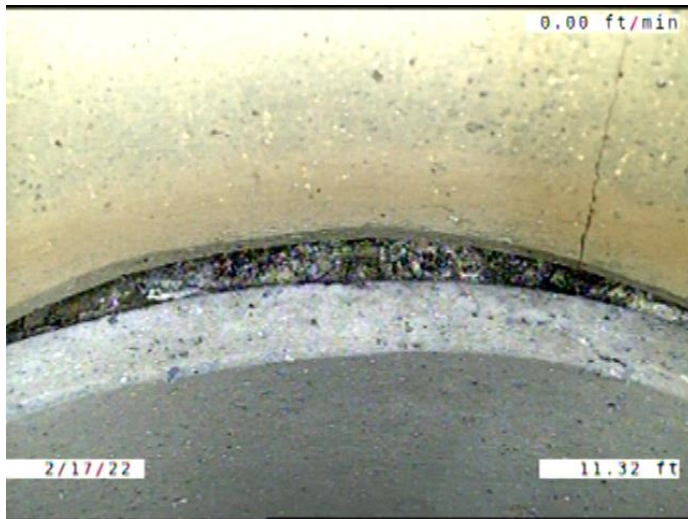
Code: **JOMD**
 Description: **Joint Offset Medium Defective**

Distance (ft): **11.3**
 Structural Grade: **3**
 O&M Grade: **0**
 Clock Start/From:
 Clock To:
 1st Value:
 2nd Value:
 Value Percent:
 Continuous Index:
 Within 8" of Joint: **NO**
 Remarks:

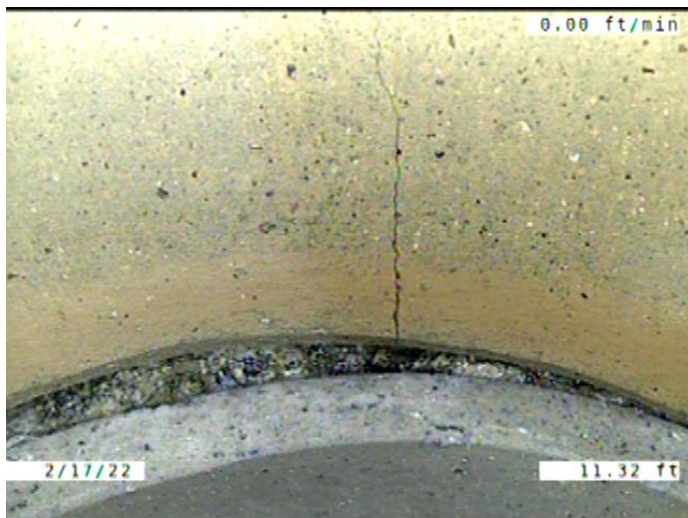
Code: **CL**
 Description: **Crack Longitudinal**

Distance (ft): **11.3**
 Structural Grade: **2**
 O&M Grade: **0**
 Clock Start/From: **12**
 Clock To:
 1st Value:
 2nd Value:
 Value Percent:
 Continuous Index:
 Within 8" of Joint: **YES**
 Remarks:

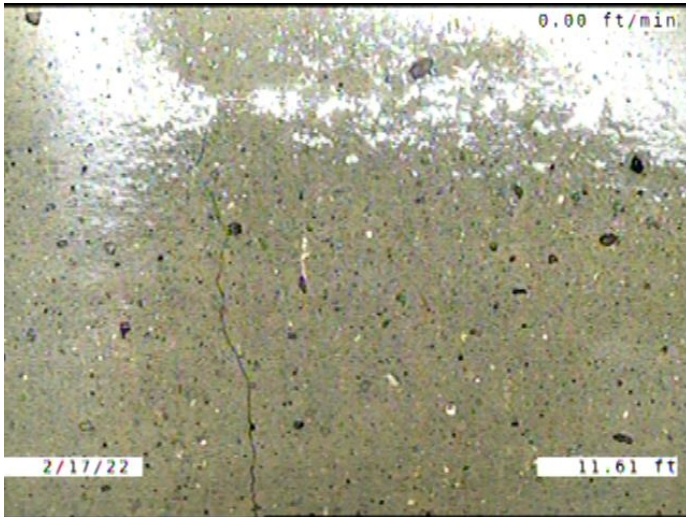
Code: **IWB**
 Description: **Infiltration Weeper Barrel**

Distance (ft): **11.6**
 Structural Grade: **0**
 O&M Grade: **2**
 Clock Start/From: **12**
 Clock To:
 1st Value:
 2nd Value:
 Value Percent:
 Continuous Index:
 Within 8" of Joint: **YES**
 Remarks:

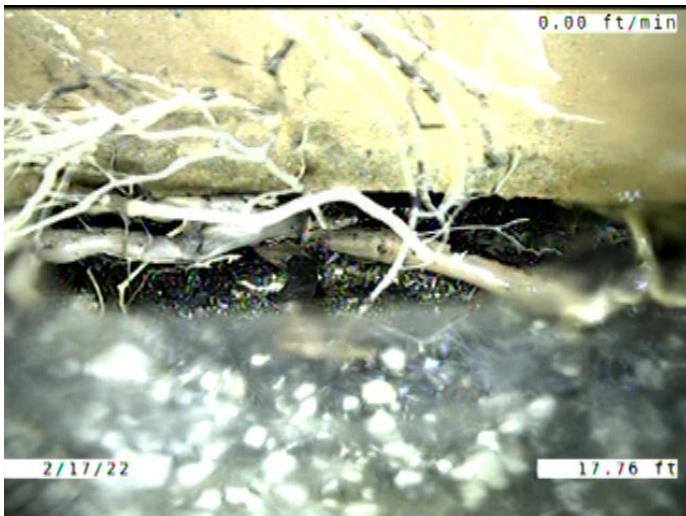
Code: **RFJ**
 Description: **Roots Fine Joint**

Distance (ft): **17.8**
 Structural Grade: **0**
 O&M Grade: **1**
 Clock Start/From: **10**
 Clock To: **2**
 1st Value:
 2nd Value:
 Value Percent:
 Continuous Index:
 Within 8" of Joint: **YES**
 Remarks:

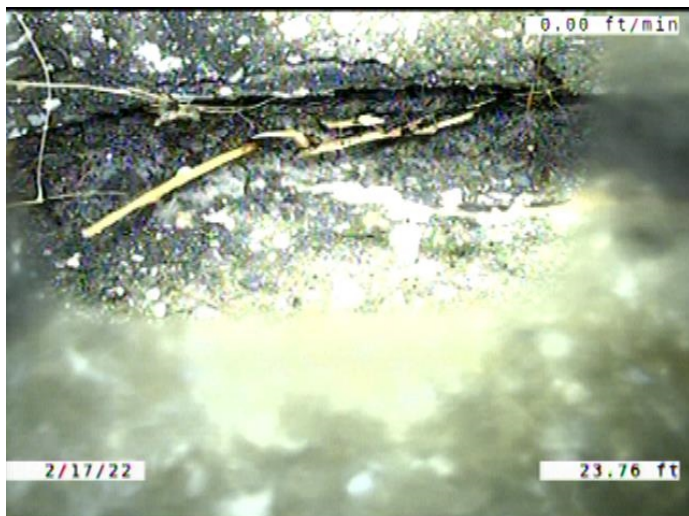
Code: **RFJ**
 Description: **Roots Fine Joint**

Distance (ft): **23.8**
 Structural Grade: **0**
 O&M Grade: **1**
 Clock Start/From: **9**
 Clock To: **3**
 1st Value:
 2nd Value:
 Value Percent:
 Continuous Index: **S03**
 Within 8" of Joint: **YES**
 Remarks:

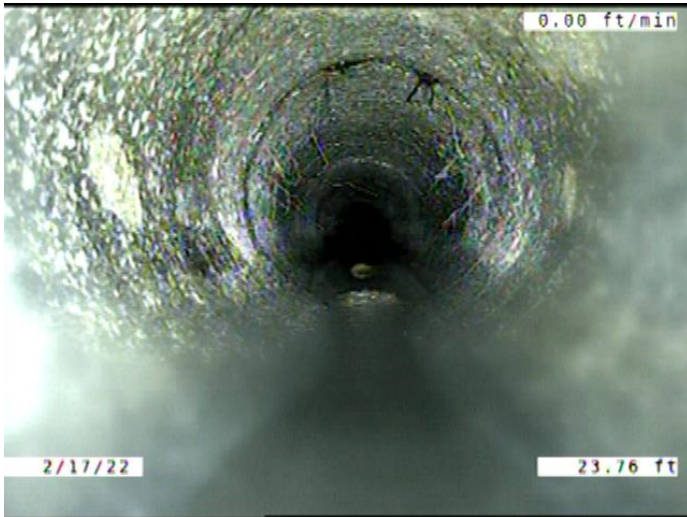
Code: **JOM**
Description: **Joint Offset Medium**

Distance (ft): **23.8**
Structural Grade: **3**
O&M Grade: **0**
Clock Start/From:
Clock To:
1st Value:
2nd Value:
Value Percent:
Continuous Index: **F01**
Within 8" of Joint: **NO**
Remarks:

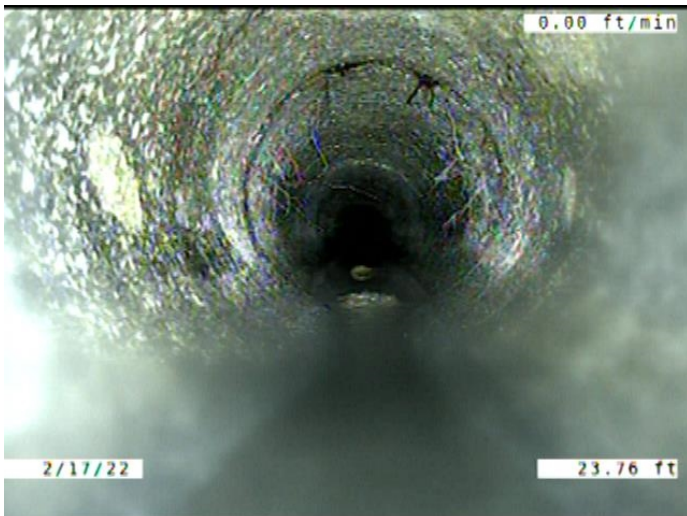
Code: **MWLS**
Description: **Miscellaneous Water Level Sag**

Distance (ft): **23.8**
Structural Grade: **2**
O&M Grade: **0**
Clock Start/From:
Clock To:
1st Value:
2nd Value:
Value Percent: **20.000**
Continuous Index: **F02**
Within 8" of Joint: **NO**
Remarks:

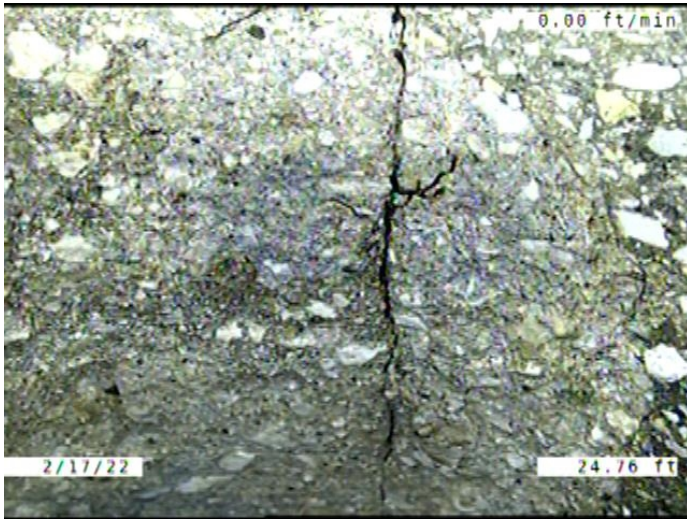
Code: **CM**
Description: **Crack Multiple**

Distance (ft): **24.8**
Structural Grade: **3**
O&M Grade: **0**
Clock Start/From: **10**
Clock To: **2**
1st Value:
2nd Value:
Value Percent:
Continuous Index:
Within 8" of Joint: **YES**
Remarks:

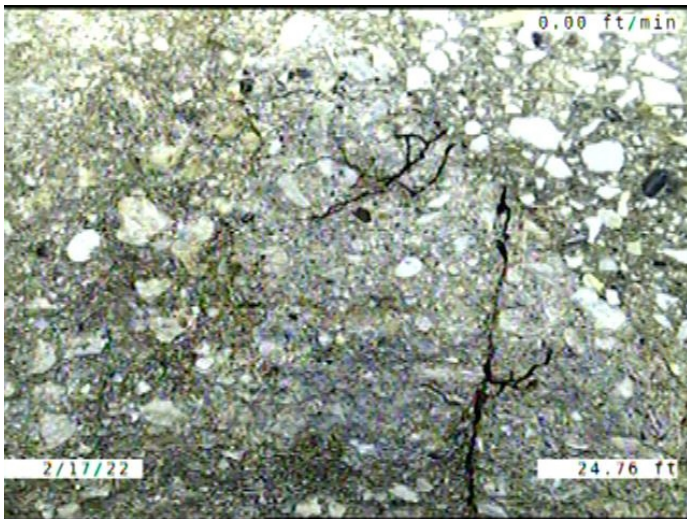
Code: **RFB**
Description: **Roots Fine Barrel**

Distance (ft): **24.8**
Structural Grade: **0**
O&M Grade: **2**
Clock Start/From: **10**
Clock To: **2**
1st Value:
2nd Value:
Value Percent:
Continuous Index:
Within 8" of Joint: **NO**
Remarks:

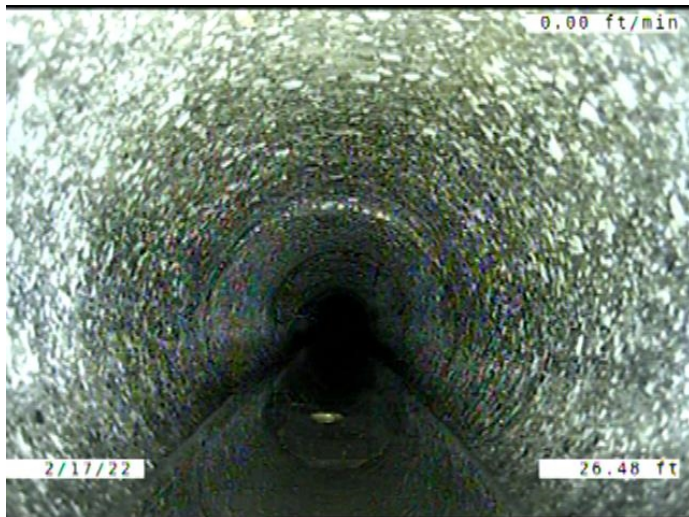
Code: **MWLS**
 Description: **Miscellaneous Water Level Sag**

Distance (ft): **26.5**
 Structural Grade: **2**
 O&M Grade: **0**
 Clock Start/From:
 Clock To:
 1st Value:
 2nd Value:
 Value Percent: **15.000**
 Continuous Index: **S04**
 Within 8" of Joint: **NO**
 Remarks:

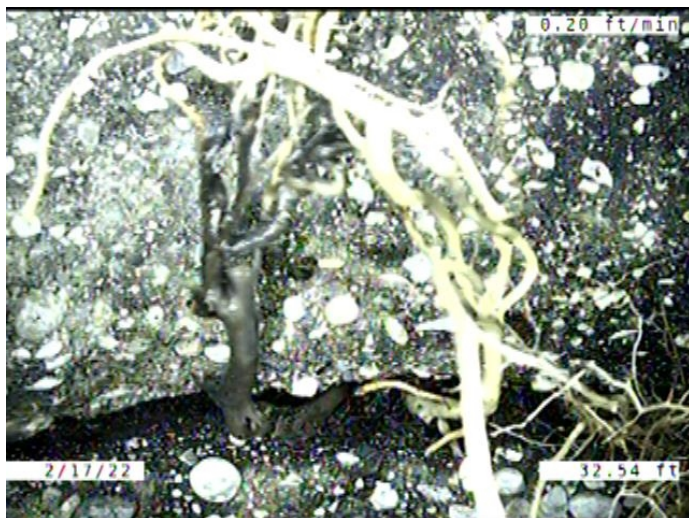
Code: **RMJ**
 Description: **Roots Medium Joint**

Distance (ft): **32.5**
 Structural Grade: **0**
 O&M Grade: **3**
 Clock Start/From: **9**
 Clock To: **3**
 1st Value:
 2nd Value:
 Value Percent: **5.000**
 Continuous Index:
 Within 8" of Joint: **YES**
 Remarks:

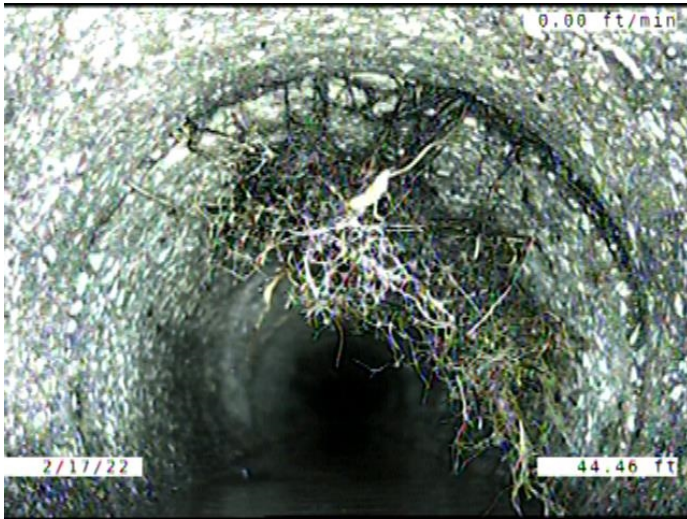
Code: **RMJ**
 Description: **Roots Medium Joint**

Distance (ft): **44.5**
 Structural Grade: **0**
 O&M Grade: **3**
 Clock Start/From: **10**
 Clock To: **5**
 1st Value:
 2nd Value:
 Value Percent: **20.000**
 Continuous Index:
 Within 8" of Joint: **YES**
 Remarks:

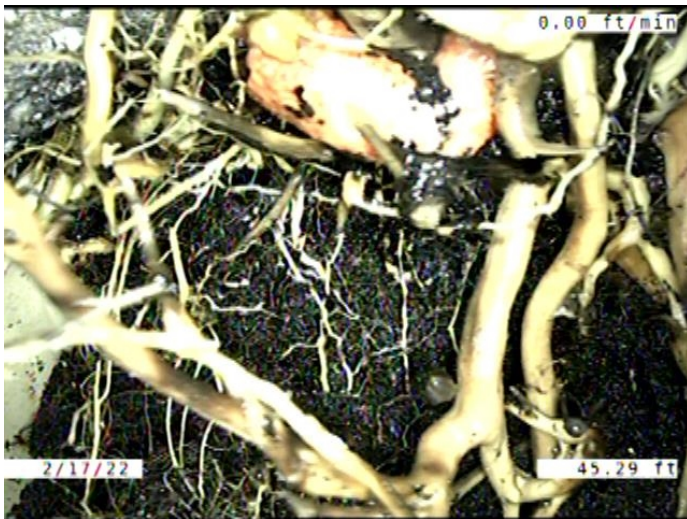
Code: **RTC**
 Description: **Roots Tap Connection**

Distance (ft): **45.3**
 Structural Grade: **0**
 O&M Grade: **2**
 Clock Start/From: **10**
 Clock To: **2**
 1st Value:
 2nd Value:
 Value Percent: **10.000**
 Continuous Index:
 Within 8" of Joint: **NO**
 Remarks:

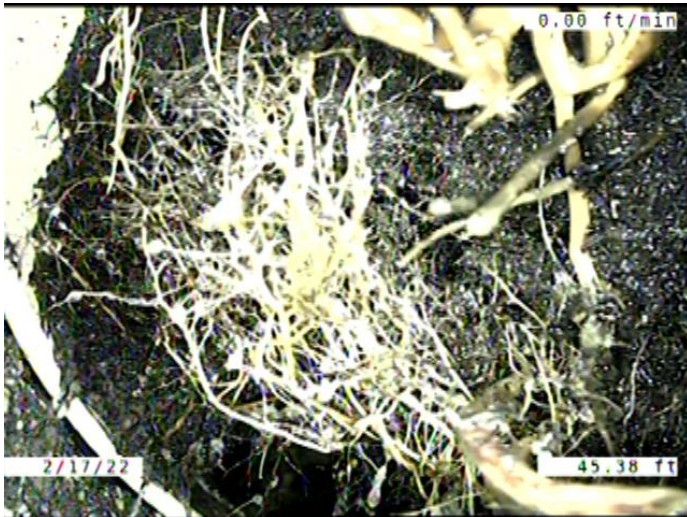
Code: **TB**
 Description: **Tap Break-in/Hammer**

Distance (ft): **45.4**
 Structural Grade: **0**
 O&M Grade: **0**
 Clock Start/From: **12**
 Clock To:
 1st Value: **4.000**
 2nd Value:
 Value Percent:
 Continuous Index:
 Within 8" of Joint: **YES**
 Remarks: **CONSTANTLY RUNNING WATER.**

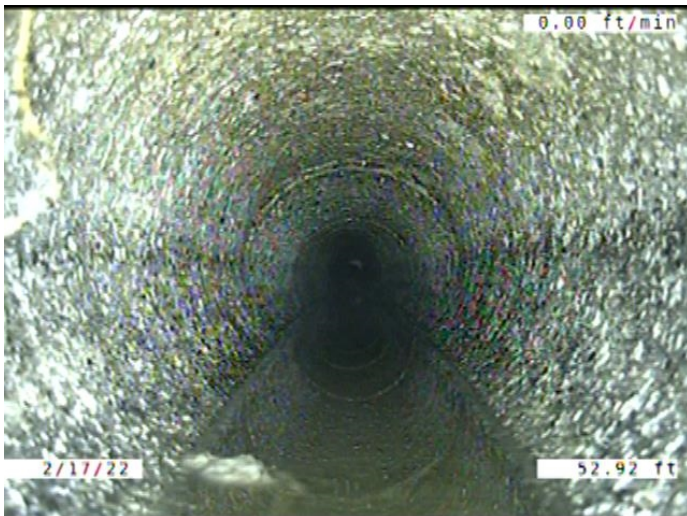
Code: **MWLS**
 Description: **Miscellaneous Water Level Sag**

Distance (ft): **52.9**
 Structural Grade: **2**
 O&M Grade: **0**
 Clock Start/From:
 Clock To:
 1st Value:
 2nd Value:
 Value Percent: **15.000**
 Continuous Index: **F04**
 Within 8" of Joint: **NO**
 Remarks:

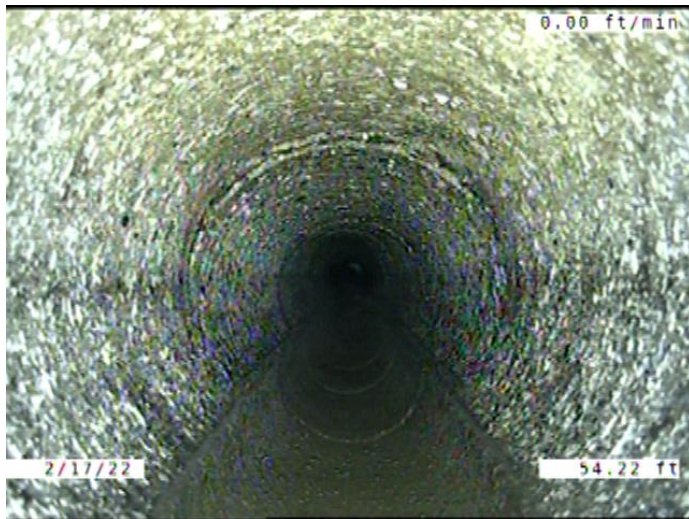
Code: **MWLS**
 Description: **Miscellaneous Water Level Sag**

Distance (ft): **54.2**
 Structural Grade: **2**
 O&M Grade: **0**
 Clock Start/From:
 Clock To:
 1st Value:
 2nd Value:
 Value Percent: **10.000**
 Continuous Index: **S05**
 Within 8" of Joint: **NO**
 Remarks:

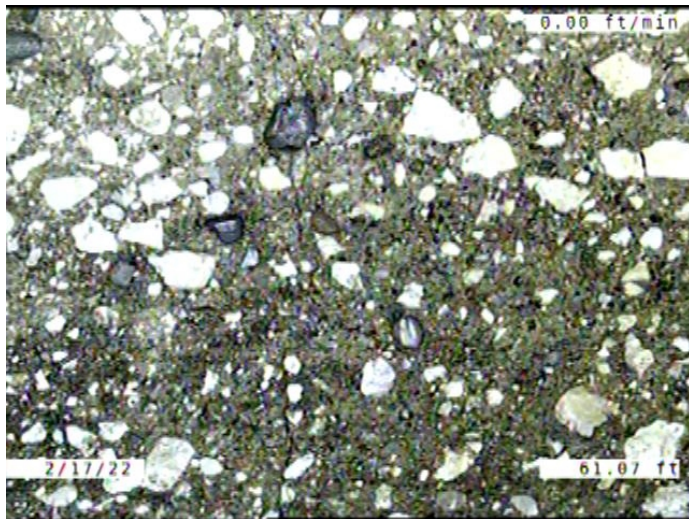
Code: **CL**
 Description: **Crack Longitudinal**

Distance (ft): **61.1**
 Structural Grade: **2**
 O&M Grade: **0**
 Clock Start/From: **11**
 Clock To:
 1st Value:
 2nd Value:
 Value Percent:
 Continuous Index:
 Within 8" of Joint: **YES**
 Remarks:

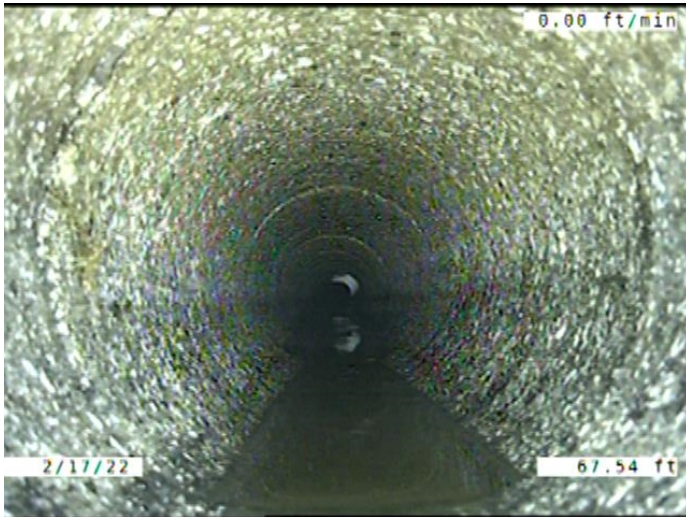
| Code: | MWLS |
| Description: | Miscellaneous Water Level Sag |
| Distance (ft): | 67.5 |
| Structural Grade: | 2 |
| Value Percent: | 10.000 |

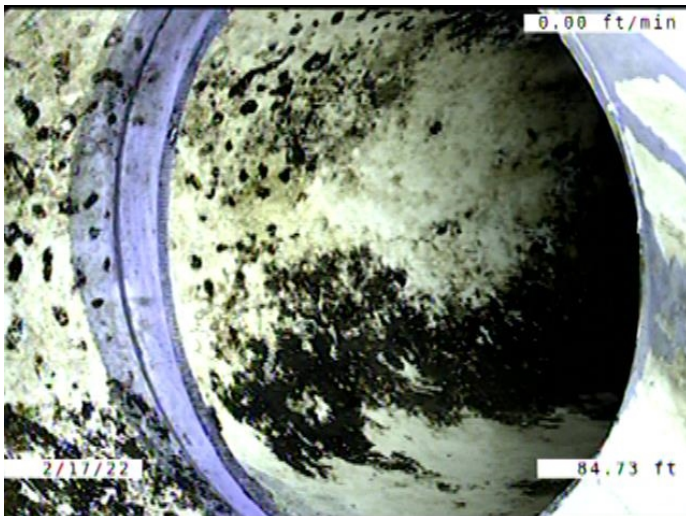
| Code: | TBI |
| Description: | Tap Break-in Intruding |
| Distance (ft): | 84.7 |
| O&M Grade: | 2 |

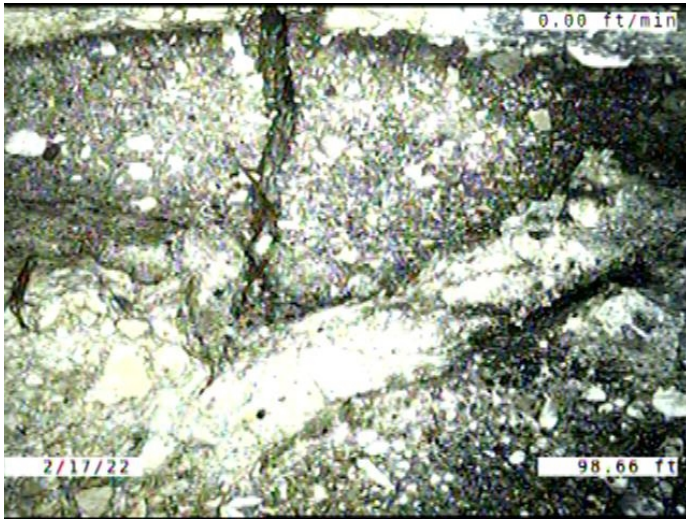
Code: **SMW**
 Description: **Surface Damage Missing Wall**

Distance (ft): **98.7**
 Structural Grade: **5**
 O&M Grade: **0**
 Clock Start/From: **1**
 Clock To: **3**
 1st Value:
 2nd Value:
 Value Percent:
 Continuous Index:
 Within 8" of Joint: **YES**
 Remarks:

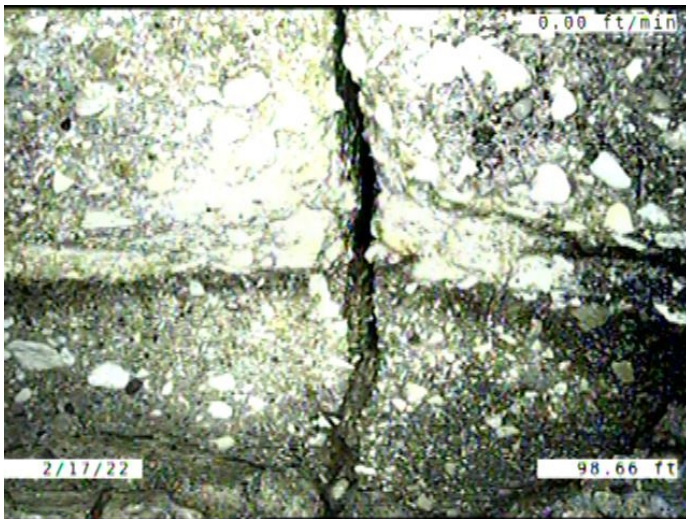
Code: **B**
 Description: **Broken**

Distance (ft): **98.7**
 Structural Grade: **4**
 O&M Grade: **0**
 Clock Start/From: **8**
 Clock To: **4**
 1st Value:
 2nd Value:
 Value Percent:
 Continuous Index: **S06**
 Within 8" of Joint: **YES**
 Remarks:

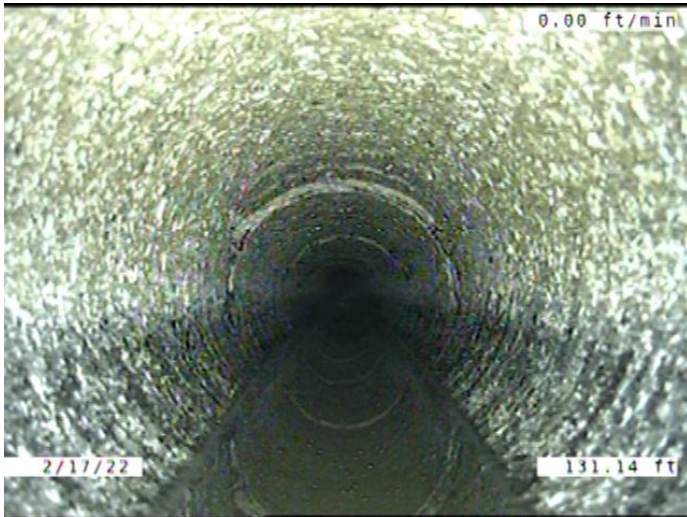
| Code: | MWLS |
| Description: | Miscellaneous Water Level Sag |
| Distance (ft): | 131.1 |
| Structural Grade: | 2 |
| Value Percent: | 15.000 |

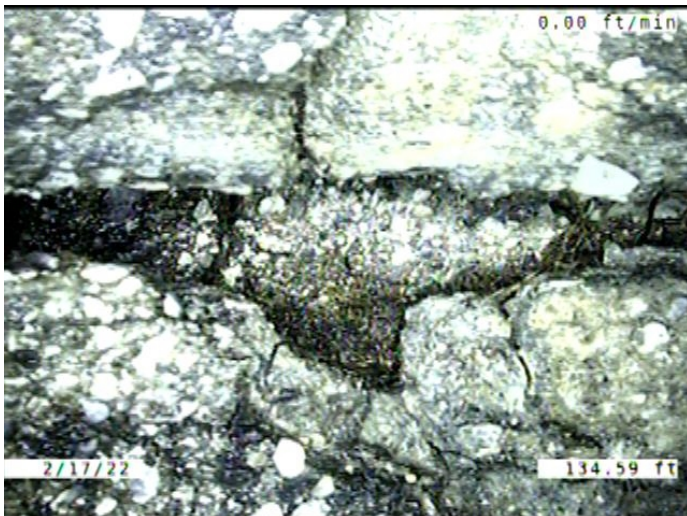
| Code: | SMW |
| Description: | Surface Damage Missing Wall |
| Distance (ft): | 134.6 |
| Structural Grade: | 5 |

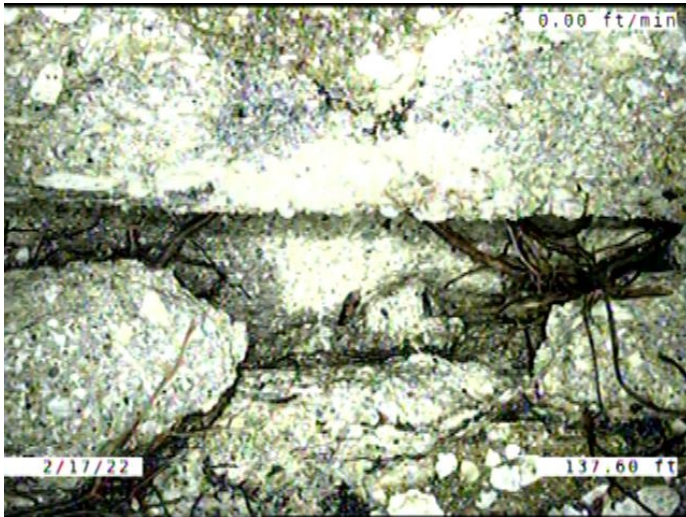
Code: **SMW**
 Description: **Surface Damage Missing Wall**

Distance (ft): **137.6**
 Structural Grade: **5**
 O&M Grade: **0**
 Clock Start/From: **10**
 Clock To: **11**
 1st Value:
 2nd Value:
 Value Percent:
 Continuous Index:
 Within 8" of Joint: **YES**
 Remarks:

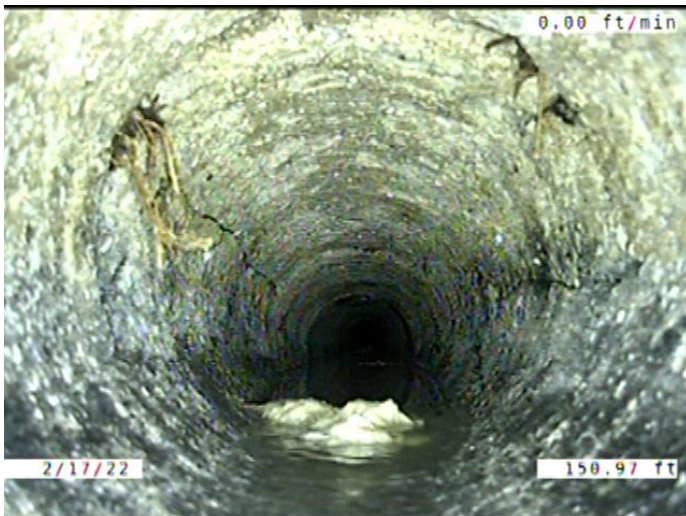
Code: **MWLS**
 Description: **Miscellaneous Water Level Sag**

Distance (ft): **151.0**
 Structural Grade: **2**
 O&M Grade: **0**
 Clock Start/From:
 Clock To:
 1st Value:
 2nd Value:
 Value Percent: **15.000**
 Continuous Index: **F07**
 Within 8" of Joint: **NO**
 Remarks:

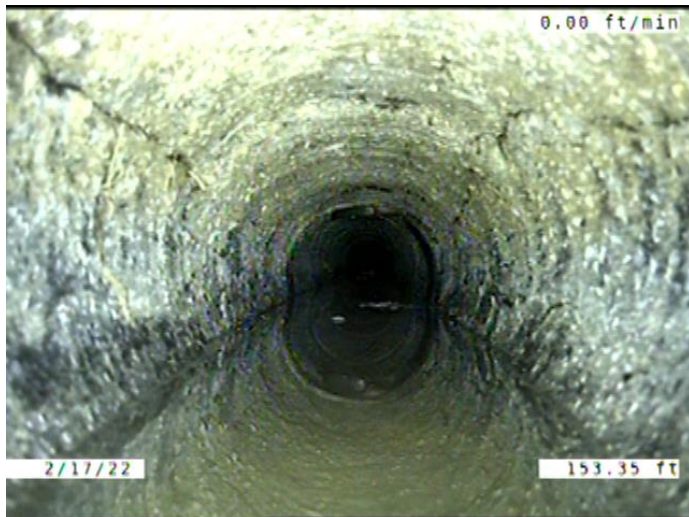
Code: **MWLS**
 Description: **Miscellaneous Water Level Sag**

Distance (ft): **153.4**
 Structural Grade: **2**
 O&M Grade: **0**
 Clock Start/From:
 Clock To:
 1st Value:
 2nd Value:
 Value Percent: **20.000**
 Continuous Index: **S08**
 Within 8" of Joint: **NO**
 Remarks:

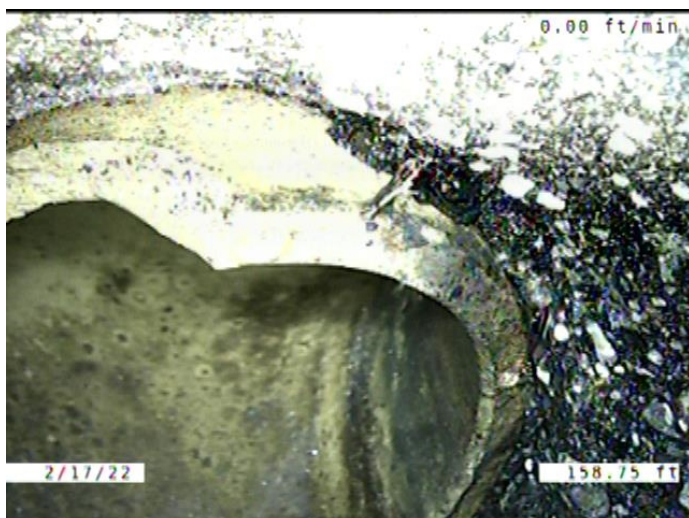
Code: **IRC**
 Description: **Infiltration Runner Connection**

Distance (ft): **158.7**
 Structural Grade: **0**
 O&M Grade: **4**
 Clock Start/From: **1**
 Clock To:
 1st Value:
 2nd Value:
 Value Percent:
 Continuous Index:
 Within 8" of Joint: **NO**
 Remarks:

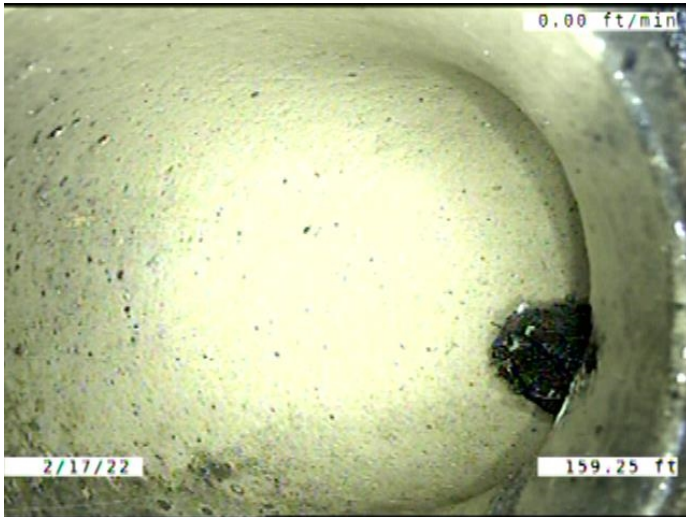
Code: **TBI**
 Description: **Tap Break-in Intruding**

Distance (ft): **159.2**
 Structural Grade: **0**
 O&M Grade: **2**
 Clock Start/From: **12**
 Clock To:
 1st Value: **6.000**
 2nd Value: **1.000**
 Value Percent:
 Continuous Index:
 Within 8" of Joint: **NO**
 Remarks:

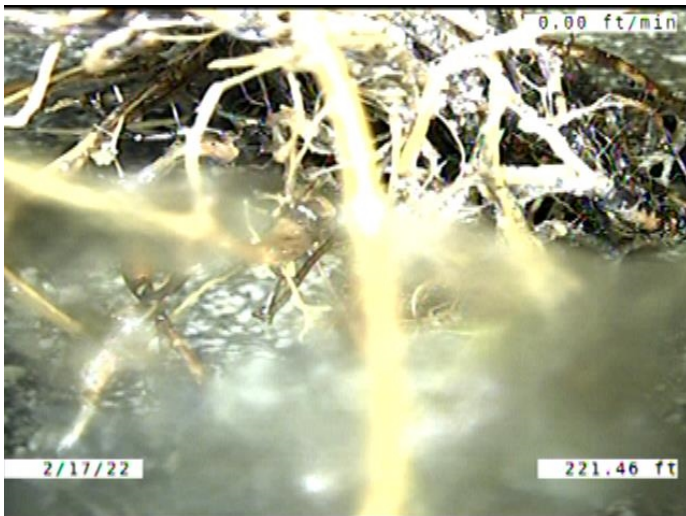
Code: **RMJ**
 Description: **Roots Medium Joint**

Distance (ft): **221.5**
 Structural Grade: **0**
 O&M Grade: **3**
 Clock Start/From: **8**
 Clock To: **11**
 1st Value:
 2nd Value:
 Value Percent: **5.000**
 Continuous Index:
 Within 8" of Joint: **YES**
 Remarks:

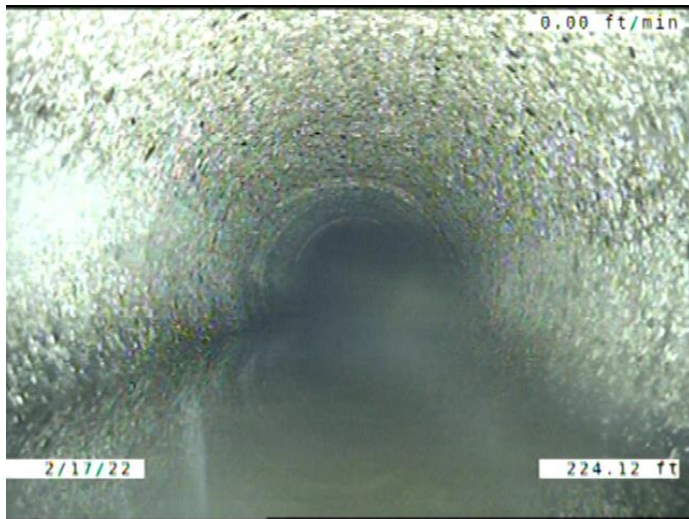
Code: **B**
Description: **Broken**

Distance (ft): **224.1**
Structural Grade: **4**
O&M Grade: **0**
Clock Start/From: **8**
Clock To: **4**
1st Value:
2nd Value:
Value Percent:
Continuous Index: **F06**
Within 8" of Joint: **YES**
Remarks:

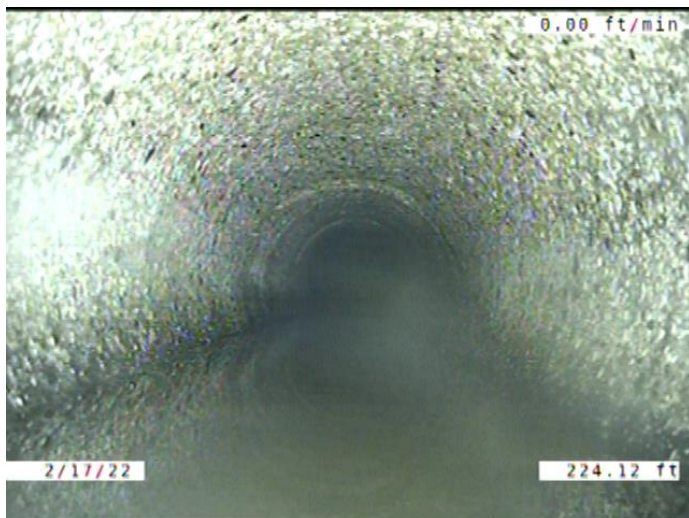
Code: **RFJ**
Description: **Roots Fine Joint**

Distance (ft): **224.1**
Structural Grade: **0**
O&M Grade: **1**
Clock Start/From: **9**
Clock To: **3**
1st Value:
2nd Value:
Value Percent:
Continuous Index: **F03**
Within 8" of Joint: **YES**
Remarks:

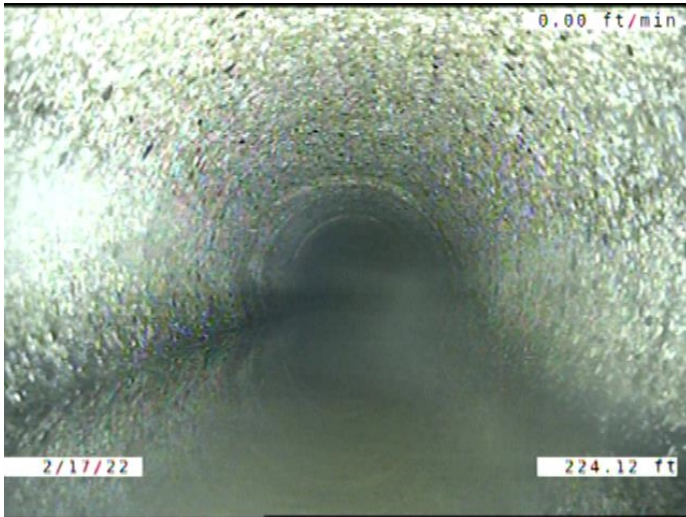
Code: **MWLS**
 Description: **Miscellaneous Water Level Sag**

Distance (ft): **224.1**
 Structural Grade: **2**
 O&M Grade: **0**
 Clock Start/From:
 Clock To:
 1st Value:
 2nd Value:
 Value Percent: **20.000**
 Continuous Index: **F08**
 Within 8" of Joint: **NO**
 Remarks:
