Profile/Photo Observation Report

Date:	02/17/2022	Weather:		Coding:	PACP 7.0
Pipe Length (ft):	168.4	Owner:	City of Hobart	Pre Clean:	Heavy Cleaning
P.O.#:	YES502259	Surveyor:	S. Bucklin	PSR:	P-707-073-072
Customer:	City of Hobart	Clean Date:	02/14/2022	Shape:	C

Street:	East 11th Place	Flow Control:	Not Controlled
City:	Hobart, IN	Year Renewed:	
Location:	Yard	Tape/Media #:	
Purpose:	Routine Assessment	Dia/Height:	10"
Use:	Sanitary Sewage Pipe	Material:	CP
Drain Area:		Lining:	None
Category:	NA		
Comment:			
Location Details:		Direction of Survey:	Upstream
US MH:	M-707-072	DS MH:	M-707-073
		Total Length Surveyed (ft):	168.4

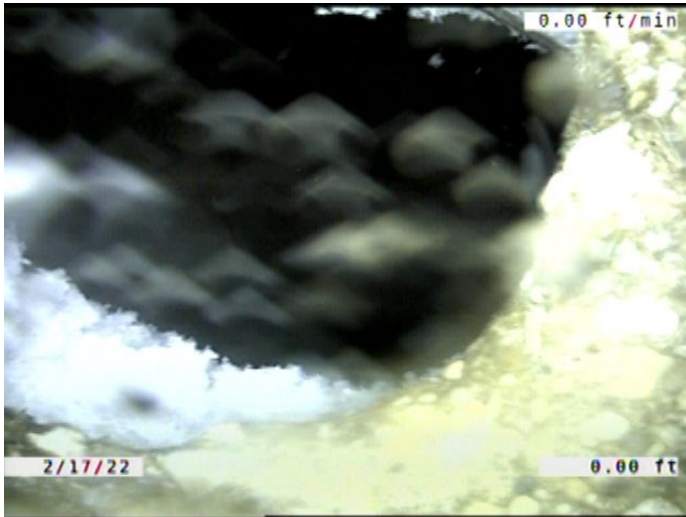
Code: **AMH**
 Description: **Manhole**

Distance (ft): **.0**
 Structural Grade: **0**
 O&M Grade: **0**
 Clock Start/From:
 Clock To:
 1st Value:
 2nd Value:
 Value Percent:
 Continuous Index:
 Within 8" of Joint: **NO**
 Remarks: **M-707-073**

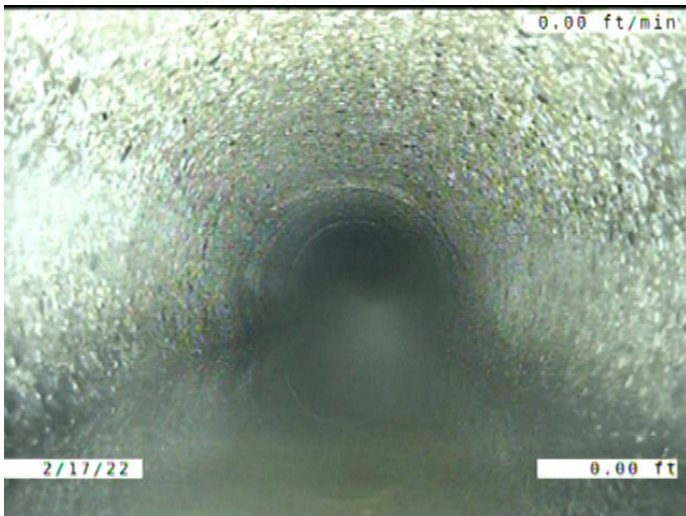
Code: **MWL**
 Description: **Miscellaneous Water Level**

Distance (ft): **.0**
 Structural Grade: **0**
 O&M Grade: **0**
 Clock Start/From:
 Clock To:
 1st Value:
 2nd Value:
 Value Percent: **15.000**
 Continuous Index:
 Within 8" of Joint: **NO**
 Remarks:

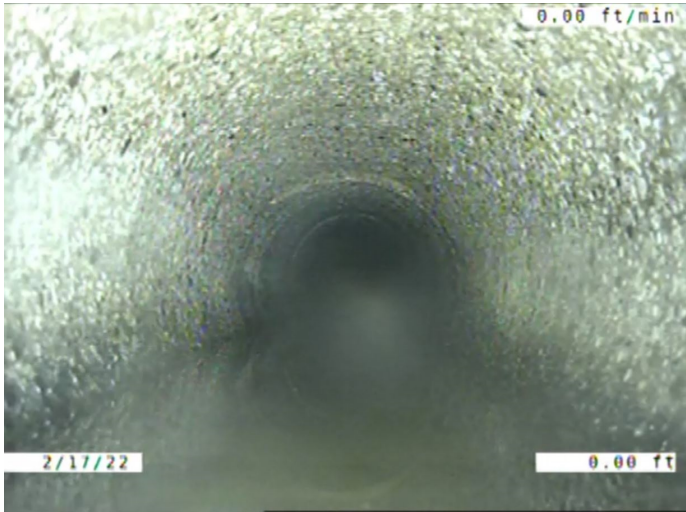
Code: **SAV**
Description: **Surface Damage Aggregate Visible**

Distance (ft): **.0**
Structural Grade: **2**
O&M Grade: **0**
Clock Start/From: **8**
Clock To: **4**
1st Value:
2nd Value:
Value Percent:
Continuous Index: **S06**
Within 8" of Joint: **NO**
Remarks:

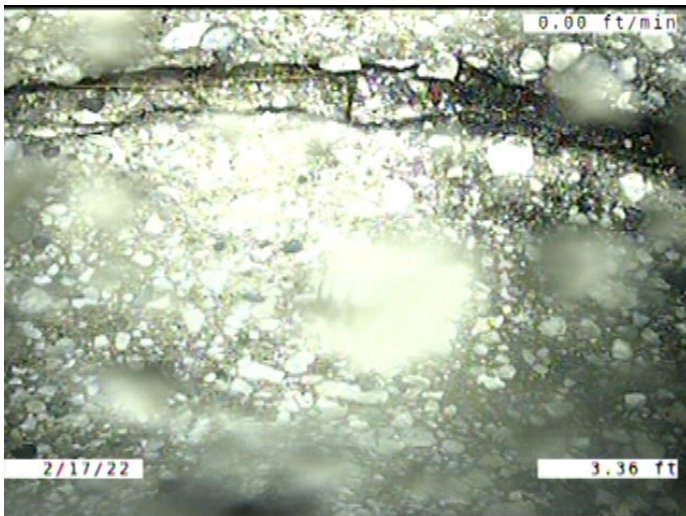
Code: **RFJ**
Description: **Roots Fine Joint**

Distance (ft): **3.4**
Structural Grade: **0**
O&M Grade: **1**
Clock Start/From: **8**
Clock To: **4**
1st Value:
2nd Value:
Value Percent:
Continuous Index: **S02**
Within 8" of Joint: **YES**
Remarks:

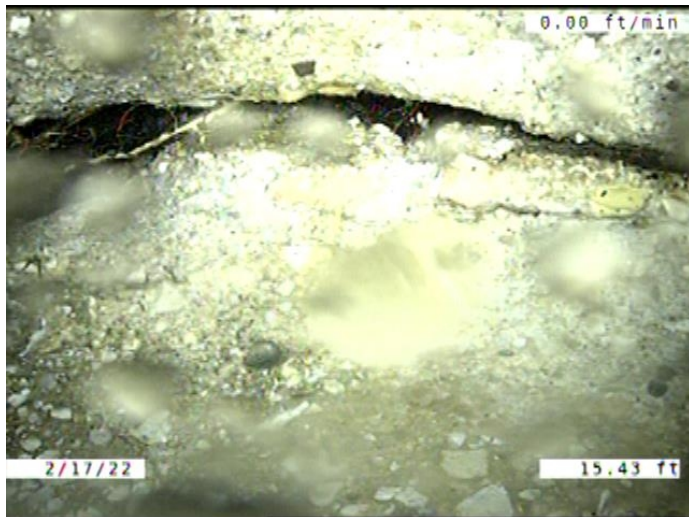
Code: **B**
 Description: **Broken**

Distance (ft): **15.4**
 Structural Grade: **4**
 O&M Grade: **0**
 Clock Start/From: **9**
 Clock To: **3**
 1st Value:
 2nd Value:
 Value Percent:
 Continuous Index:
 Within 8" of Joint: **YES**
 Remarks:

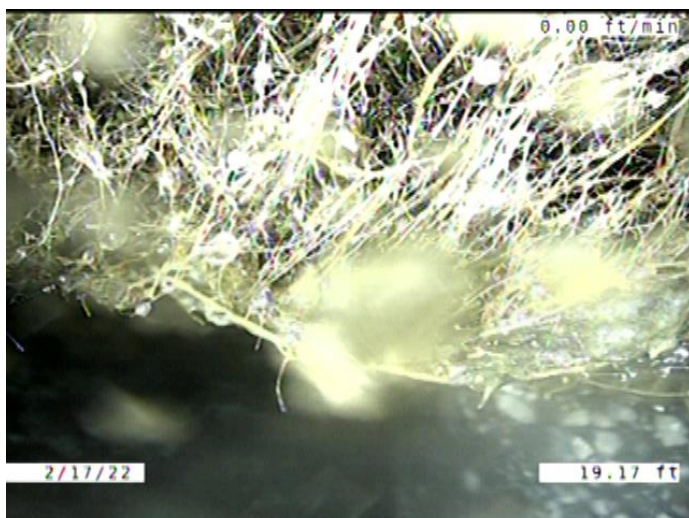
Code: **RMC**
 Description: **Roots Medium Connection**

Distance (ft): **19.2**
 Structural Grade: **0**
 O&M Grade: **3**
 Clock Start/From: **1**
 Clock To: **2**
 1st Value:
 2nd Value:
 Value Percent: **5.000**
 Continuous Index:
 Within 8" of Joint: **NO**
 Remarks:

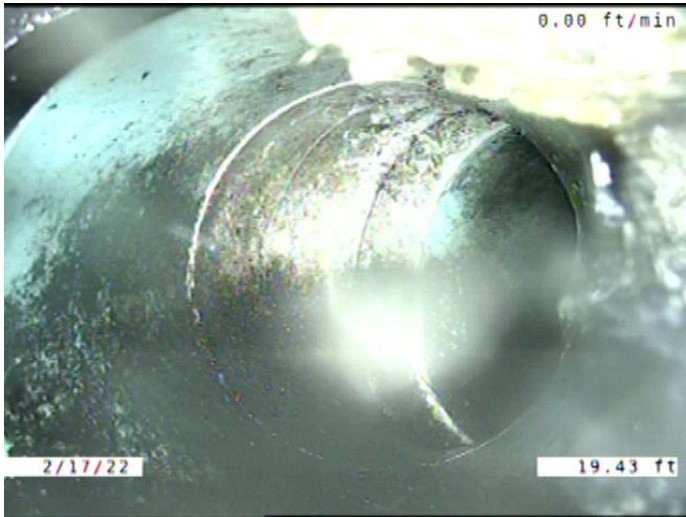
Code: **TBA**
 Description: **Tap Break-in Activity**

Distance (ft): **19.4**
 Structural Grade: **0**
 O&M Grade: **0**
 Clock Start/From: **1**
 Clock To:
 1st Value: **4.000**
 2nd Value:
 Value Percent:
 Continuous Index:
 Within 8" of Joint: **YES**
 Remarks: **CONSTANTLY RUNNING WATER.**

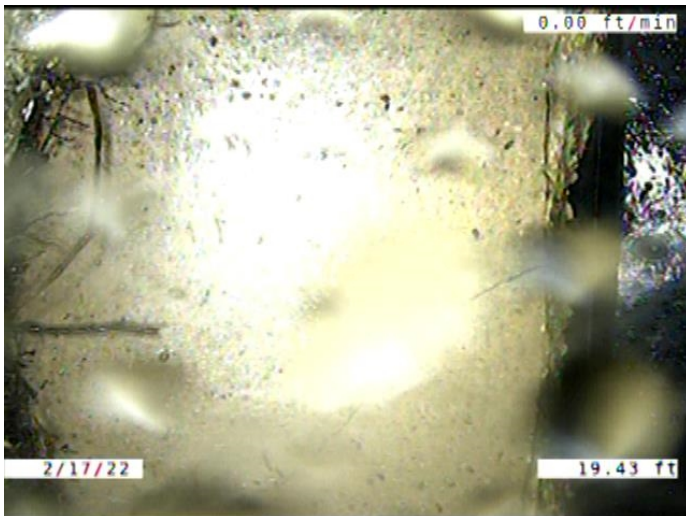
Code: **RPP**
 Description: **Point Repair Patch**

Distance (ft): **19.4**
 Structural Grade: **0**
 O&M Grade: **0**
 Clock Start/From: **11**
 Clock To: **12**
 1st Value:
 2nd Value:
 Value Percent:
 Continuous Index:
 Within 8" of Joint: **YES**
 Remarks: **USED A PIECE OF VCP TO PATCH BY THE SERVICE**

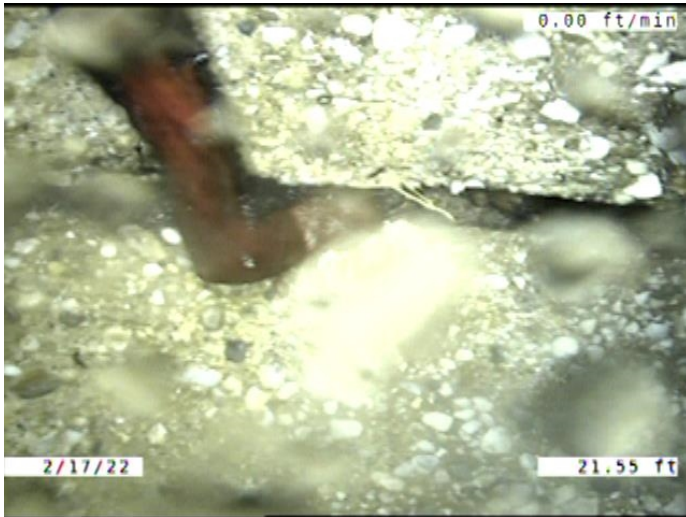
Code: **RTJ**
 Description: **Roots Tap Joint**

Distance (ft): **21.5**
 Structural Grade: **0**
 O&M Grade: **2**
 Clock Start/From: **1**
 Clock To:
 1st Value:
 2nd Value:
 Value Percent: **5.000**
 Continuous Index:
 Within 8" of Joint: **YES**
 Remarks:

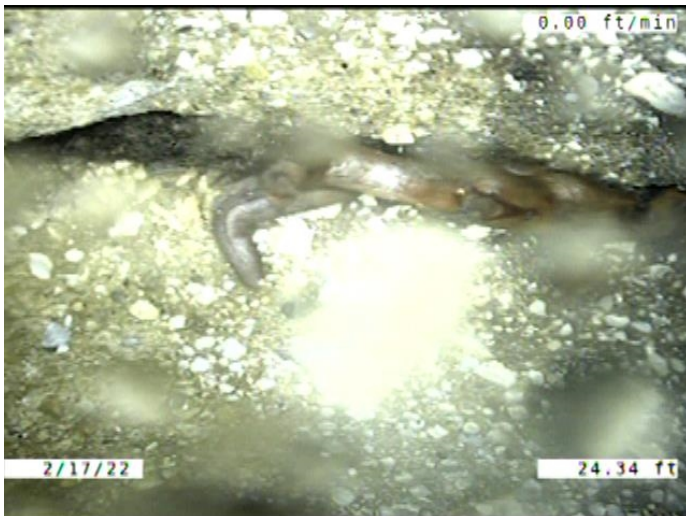
Code: **RTJ**
 Description: **Roots Tap Joint**

Distance (ft): **24.3**
 Structural Grade: **0**
 O&M Grade: **2**
 Clock Start/From: **1**
 Clock To: **2**
 1st Value:
 2nd Value:
 Value Percent: **5.000**
 Continuous Index:
 Within 8" of Joint: **YES**
 Remarks:

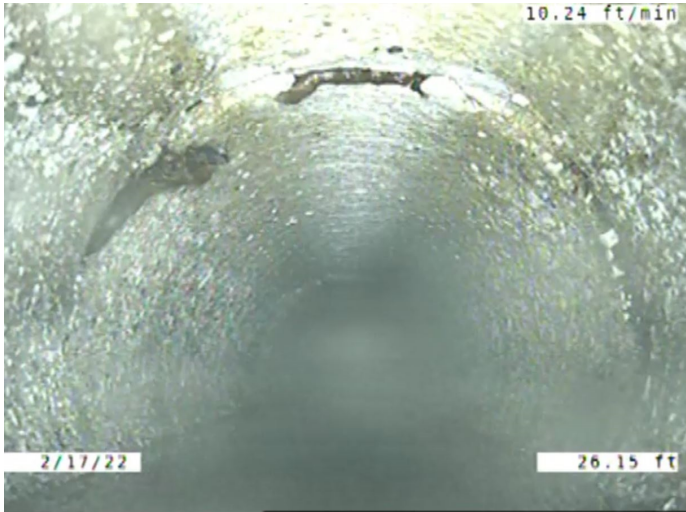
Code: **FM**
 Description: **Fracture Multiple**

Distance (ft): **26.6**
 Structural Grade: **4**
 O&M Grade: **0**
 Clock Start/From: **9**
 Clock To: **3**
 1st Value:
 2nd Value:
 Value Percent:
 Continuous Index: **S05**
 Within 8" of Joint: **YES**
 Remarks: **Wandering**

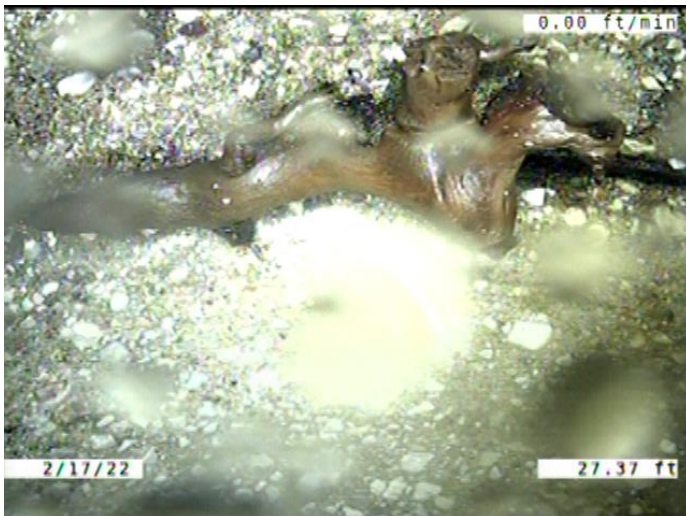
Code: **RTJ**
 Description: **Roots Tap Joint**

Distance (ft): **27.4**
 Structural Grade: **0**
 O&M Grade: **2**
 Clock Start/From: **10**
 Clock To: **1**
 1st Value:
 2nd Value:
 Value Percent: **5.000**
 Continuous Index:
 Within 8" of Joint: **YES**
 Remarks:

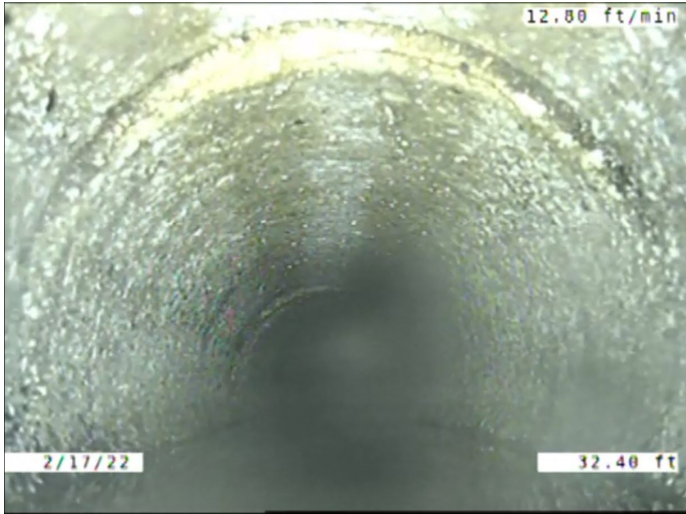
Code: **FM**
Description: **Fracture Multiple**

Distance (ft): **32.4**
Structural Grade: **4**
O&M Grade: **0**
Clock Start/From: **9**
Clock To: **3**
1st Value:
2nd Value:
Value Percent:
Continuous Index: **F05**
Within 8" of Joint: **YES**
Remarks: **Wandering**

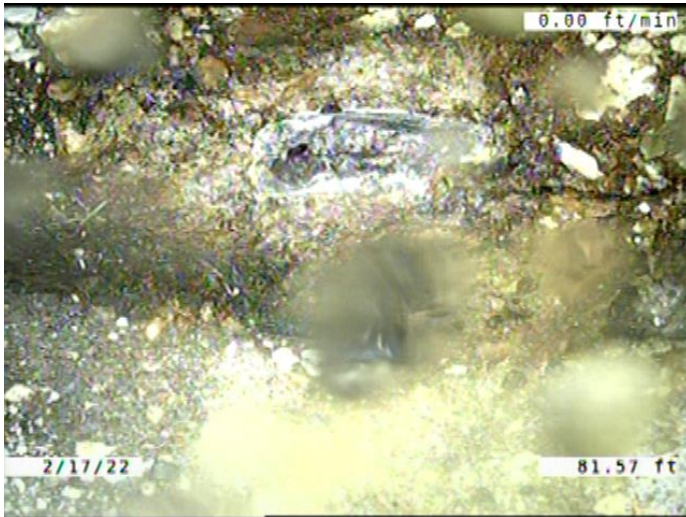
Code: **DAE**
Description: **Deposits Attached Encrustation**

Distance (ft): **81.6**
Structural Grade: **0**
O&M Grade: **2**
Clock Start/From: **1**
Clock To: **2**
1st Value:
2nd Value:
Value Percent: **5.000**
Continuous Index:
Within 8" of Joint: **YES**
Remarks:

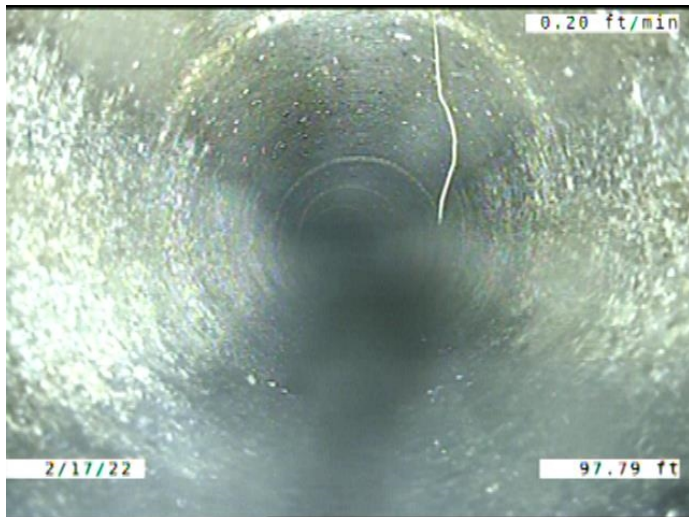
Code: **MWL**
 Description: **Miscellaneous Water Level**

Distance (ft): **97.8**
 Structural Grade: **0**
 O&M Grade: **0**
 Clock Start/From:
 Clock To:
 1st Value:
 2nd Value:
 Value Percent: **5.000**
 Continuous Index:
 Within 8" of Joint: **NO**
 Remarks:

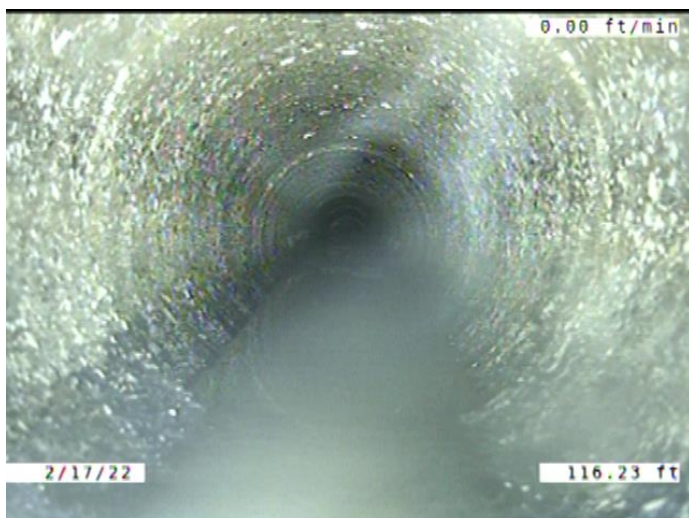
Code: **MWLS**
 Description: **Miscellaneous Water Level Sag**

Distance (ft): **116.2**
 Structural Grade: **2**
 O&M Grade: **0**
 Clock Start/From:
 Clock To:
 1st Value:
 2nd Value:
 Value Percent: **20.000**
 Continuous Index: **S03**
 Within 8" of Joint: **NO**
 Remarks:

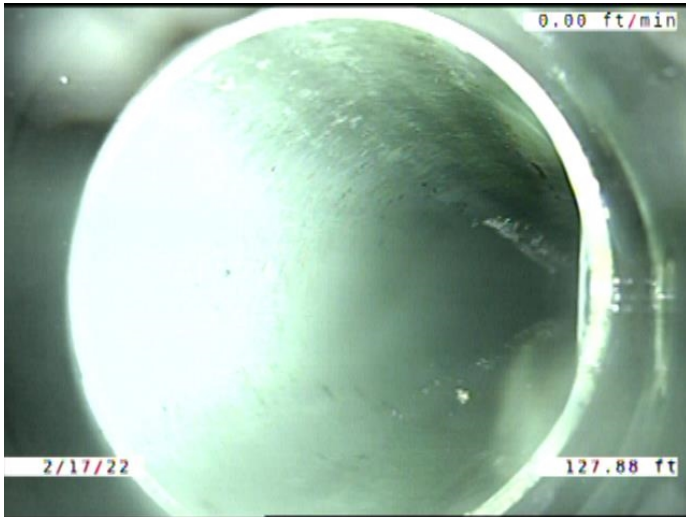
Code: **TB**
Description: **Tap Break-in/Hammer**

Distance (ft): **127.9**
Structural Grade: **0**
O&M Grade: **0**
Clock Start/From: **2**
Clock To:
1st Value: **4.000**
2nd Value:
Value Percent:
Continuous Index:
Within 8" of Joint: **NO**
Remarks: **CONSTANTLY DRIPPING WATER.**

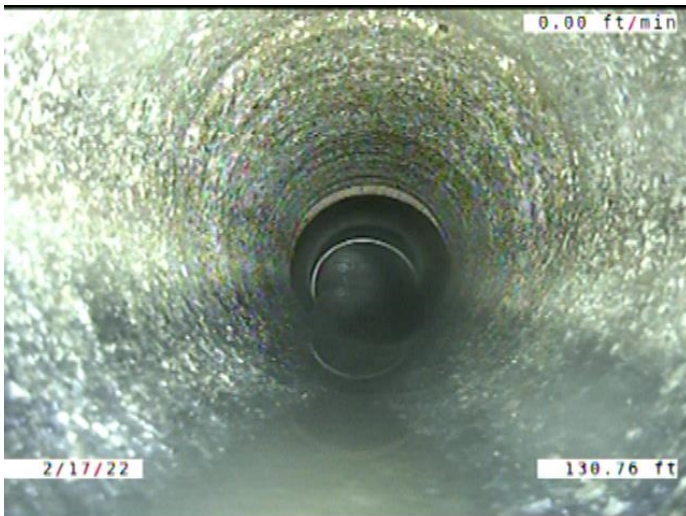
Code: **MWLS**
Description: **Miscellaneous Water Level Sag**

Distance (ft): **130.8**
Structural Grade: **2**
O&M Grade: **0**
Clock Start/From:
Clock To:
1st Value:
2nd Value:
Value Percent: **20.000**
Continuous Index: **F03**
Within 8" of Joint: **NO**
Remarks:

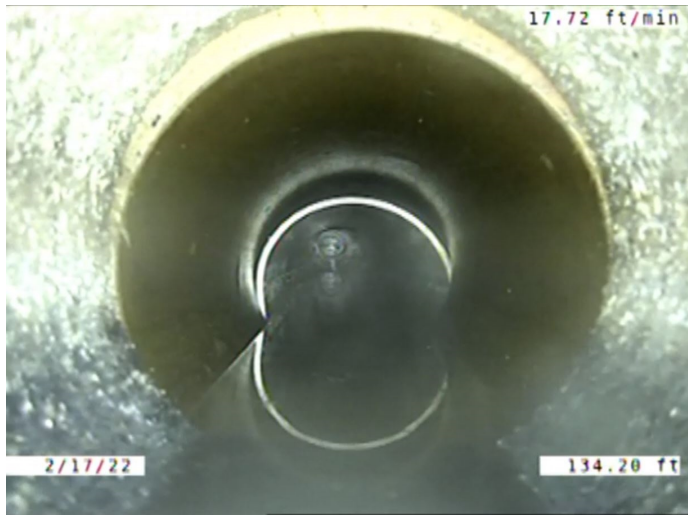
Code: **SAV**
 Description: **Surface Damage Aggregate Visible**

Distance (ft): **134.2**
 Structural Grade: **2**
 O&M Grade: **0**
 Clock Start/From: **8**
 Clock To: **4**
 1st Value:
 2nd Value:
 Value Percent:
 Continuous Index: **F06**
 Within 8" of Joint: **NO**
 Remarks:

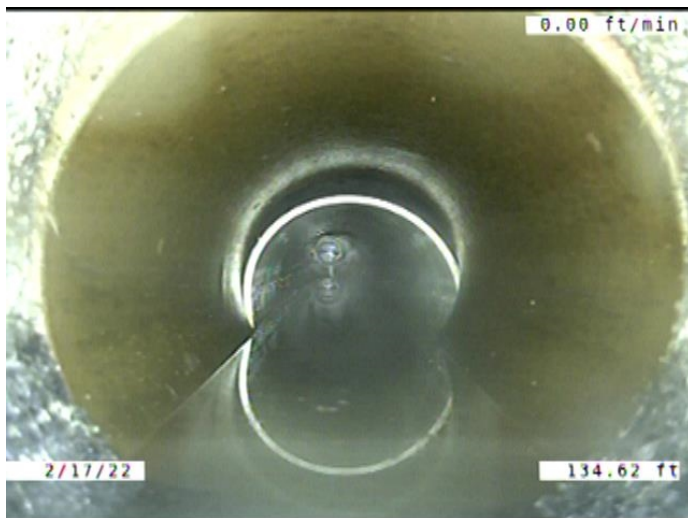
Code: **MWLS**
 Description: **Miscellaneous Water Level Sag**

Distance (ft): **134.6**
 Structural Grade: **2**
 O&M Grade: **0**
 Clock Start/From:
 Clock To:
 1st Value:
 2nd Value:
 Value Percent: **20.000**
 Continuous Index: **S04**
 Within 8" of Joint: **NO**
 Remarks:

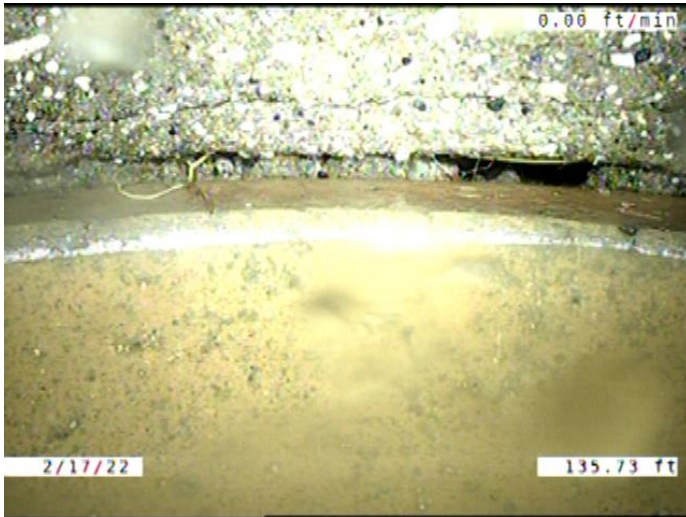
Code: **MMC**
 Description: **Miscellaneous Material Change**

Distance (ft): **135.7**
 Structural Grade: **0**
 O&M Grade: **0**
 Clock Start/From:
 Clock To:
 1st Value:
 2nd Value:
 Value Percent:
 Continuous Index:
 Within 8" of Joint: **NO**
 Remarks: **CONCRETE TO VCP**

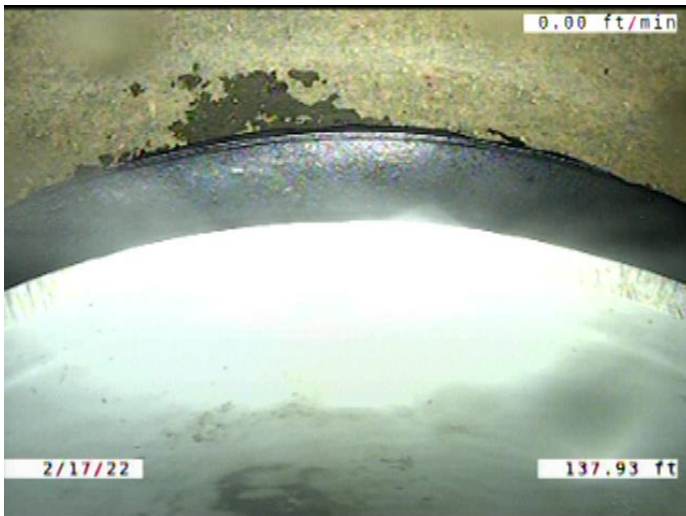
Code: **JOL**
 Description: **Joint Offset Large**

Distance (ft): **137.9**
 Structural Grade: **4**
 O&M Grade: **0**
 Clock Start/From:
 Clock To:
 1st Value: **1.000**
 2nd Value:
 Value Percent:
 Continuous Index:
 Within 8" of Joint: **NO**
 Remarks:

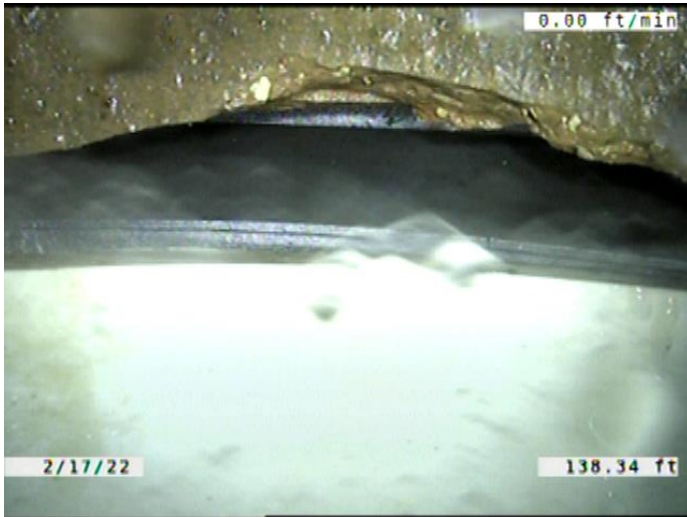
Code:	MMC
Description:	Miscellaneous Material Change
Distance (ft):	138.3
Structural Grade:	0
O&M Grade:	0
Clock Start/From:	
Clock To:	
1st Value:	
2nd Value:	
Value Percent:	
Continuous Index:	
Within 8" of Joint:	NO
Remarks:	VCP TO PVC

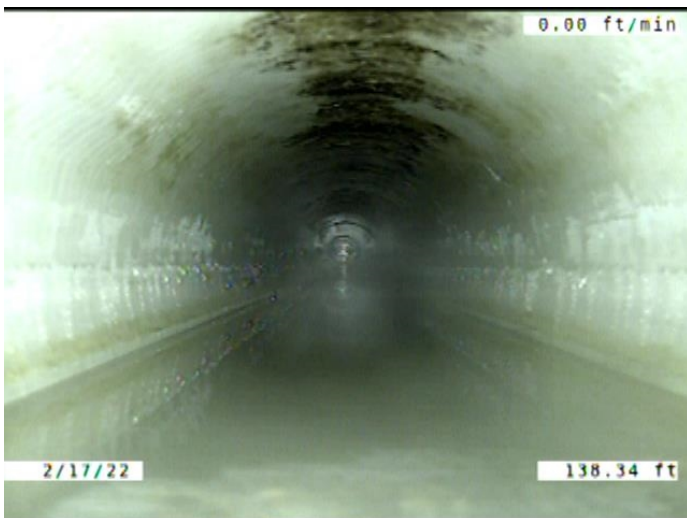
Code:	RFJ
Description:	Roots Fine Joint
Distance (ft):	138.3
Structural Grade:	0
O&M Grade:	1
Clock Start/From:	8
Clock To:	4
1st Value:	
2nd Value:	
Value Percent:	
Continuous Index:	F02
Within 8" of Joint:	YES
Remarks:

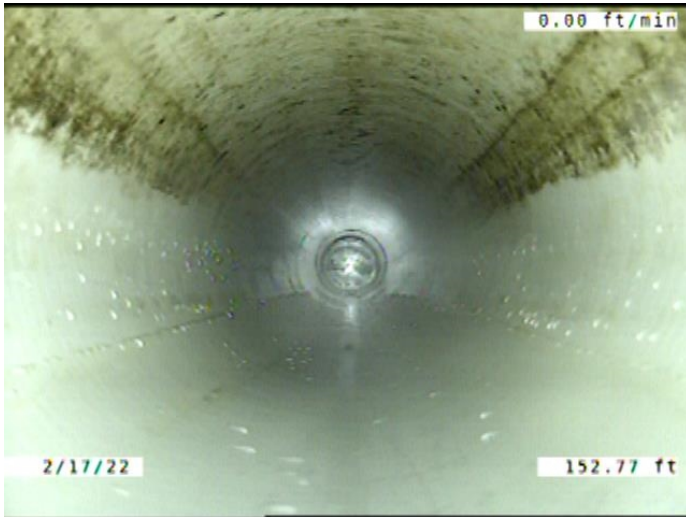
Code: **MWLS**
Description: **Miscellaneous Water Level Sag**

Distance (ft): **152.8**
Structural Grade: **2**
O&M Grade: **0**
Clock Start/From:
Clock To:
1st Value:
2nd Value:
Value Percent: **20.000**
Continuous Index: **F04**
Within 8" of Joint: **NO**
Remarks:

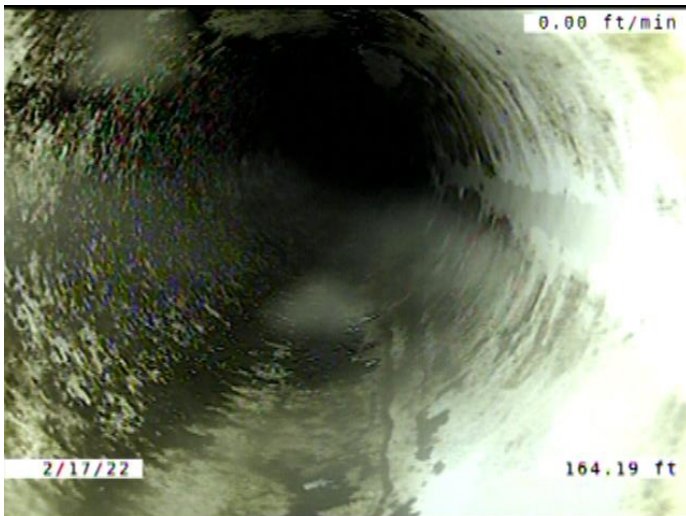
Code: **TF**
Description: **Tap Factory**

Distance (ft): **164.2**
Structural Grade: **0**
O&M Grade: **0**
Clock Start/From: **3**
Clock To:
1st Value: **4.000**
2nd Value:
Value Percent:
Continuous Index:
Within 8" of Joint: **YES**
Remarks:

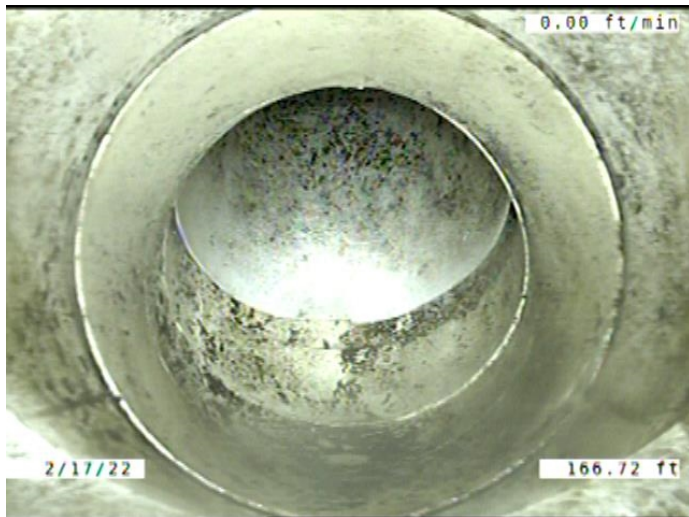
Code: **TF**
Description: **Tap Factory**

Distance (ft): **166.7**
Structural Grade: **0**
O&M Grade: **0**
Clock Start/From: **12**
Clock To:
1st Value: **4.000**
2nd Value:
Value Percent:
Continuous Index:
Within 8" of Joint: **YES**
Remarks:

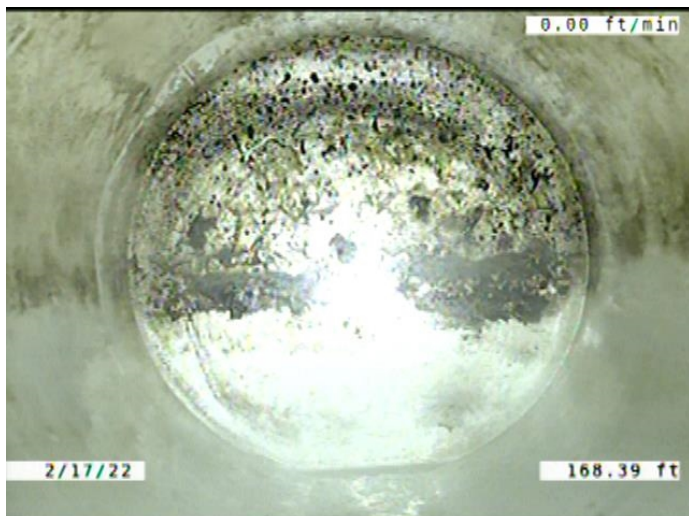
Code: **AEP**
Description: **Access Point End of Pipe**

Distance (ft): **168.4**
Structural Grade: **0**
O&M Grade: **0**
Clock Start/From:
Clock To:
1st Value:
2nd Value:
Value Percent:
Continuous Index:
Within 8" of Joint: **NO**
Remarks: **PVC PIPE HAS BEEN CAPPED OFF.**
