# Profile/Photo Observation Report

Date:	<b>10/21/2021</b>	Weather:		Coding:	<b>PACP 6.0</b>
Pipe Length (ft):		Owner:	<b>Hobart, IN</b>	Pre Clean:	<b>Not Known</b>
P.O.#:	<b>942_2</b>	Surveyor:	<b>M. Pielacha</b>	PSR:	<b>P-707-074-010.6</b>
Customer:	<b>Hobart, IN</b>	Clean Date:		Shape:	<b>C</b>

Street:	<b>State Street</b>	Flow Control:			
City:	<b>Hobart, IN</b>	Year Renewed:			
Location:	<b>Light Highway</b>	Tape/Media #:	<b>942</b>		
Purpose:	<b>Routine Assessment</b>	Dia/Height:	<b>12"</b>		
Use:	<b>Sanitary</b>	Material:	<b>VCP</b>		
Drain Area:		Lining:			
Category:	<b>NA</b>				
Comment:					
Location Details:		Direction of Survey:	<b>Downstream</b>		
US MH:	<b>M-707-74</b>	DS MH:	<b>M-706-10.6</b>	Total Length Surveyed (ft):	<b>50.0</b>

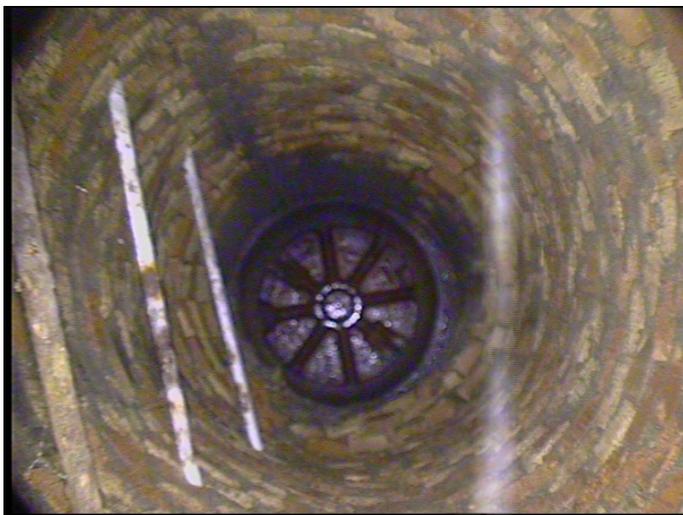
Code: **AMH**  
Description: **Manhole**

Distance (ft): **.0**  
Structural Grade: **0**  
O&M Grade: **0**  
Clock Start/From:  
Clock To:  
1st Value:  
2nd Value:  
Value Percent:  
Continuous Index:  
Within 8" of Joint: **NO**  
Remarks: **M-707-74**

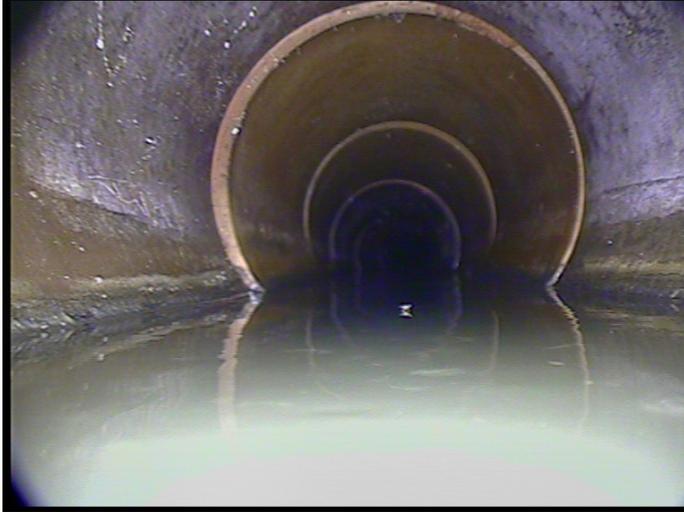
Code: **MWL**  
Description: **Water Level**

Distance (ft): **.0**  
Structural Grade: **0**  
O&M Grade: **0**  
Clock Start/From:  
Clock To:  
1st Value:  
2nd Value:  
Value Percent: **15.000**  
Continuous Index:  
Within 8" of Joint: **NO**  
Remarks:

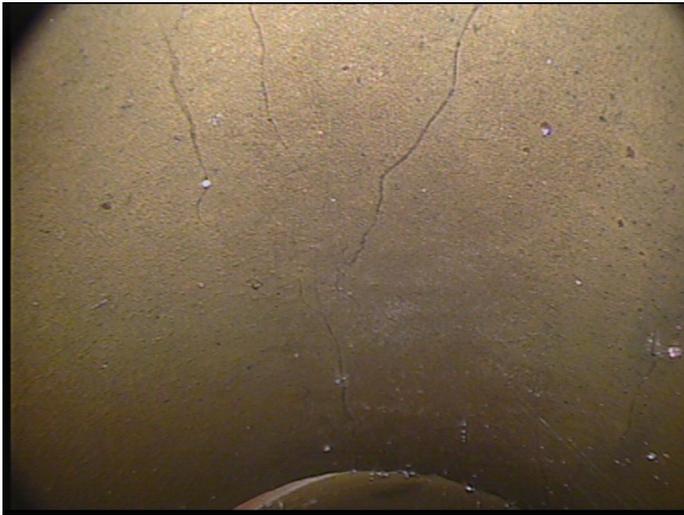
Code: **CM**  
Description: **Crack Multiple**

Distance (ft): **8.6**  
Structural Grade: **3**  
O&M Grade: **0**  
Clock Start/From: **11**  
Clock To: **12**  
1st Value:  
2nd Value:  
Value Percent:  
Continuous Index:  
Within 8" of Joint: **YES**  
Remarks:

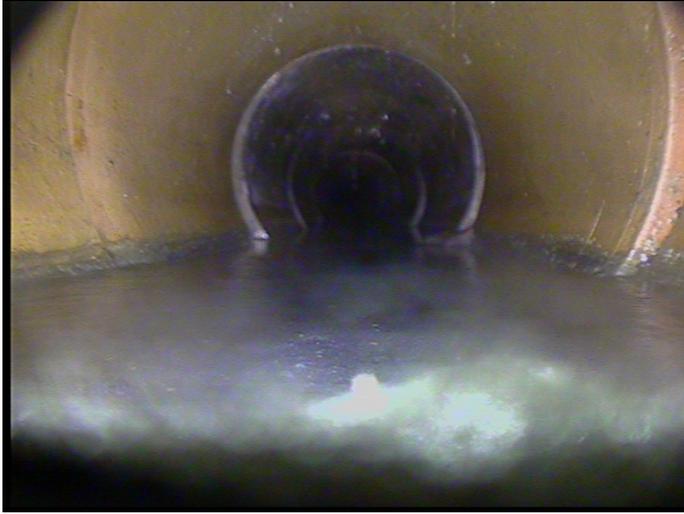
Code: **DSF**  
Description: **Deposits Settled Fine**

Distance (ft): **10.8**  
Structural Grade: **0**  
O&M Grade: **3**  
Clock Start/From: **4**  
Clock To: **8**  
1st Value:  
2nd Value:  
Value Percent: **15.000**  
Continuous Index: **S01**  
Within 8" of Joint: **YES**  
Remarks:

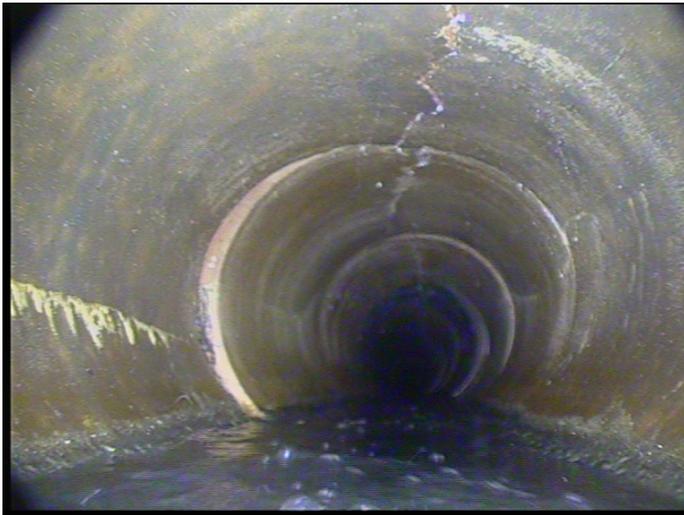
Code: **DSF**  
Description: **Deposits Settled Fine**

Distance (ft): **19.8**  
Structural Grade: **0**  
O&M Grade: **3**  
Clock Start/From: **4**  
Clock To: **8**  
1st Value:  
2nd Value:  
Value Percent: **15.000**  
Continuous Index: **F01**  
Within 8" of Joint: **NO**  
Remarks:

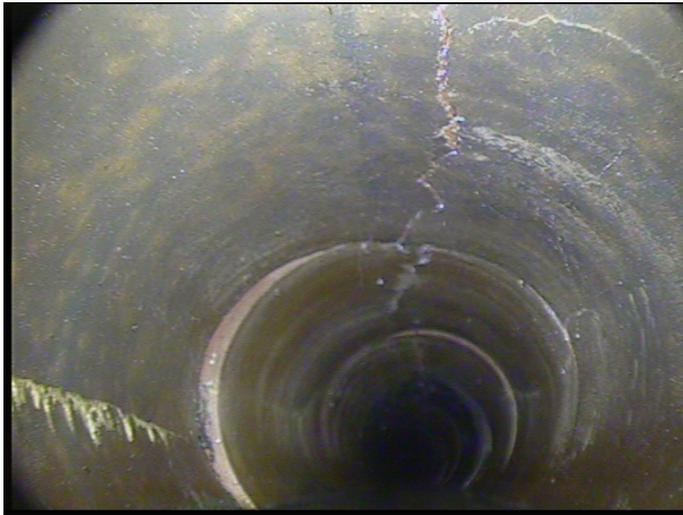
Code: **FH2**  
Description: **Fracture Longitudinal Hinge, 2**

Distance (ft): **19.8**  
Structural Grade: **4**  
O&M Grade: **0**  
Clock Start/From: **12**  
Clock To: **6**  
1st Value:  
2nd Value:  
Value Percent:  
Continuous Index: **S02**  
Within 8" of Joint: **YES**  
Remarks:

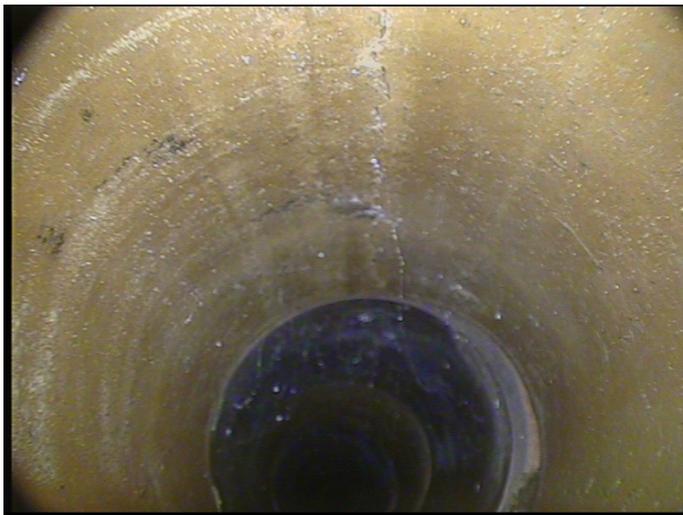
Code: **FH2**  
Description: **Fracture Longitudinal Hinge, 2**

Distance (ft): **23.6**  
Structural Grade: **4**  
O&M Grade: **0**  
Clock Start/From: **12**  
Clock To: **6**  
1st Value:  
2nd Value:  
Value Percent:  
Continuous Index: **F02**  
Within 8" of Joint: **NO**  
Remarks:

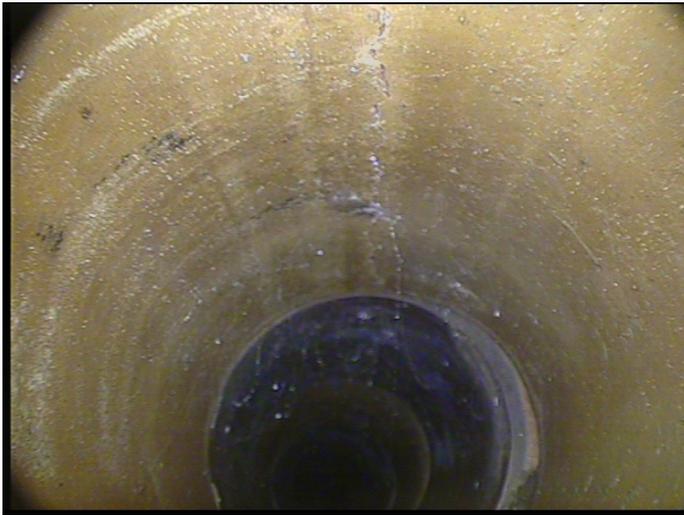
Code: **CL**  
Description: **Crack Longitudinal**

Distance (ft): **23.6**  
Structural Grade: **2**  
O&M Grade: **0**  
Clock Start/From: **12**  
Clock To:  
1st Value:  
2nd Value:  
Value Percent:  
Continuous Index:  
Within 8" of Joint: **YES**  
Remarks:

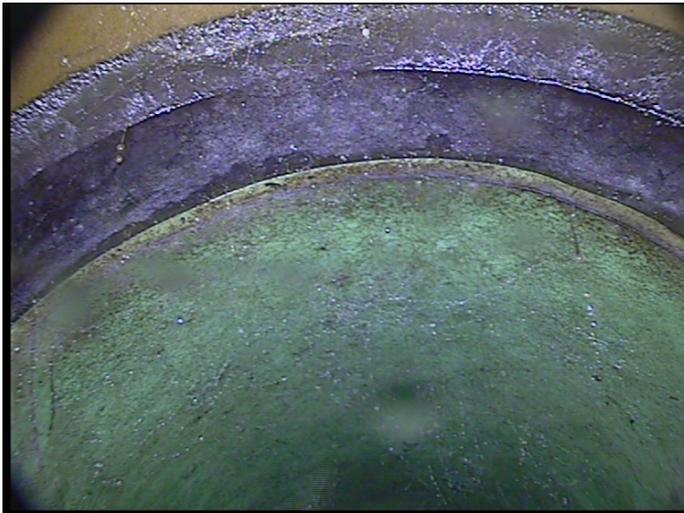
Code: **MMC**  
Description: **Material Change**

Distance (ft): **44.7**  
Structural Grade: **0**  
O&M Grade: **0**  
Clock Start/From:  
Clock To:  
1st Value:  
2nd Value:  
Value Percent:  
Continuous Index:  
Within 8" of Joint: **NO**  
Remarks: **pvc**

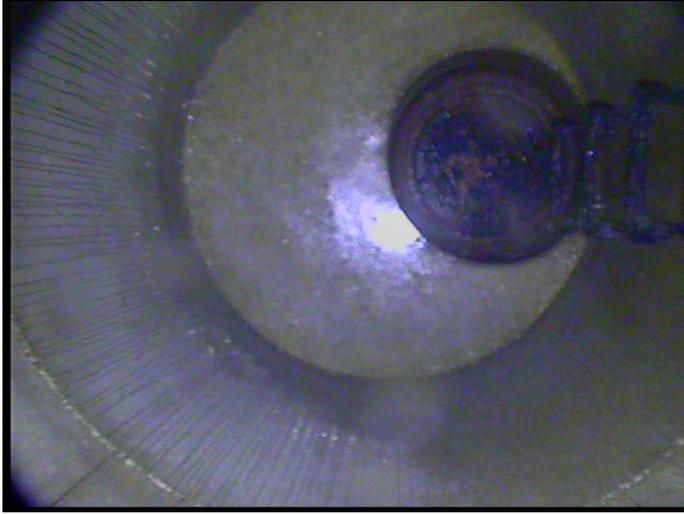
Code:	<b>AMH</b>
Description:	<b>Manhole</b>
Distance (ft):	<b>50.0</b>
Structural Grade:	<b>0</b>
O&M Grade:	<b>0</b>
Clock Start/From:	
Clock To:	
1st Value:	
2nd Value:	
Value Percent:	
Continuous Index:	
Within 8" of Joint:	<b>NO</b>
Remarks:	<b>M-706-10.6</b>
