## Profile/Photo Observation Report

Date:	<b>10/21/2021</b>	Weather:		Coding:	<b>PACP 6.0</b>
Pipe Length (ft):		Owner:	<b>Hobart, IN</b>	Pre Clean:	<b>Not Known</b>
P.O.#:	<b>942_1</b>	Surveyor:	<b>M. Pielacha</b>	PSR:	<b>P-707-075-074</b>
Customer:	<b>Hobart, IN</b>	Clean Date:		Shape:	<b>C</b>

Street:	<b>State Street</b>	Flow Control:	
City:	<b>Hobart, IN</b>	Year Renewed:	
Location:	<b>Light Highway</b>	Tape/Media #:	<b>942</b>
Purpose:	<b>Routine Assessment</b>	Dia/Height:	<b>12"</b>
Use:	<b>Sanitary</b>	Material:	<b>VCP</b>
Drain Area:		Lining:	
Category:	<b>NA</b>		
Comment:

Location Details:		Direction of Survey:	<b>Downstream</b>
US MH:	<b>M-707-75</b>	DS MH:	<b>M-707-74</b>
		Total Length Surveyed (ft):	<b>52.5</b>

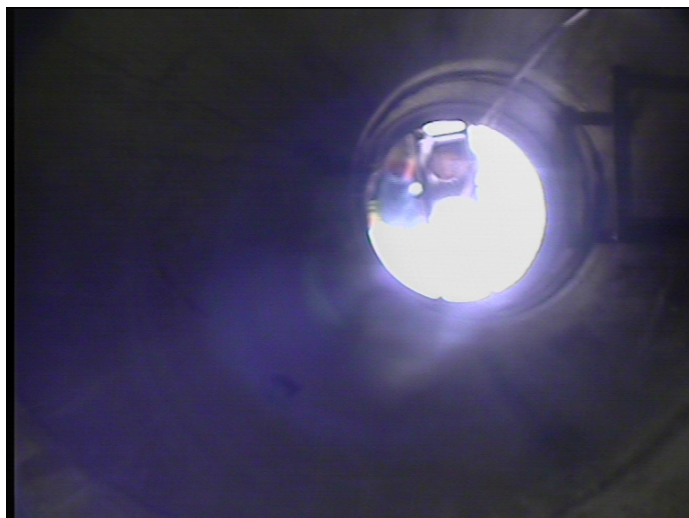
Code: **AMH**  
Description: **Manhole**

Distance (ft): **.0**  
Structural Grade: **0**  
O&M Grade: **0**  
Clock Start/From:  
Clock To:  
1st Value:  
2nd Value:  
Value Percent:  
Continuous Index:  
Within 8" of Joint: **NO**  
Remarks: **M-707-75**

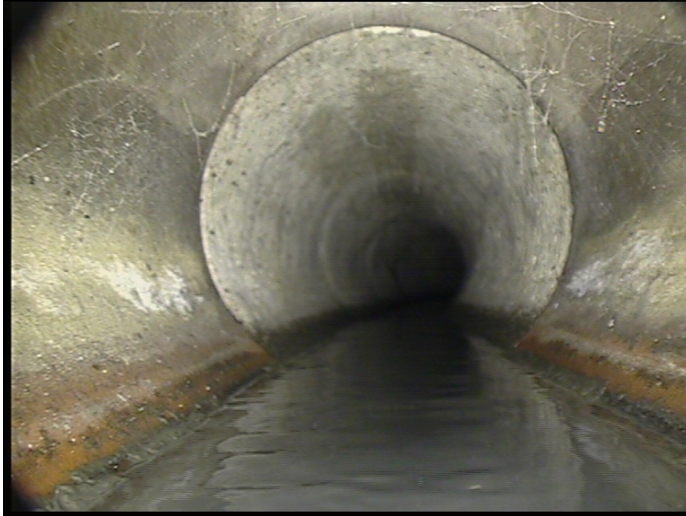
Code: **MWL**  
Description: **Water Level**

Distance (ft): **.0**  
Structural Grade: **0**  
O&M Grade: **0**  
Clock Start/From:  
Clock To:  
1st Value:  
2nd Value:  
Value Percent: **10.000**  
Continuous Index:  
Within 8" of Joint: **NO**  
Remarks:

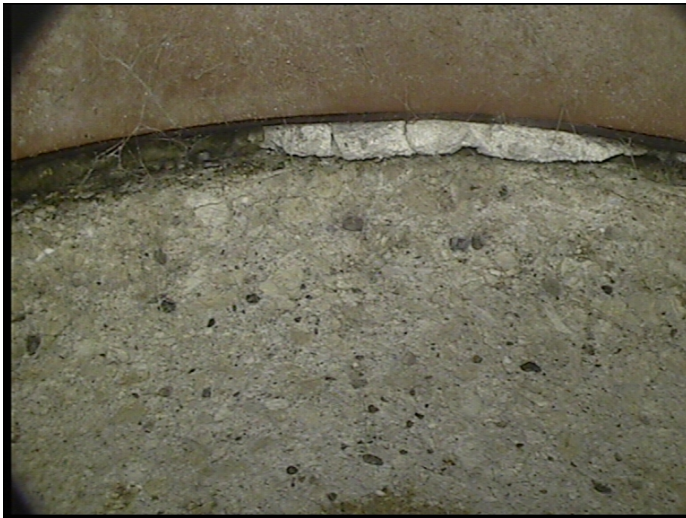
Code: **MMC**  
Description: **Material Change**

Distance (ft): **2.0**  
Structural Grade: **0**  
O&M Grade: **0**  
Clock Start/From:  
Clock To:  
1st Value:  
2nd Value:  
Value Percent:  
Continuous Index:  
Within 8" of Joint: **NO**  
Remarks: **concrete**

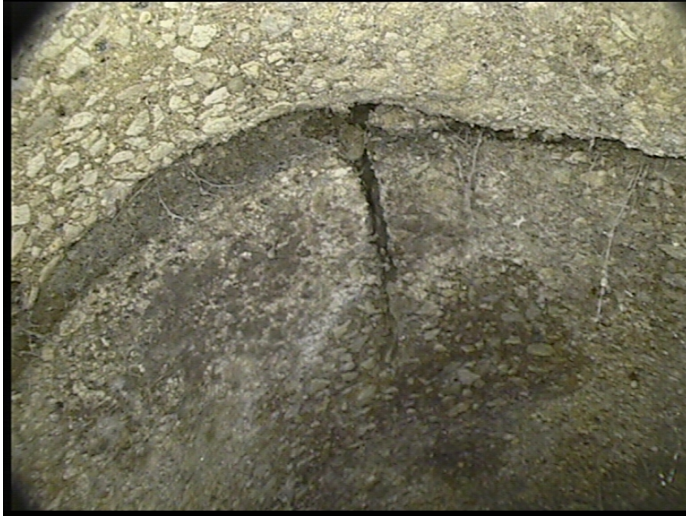
Code: **FL**  
Description: **Fracture Longitudinal**

Distance (ft): **15.5**  
Structural Grade: **3**  
O&M Grade: **0**  
Clock Start/From: **11**  
Clock To:  
1st Value:  
2nd Value:  
Value Percent:  
Continuous Index:  
Within 8" of Joint: **YES**  
Remarks:

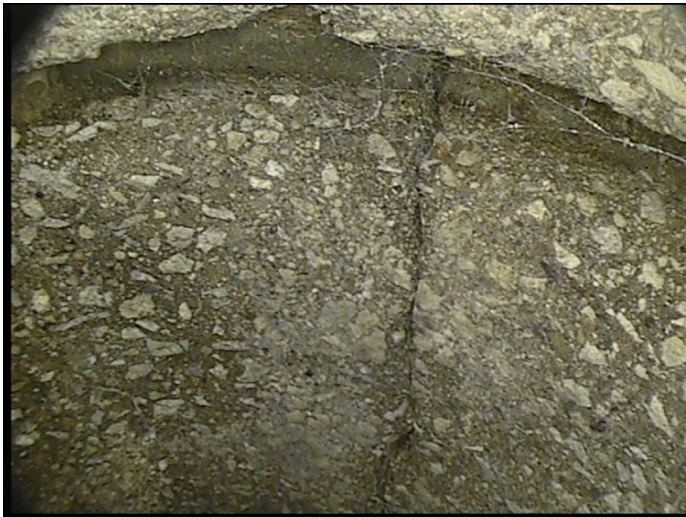
Code: **FL**  
Description: **Fracture Longitudinal**

Distance (ft): **28.1**  
Structural Grade: **3**  
O&M Grade: **0**  
Clock Start/From: **2**  
Clock To:  
1st Value:  
2nd Value:  
Value Percent:  
Continuous Index:  
Within 8" of Joint: **YES**  
Remarks:

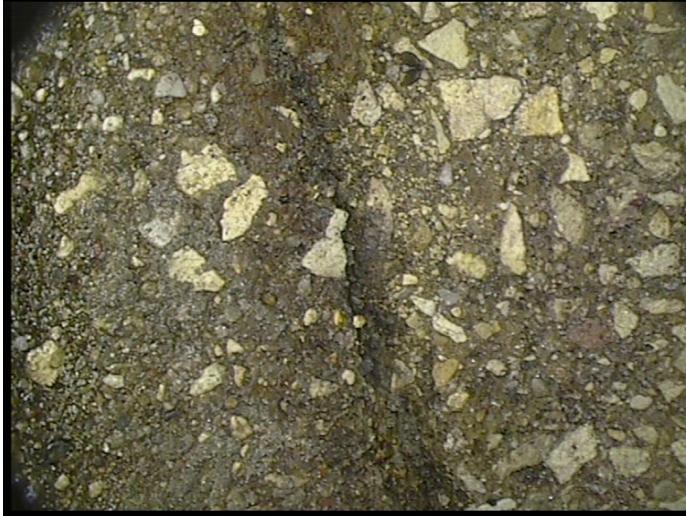
Code: **CL**  
Description: **Crack Longitudinal**

Distance (ft): **31.3**  
Structural Grade: **2**  
O&M Grade: **0**  
Clock Start/From: **8**  
Clock To:  
1st Value:  
2nd Value:  
Value Percent:  
Continuous Index:  
Within 8" of Joint: **YES**  
Remarks:

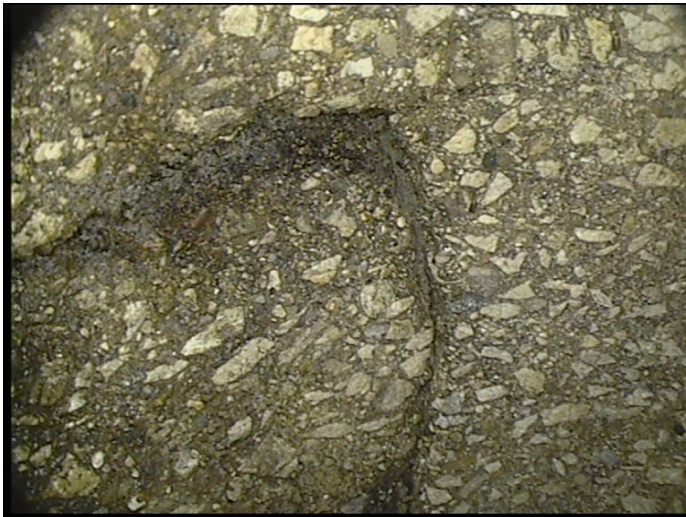
Code: **FC**  
Description: **Fracture Circumferential**

Distance (ft): **37.9**  
Structural Grade: **2**  
O&M Grade: **0**  
Clock Start/From: **7**  
Clock To: **9**  
1st Value:  
2nd Value:  
Value Percent:  
Continuous Index:  
Within 8" of Joint: **YES**  
Remarks:

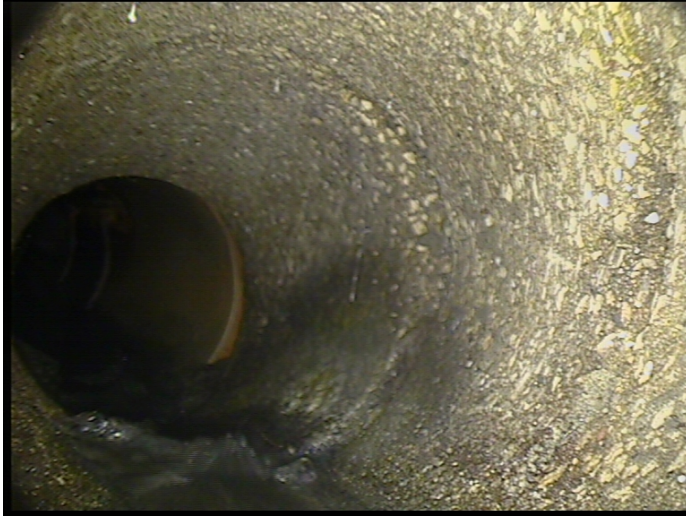
Code:	LL
Description:	Alignment Left
Distance (ft):	46.1
Structural Grade:	0
O&M Grade:	2
Clock Start/From:	
Clock To:	
1st Value:	
2nd Value:	
Value Percent:	15.000
Continuous Index:	
Within 8" of Joint:	NO
Remarks:

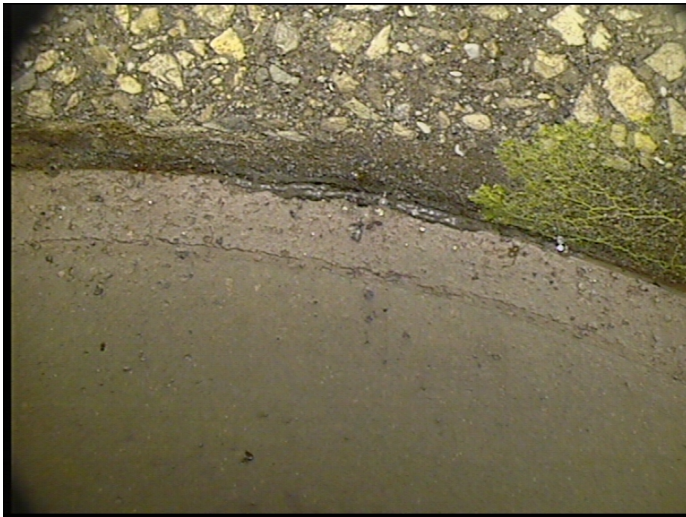
Code:	MMC
Description:	Material Change
Distance (ft):	49.1
Structural Grade:	0
O&M Grade:	0
Clock Start/From:	
Clock To:	
1st Value:	
2nd Value:	
Value Percent:	
Continuous Index:	
Within 8" of Joint:	NO
Remarks:	vcp

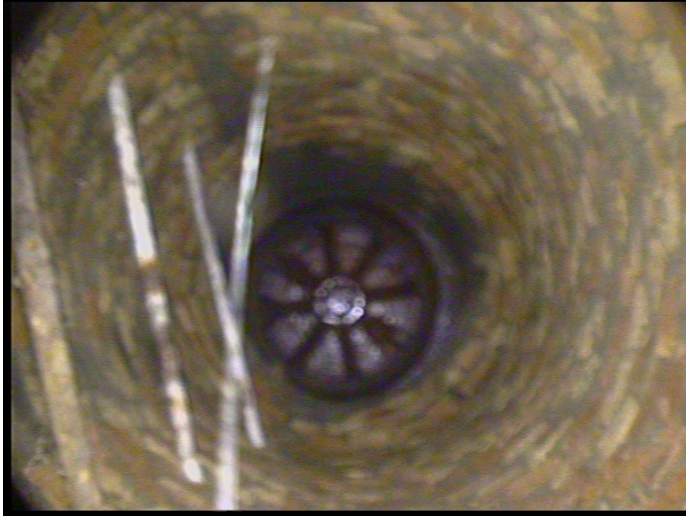
Code:	<b>AMH</b>
Description:	<b>Manhole</b>
Distance (ft):	<b>52.5</b>
Structural Grade:	<b>0</b>
O&M Grade:	<b>0</b>
Clock Start/From:	
Clock To:	
1st Value:	
2nd Value:	
Value Percent:	
Continuous Index:	
Within 8" of Joint:	<b>NO</b>
Remarks:	<b>M-707-74</b>
