Profile/Photo Observation Report

Date:	04/11/2018	Weather:		Coding:	PACP 6.0
Pipe Length (ft):	357.8	Owner:	NA	Pre Clean:	Not Known
P.O.#:		Surveyor:	Jen Costello	PSR:	P-707-081-076
Customer:		Clean Date:	01/01/1900	Shape:	C

Street:	STATE ST	Flow Control:	Not Controlled
City:	Hobart, IN	Year Renewed:	
Location:	Light Highway	Tape/Media #:	
Purpose:	Maintenance Related	Dia/Height:	12"
Use:	Sanitary	Material:	PVC
Drain Area:	NA	Lining:	Cured in Place
Category:	NA		
Comment:	heavy soft debris at 203'.-flow incorrect.		
Location Details:		Direction of Survey:	Downstream
US MH:	M-707-076	DS MH:	M-707-081
		Total Length Surveyed (ft):	202.9

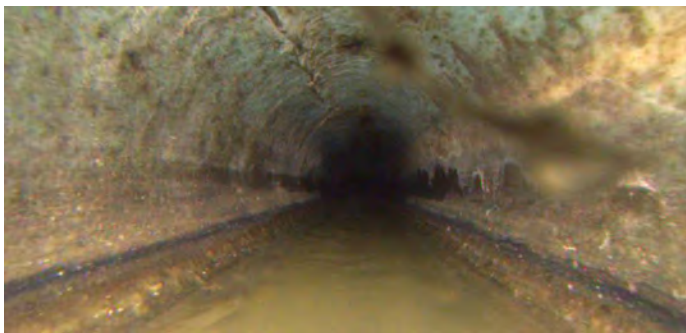
Code: **AMH**
Description: **Manhole**

Distance (ft): **.0**
Structural Grade: **0**
O&M Grade: **0**
Clock Start/From:
Clock To:
1st Value:
2nd Value:
Value Percent:
Continuous Index:
Within 8" of Joint: **NO**
Remarks: **M-707-076**

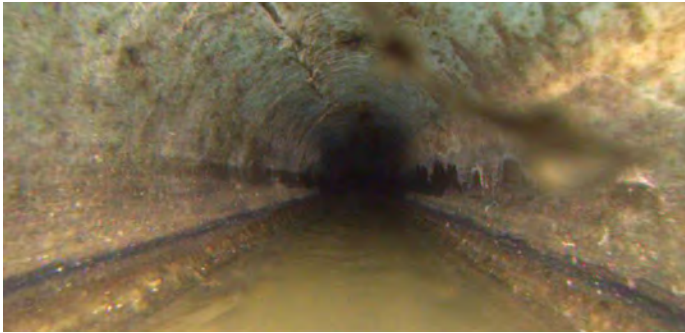
Code:	MWL
Description:	Water Level

Distance (ft):	.0
Structural Grade:	0
O&M Grade:	0
Clock Start/From:	
Clock To:	
1st Value:	
2nd Value:	
Value Percent:	20.000
Continuous Index:	
Within 8" of Joint:	NO
Remarks:

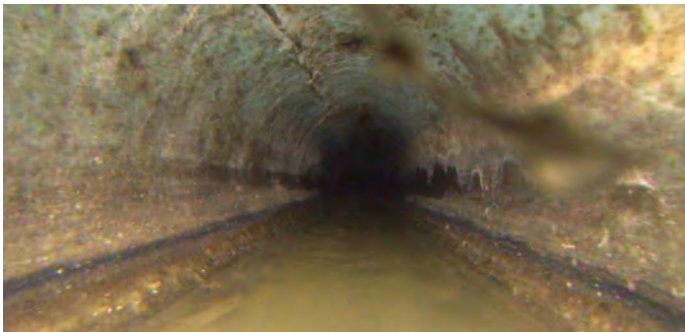
Code:	LFW
Description:	Lining Failure Wrinkled

Distance (ft):	.0
Structural Grade:	3
O&M Grade:	0
Clock Start/From:	11
Clock To:	
1st Value:	
2nd Value:	
Value Percent:	
Continuous Index:	S01
Within 8" of Joint:	NO
Remarks:

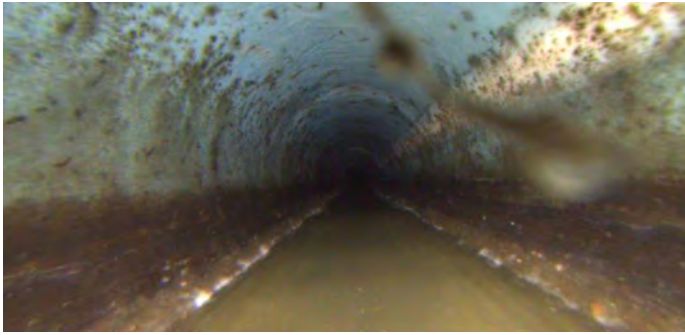
Code: **LFW**
Description: **Lining Failure Wrinkled**

Distance (ft): **18.9**
Structural Grade: **3**
O&M Grade: **0**
Clock Start/From: **11**
Clock To:
1st Value:
2nd Value:
Value Percent:
Continuous Index: **F01**
Within 8" of Joint: **NO**
Remarks:

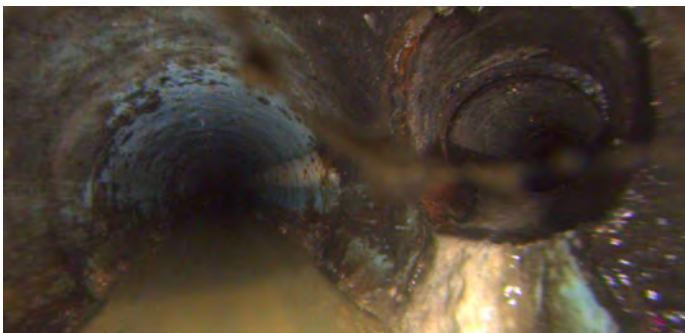
Code: **TFA**
Description: **Tap Factory Active**

Distance (ft): **59.4**
Structural Grade: **0**
O&M Grade: **0**
Clock Start/From: **3**
Clock To:
1st Value: **4.000**
2nd Value:
Value Percent:
Continuous Index:
Within 8" of Joint:
Remarks:

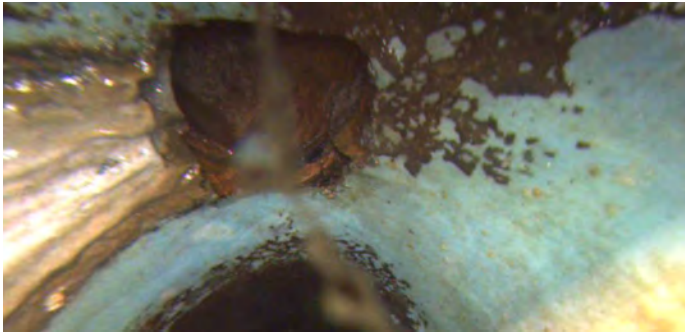
Code: **TB**
Description: **Tap Break-in**

Distance (ft): **80.2**
Structural Grade: **0**
O&M Grade: **0**
Clock Start/From: **12**
Clock To:
1st Value: **4.000**
2nd Value:
Value Percent:
Continuous Index:
Within 8" of Joint:
Remarks:

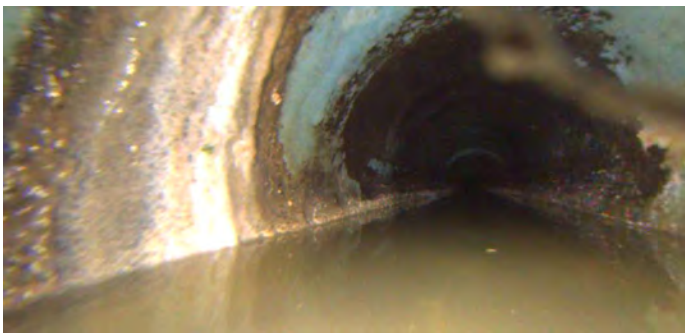
Code: **DAE**
Description: **Deposits Attached Encrustation**

Distance (ft): **80.2**
Structural Grade: **0**
O&M Grade: **2**
Clock Start/From: **7**
Clock To: **11**
1st Value:
2nd Value:
Value Percent: **5.000**
Continuous Index:
Within 8" of Joint: **NO**
Remarks:

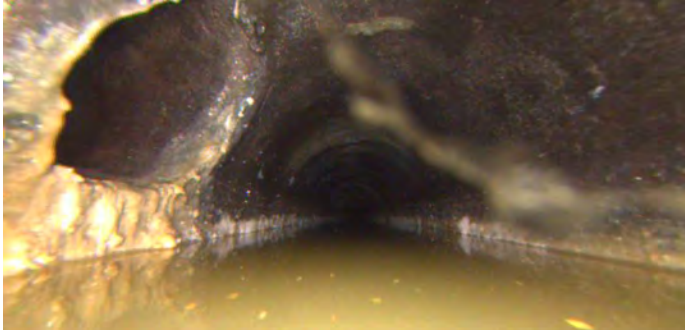
Code: **TB**
Description: **Tap Break-in**

Distance (ft): **95.7**
Structural Grade: **0**
O&M Grade: **0**
Clock Start/From: **9**
Clock To:
1st Value: **4.000**
2nd Value:
Value Percent:
Continuous Index:
Within 8" of Joint:
Remarks:

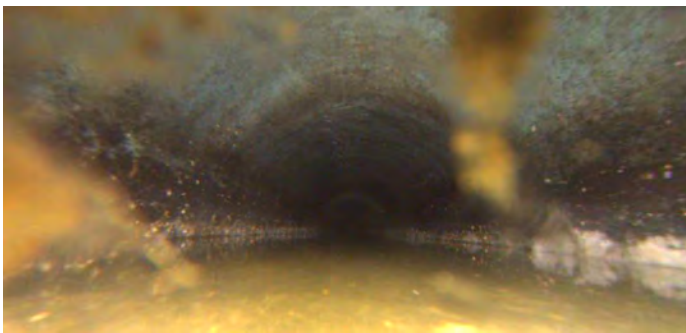
Code: **MCU**
Description: **Camera Underwater**

Distance (ft): **139.3**
Structural Grade: **0**
O&M Grade: **4**
Clock Start/From:
Clock To:
1st Value:
2nd Value:
Value Percent:
Continuous Index: **F02**
Within 8" of Joint: **NO**
Remarks:

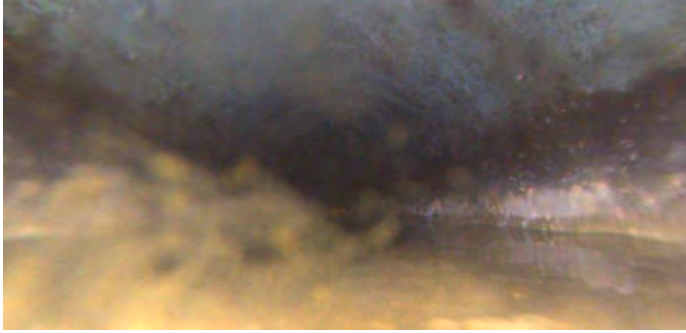
Code: **MGO**
Description: **General Observation**

Distance (ft): **147.3**
Structural Grade: **0**
O&M Grade: **0**
Clock Start/From:
Clock To:
1st Value:
2nd Value:
Value Percent:
Continuous Index:
Within 8" of Joint: **NO**
Remarks: **rear camera**
