Profile/Photo Observation Report

Date:	04/11/2018	Weather:		Coding:	PACP 6.0
Pipe Length (ft):	357.8	Owner:	NA	Pre Clean:	Not Known
P.O.#:		Surveyor:	Jen Costello	PSR:	P-707-081-076
Customer:		Clean Date:	01/01/1900	Shape:	C

Street:	Capitol	Flow Control:	Not Controlled
City:	Hobart, IN	Year Renewed:	
Location:	Light Highway	Tape/Media #:	
Purpose:	Maintenance Related	Dia/Height:	12"
Use:	Sanitary	Material:	PVC
Drain Area:	NA	Lining:	Cured in Place
Category:	NA		
Comment:	heavy soft debris at 203'.-flow incorrect.		
Location Details:		Direction of Survey:	Downstream
US MH:	M-707-076	DS MH:	M-707-081
		Total Length Surveyed (ft):	202.9

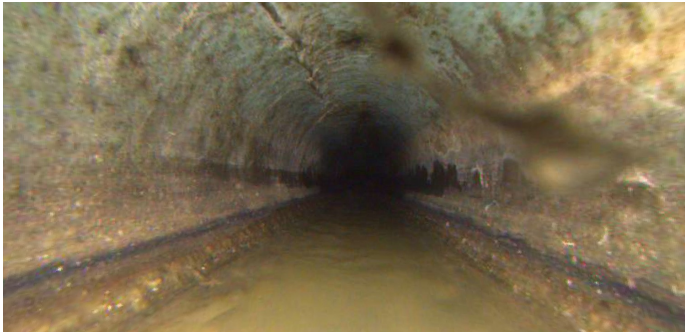
Code:	MWL
Description:	Water Level

Distance (ft):	.0
Structural Grade:	0
O&M Grade:	0
Clock Start/From:	
Clock To:	
1st Value:	
2nd Value:	
Value Percent:	20.000
Continuous Index:	
Within 8" of Joint:	NO
Remarks:

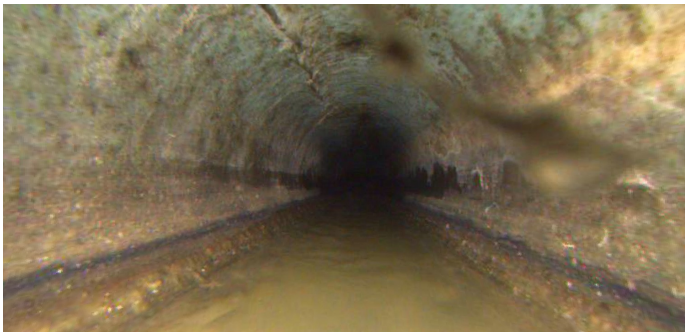
Code:	LFW
Description:	Lining Failure Wrinkled

Distance (ft):	.0
Structural Grade:	3
O&M Grade:	0
Clock Start/From:	11
Clock To:	
1st Value:	
2nd Value:	
Value Percent:	
Continuous Index:	S01
Within 8" of Joint:	NO
Remarks:

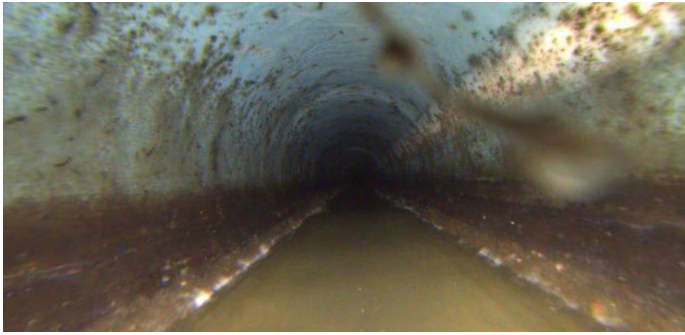
Code: **LFW**
Description: **Lining Failure Wrinkled**

Distance (ft): **18.9**
Structural Grade: **3**
O&M Grade: **0**
Clock Start/From: **11**
Clock To:
1st Value:
2nd Value:
Value Percent:
Continuous Index: **F01**
Within 8" of Joint: **NO**
Remarks:

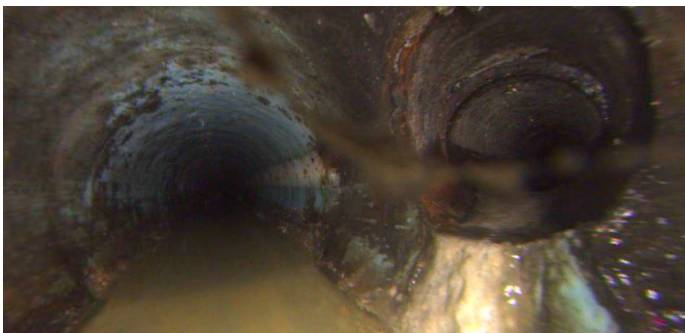
Code: **TFA**
Description: **Tap Factory Active**

Distance (ft): **59.4**
Structural Grade: **0**
O&M Grade: **0**
Clock Start/From: **3**
Clock To:
1st Value: **4.000**
2nd Value:
Value Percent:
Continuous Index:
Within 8" of Joint:
Remarks:

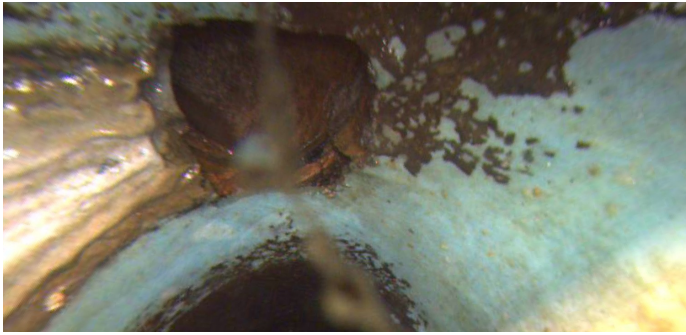
Code: **TB**
Description: **Tap Break-in**

Distance (ft): **80.2**
Structural Grade: **0**
O&M Grade: **0**
Clock Start/From: **12**
Clock To:
1st Value: **4.000**
2nd Value:
Value Percent:
Continuous Index:
Within 8" of Joint:
Remarks:

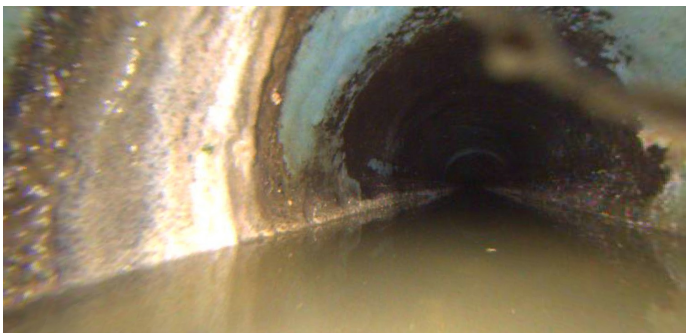
Code: **DAE**
Description: **Deposits Attached Encrustation**

Distance (ft): **80.2**
Structural Grade: **0**
O&M Grade: **2**
Clock Start/From: **7**
Clock To: **11**
1st Value:
2nd Value:
Value Percent: **5.000**
Continuous Index:
Within 8" of Joint: **NO**
Remarks:

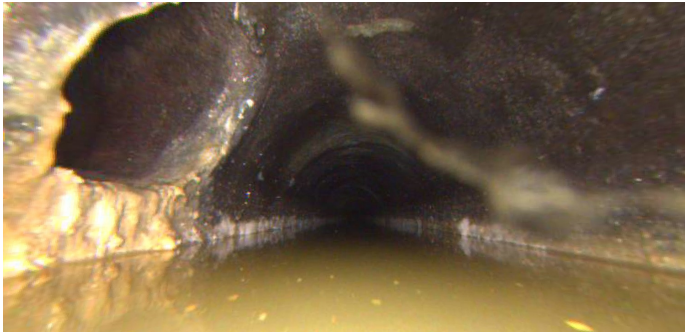
Code: **TB**
Description: **Tap Break-in**

Distance (ft): **95.7**
Structural Grade: **0**
O&M Grade: **0**
Clock Start/From: **9**
Clock To:
1st Value: **4.000**
2nd Value:
Value Percent:
Continuous Index:
Within 8" of Joint:
Remarks:

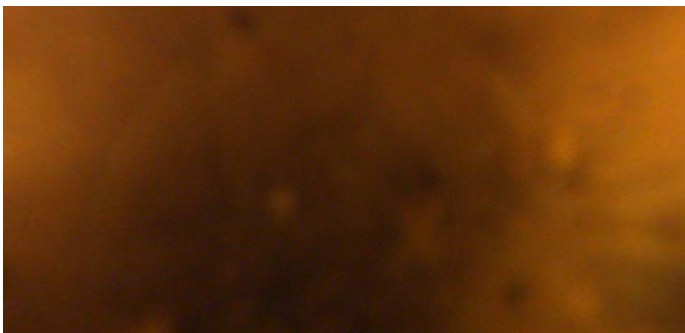
Code: **MWL**
Description: **Water Level**

Distance (ft): **132.3**
Structural Grade: **0**
O&M Grade: **0**
Clock Start/From:
Clock To:
1st Value:
2nd Value:
Value Percent: **100.000**
Continuous Index:
Within 8" of Joint: **NO**
Remarks:

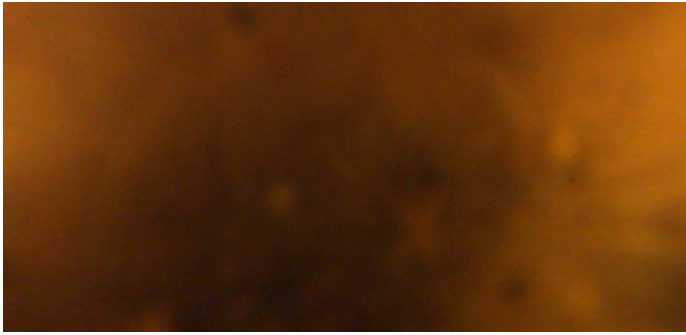
Code: **MCU**
Description: **Camera Underwater**

Distance (ft): **132.3**
Structural Grade: **0**
O&M Grade: **4**
Clock Start/From:
Clock To:
1st Value:
2nd Value:
Value Percent:
Continuous Index: **S02**
Within 8" of Joint: **NO**
Remarks:

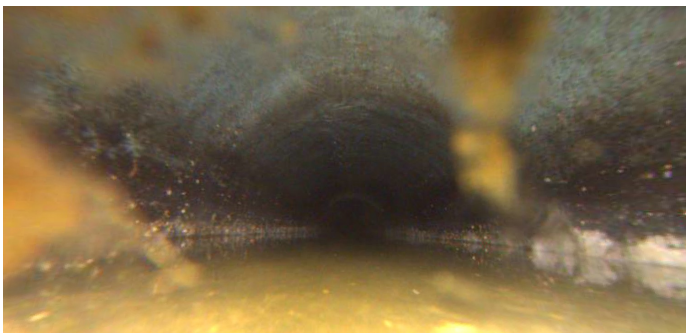
Code: **MCU**
Description: **Camera Underwater**

Distance (ft): **139.3**
Structural Grade: **0**
O&M Grade: **4**
Clock Start/From:
Clock To:
1st Value:
2nd Value:
Value Percent:
Continuous Index: **F02**
Within 8" of Joint: **NO**
Remarks:

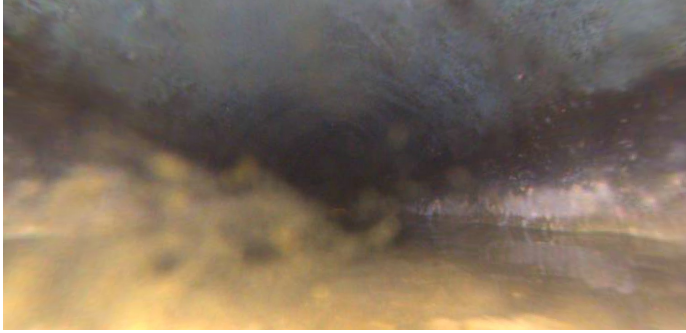
Code: **MGO**
Description: **General Observation**

Distance (ft): **147.3**
Structural Grade: **0**
O&M Grade: **0**
Clock Start/From:
Clock To:
1st Value:
2nd Value:
Value Percent:
Continuous Index:
Within 8" of Joint: **NO**
Remarks: **rear camera**

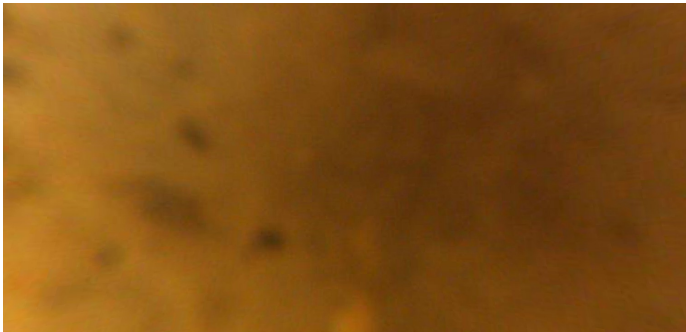
Code: **MCU**
Description: **Camera Underwater**

Distance (ft): **160.6**
Structural Grade: **0**
O&M Grade: **4**
Clock Start/From:
Clock To:
1st Value:
2nd Value:
Value Percent:
Continuous Index: **S03**
Within 8" of Joint: **NO**
Remarks:
