Profile/Photo Observation Report

Date:	04/11/2018	Weather:		Coding:	PACP 6.0
Pipe Length (ft):	357.8	Owner:	NA	Pre Clean:	Not Known
P.O.#:		Surveyor:	Jen Costello	PSR:	P-707-081-076
Customer:		Clean Date:	01/01/1900	Shape:	C

Street:	STATE ST	Flow Control:	Not Controlled
City:	Hobart, IN	Year Renewed:	
Location:	Light Highway	Tape/Media #:	
Purpose:	Maintenance Related	Dia/Height:	12"
Use:	Sanitary	Material:	PVC
Drain Area:	NA	Lining:	Cured in Place
Category:	NA		
Comment:	Reverse setup.blk silt at 79'.-flow incorrect.		
Location Details:		Direction of Survey:	Upstream
US MH:	M-707-076	DS MH:	M-707-081
		Total Length Surveyed (ft):	80.2

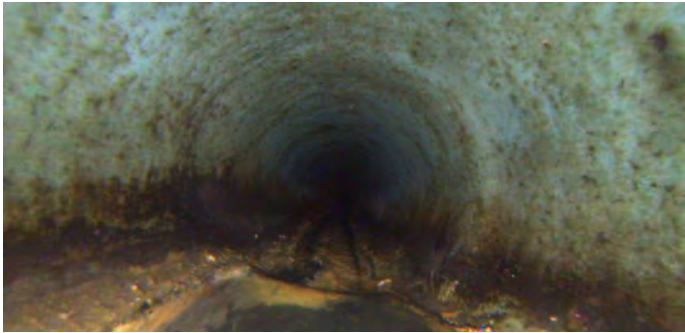
Code:	MWL
Description:	Water Level

Distance (ft):	.0
Structural Grade:	0
O&M Grade:	0
Clock Start/From:	
Clock To:	
1st Value:	
2nd Value:	
Value Percent:	5.000
Continuous Index:	
Within 8" of Joint:	NO
Remarks:

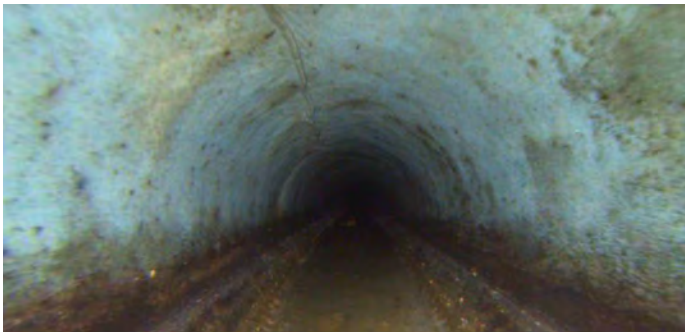
Code:	LFW
Description:	Lining Failure Wrinkled

Distance (ft):	30.6
Structural Grade:	3
O&M Grade:	0
Clock Start/From:	11
Clock To:	
1st Value:	
2nd Value:	
Value Percent:	
Continuous Index:	
Within 8" of Joint:	NO
Remarks:

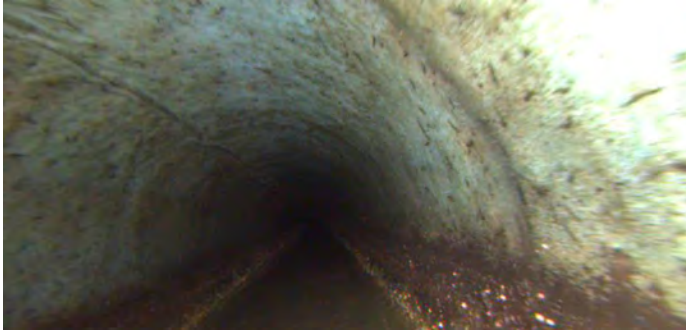
Code: **LFW**
Description: **Lining Failure Wrinkled**

Distance (ft): **38.5**
Structural Grade: **3**
O&M Grade: **0**
Clock Start/From: **11**
Clock To:
1st Value:
2nd Value:
Value Percent:
Continuous Index: **S01**
Within 8" of Joint: **NO**
Remarks:

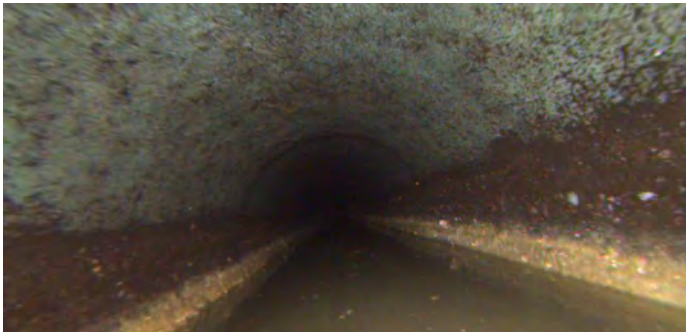
Code: **LFW**
Description: **Lining Failure Wrinkled**

Distance (ft): **77.5**
Structural Grade: **3**
O&M Grade: **0**
Clock Start/From: **11**
Clock To:
1st Value:
2nd Value:
Value Percent:
Continuous Index: **F01**
Within 8" of Joint: **NO**
Remarks:

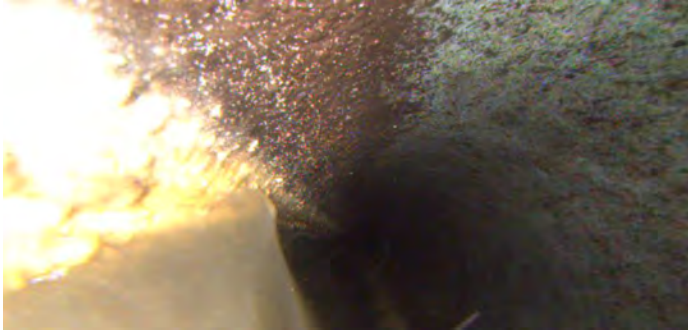
Code:	MSA
Description:	Abandoned Survey
Distance (ft):	80.2
Structural Grade:	0
O&M Grade:	0
Clock Start/From:	
Clock To:	
1st Value:	
2nd Value:	
Value Percent:	
Continuous Index:	
Within 8" of Joint:	NO
Remarks:	debris
