Profile/Photo Observation Report

Date:	04/11/2018	Weather:		Coding:	PACP 6.0
Pipe Length (ft):	357.8	Owner:	NA	Pre Clean:	Not Known
P.O.#:		Surveyor:	Jen Costello	PSR:	P-707-081-076
Customer:		Clean Date:	01/01/1900	Shape:	C

Street:	Capitol	Flow Control:	Not Controlled
City:	Hobart, IN	Year Renewed:	
Location:	Light Highway	Tape/Media #:	
Purpose:	Maintenance Related	Dia/Height:	12"
Use:	Sanitary	Material:	PVC
Drain Area:	NA	Lining:	Cured in Place
Category:	NA		
Comment:	Reverse setup.blk silt at 79'.-flow incorrect.		
Location Details:		Direction of Survey:	Upstream
US MH:	M-707-076	DS MH:	M-707-081
		Total Length Surveyed (ft):	80.2

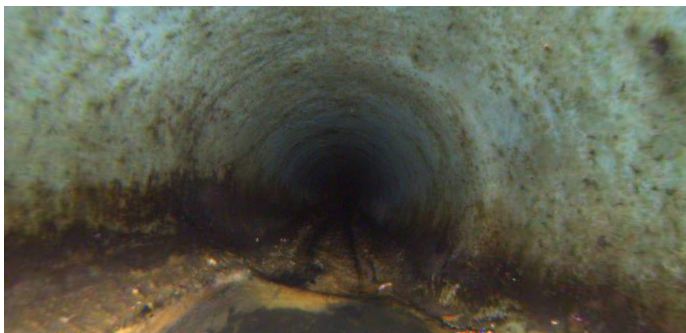
Code: **AMH**
Description: **Manhole**

Distance (ft): **.0**
Structural Grade: **0**
O&M Grade: **0**
Clock Start/From:
Clock To:
1st Value:
2nd Value:
Value Percent:
Continuous Index:
Within 8" of Joint: **NO**
Remarks: **M-707-081**

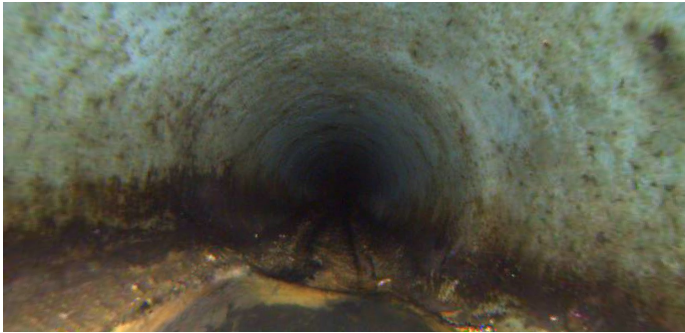
Code:	MWL
Description:	Water Level

Distance (ft):	.0
Structural Grade:	0
O&M Grade:	0
Clock Start/From:	
Clock To:	
1st Value:	
2nd Value:	
Value Percent:	5.000
Continuous Index:	
Within 8" of Joint:	NO
Remarks:

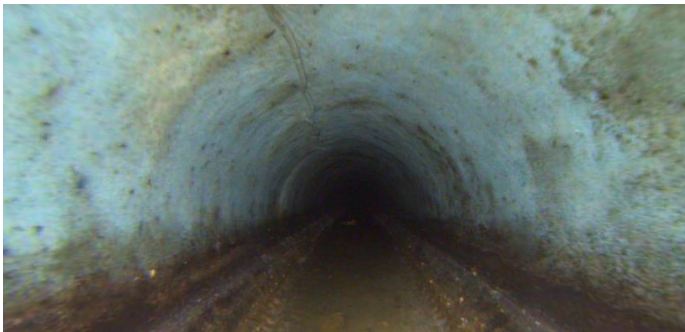
Code:	LFW
Description:	Lining Failure Wrinkled

Distance (ft):	30.6
Structural Grade:	3
O&M Grade:	0
Clock Start/From:	11
Clock To:	
1st Value:	
2nd Value:	
Value Percent:	
Continuous Index:	
Within 8" of Joint:	NO
Remarks:

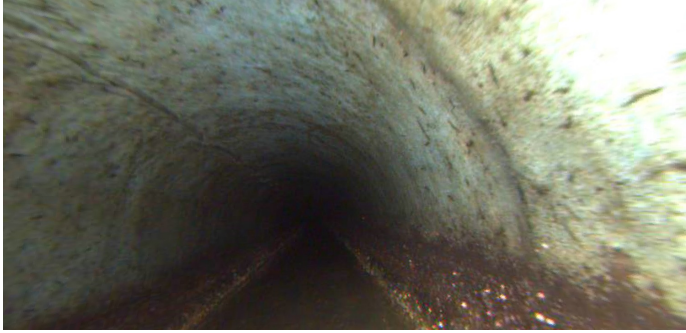
Code: **LFW**
Description: **Lining Failure Wrinkled**

Distance (ft): **38.5**
Structural Grade: **3**
O&M Grade: **0**
Clock Start/From: **11**
Clock To:
1st Value:
2nd Value:
Value Percent:
Continuous Index: **S01**
Within 8" of Joint: **NO**
Remarks:

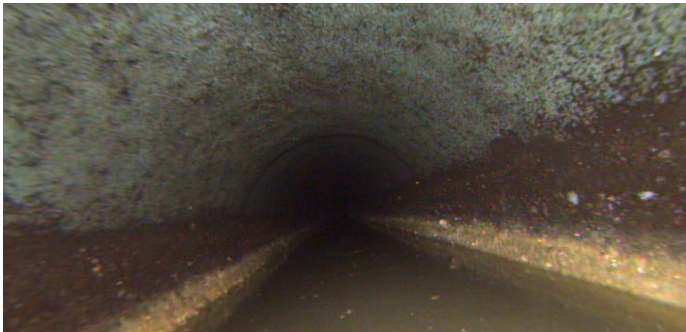
Code: **LFW**
Description: **Lining Failure Wrinkled**

Distance (ft): **77.5**
Structural Grade: **3**
O&M Grade: **0**
Clock Start/From: **11**
Clock To:
1st Value:
2nd Value:
Value Percent:
Continuous Index: **F01**
Within 8" of Joint: **NO**
Remarks:

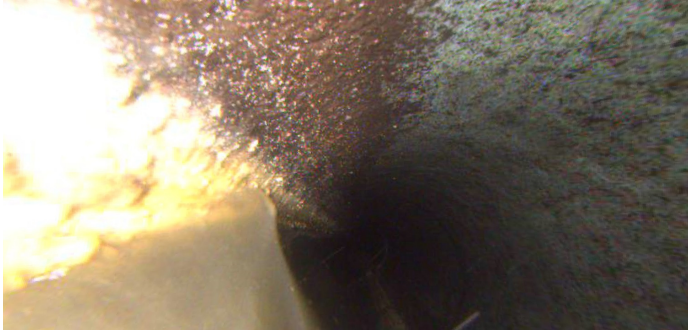
Code:	MSA
Description:	Abandoned Survey
Distance (ft):	80.2
Structural Grade:	0
O&M Grade:	0
Clock Start/From:	
Clock To:	
1st Value:	
2nd Value:	
Value Percent:	
Continuous Index:	
Within 8" of Joint:	NO
Remarks:	debris
