Profile/Photo Observation Report

Date:	02/09/2022	Weather:		Coding:	PACP 7.0
Pipe Length (ft):	357.4	Owner:	City of Hobart	Pre Clean:	Heavy Cleaning
P.O.#:	YES502259	Surveyor:	S. Bucklin	PSR:	P-707-081-076
Customer:	City of Hobart	Clean Date:	02/08/2022	Shape:	C

Street:	South State Street	Flow Control:	Not Controlled
City:	Hobart, IN	Year Renewed:	
Location:	Local rural streets with light traffic, t	Tape/Media #:	
Purpose:	Routine Assessment	Dia/Height:	12"
Use:	Sanitary Sewage Pipe	Material:	VCP
Drain Area:		Lining:	Not Known
Category:	NA		
Comment:			
Location Details:		Direction of Survey:	Downstream
US MH:	M-707-076	DS MH:	M-707-081
		Total Length Surveyed (ft):	357.4

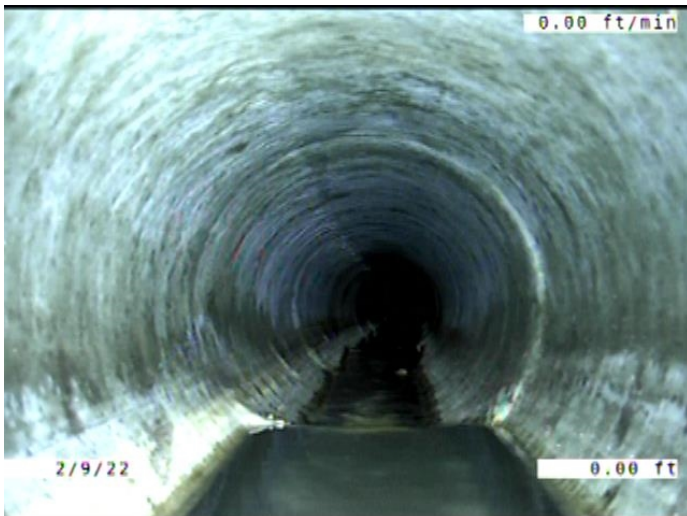
Code: **MWL**
Description: **Miscellaneous Water Level**

Distance (ft): **.0**
Structural Grade: **0**
O&M Grade: **0**
Clock Start/From:
Clock To:
1st Value:
2nd Value:
Value Percent: **5.000**
Continuous Index:
Within 8" of Joint: **NO**
Remarks:

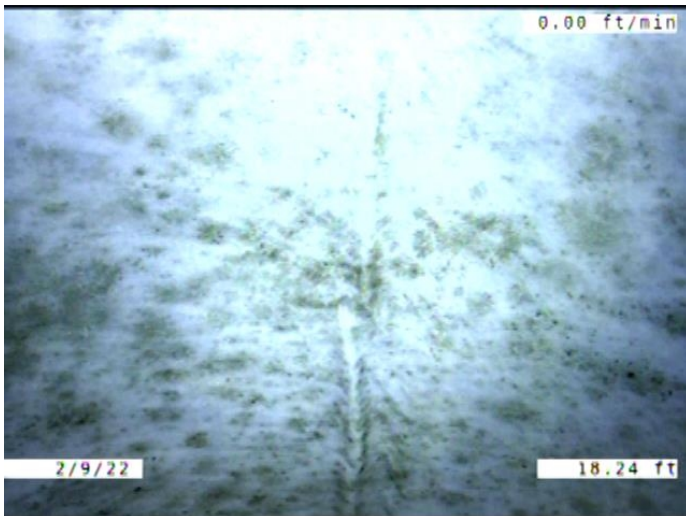
Code:	LFW
Description:	Lining Feature Wrinkled
Distance (ft):	18.2
Structural Grade:	3
O&M Grade:	0
Clock Start/From:	11
Clock To:	12
1st Value:	
2nd Value:	
Value Percent:	
Continuous Index:	
Within 8" of Joint:	NO
Remarks:

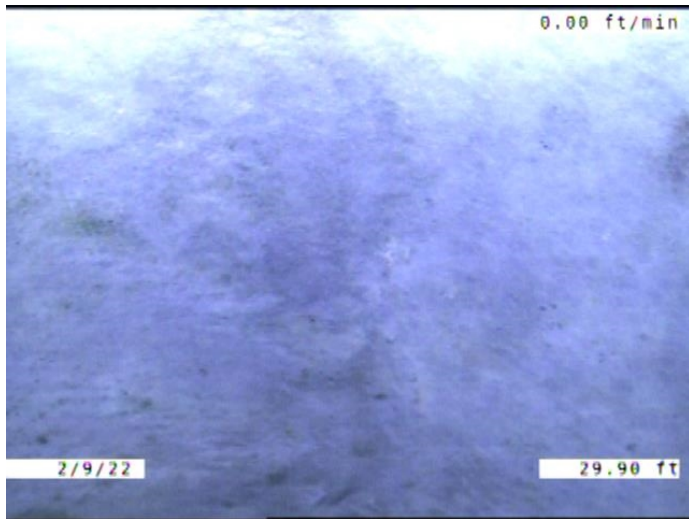
Code: **LFW**
Description: **Lining Feature Wrinkled**

Distance (ft): **29.9**
Structural Grade: **3**
O&M Grade: **0**
Clock Start/From: **11**
Clock To: **1**
1st Value:
2nd Value:
Value Percent:
Continuous Index: **S01**
Within 8" of Joint: **NO**
Remarks:

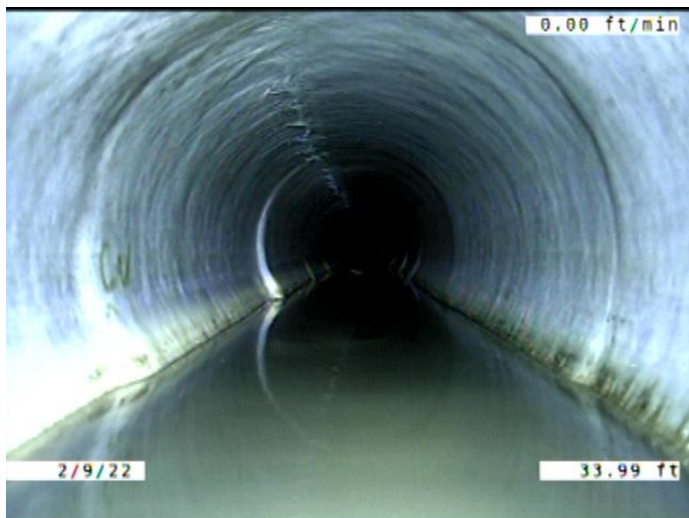
Code: **MWL**
Description: **Miscellaneous Water Level**

Distance (ft): **34.0**
Structural Grade: **0**
O&M Grade: **0**
Clock Start/From:
Clock To:
1st Value:
2nd Value:
Value Percent: **15.000**
Continuous Index:
Within 8" of Joint: **NO**
Remarks:

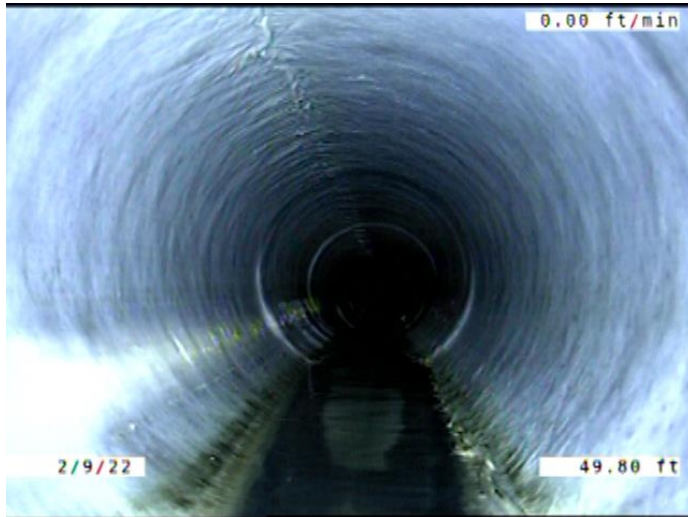
Code: **MWL**
 Description: **Miscellaneous Water Level**

Distance (ft): **49.8**
 Structural Grade: **0**
 O&M Grade: **0**
 Clock Start/From:
 Clock To:
 1st Value:
 2nd Value:
 Value Percent: **5.000**
 Continuous Index:
 Within 8" of Joint: **NO**
 Remarks:

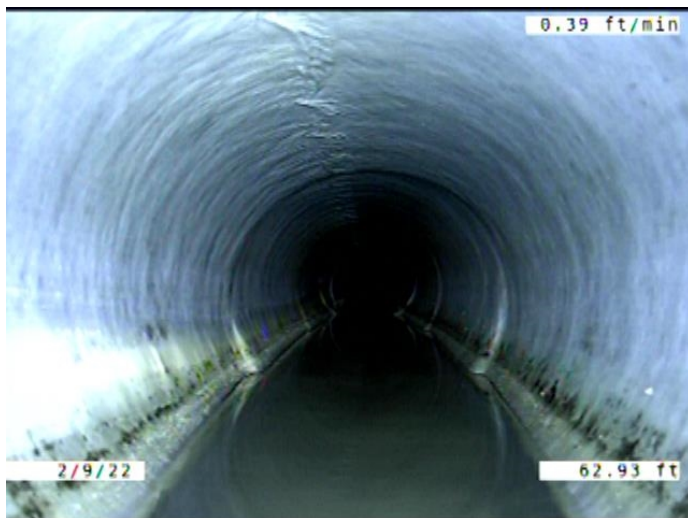
Code: **MWL**
 Description: **Miscellaneous Water Level**

Distance (ft): **62.9**
 Structural Grade: **0**
 O&M Grade: **0**
 Clock Start/From:
 Clock To:
 1st Value:
 2nd Value:
 Value Percent: **15.000**
 Continuous Index:
 Within 8" of Joint: **NO**
 Remarks:

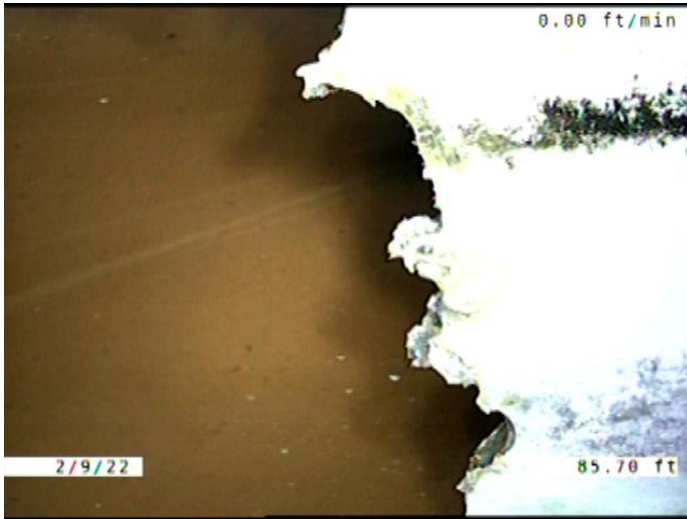
Code: **LFUC**
 Description: **Lining Feature Undercut Service**

Distance (ft): **85.7**
 Structural Grade: **3**
 O&M Grade: **0**
 Clock Start/From: **2**
 Clock To:
 1st Value:
 2nd Value:
 Value Percent:
 Continuous Index:
 Within 8" of Joint: **NO**
 Remarks:

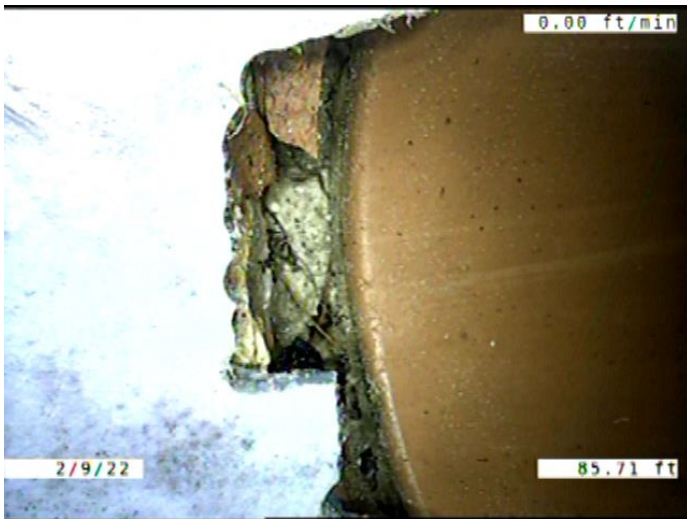
Code: **LFOC**
 Description: **Lining Feature Overcut Service**

Distance (ft): **85.7**
 Structural Grade: **3**
 O&M Grade: **0**
 Clock Start/From: **12**
 Clock To:
 1st Value:
 2nd Value:
 Value Percent:
 Continuous Index:
 Within 8" of Joint: **NO**
 Remarks:

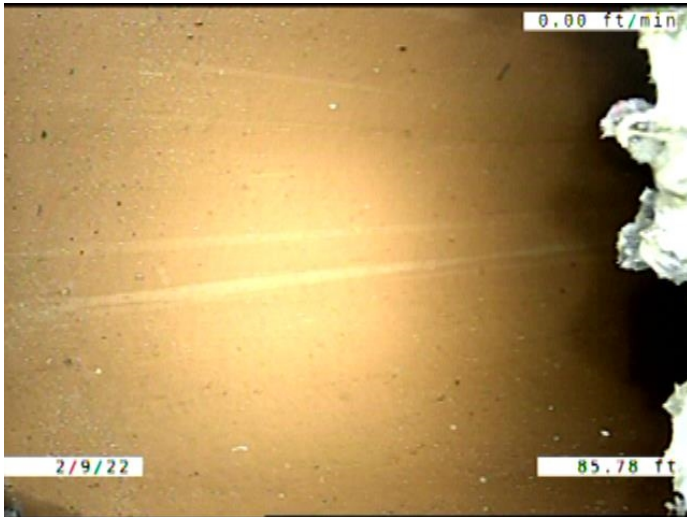
Code: **TB**
 Description: **Tap Break-in/Hammer**

Distance (ft): **85.8**
 Structural Grade: **0**
 O&M Grade: **0**
 Clock Start/From: **1**
 Clock To:
 1st Value: **4.000**
 2nd Value:
 Value Percent:
 Continuous Index:
 Within 8" of Joint: **NO**
 Remarks:

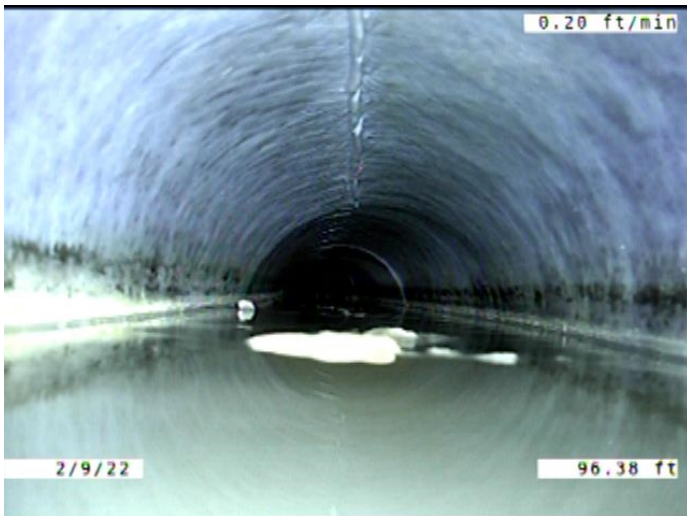
Code: **MWL**
 Description: **Miscellaneous Water Level**

Distance (ft): **96.4**
 Structural Grade: **0**
 O&M Grade: **0**
 Clock Start/From:
 Clock To:
 1st Value:
 2nd Value:
 Value Percent: **40.000**
 Continuous Index:
 Within 8" of Joint: **NO**
 Remarks:

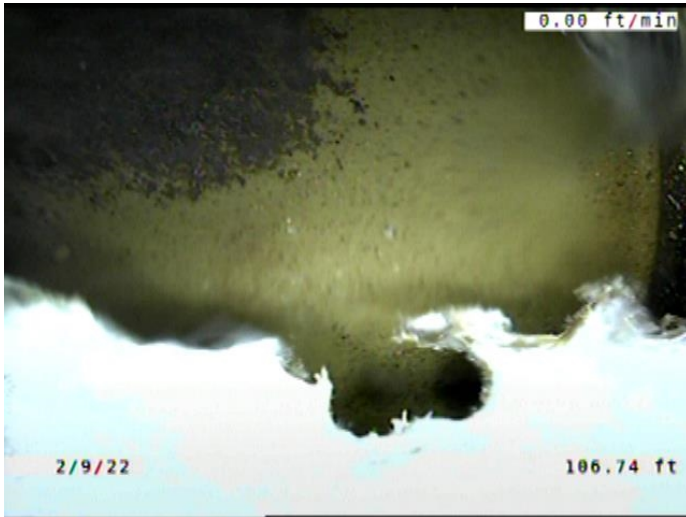
Code: **LFUC**
Description: **Lining Feature Undercut Service**

Distance (ft): **106.7**
Structural Grade: **3**
O&M Grade: **0**
Clock Start/From: **12**
Clock To:
1st Value:
2nd Value:
Value Percent:
Continuous Index:
Within 8" of Joint: **NO**
Remarks:

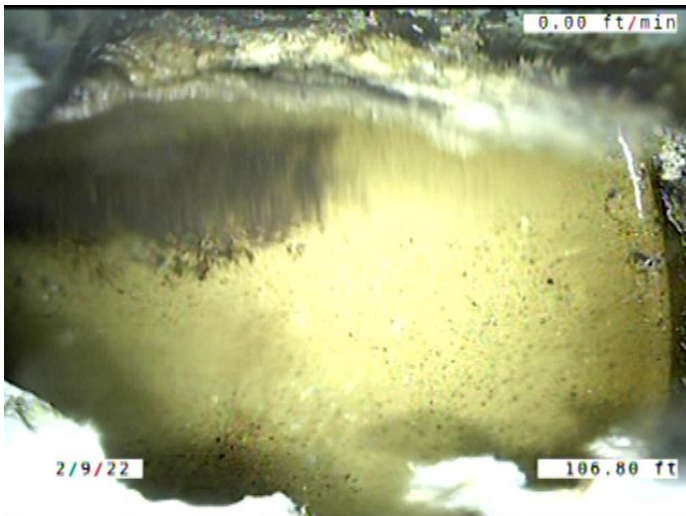
Code: **TB**
Description: **Tap Break-in/Hammer**

Distance (ft): **106.8**
Structural Grade: **0**
O&M Grade: **0**
Clock Start/From: **12**
Clock To:
1st Value: **4.000**
2nd Value:
Value Percent:
Continuous Index:
Within 8" of Joint: **NO**
Remarks:

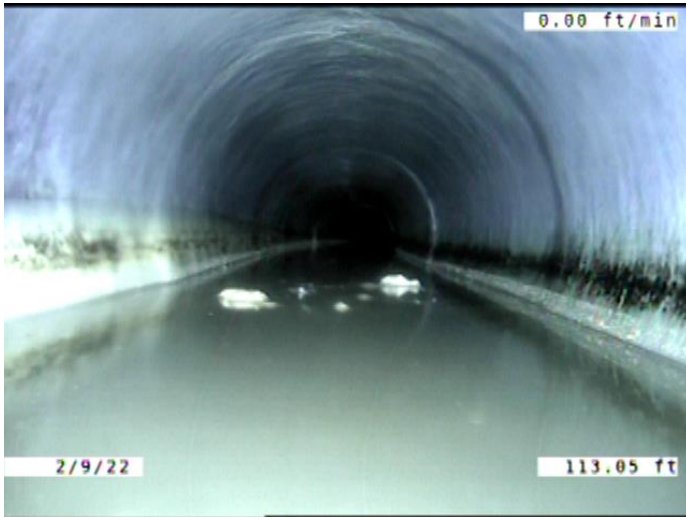
Code: **MWL**
 Description: **Miscellaneous Water Level**

Distance (ft): **113.0**
 Structural Grade: **0**
 O&M Grade: **0**
 Clock Start/From:
 Clock To:
 1st Value:
 2nd Value:
 Value Percent: **15.000**
 Continuous Index:
 Within 8" of Joint: **NO**
 Remarks:

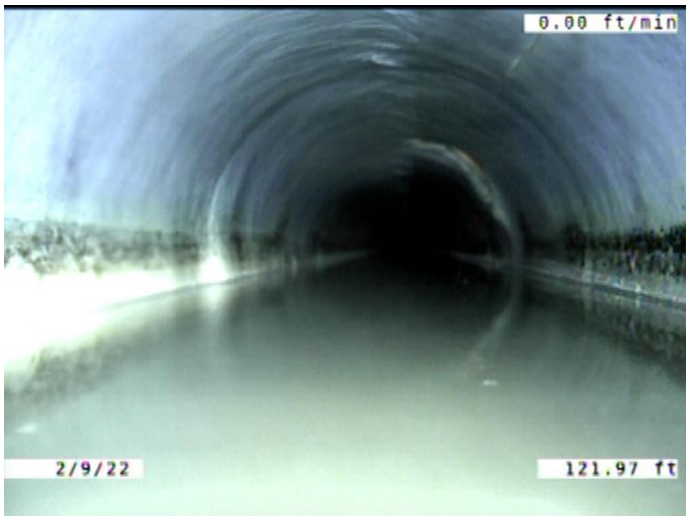
Code: **MWL**
 Description: **Miscellaneous Water Level**

Distance (ft): **122.0**
 Structural Grade: **0**
 O&M Grade: **0**
 Clock Start/From:
 Clock To:
 1st Value:
 2nd Value:
 Value Percent: **30.000**
 Continuous Index:
 Within 8" of Joint: **NO**
 Remarks:

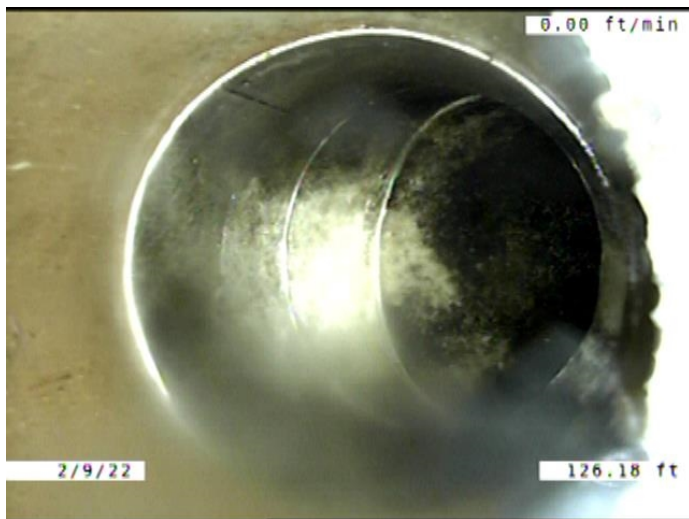
Code: **TB**
 Description: **Tap Break-in/Hammer**

Distance (ft): **126.2**
 Structural Grade: **0**
 O&M Grade: **0**
 Clock Start/From: **1**
 Clock To:
 1st Value: **4.000**
 2nd Value:
 Value Percent:
 Continuous Index:
 Within 8" of Joint: **NO**
 Remarks:

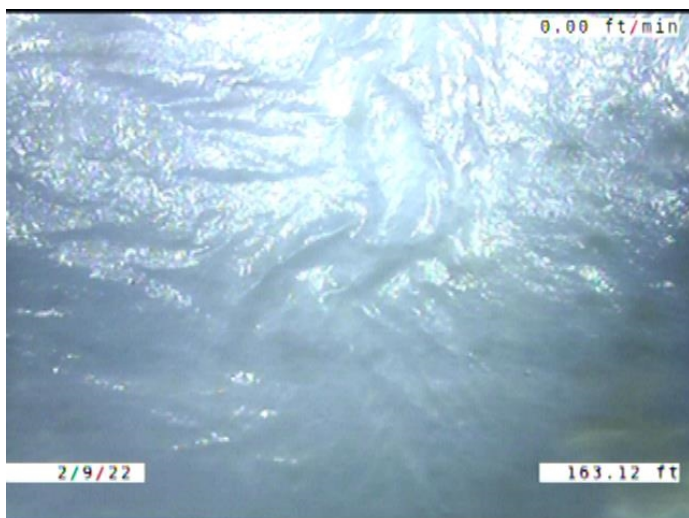
Code: **MWL**
 Description: **Miscellaneous Water Level**

Distance (ft): **163.1**
 Structural Grade: **0**
 O&M Grade: **0**
 Clock Start/From:
 Clock To:
 1st Value:
 2nd Value:
 Value Percent: **50.000**
 Continuous Index:
 Within 8" of Joint: **NO**
 Remarks:

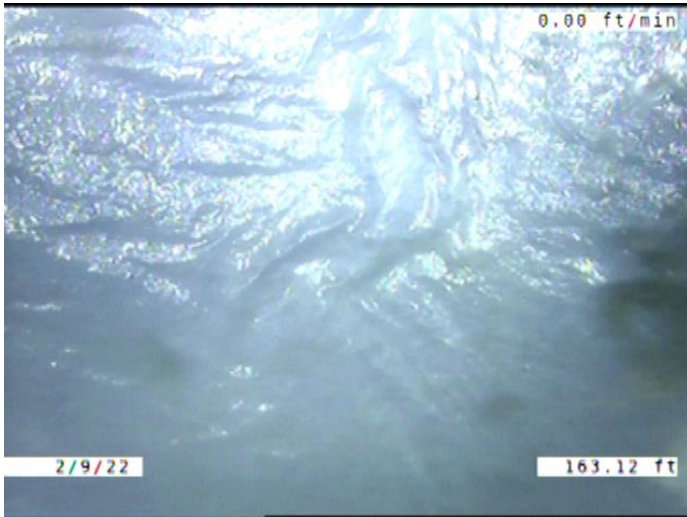
Code: **MCU**
Description: **Miscellaneous Camera Underwater**

Distance (ft): **163.1**
Structural Grade: **0**
O&M Grade: **4**
Clock Start/From:
Clock To:
1st Value:
2nd Value:
Value Percent:
Continuous Index: **S02**
Within 8" of Joint: **NO**
Remarks:

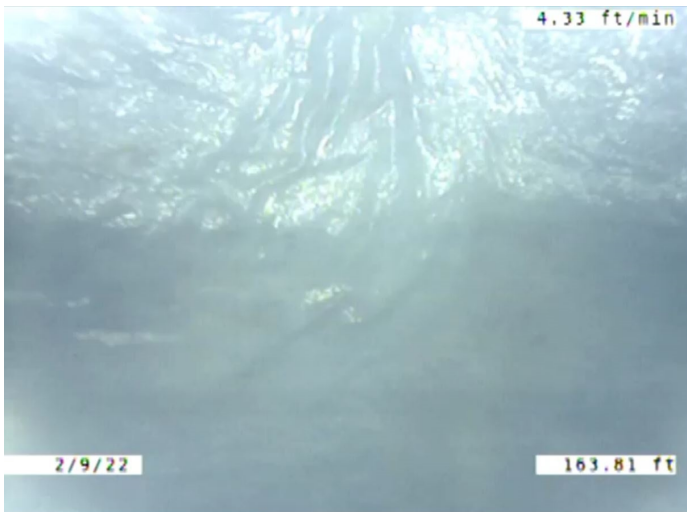
Code: **MGO**
Description: **Miscellaneous General Observation**

Distance (ft): **163.8**
Structural Grade: **0**
O&M Grade: **0**
Clock Start/From:
Clock To:
1st Value:
2nd Value:
Value Percent:
Continuous Index:
Within 8" of Joint: **NO**
Remarks: **LFW visible through water**

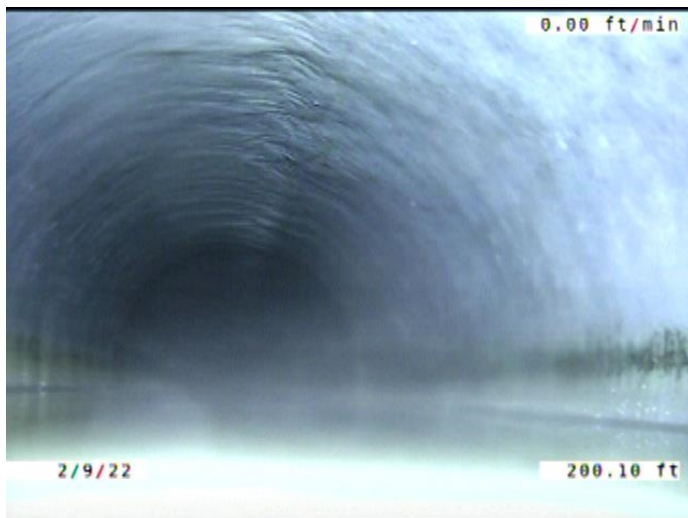
Code: **MCU**
Description: **Miscellaneous Camera Underwater**

Distance (ft): **200.1**
Structural Grade: **0**
O&M Grade: **4**
Clock Start/From:
Clock To:
1st Value:
2nd Value:
Value Percent:
Continuous Index: **F02**
Within 8" of Joint: **NO**
Remarks:

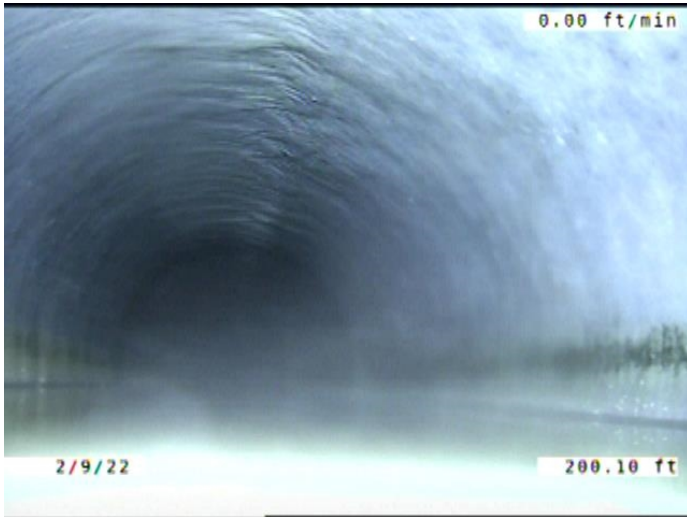
Code: **MWL**
 Description: **Miscellaneous Water Level**

Distance (ft): **200.1**
 Structural Grade: **0**
 O&M Grade: **0**
 Clock Start/From:
 Clock To:
 1st Value:
 2nd Value:
 Value Percent: **30.000**
 Continuous Index:
 Within 8" of Joint: **NO**
 Remarks:

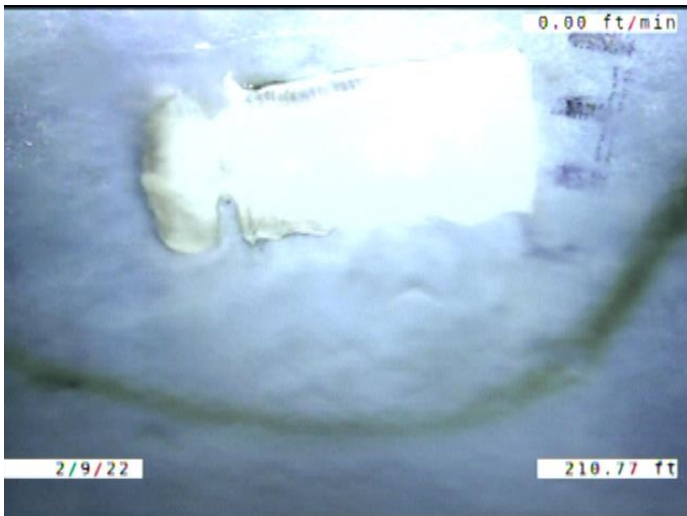
Code: **LFRS**
 Description: **Lining Feature Resin slug**

Distance (ft): **210.8**
 Structural Grade: **3**
 O&M Grade: **0**
 Clock Start/From: **10**
 Clock To:
 1st Value:
 2nd Value:
 Value Percent:
 Continuous Index:
 Within 8" of Joint: **NO**
 Remarks:

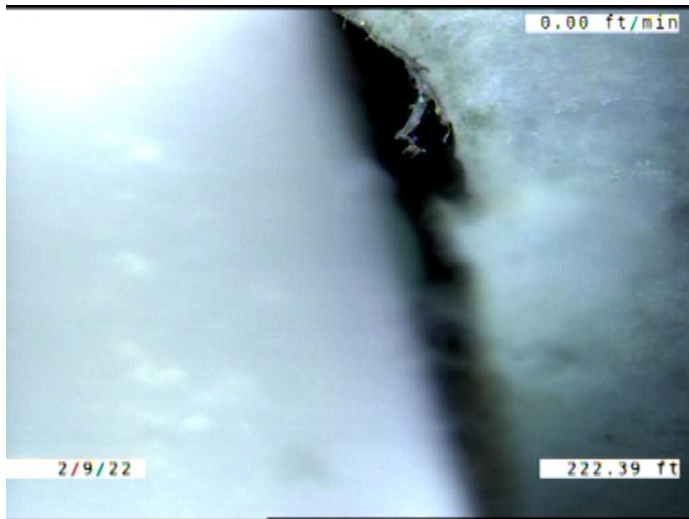
Code: **TB**
Description: **Tap Break-in/Hammer**

Distance (ft): **222.4**
Structural Grade: **0**
O&M Grade: **0**
Clock Start/From: **9**
Clock To:
1st Value: **4.000**
2nd Value:
Value Percent:
Continuous Index:
Within 8" of Joint: **NO**
Remarks:

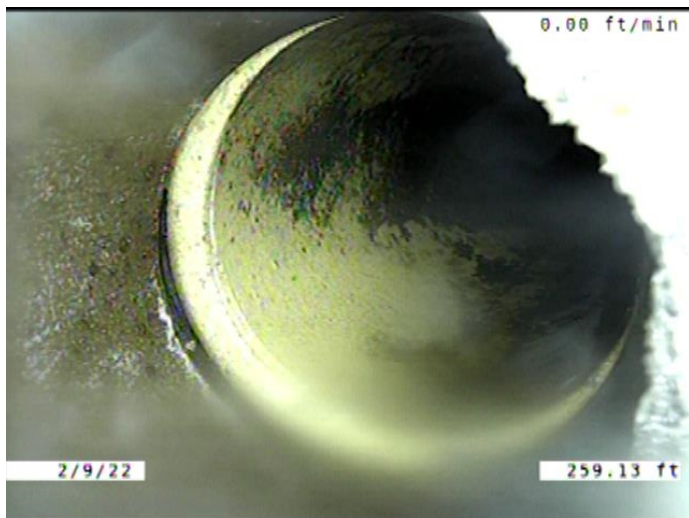
Code: **TB**
Description: **Tap Break-in/Hammer**

Distance (ft): **259.1**
Structural Grade: **0**
O&M Grade: **0**
Clock Start/From: **2**
Clock To:
1st Value: **4.000**
2nd Value:
Value Percent:
Continuous Index:
Within 8" of Joint: **NO**
Remarks:

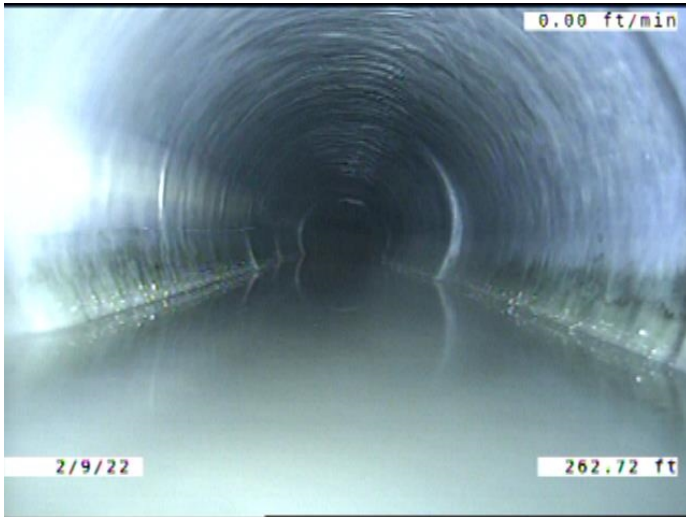
Code: **MWL**
 Description: **Miscellaneous Water Level**

Distance (ft): **262.7**
 Structural Grade: **0**
 O&M Grade: **0**
 Clock Start/From:
 Clock To:
 1st Value:
 2nd Value:
 Value Percent: **15.000**
 Continuous Index:
 Within 8" of Joint: **NO**
 Remarks:

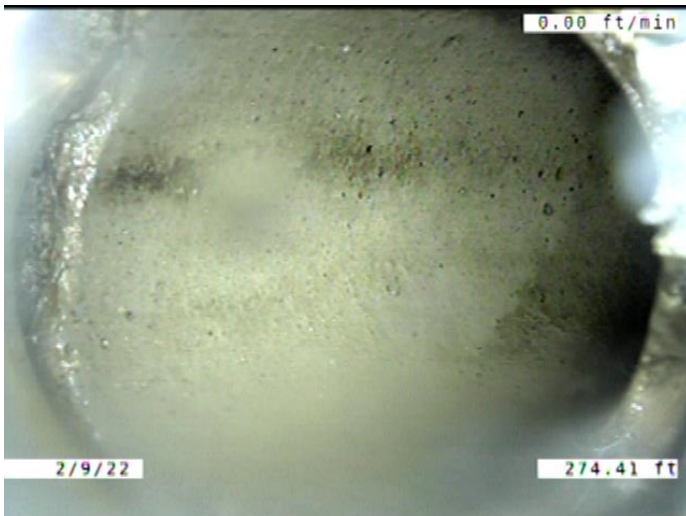
Code: **TB**
 Description: **Tap Break-in/Hammer**

Distance (ft): **274.4**
 Structural Grade: **0**
 O&M Grade: **0**
 Clock Start/From: **1**
 Clock To:
 1st Value: **4.000**
 2nd Value:
 Value Percent:
 Continuous Index:
 Within 8" of Joint: **NO**
 Remarks:

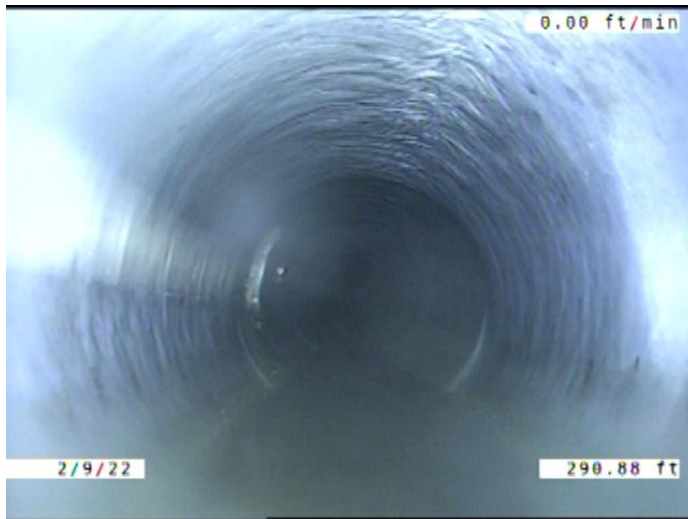
Code: **MWL**
Description: **Miscellaneous Water Level**

Distance (ft): **290.8**
Structural Grade: **0**
O&M Grade: **0**
Clock Start/From:
Clock To:
1st Value:
2nd Value:
Value Percent: **5.000**
Continuous Index:
Within 8" of Joint: **NO**
Remarks:

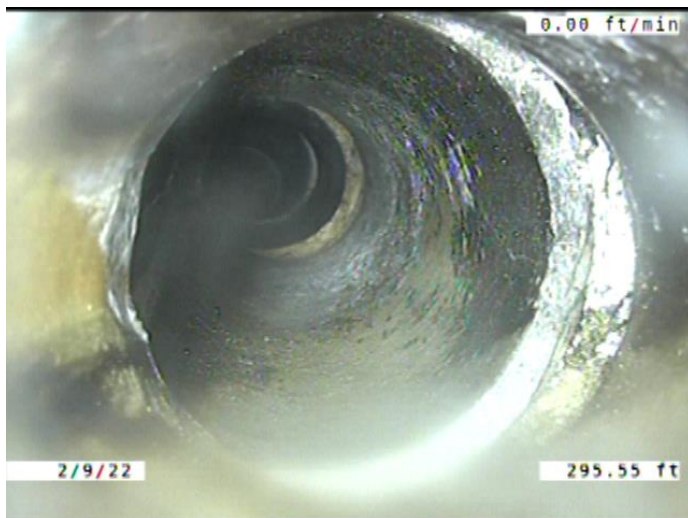
Code: **TB**
Description: **Tap Break-in/Hammer**

Distance (ft): **295.5**
Structural Grade: **0**
O&M Grade: **0**
Clock Start/From: **9**
Clock To:
1st Value: **4.000**
2nd Value:
Value Percent:
Continuous Index:
Within 8" of Joint: **YES**
Remarks: **SEVERAL OFFSET JOINTS**

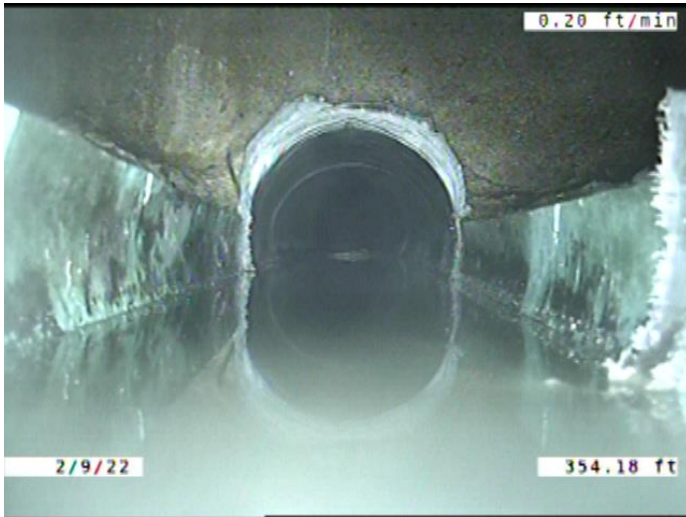
Code: **LFW**
 Description: **Lining Feature Wrinkled**

Distance (ft): **354.2**
 Structural Grade: **3**
 O&M Grade: **0**
 Clock Start/From: **11**
 Clock To: **1**
 1st Value:
 2nd Value:
 Value Percent:
 Continuous Index: **F01**
 Within 8" of Joint: **NO**
 Remarks:
