Profile/Photo Observation Report

| Street: | E 13TH ST | Flow Control: | Not Controlled |
| City: | Hobart, IN | Year Renewed: | |
| US MH: | M-707-078 | DS MH: | M-707-042 |

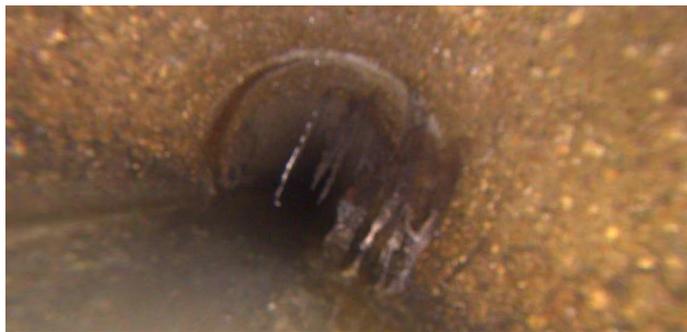
Code: **AMH**
Description: **Manhole**
Distance (ft): **.0**
Structural Grade: **0**
O&M Grade: **0**
Clock Start/From:
Clock To:
1st Value:
2nd Value:
Value Percent:
Continuous Index:
Within 8" of Joint: **NO**
Remarks: **M-707-078**

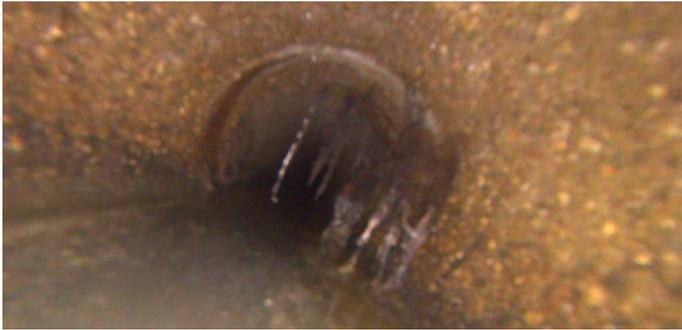
Code: **MWL**
Description: **Water Level**

Distance (ft): **.0**
Structural Grade: **0**
O&M Grade: **0**
Clock Start/From:
Clock To:
1st Value:
2nd Value:
Value Percent: **30.000**
Continuous Index:
Within 8" of Joint: **NO**
Remarks:

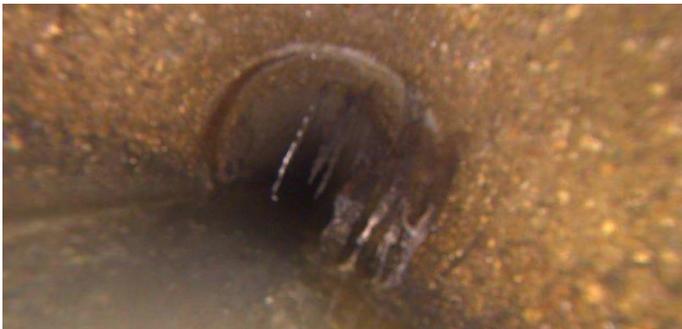
Code: **SAP**
Description: **Surface Aggregate Projecting**

Distance (ft): **.0**
Structural Grade: **3**
O&M Grade: **0**
Clock Start/From: **8**
Clock To: **4**
1st Value:
2nd Value:
Value Percent:
Continuous Index: **S01**
Within 8" of Joint:
Remarks:

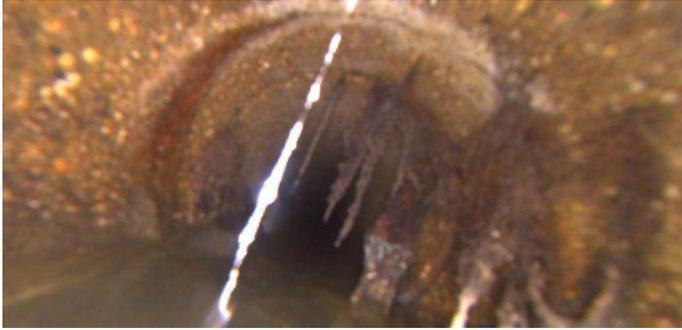
Code: **IW**
Description: **Infil Weeper**

Distance (ft): **.8**
Structural Grade: **0**
O&M Grade: **2**
Clock Start/From: **8**
Clock To: **11**
1st Value:
2nd Value:
Value Percent:
Continuous Index:
Within 8" of Joint: **YES**
Remarks:

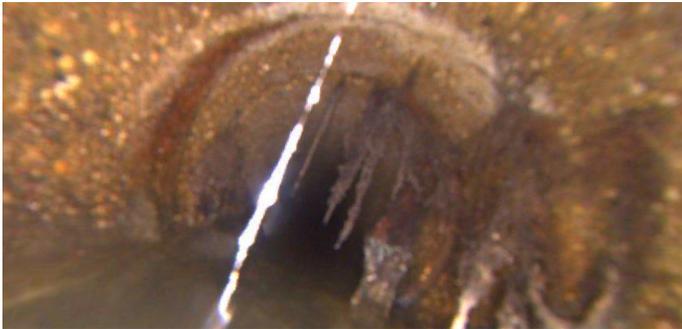
Code: **RMJ**
Description: **Roots Medium Joint**

Distance (ft): **.8**
Structural Grade: **0**
O&M Grade: **3**
Clock Start/From: **12**
Clock To: **4**
1st Value:
2nd Value:
Value Percent: **10.000**
Continuous Index:
Within 8" of Joint: **YES**
Remarks:

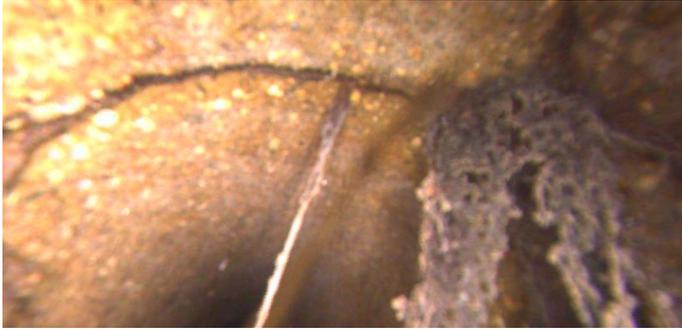
Code: **FC**
Description: **Fracture Circumferential**

Distance (ft): **2.3**
Structural Grade: **2**
O&M Grade: **0**
Clock Start/From: **8**
Clock To: **4**
1st Value:
2nd Value:
Value Percent:
Continuous Index:
Within 8" of Joint:
Remarks:

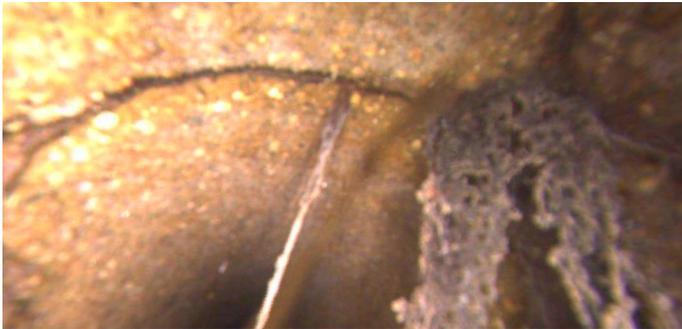
Code: **RFB**
Description: **Roots Fine Barrel**

Distance (ft): **2.3**
Structural Grade: **0**
O&M Grade: **2**
Clock Start/From: **12**
Clock To:
1st Value:
2nd Value:
Value Percent:
Continuous Index:
Within 8" of Joint: **NO**
Remarks:

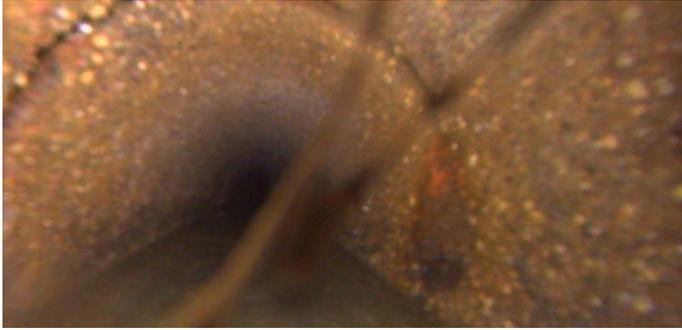
Code: **IS**
Description: **Infil Stain**

Distance (ft): **4.8**
Structural Grade: **0**
O&M Grade: **0**
Clock Start/From: **3**
Clock To: **4**
1st Value:
2nd Value:
Value Percent:
Continuous Index:
Within 8" of Joint: **YES**
Remarks:

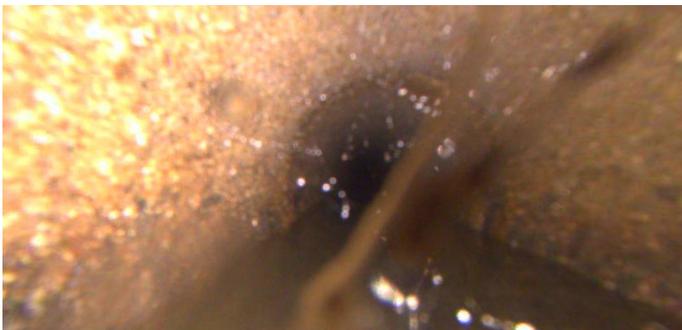
| Comment: | sinking in mud and silt at 8'. | | |

Code: **MSA**
Description: **Abandoned Survey**

Distance (ft): **10.0**
Structural Grade: **0**
O&M Grade: **0**
Clock Start/From:
Clock To:
1st Value:
2nd Value:
Value Percent:
Continuous Index:
Within 8" of Joint: **NO**
Remarks: **debris under water**

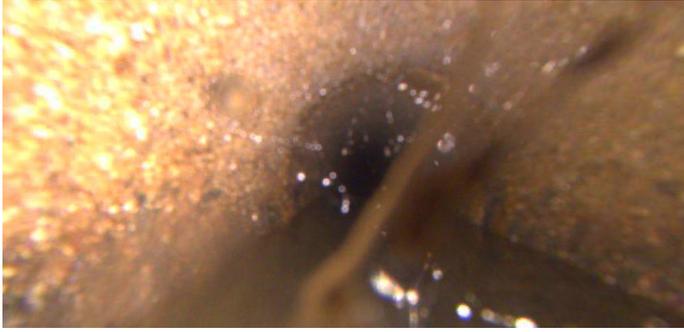
Code: **SAP**
Description: **Surface Aggregate Projecting**

Distance (ft): **10.0**
Structural Grade: **3**
O&M Grade: **0**
Clock Start/From: **8**
Clock To: **4**
1st Value:
2nd Value:
Value Percent:
Continuous Index: **F01**
Within 8" of Joint:
Remarks:
