Profile/Photo Observation Report

Date:	02/13/2022	Weather:		Coding:	PACP 7.0
Pipe Length (ft):	125.8	Owner:	City of Hobart	Pre Clean:	Heavy Cleaning
P.O.#:	YES502259	Surveyor:	S. Bucklin	PSR:	P-707-042-078
Customer:	City of Hobart	Clean Date:	02/09/2022	Shape:	C

Street:	East 13th Street	Flow Control:	Not Controlled
City:	Hobart, IN	Year Renewed:	
Location:	Local rural streets with light traffic, t	Tape/Media #:	
Purpose:	Routine Assessment	Dia/Height:	12"
Use:	Sanitary Sewage Pipe	Material:	CP
Drain Area:		Lining:	None
Category:	NA		
Comment:			
Location Details:		Direction of Survey:	Downstream
US MH:	M-707-078	DS MH:	M-707-042
		Total Length Surveyed (ft):	125.8

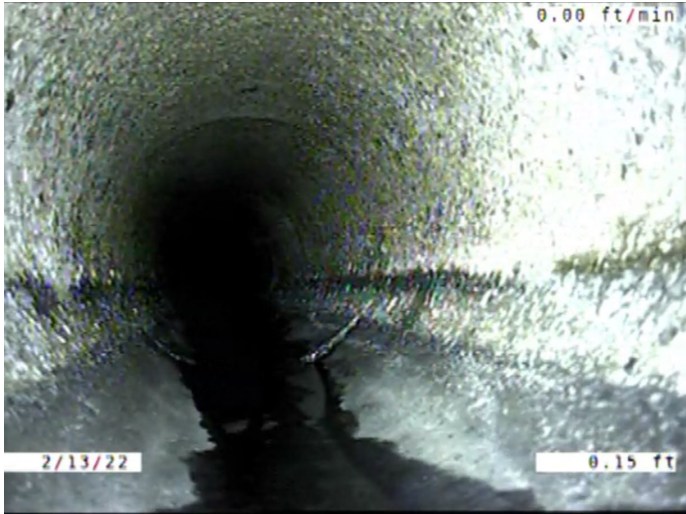
Code:	SAV
Description:	Surface Damage Aggregate Visible
Distance (ft):	.2
Structural Grade:	2
O&M Grade:	0
Clock Start/From:	7
Clock To:	5
1st Value:	
2nd Value:	
Value Percent:	
Continuous Index:	S03
Within 8" of Joint:	NO
Remarks:

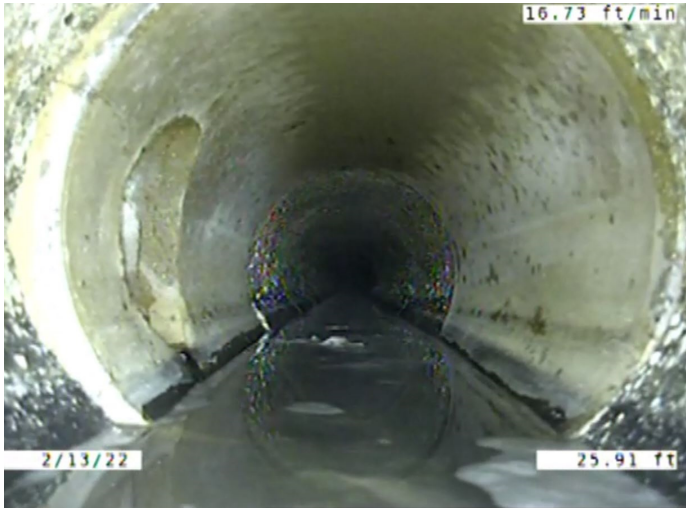
Code: **SAV**
Description: **Surface Damage Aggregate Visible**

Distance (ft): **25.9**
Structural Grade: **2**
O&M Grade: **0**
Clock Start/From: **7**
Clock To: **5**
1st Value:
2nd Value:
Value Percent:
Continuous Index: **F03**
Within 8" of Joint: **NO**
Remarks:

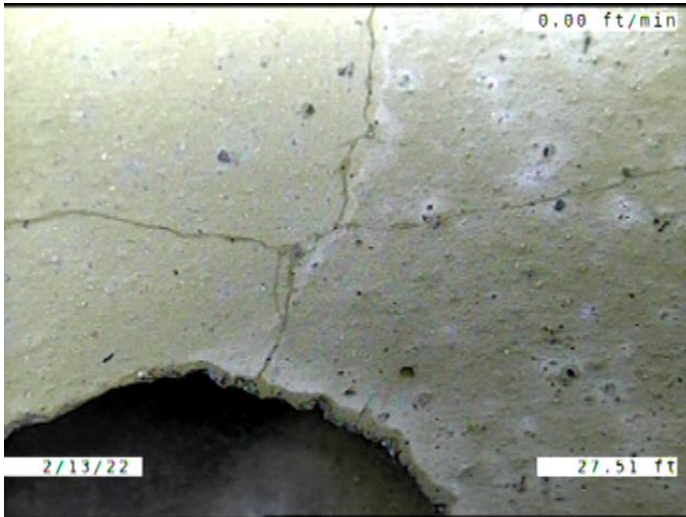
Code: **CM**
 Description: **Crack Multiple**

Distance (ft): **27.5**
 Structural Grade: **3**
 O&M Grade: **0**
 Clock Start/From: **8**
 Clock To: **12**
 1st Value:
 2nd Value:
 Value Percent:
 Continuous Index:
 Within 8" of Joint: **YES**
 Remarks:

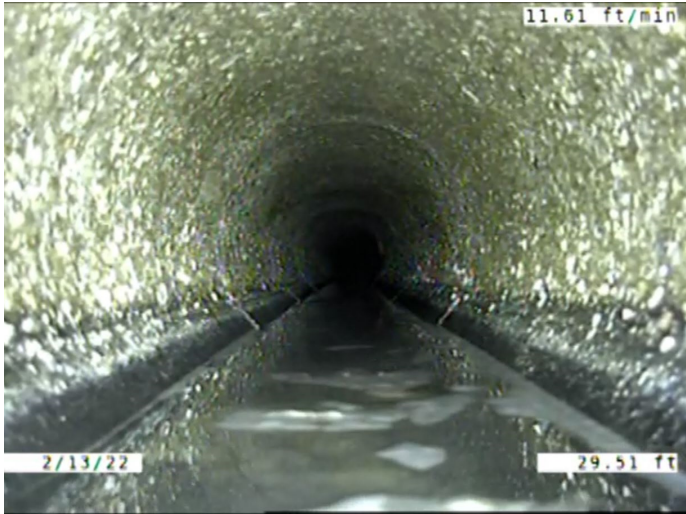
Code: **SAV**
Description: **Surface Damage Aggregate Visible**

Distance (ft): **29.5**
Structural Grade: **2**
O&M Grade: **0**
Clock Start/From: **8**
Clock To: **4**
1st Value:
2nd Value:
Value Percent:
Continuous Index: **S04**
Within 8" of Joint: **NO**
Remarks:

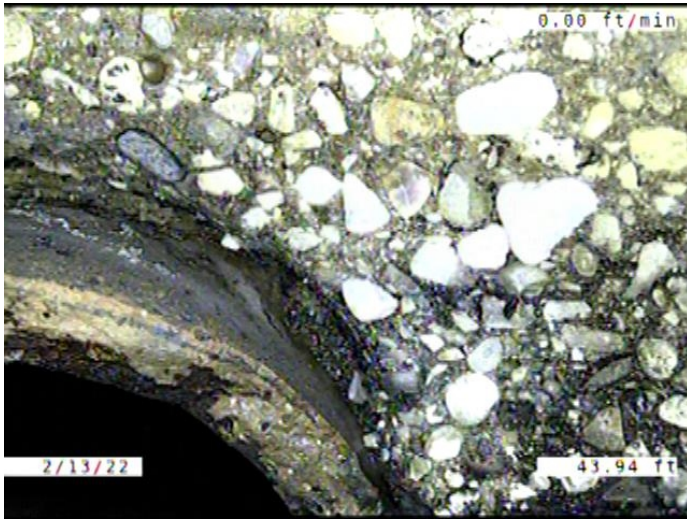
Code: **SSS**
 Description: **Surface Damage Surface Spalling**

Distance (ft): **43.9**
 Structural Grade: **2**
 O&M Grade: **0**
 Clock Start/From: **1**
 Clock To: **3**
 1st Value:
 2nd Value:
 Value Percent:
 Continuous Index:
 Within 8" of Joint: **YES**
 Remarks:

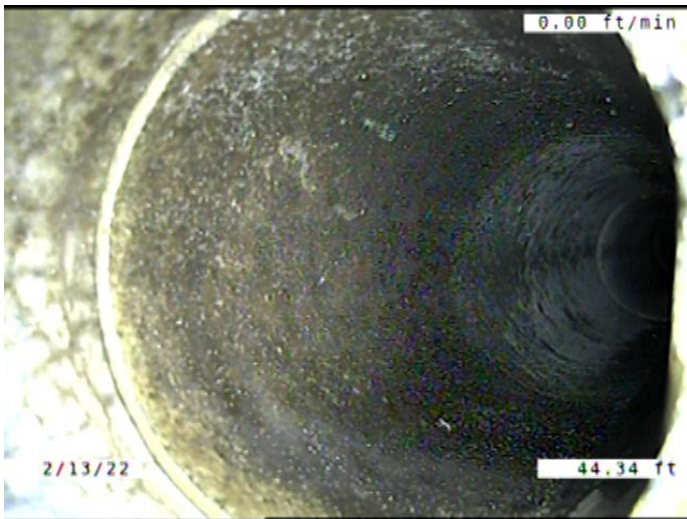
Code: **TBI**
 Description: **Tap Break-in Intruding**

Distance (ft): **44.3**
 Structural Grade: **0**
 O&M Grade: **2**
 Clock Start/From: **2**
 Clock To:
 1st Value: **6.000**
 2nd Value: **1.000**
 Value Percent:
 Continuous Index:
 Within 8" of Joint: **NO**
 Remarks:

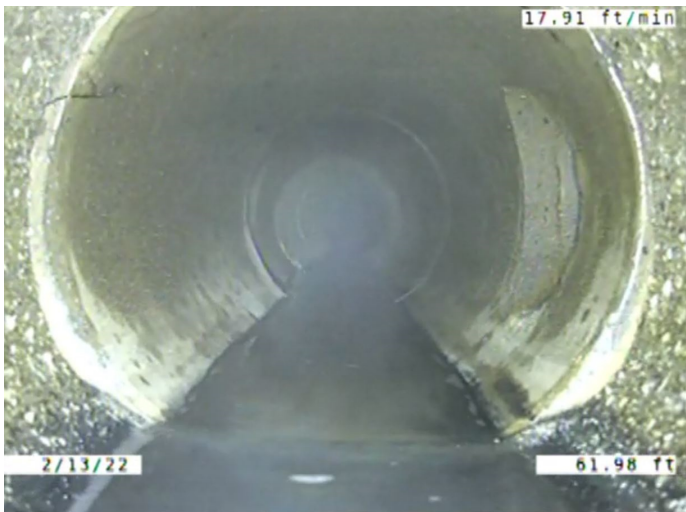
Code: **SAV**
 Description: **Surface Damage Aggregate Visible**

Distance (ft): **62.0**
 Structural Grade: **2**
 O&M Grade: **0**
 Clock Start/From: **8**
 Clock To: **4**
 1st Value:
 2nd Value:
 Value Percent:
 Continuous Index: **F04**
 Within 8" of Joint: **NO**
 Remarks:

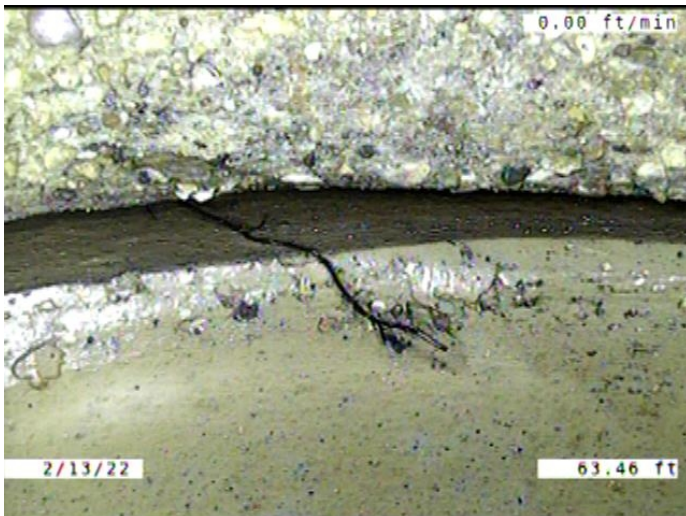
Code: **RFJ**
Description: **Roots Fine Joint**

Distance (ft): **63.5**
Structural Grade: **0**
O&M Grade: **1**
Clock Start/From: **10**
Clock To:
1st Value:
2nd Value:
Value Percent:
Continuous Index:
Within 8" of Joint: **YES**
Remarks:

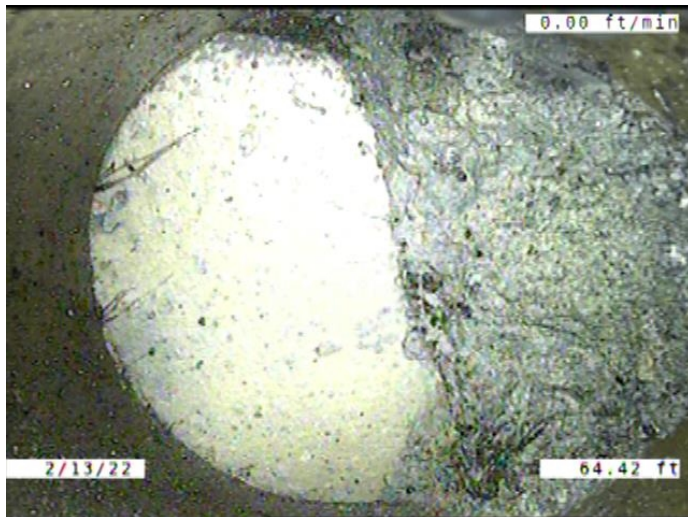
Code:	TFC
Description:	Tap Factory Capped
Distance (ft):	64.4
Structural Grade:	0
O&M Grade:	0
Clock Start/From:	3
Clock To:	
1st Value:	6.000
2nd Value:	
Value Percent:	
Continuous Index:	
Within 8" of Joint:	YES
Remarks:	ROOTS GROWING IN AROUND THE CAP

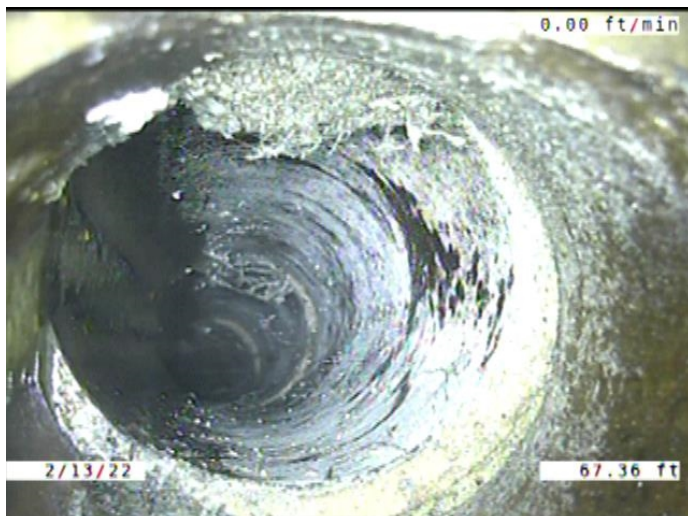
Code:	TF
Description:	Tap Factory
Distance (ft):	67.4
Structural Grade:	0
O&M Grade:	0
Clock Start/From:	9
Clock To:	
1st Value:	6.000
2nd Value:	
Value Percent:	
Continuous Index:	
Within 8" of Joint:	YES
Remarks:	CONSTANTLY RUNNING WATER. ROOTS GROWING IN THE JOINTS OF

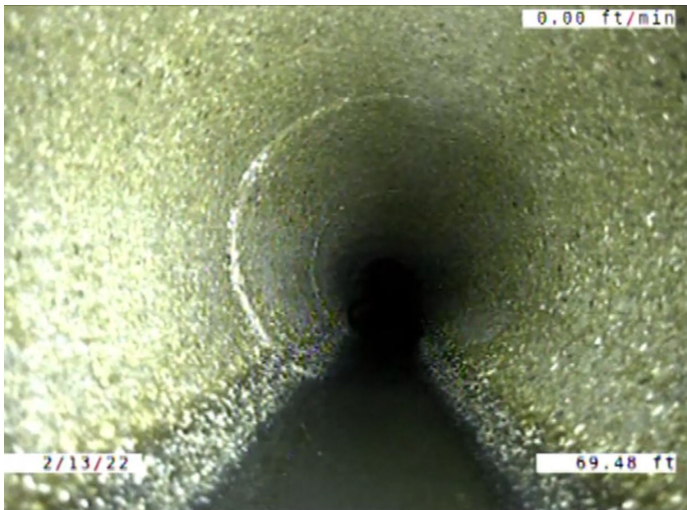
Code:	SAV
Description:	Surface Damage Aggregate Visible
Distance (ft):	69.5
Structural Grade:	2
O&M Grade:	0
Clock Start/From:	7
Clock To:	5
1st Value:	
2nd Value:	
Value Percent:	
Continuous Index:	S05
Within 8" of Joint:	NO
Remarks:

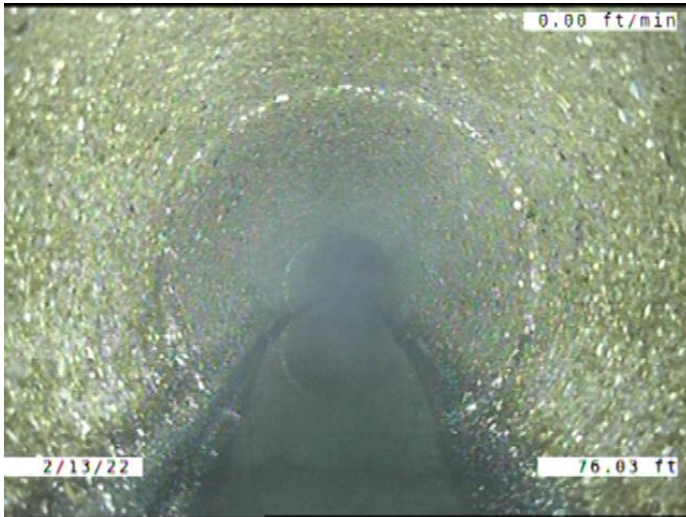
Code: **MWLS**
Description: **Miscellaneous Water Level Sag**

Distance (ft): **76.0**
Structural Grade: **2**
O&M Grade: **0**
Clock Start/From:
Clock To:
1st Value:
2nd Value:
Value Percent: **15.000**
Continuous Index: **S01**
Within 8" of Joint: **NO**
Remarks:

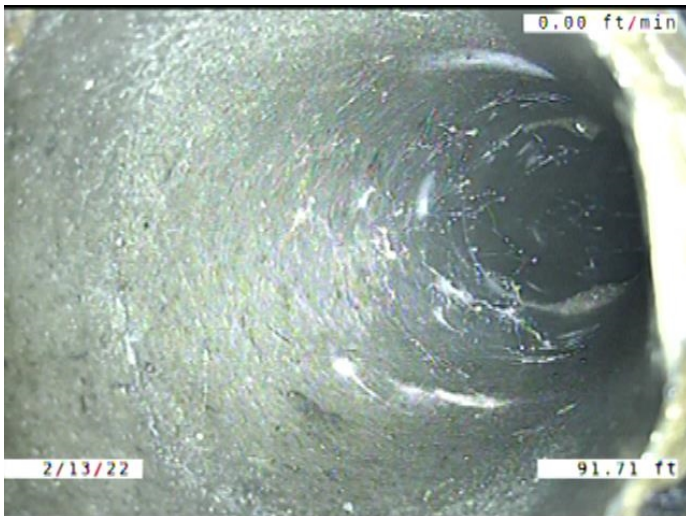
Code: **TBI**
Description: **Tap Break-in Intruding**

Distance (ft): **91.7**
Structural Grade: **0**
O&M Grade: **2**
Clock Start/From: **2**
Clock To:
1st Value: **6.000**
2nd Value: **1.000**
Value Percent:
Continuous Index:
Within 8" of Joint: **NO**
Remarks:

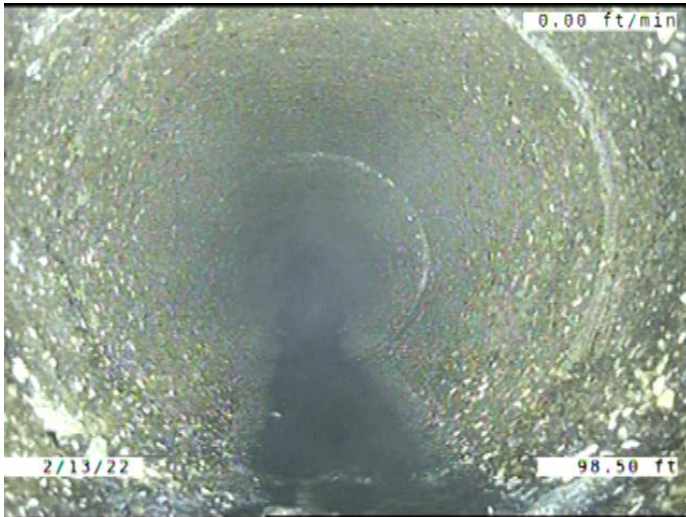
Code: **MWLS**
 Description: **Miscellaneous Water Level Sag**

Distance (ft): **98.5**
 Structural Grade: **2**
 O&M Grade: **0**
 Clock Start/From:
 Clock To:
 1st Value:
 2nd Value:
 Value Percent: **15.000**
 Continuous Index: **F01**
 Within 8" of Joint: **NO**
 Remarks:

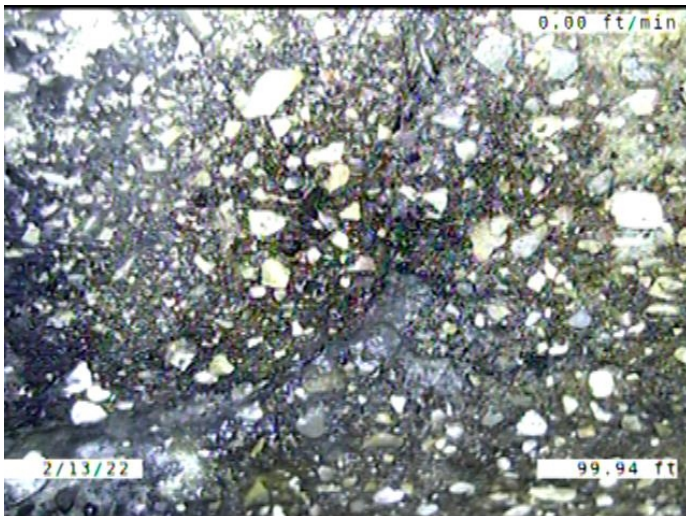
Code: **B**
 Description: **Broken**

Distance (ft): **99.9**
 Structural Grade: **4**
 O&M Grade: **0**
 Clock Start/From: **12**
 Clock To: **12**
 1st Value:
 2nd Value:
 Value Percent:
 Continuous Index:
 Within 8" of Joint: **YES**
 Remarks:

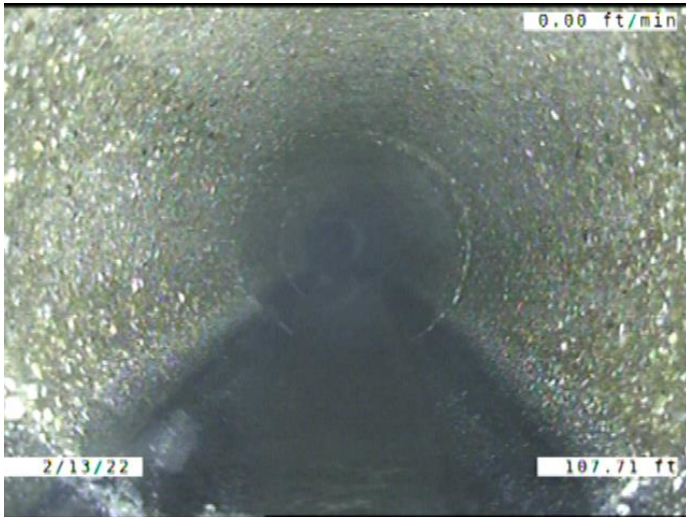
Code: **MWLS**
Description: **Miscellaneous Water Level Sag**

Distance (ft): **107.7**
Structural Grade: **2**
O&M Grade: **0**
Clock Start/From:
Clock To:
1st Value:
2nd Value:
Value Percent: **10.000**
Continuous Index: **S02**
Within 8" of Joint: **NO**
Remarks:

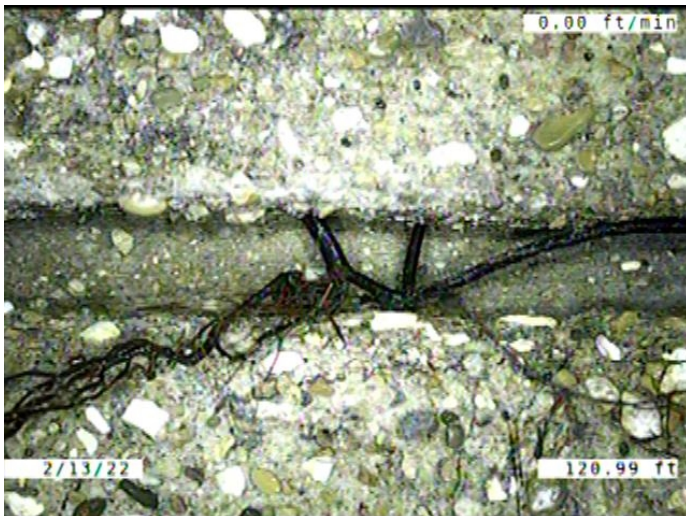
Code: **RFJ**
Description: **Roots Fine Joint**

Distance (ft): **121.0**
Structural Grade: **0**
O&M Grade: **1**
Clock Start/From: **11**
Clock To:
1st Value:
2nd Value:
Value Percent:
Continuous Index:
Within 8" of Joint: **YES**
Remarks:

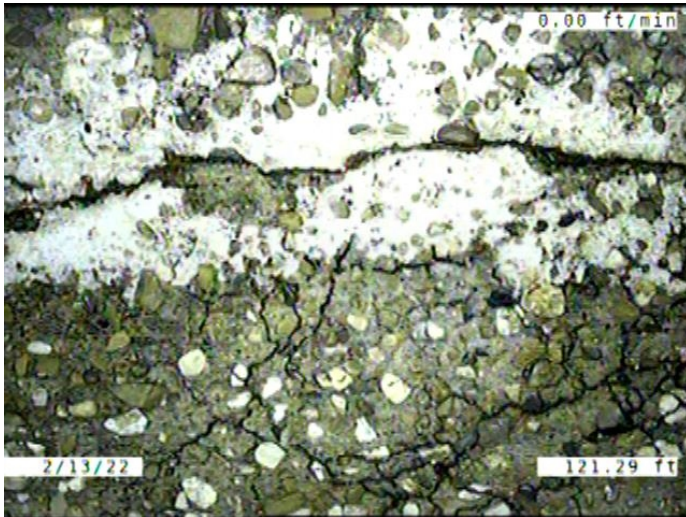
Code: **FM**
 Description: **Fracture Multiple**

Distance (ft): **121.3**
 Structural Grade: **4**
 O&M Grade: **0**
 Clock Start/From: **12**
 Clock To: **12**
 1st Value:
 2nd Value:
 Value Percent:
 Continuous Index:
 Within 8" of Joint: **YES**
 Remarks:

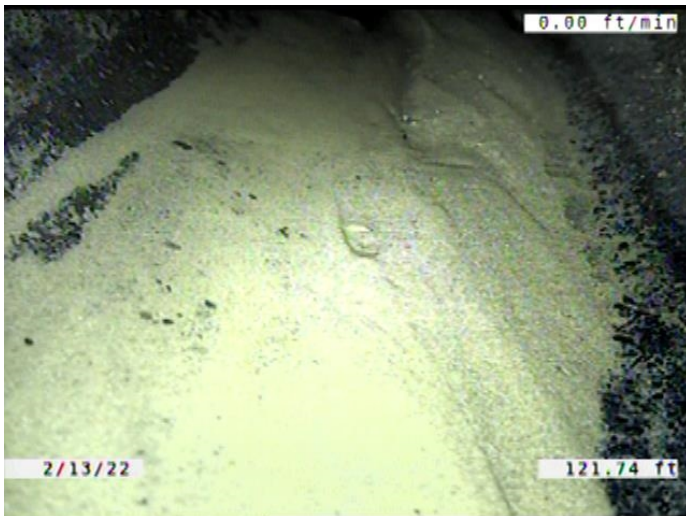
Code: **DSF**
 Description: **Deposits Settled Fine**

Distance (ft): **121.7**
 Structural Grade: **0**
 O&M Grade: **2**
 Clock Start/From: **5**
 Clock To: **7**
 1st Value:
 2nd Value:
 Value Percent: **5.000**
 Continuous Index:
 Within 8" of Joint: **YES**
 Remarks:

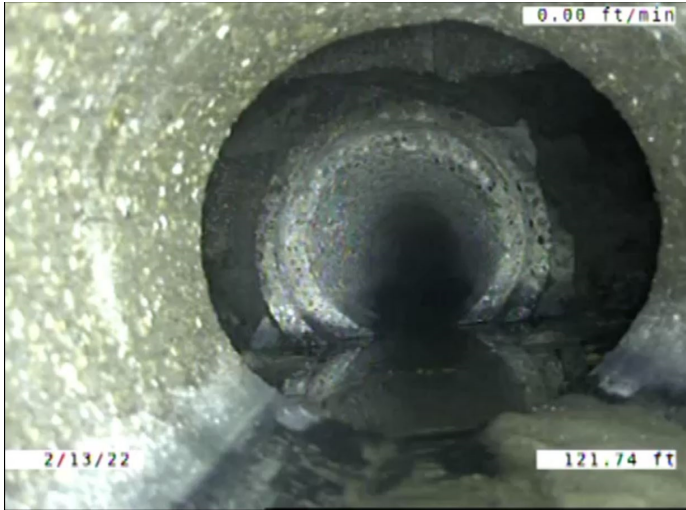
Code: **SAV**
Description: **Surface Damage Aggregate Visible**

Distance (ft): **121.7**
Structural Grade: **2**
O&M Grade: **0**
Clock Start/From: **7**
Clock To: **5**
1st Value:
2nd Value:
Value Percent:
Continuous Index: **F05**
Within 8" of Joint: **NO**
Remarks:

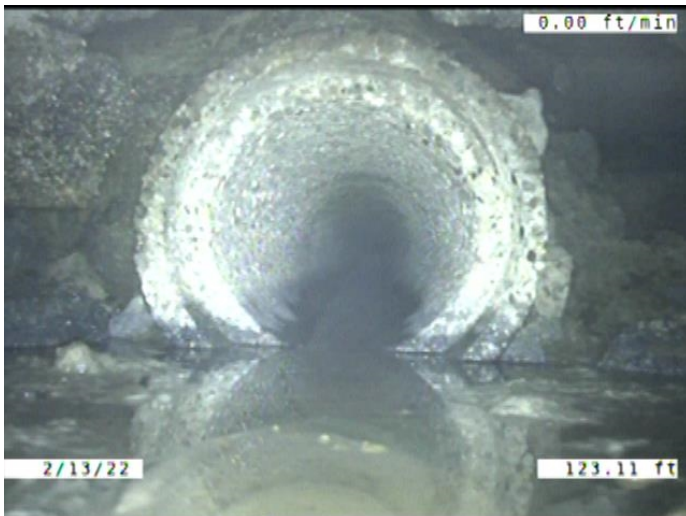
Code: **MWLS**
Description: **Miscellaneous Water Level Sag**

Distance (ft): **123.1**
Structural Grade: **2**
O&M Grade: **0**
Clock Start/From:
Clock To:
1st Value:
2nd Value:
Value Percent: **10.000**
Continuous Index: **F02**
Within 8" of Joint: **NO**
Remarks:
