Profile/Photo Observation Report

Street:	STATE ST & E 13TH ST	Flow Control:	Not Controlled
City:	Hobart, IN	Year Renewed:	
Location:	Light Highway	Tape/Media #:	
Purpose:	Maintenance Related	Dia/Height:	12"
Use:	Sanitary	Material:	PVC
Drain Area:	NA	Lining:	Cured in Place
Category:	NA		
Comment:	heavy silt at 58'-flow incorrect.

Location Details:		Direction of Survey:	Upstream
US MH:	M-707-079	DS MH:	M-707-036
		Total Length Surveyed (ft):	59.2

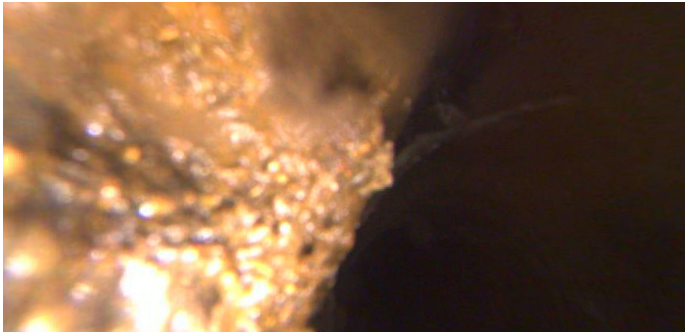
Code:	MWL
Description:	Water Level

Distance (ft):	.0
Structural Grade:	0
O&M Grade:	0
Clock Start/From:	
Clock To:	
1st Value:	
2nd Value:	
Value Percent:	10.000
Continuous Index:	
Within 8" of Joint:	NO
Remarks:

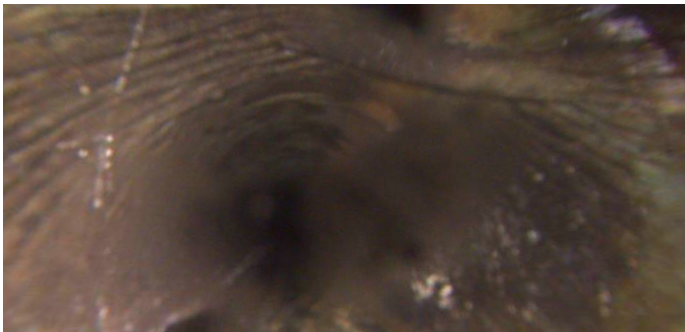
Code:	LFW
Description:	Lining Failure Wrinkled

Distance (ft):	1.5
Structural Grade:	3
O&M Grade:	0
Clock Start/From:	10
Clock To:	2
1st Value:	
2nd Value:	
Value Percent:	
Continuous Index:	
Within 8" of Joint:	NO
Remarks:

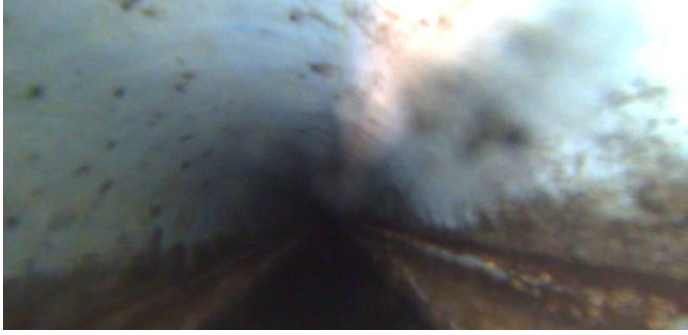
Code:	MSA
Description:	Abandoned Survey
Distance (ft):	59.2
Structural Grade:	0
O&M Grade:	0
Clock Start/From:	
Clock To:	
1st Value:	
2nd Value:	
Value Percent:	
Continuous Index:	
Within 8" of Joint:	NO
Remarks:	debris
