Profile/Photo Observation Report

Date:	04/11/2018	Weather:		Coding:	PACP 6.0
Pipe Length (ft):	247.5	Owner:	NA	Pre Clean:	Not Known
P.O.#:		Surveyor:	Jen Costello	PSR:	P-707-036-079
Customer:		Clean Date:	01/01/1900	Shape:	C

Street:	Capitol	Flow Control:	Not Controlled
City:	Hobart, IN	Year Renewed:	
Location:	Light Highway	Tape/Media #:	
Purpose:	Maintenance Related	Dia/Height:	12"
Use:	Sanitary	Material:	PVC
Drain Area:	NA	Lining:	Cured in Place
Category:	NA		
Comment:	heavy silt at 58'-flow incorrect.		
Location Details:		Direction of Survey:	Upstream
US MH:	M-707-079	DS MH:	M-707-036
		Total Length Surveyed (ft):	59.2

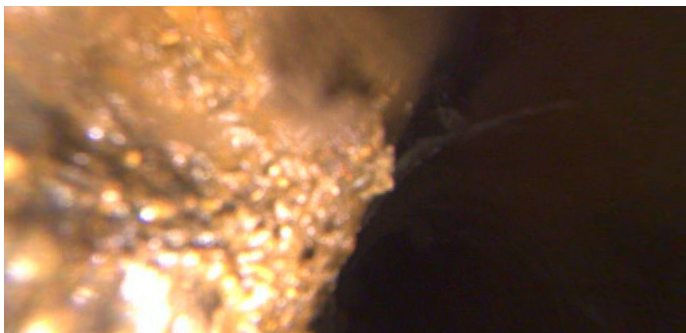
Code: **AMH**
Description: **Manhole**

Distance (ft): **.0**
Structural Grade: **0**
O&M Grade: **0**
Clock Start/From:
Clock To:
1st Value:
2nd Value:
Value Percent:
Continuous Index:
Within 8" of Joint: **NO**
Remarks: **M-707-036**

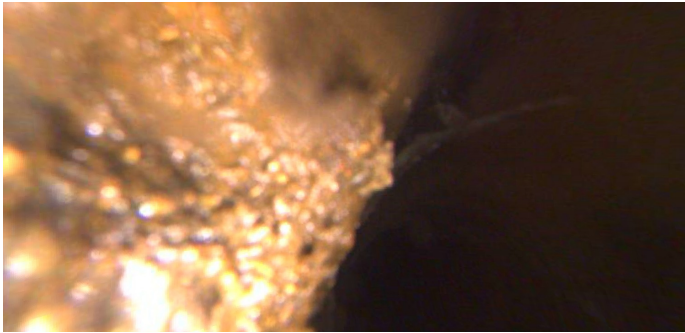
Code:	MWL
Description:	Water Level

Distance (ft):	.0
Structural Grade:	0
O&M Grade:	0
Clock Start/From:	
Clock To:	
1st Value:	
2nd Value:	
Value Percent:	10.000
Continuous Index:	
Within 8" of Joint:	NO
Remarks:

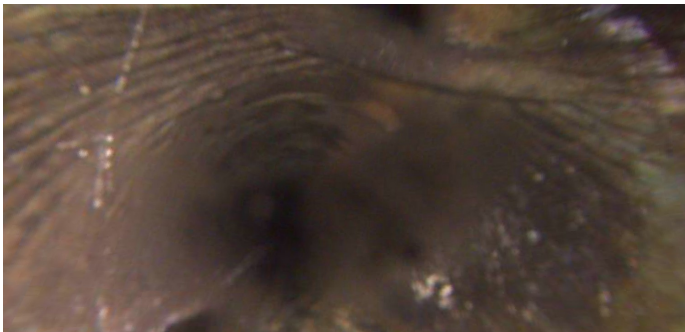
Code:	LFW
Description:	Lining Failure Wrinkled

Distance (ft):	1.5
Structural Grade:	3
O&M Grade:	0
Clock Start/From:	10
Clock To:	2
1st Value:	
2nd Value:	
Value Percent:	
Continuous Index:	
Within 8" of Joint:	NO
Remarks:

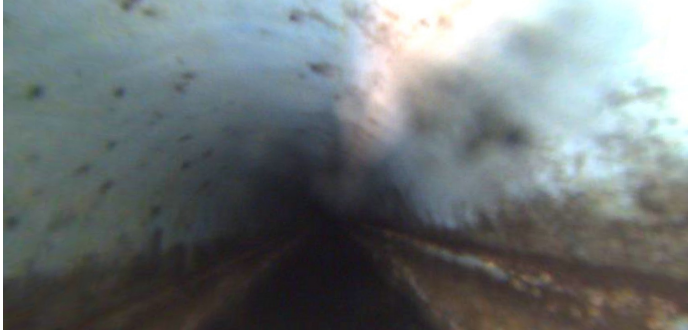
Code:	MSA
Description:	Abandoned Survey
Distance (ft):	59.2
Structural Grade:	0
O&M Grade:	0
Clock Start/From:	
Clock To:	
1st Value:	
2nd Value:	
Value Percent:	
Continuous Index:	
Within 8" of Joint:	NO
Remarks:	debris
