Profile/Photo Observation Report

Street:	STATE ST & E 13TH ST	Flow Control:	Not Controlled
City:	Hobart, IN	Year Renewed:	
Location:	Light Highway	Tape/Media #:	
Purpose:	Maintenance Related	Dia/Height:	12"
Use:	Sanitary	Material:	PVC
Drain Area:	NA	Lining:	Cured in Place
Category:	NA		
Comment:	Reverse setup. heavy silt at 5'. -flow incorrect.		
Location Details:		Direction of Survey:	Downstream
US MH:	M-707-079	DS MH:	M-707-036
		Total Length Surveyed (ft):	6.6

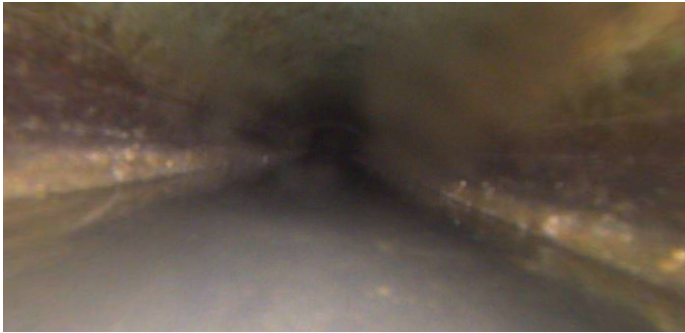
Code:	MWL
Description:	Water Level

Distance (ft):	.0
Structural Grade:	0
O&M Grade:	0
Clock Start/From:	
Clock To:	
1st Value:	
2nd Value:	
Value Percent:	40.000
Continuous Index:	
Within 8" of Joint:	NO
Remarks:

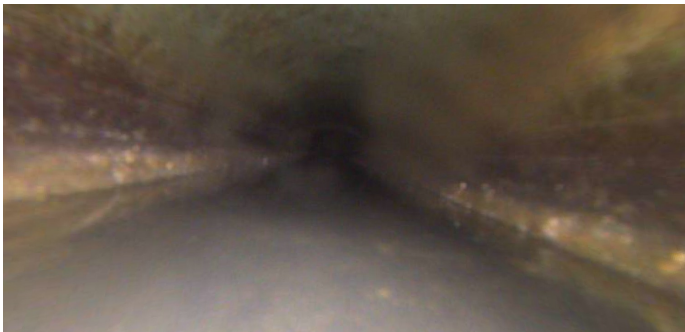
Code:	DAGS
Description:	Deposits Attached Grease

Distance (ft):	.0
Structural Grade:	0
O&M Grade:	2
Clock Start/From:	8
Clock To:	4
1st Value:	
2nd Value:	
Value Percent:	5.000
Continuous Index:	S01
Within 8" of Joint:	NO
Remarks:

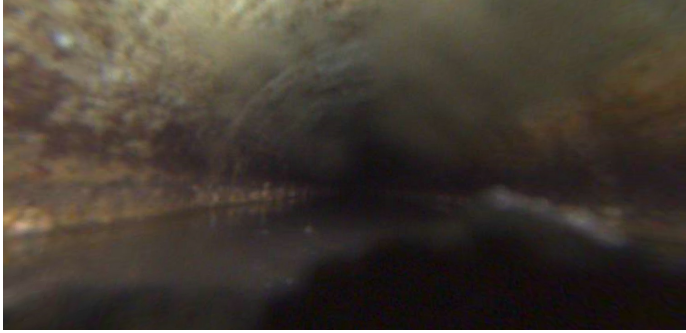
Code: **DAGS**
Description: **Deposits Attached Grease**

Distance (ft): **6.6**
Structural Grade: **0**
O&M Grade: **2**
Clock Start/From: **8**
Clock To: **4**
1st Value:
2nd Value:
Value Percent: **5.000**
Continuous Index: **F01**
Within 8" of Joint: **NO**
Remarks:

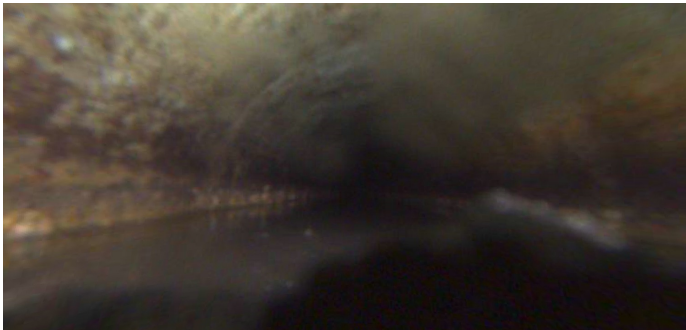
Code: **MSA**
Description: **Abandoned Survey**

Distance (ft): **6.6**
Structural Grade: **0**
O&M Grade: **0**
Clock Start/From:
Clock To:
1st Value:
2nd Value:
Value Percent:
Continuous Index:
Within 8" of Joint: **NO**
Remarks: **DEBRIS UNDER WATER**
