Profile/Photo Observation Report

Date:	04/11/2018	Weather:		Coding:	PACP 6.0
Pipe Length (ft):	247.5	Owner:	NA	Pre Clean:	Not Known
P.O.#:		Surveyor:	Jen Costello	PSR:	P-707-036-079
Customer:		Clean Date:	01/01/1900	Shape:	C

Street:	Capitol	Flow Control:	Not Controlled
City:	Hobart, IN	Year Renewed:	
Location:	Light Highway	Tape/Media #:	
Purpose:	Maintenance Related	Dia/Height:	12"
Use:	Sanitary	Material:	PVC
Drain Area:	NA	Lining:	Cured in Place
Category:	NA		
Comment:	Reverse setup. heavy silt at 5'. -flow incorrect.		
Location Details:		Direction of Survey:	Downstream
US MH:	M-707-079	DS MH:	M-707-036
		Total Length Surveyed (ft):	6.6

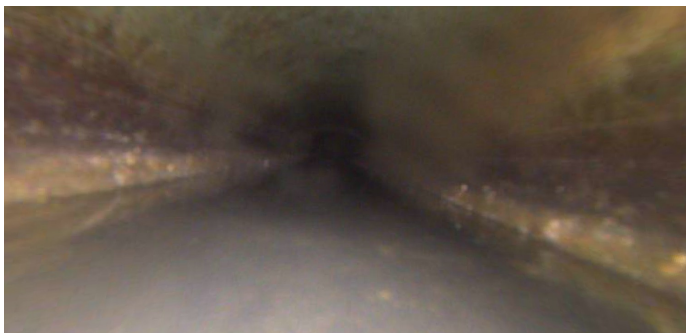
Code: **AMH**
Description: **Manhole**

Distance (ft): **.0**
Structural Grade: **0**
O&M Grade: **0**
Clock Start/From:
Clock To:
1st Value:
2nd Value:
Value Percent:
Continuous Index:
Within 8" of Joint: **NO**
Remarks: **M-707-079**

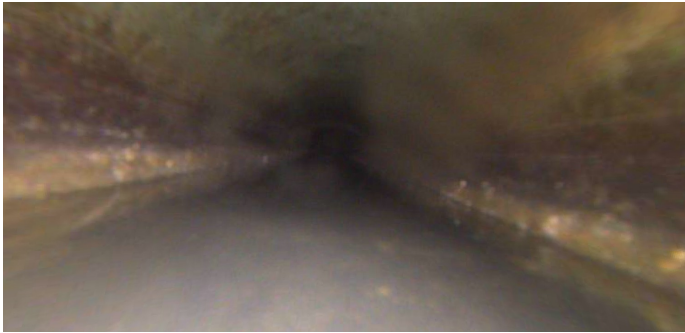
Code:	MWL
Description:	Water Level

Distance (ft):	.0
Structural Grade:	0
O&M Grade:	0
Clock Start/From:	
Clock To:	
1st Value:	
2nd Value:	
Value Percent:	40.000
Continuous Index:	
Within 8" of Joint:	NO
Remarks:

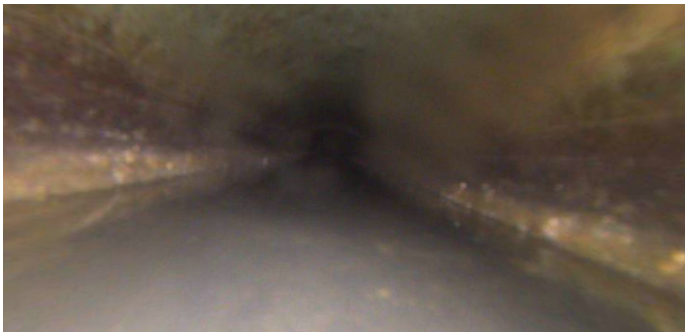
Code:	DAGS
Description:	Deposits Attached Grease

Distance (ft):	.0
Structural Grade:	0
O&M Grade:	2
Clock Start/From:	8
Clock To:	4
1st Value:	
2nd Value:	
Value Percent:	5.000
Continuous Index:	S01
Within 8" of Joint:	NO
Remarks:

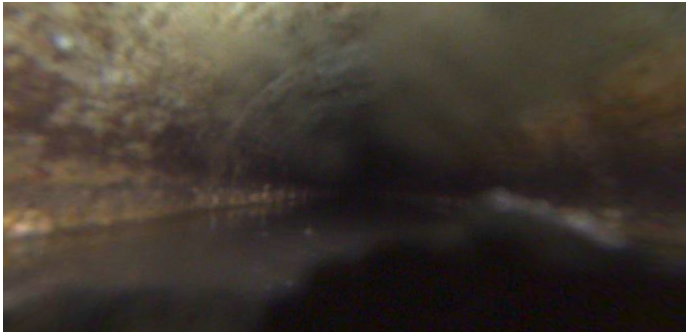
Code: **DAGS**
Description: **Deposits Attached Grease**

Distance (ft): **6.6**
Structural Grade: **0**
O&M Grade: **2**
Clock Start/From: **8**
Clock To: **4**
1st Value:
2nd Value:
Value Percent: **5.000**
Continuous Index: **F01**
Within 8" of Joint: **NO**
Remarks:

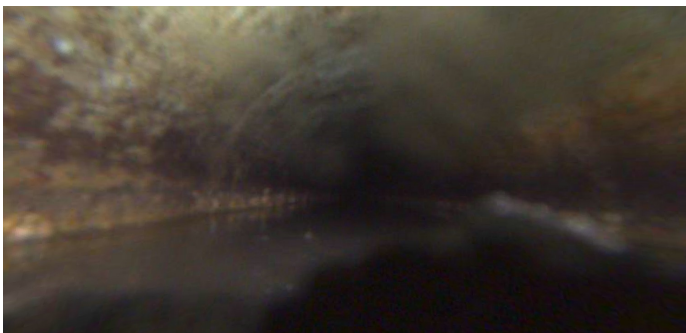
Code: **MSA**
Description: **Abandoned Survey**

Distance (ft): **6.6**
Structural Grade: **0**
O&M Grade: **0**
Clock Start/From:
Clock To:
1st Value:
2nd Value:
Value Percent:
Continuous Index:
Within 8" of Joint: **NO**
Remarks: **DEBRIS UNDER WATER**
