## Profile/Photo Observation Report

Date:	<b>02/12/2022</b>	Weather:		Coding:	<b>PACP 7.0</b>
Pipe Length (ft):	<b>247.1</b>	Owner:	<b>City of Hobart</b>	Pre Clean:	<b>Heavy Cleaning</b>
P.O.#:	<b>YES502259</b>	Surveyor:	<b>S. Bucklin</b>	PSR:	<b>P-707-036-079</b>
Customer:	<b>City of Hobart</b>	Clean Date:	<b>02/10/2022</b>	Shape:	<b>C</b>

Street:	<b>South State Street</b>	Flow Control:	<b>Not Controlled</b>
City:	<b>Hobart, IN</b>	Year Renewed:	
Location:	<b>Local rural streets with light traffic, t</b>	Tape/Media #:	
Purpose:	<b>Routine Assessment</b>	Dia/Height:	<b>12"</b>
Use:	<b>Sanitary Sewage Pipe</b>	Material:	<b>VCP</b>
Drain Area:		Lining:	<b>Not Known</b>
Category:	<b>NA</b>		
Comment:			
Location Details:		Direction of Survey:	<b>Downstream</b>
US MH:	<b>M-707-079</b>	DS MH:	<b>M-707-036</b>
		Total Length Surveyed (ft):	<b>247.1</b>

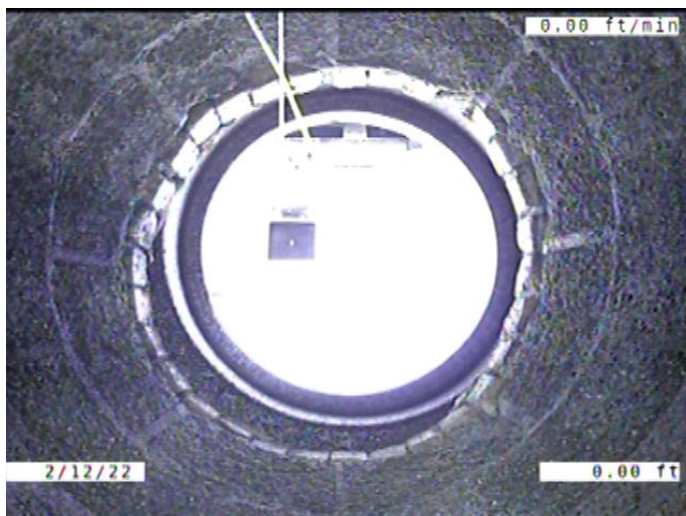
Code: **AMH**  
Description: **Manhole**

Distance (ft): **.0**  
Structural Grade: **0**  
O&M Grade: **0**  
Clock Start/From:  
Clock To:  
1st Value:  
2nd Value:  
Value Percent:  
Continuous Index:  
Within 8" of Joint: **NO**  
Remarks: **M-707-079**

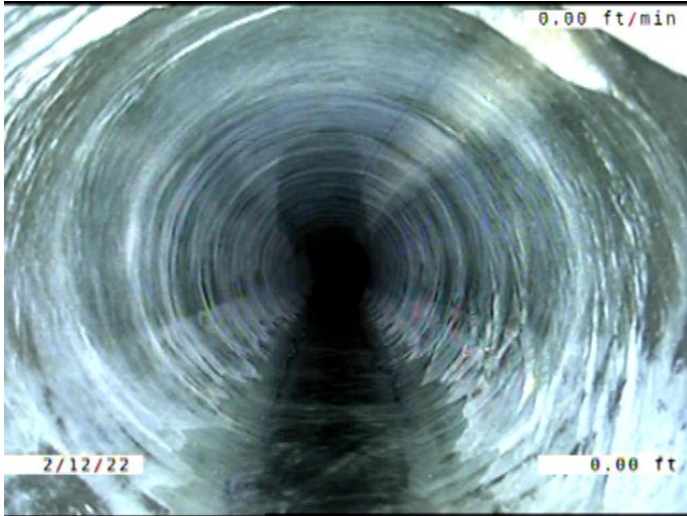
Code:	<b>MWL</b>
Description:	<b>Miscellaneous Water Level</b>
Distance (ft):	<b>.0</b>
Structural Grade:	<b>0</b>
O&M Grade:	<b>0</b>
Clock Start/From:	
Clock To:	
1st Value:	
2nd Value:	
Value Percent:	<b>5.000</b>
Continuous Index:	
Within 8" of Joint:	<b>NO</b>
Remarks:

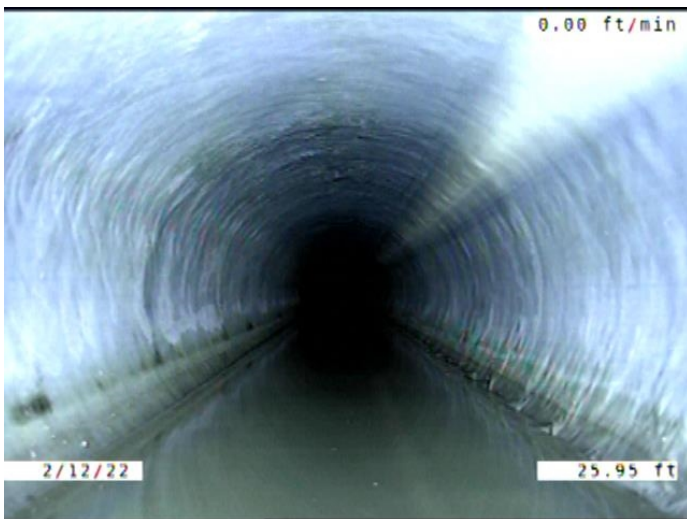
Code:	<b>MWL</b>
Description:	<b>Miscellaneous Water Level</b>
Distance (ft):	<b>25.9</b>
Structural Grade:	<b>0</b>
O&M Grade:	<b>0</b>
Clock Start/From:	
Clock To:	
1st Value:	
2nd Value:	
Value Percent:	<b>15.000</b>
Continuous Index:	
Within 8" of Joint:	<b>NO</b>
Remarks:

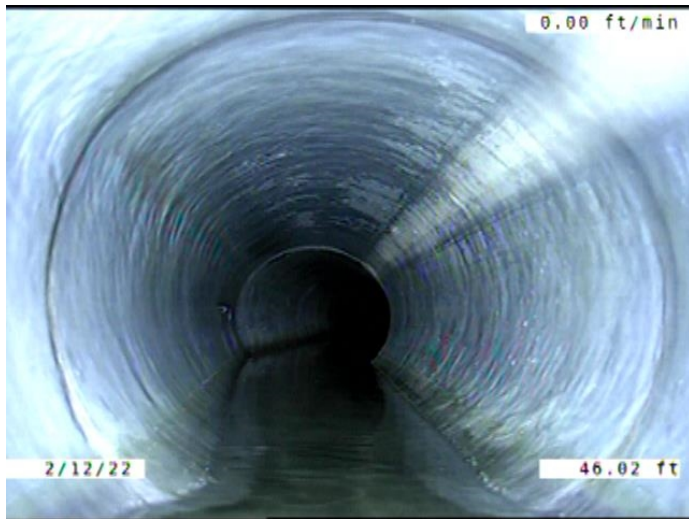
Code: **LL**  
Description: **Line Left**

Distance (ft): **46.0**  
Structural Grade: **0**  
O&M Grade: **1**  
Clock Start/From:  
Clock To:  
1st Value:  
2nd Value:  
Value Percent: **10.000**  
Continuous Index:  
Within 8" of Joint: **NO**  
Remarks:

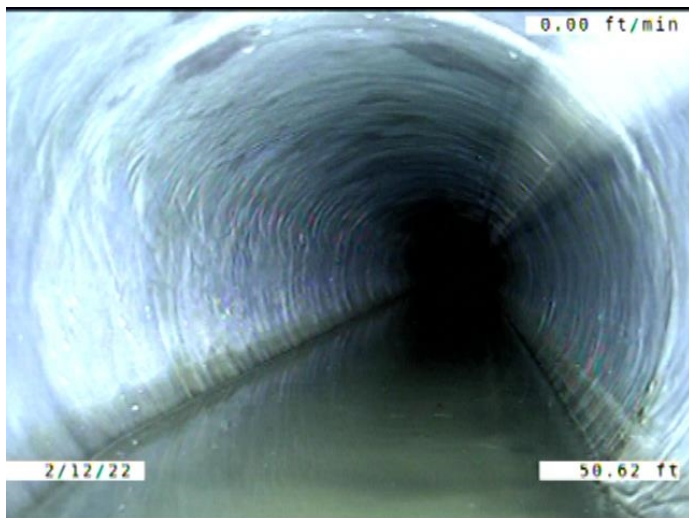
Code: **LR**  
Description: **Line Right**

Distance (ft): **50.6**  
Structural Grade: **0**  
O&M Grade: **1**  
Clock Start/From:  
Clock To:  
1st Value:  
2nd Value:  
Value Percent: **10.000**  
Continuous Index:  
Within 8" of Joint: **NO**  
Remarks:

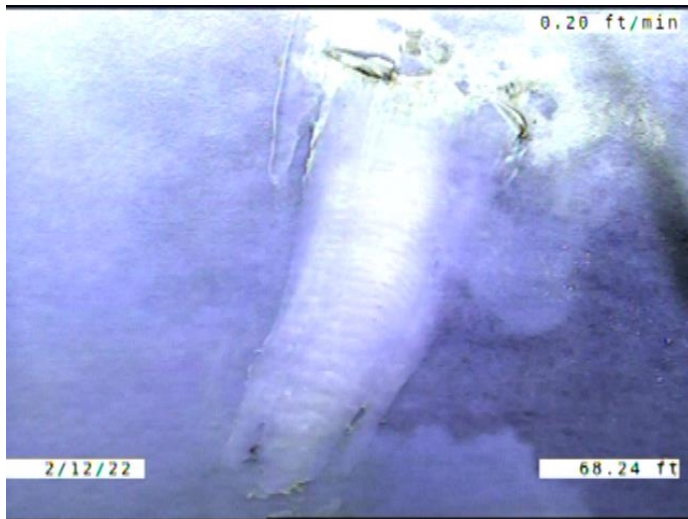
Code: **LFRS**  
Description: **Lining Feature Resin slug**

Distance (ft): **68.2**  
Structural Grade: **3**  
O&M Grade: **0**  
Clock Start/From: **12**  
Clock To: **1**  
1st Value:  
2nd Value:  
Value Percent:  
Continuous Index:  
Within 8" of Joint: **NO**  
Remarks:

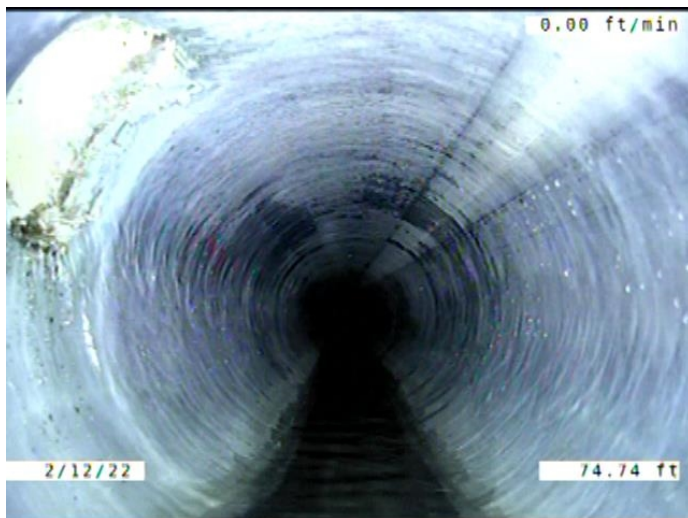
Code: **MWL**  
Description: **Miscellaneous Water Level**

Distance (ft): **74.7**  
Structural Grade: **0**  
O&M Grade: **0**  
Clock Start/From:  
Clock To:  
1st Value:  
2nd Value:  
Value Percent: **5.000**  
Continuous Index:  
Within 8" of Joint: **NO**  
Remarks:

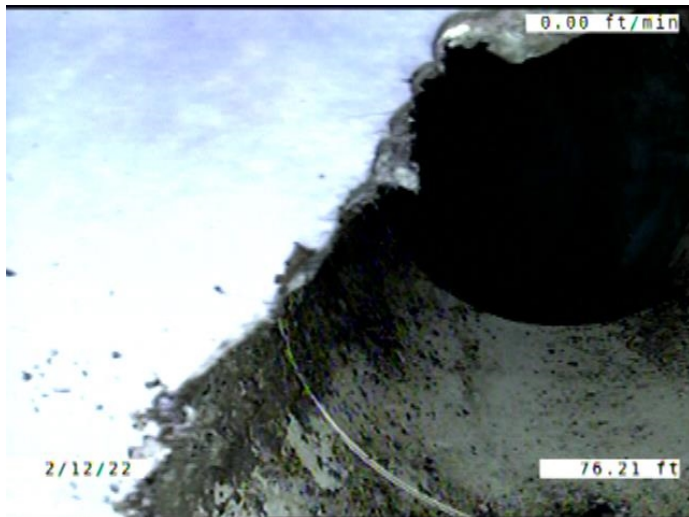
Code: **LFUC**  
 Description: **Lining Feature Undercut Service**

Distance (ft): **76.2**  
 Structural Grade: **3**  
 O&M Grade: **0**  
 Clock Start/From: **10**  
 Clock To:  
 1st Value:  
 2nd Value:  
 Value Percent:  
 Continuous Index:  
 Within 8" of Joint: **NO**  
 Remarks:

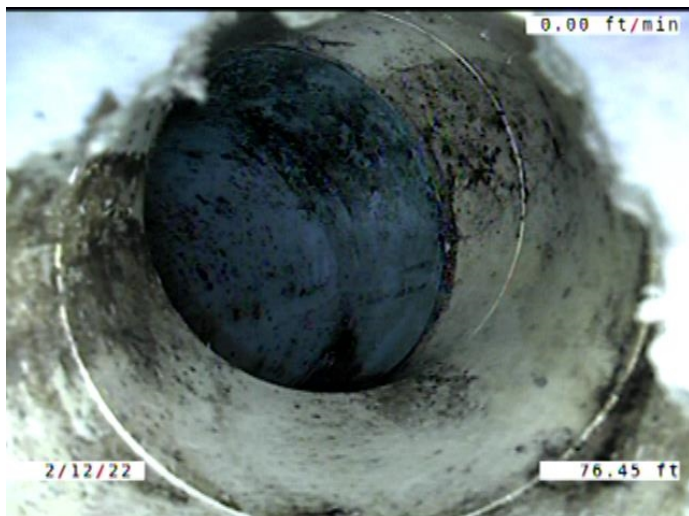
Code: **TB**  
 Description: **Tap Break-in/Hammer**

Distance (ft): **76.5**  
 Structural Grade: **0**  
 O&M Grade: **0**  
 Clock Start/From: **11**  
 Clock To:  
 1st Value: **6.000**  
 2nd Value:  
 Value Percent:  
 Continuous Index:  
 Within 8" of Joint: **NO**  
 Remarks:

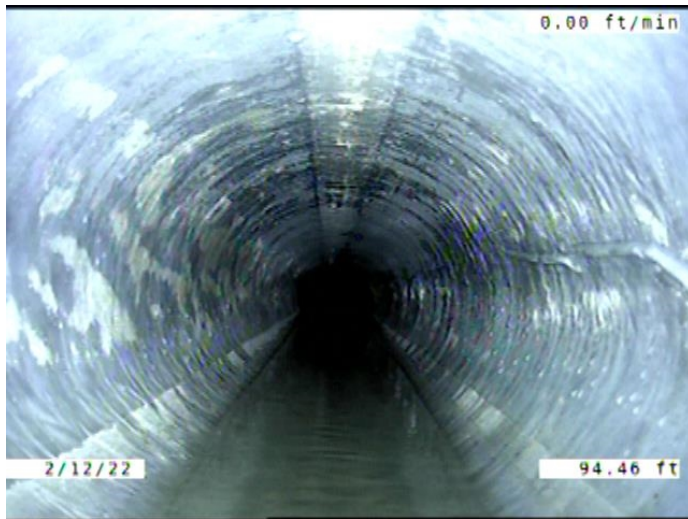
Code: **MWL**  
 Description: **Miscellaneous Water Level**

Distance (ft): **94.5**  
 Structural Grade: **0**  
 O&M Grade: **0**  
 Clock Start/From:  
 Clock To:  
 1st Value:  
 2nd Value:  
 Value Percent: **15.000**  
 Continuous Index:  
 Within 8" of Joint: **NO**  
 Remarks:

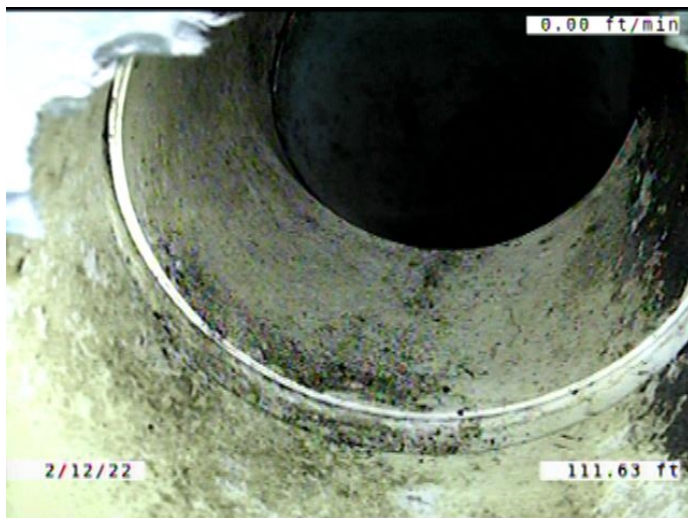
Code: **TB**  
 Description: **Tap Break-in/Hammer**

Distance (ft): **111.6**  
 Structural Grade: **0**  
 O&M Grade: **0**  
 Clock Start/From: **2**  
 Clock To:  
 1st Value: **6.000**  
 2nd Value:  
 Value Percent:  
 Continuous Index:  
 Within 8" of Joint: **NO**  
 Remarks:

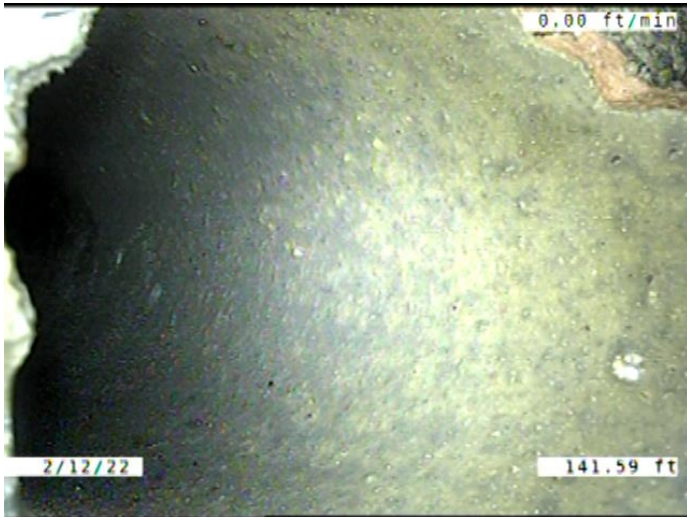
Code:	<b>TBD</b>
Description:	<b>Tap Break-in/Hammer Defective</b>
Distance (ft):	<b>141.6</b>
Structural Grade:	<b>0</b>
O&M Grade:	<b>3</b>
Clock Start/From:	<b>10</b>
Clock To:	
1st Value:	<b>6.000</b>
2nd Value:	
Value Percent:	
Continuous Index:	
Within 8" of Joint:	<b>NO</b>
Remarks:	<b>HSV in Tap</b>

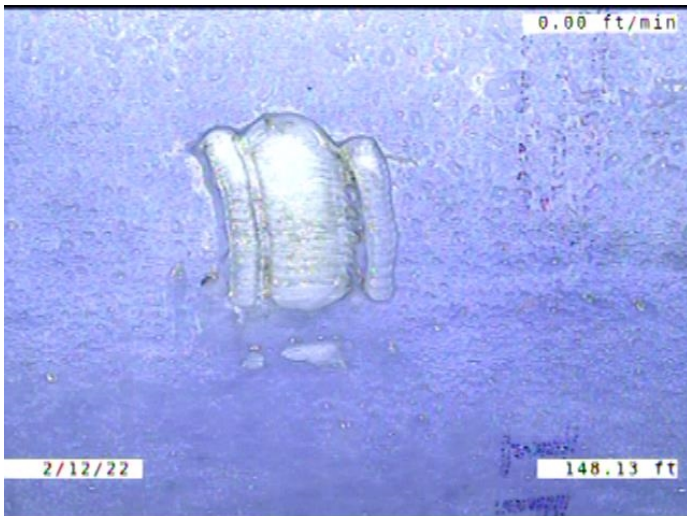
Code:	<b>LFRS</b>
Description:	<b>Lining Feature Resin slug</b>
Distance (ft):	<b>148.1</b>
Structural Grade:	<b>3</b>
O&M Grade:	<b>0</b>
Clock Start/From:	<b>12</b>
Clock To:	
1st Value:	
2nd Value:	
Value Percent:	
Continuous Index:	
Within 8" of Joint:	<b>NO</b>
Remarks:

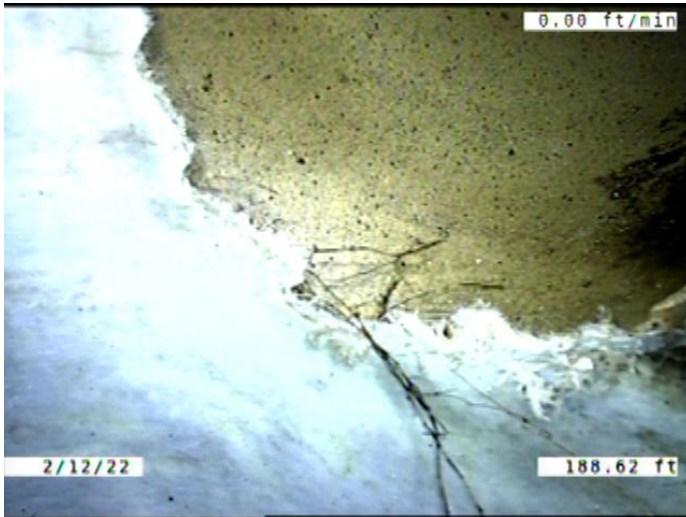
Code: **RFC**  
 Description: **Roots Fine Connection**

Distance (ft): **188.6**  
 Structural Grade: **0**  
 O&M Grade: **1**  
 Clock Start/From: **1**  
 Clock To: **2**  
 1st Value:  
 2nd Value:  
 Value Percent:  
 Continuous Index:  
 Within 8" of Joint: **NO**  
 Remarks:

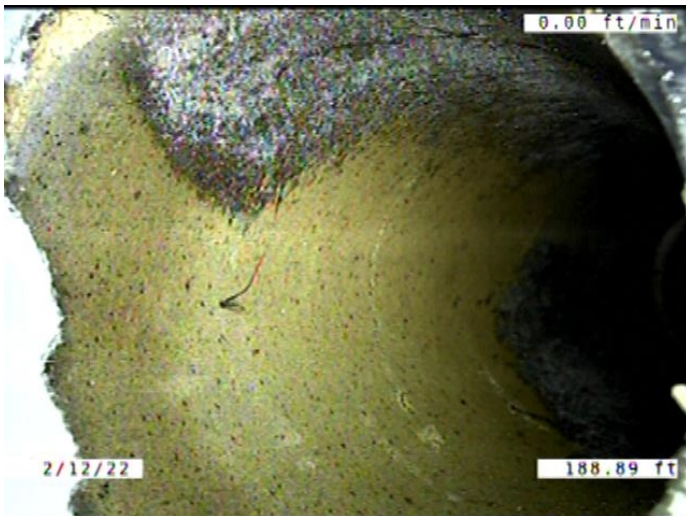
Code: **TB**  
 Description: **Tap Break-in/Hammer**

Distance (ft): **188.9**  
 Structural Grade: **0**  
 O&M Grade: **0**  
 Clock Start/From: **2**  
 Clock To:  
 1st Value: **6.000**  
 2nd Value:  
 Value Percent:  
 Continuous Index:  
 Within 8" of Joint: **NO**  
 Remarks:

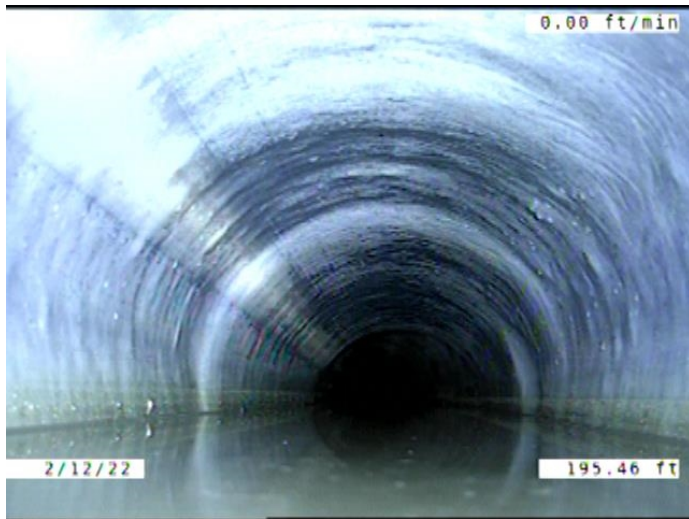
Code: **MWL**  
 Description: **Miscellaneous Water Level**

Distance (ft): **195.5**  
 Structural Grade: **0**  
 O&M Grade: **0**  
 Clock Start/From:  
 Clock To:  
 1st Value:  
 2nd Value:  
 Value Percent: **25.000**  
 Continuous Index:  
 Within 8" of Joint: **NO**  
 Remarks:

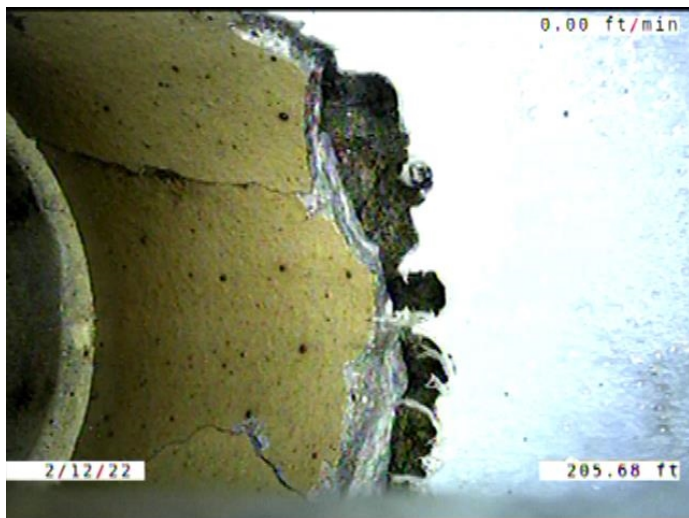
Code: **HSV**  
 Description: **Hole Soil Visible**

Distance (ft): **205.7**  
 Structural Grade: **5**  
 O&M Grade: **0**  
 Clock Start/From: **11**  
 Clock To:  
 1st Value:  
 2nd Value:  
 Value Percent:  
 Continuous Index:  
 Within 8" of Joint: **NO**  
 Remarks:

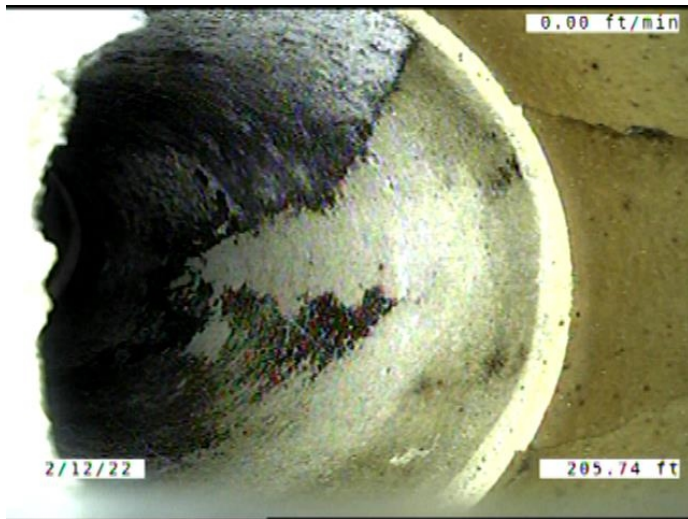
Code:	<b>TBD</b>
Description:	<b>Tap Break-in/Hammer Defective</b>
Distance (ft):	<b>205.7</b>
Structural Grade:	<b>0</b>
O&M Grade:	<b>3</b>
Clock Start/From:	<b>10</b>
Clock To:	
1st Value:	<b>6.000</b>
2nd Value:	
Value Percent:	
Continuous Index:	
Within 8" of Joint:	<b>NO</b>
Remarks:	<b>HSV in tap</b>

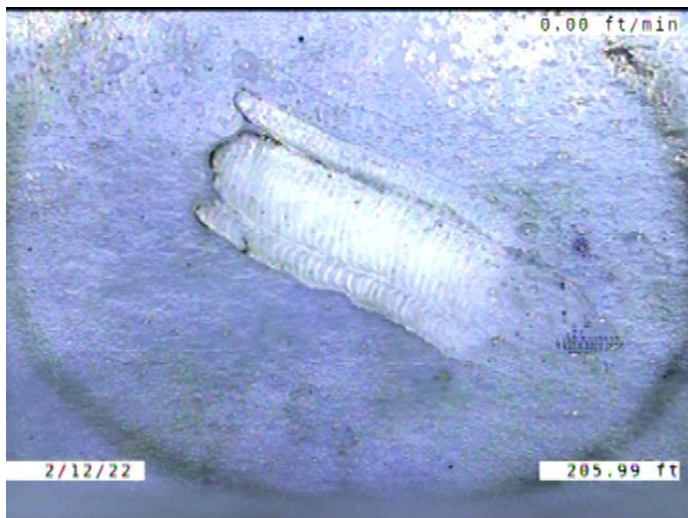
Code:	<b>LFRS</b>
Description:	<b>Lining Feature Resin slug</b>
Distance (ft):	<b>206.0</b>
Structural Grade:	<b>3</b>
O&M Grade:	<b>0</b>
Clock Start/From:	<b>12</b>
Clock To:	
1st Value:	
2nd Value:	
Value Percent:	
Continuous Index:	
Within 8" of Joint:	<b>NO</b>
Remarks:

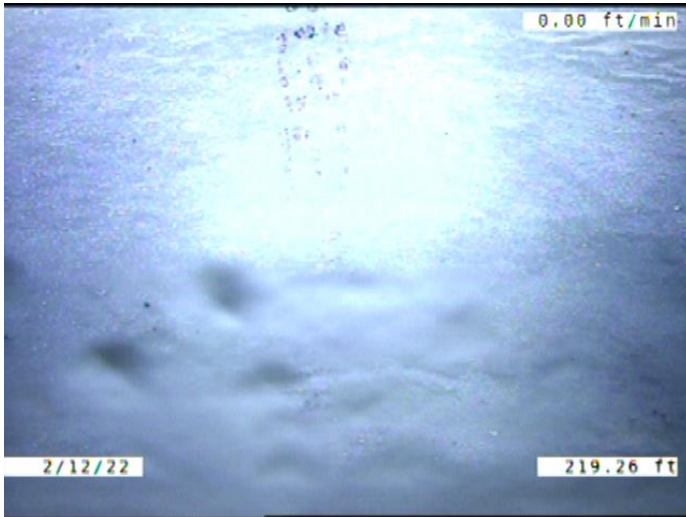
Code: **MWL**  
 Description: **Miscellaneous Water Level**

Distance (ft): **219.3**  
 Structural Grade: **0**  
 O&M Grade: **0**  
 Clock Start/From:  
 Clock To:  
 1st Value:  
 2nd Value:  
 Value Percent: **35.000**  
 Continuous Index:  
 Within 8" of Joint: **NO**  
 Remarks:

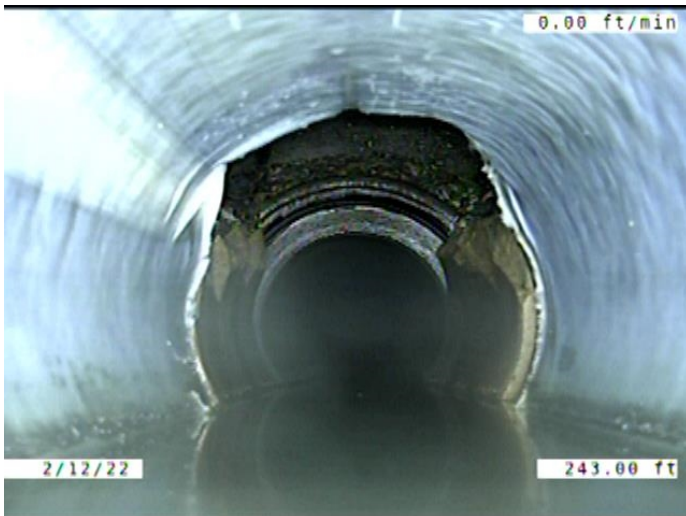
Code: **MWL**  
 Description: **Miscellaneous Water Level**

Distance (ft): **243.0**  
 Structural Grade: **0**  
 O&M Grade: **0**  
 Clock Start/From:  
 Clock To:  
 1st Value:  
 2nd Value:  
 Value Percent: **10.000**  
 Continuous Index:  
 Within 8" of Joint: **NO**  
 Remarks:

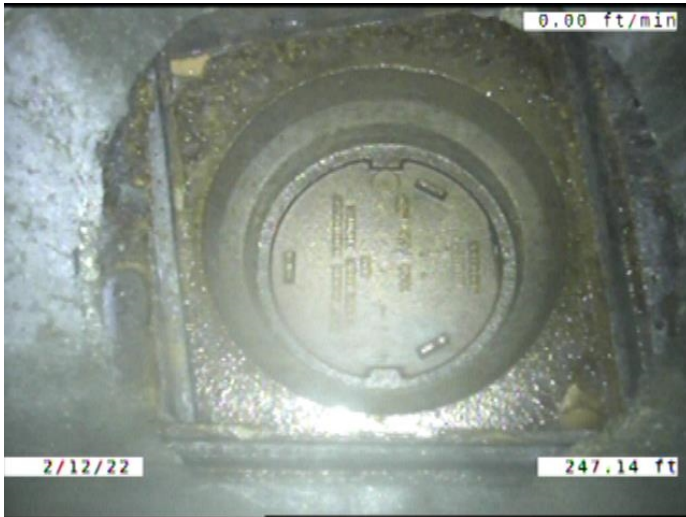
Code:	AMH
Description:	Manhole
Distance (ft):	247.1
Structural Grade:	0
O&M Grade:	0
Clock Start/From:	
Clock To:	
1st Value:	
2nd Value:	
Value Percent:	
Continuous Index:	
Within 8" of Joint:	NO
Remarks:	M-707-036
