Profile/Photo Observation Report

Street:	LINCOLN ST & E 13TH ST	Flow Control:	Not Controlled
City:	Hobart, IN	Year Renewed:	
Location:	Light Highway	Tape/Media #:	
Purpose:	Maintenance Related	Dia/Height:	8"
Use:	Sanitary	Material:	PVC
Drain Area:	NA	Lining:	Cured in Place
Category:	NA		
Comment:	debris at 274'. flow incorrect.		
Location Details:		Direction of Survey:	Downstream
US MH:	M-707-080	DS MH:	M-707-021
		Total Length Surveyed (ft):	275.6

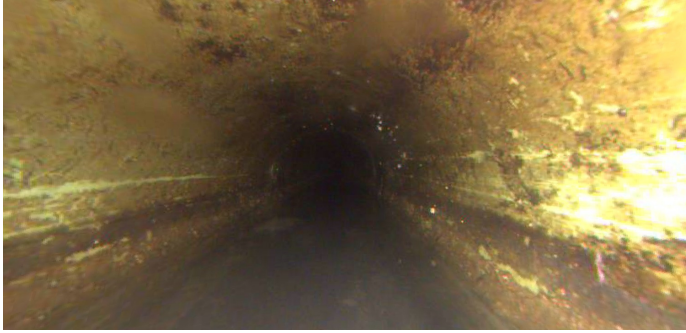
Code: **AMH**
Description: **Manhole**

Distance (ft): **.0**
Structural Grade: **0**
O&M Grade: **0**
Clock Start/From:
Clock To:
1st Value:
2nd Value:
Value Percent:
Continuous Index:
Within 8" of Joint: **NO**
Remarks: **M-707-080**

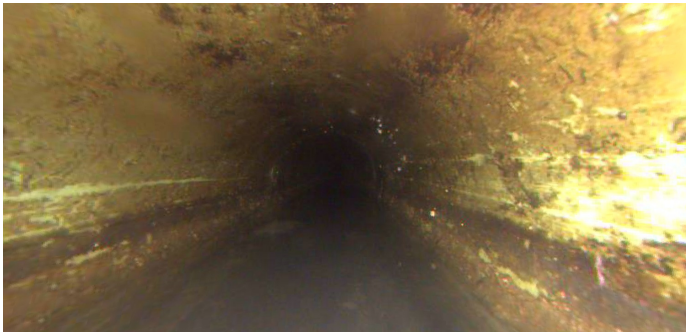
Code: **MWL**
Description: **Water Level**

Distance (ft): **.0**
Structural Grade: **0**
O&M Grade: **0**
Clock Start/From:
Clock To:
1st Value:
2nd Value:
Value Percent: **20.000**
Continuous Index:
Within 8" of Joint: **NO**
Remarks:

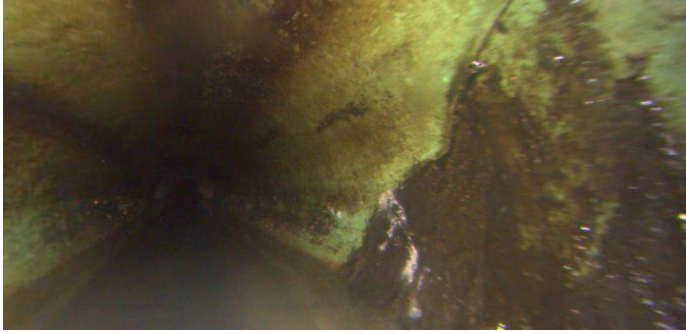
Code: **FS**
Description: **Fracture Spiral**

Distance (ft): **5.7**
Structural Grade: **3**
O&M Grade: **0**
Clock Start/From: **2**
Clock To: **4**
1st Value:
2nd Value:
Value Percent:
Continuous Index:
Within 8" of Joint:
Remarks:

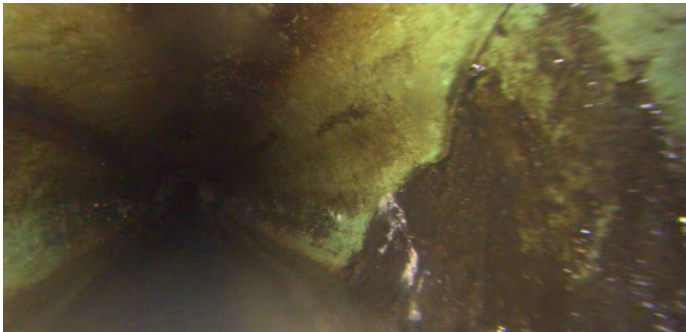
Code: **IW**
Description: **Infil Weeper**

Distance (ft): **5.7**
Structural Grade: **0**
O&M Grade: **2**
Clock Start/From: **1**
Clock To: **4**
1st Value:
2nd Value:
Value Percent:
Continuous Index:
Within 8" of Joint:
Remarks:

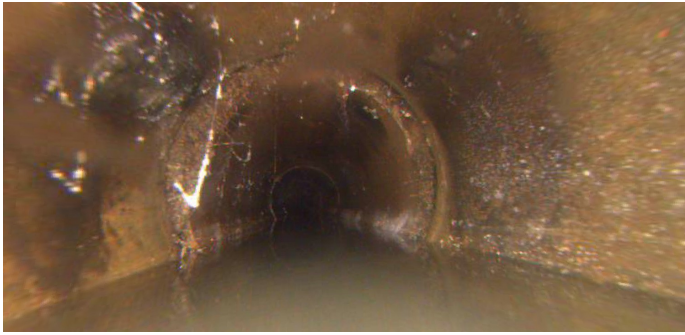
Code: **MMC**
Description: **Material Change**

Distance (ft): **24.7**
Structural Grade: **0**
O&M Grade: **0**
Clock Start/From:
Clock To:
1st Value:
2nd Value:
Value Percent:
Continuous Index:
Within 8" of Joint: **NO**
Remarks: **VCP**

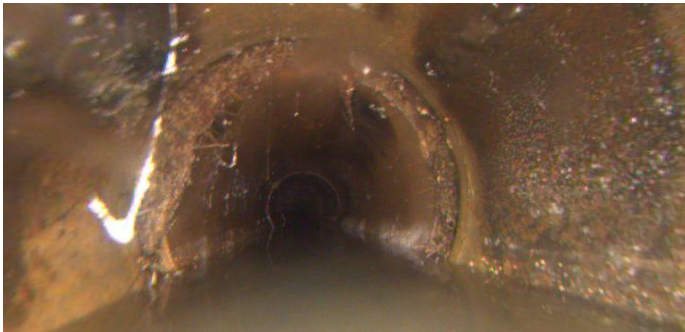
Code: **RFJ**
Description: **Roots Fine Joint**

Distance (ft): **24.9**
Structural Grade: **0**
O&M Grade: **1**
Clock Start/From: **8**
Clock To: **4**
1st Value:
2nd Value:
Value Percent:
Continuous Index:
Within 8" of Joint: **YES**
Remarks:

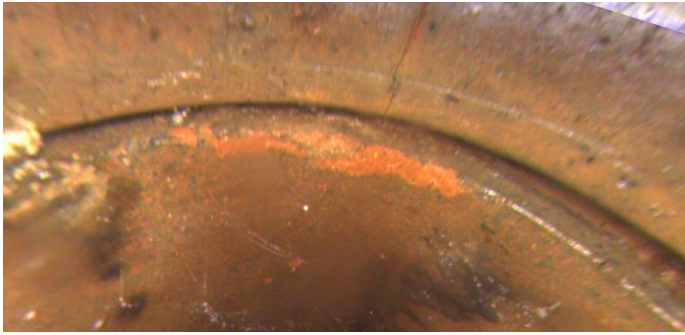
Code: **FL**
Description: **Fracture Longitudinal**

Distance (ft): **27.5**
Structural Grade: **3**
O&M Grade: **0**
Clock Start/From: **12**
Clock To:
1st Value:
2nd Value:
Value Percent:
Continuous Index:
Within 8" of Joint: **YES**
Remarks:

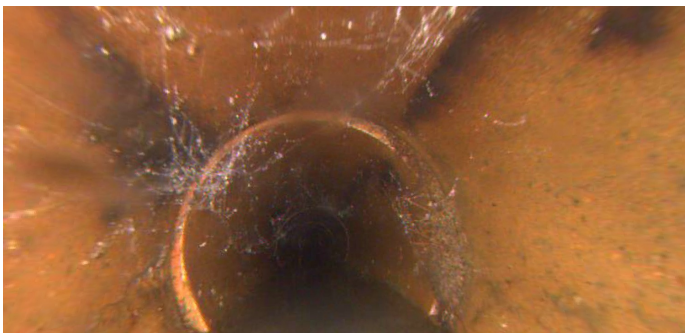
Code: **RFJ**
Description: **Roots Fine Joint**

Distance (ft): **29.1**
Structural Grade: **0**
O&M Grade: **1**
Clock Start/From: **8**
Clock To: **4**
1st Value:
2nd Value:
Value Percent:
Continuous Index:
Within 8" of Joint: **YES**
Remarks:

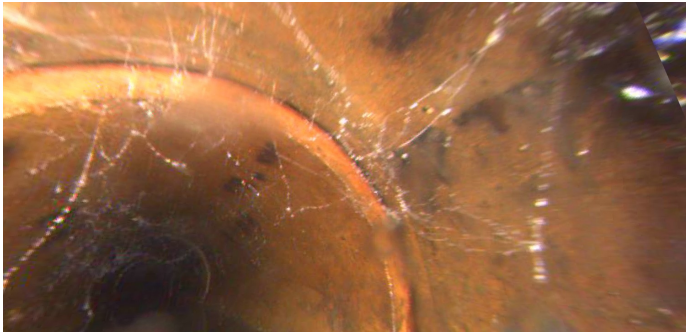
Code: **FL**
Description: **Fracture Longitudinal**

Distance (ft): **40.1**
Structural Grade: **3**
O&M Grade: **0**
Clock Start/From: **2**
Clock To:
1st Value:
2nd Value:
Value Percent:
Continuous Index:
Within 8" of Joint: **YES**
Remarks:

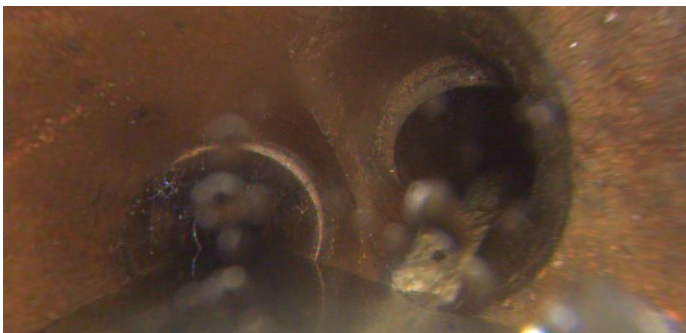
Code: **TFA**
Description: **Tap Factory Active**

Distance (ft): **56.4**
Structural Grade: **0**
O&M Grade: **0**
Clock Start/From: **3**
Clock To:
1st Value: **4.000**
2nd Value:
Value Percent:
Continuous Index:
Within 8" of Joint:
Remarks:

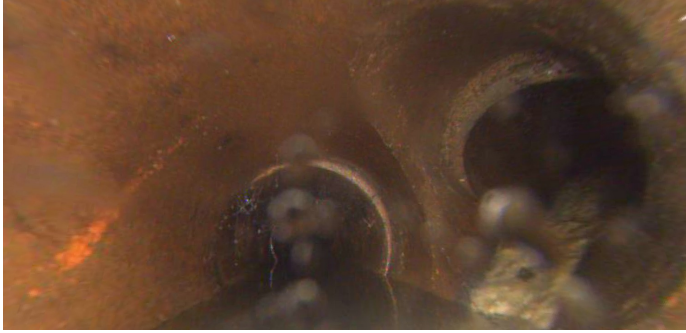
Code: **SSS**
Description: **Surface Spalling**

Distance (ft): **56.4**
Structural Grade: **2**
O&M Grade: **0**
Clock Start/From: **9**
Clock To: **10**
1st Value:
2nd Value:
Value Percent:
Continuous Index:
Within 8" of Joint:
Remarks:

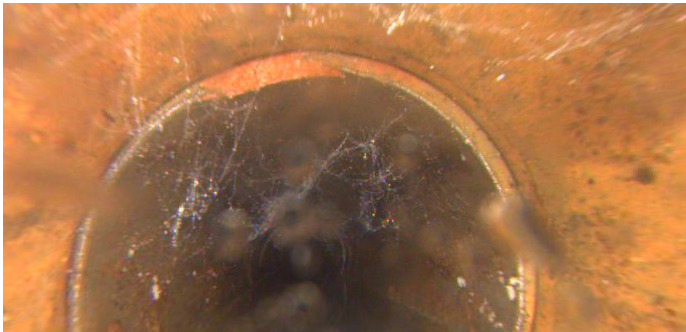
Code: **SSS**
Description: **Surface Spalling**

Distance (ft): **70.0**
Structural Grade: **2**
O&M Grade: **0**
Clock Start/From: **12**
Clock To:
1st Value:
2nd Value:
Value Percent:
Continuous Index:
Within 8" of Joint: **YES**
Remarks:

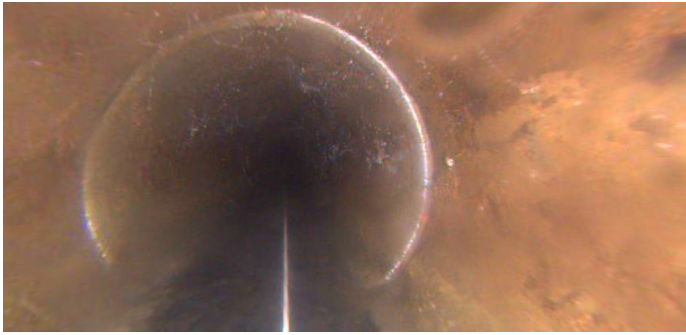
Code: **MGO**
Description: **General Observation**

Distance (ft): **88.1**
Structural Grade: **0**
O&M Grade: **0**
Clock Start/From:
Clock To:
1st Value:
2nd Value:
Value Percent:
Continuous Index:
Within 8" of Joint: **NO**
Remarks: **REAR CAMERA**

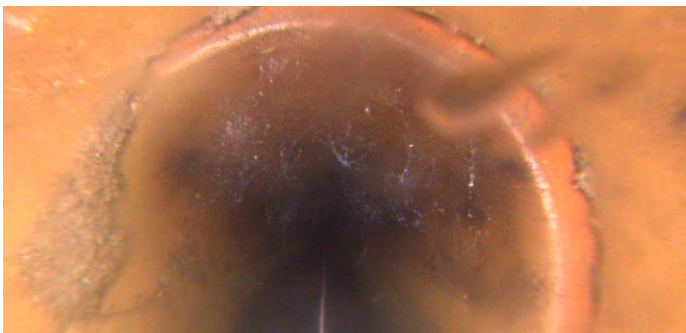
Code: **DAZ**
Description: **Deposits Attached Other**

Distance (ft): **111.4**
Structural Grade: **0**
O&M Grade: **2**
Clock Start/From: **2**
Clock To: **3**
1st Value:
2nd Value:
Value Percent: **5.000**
Continuous Index:
Within 8" of Joint: **YES**
Remarks:

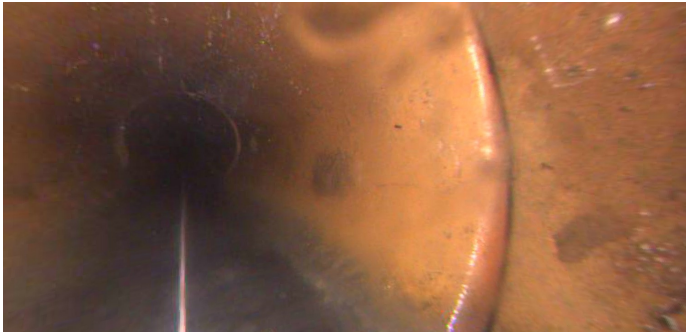
Code: **CL**
Description: **Crack Longitudinal**

Distance (ft): **113.4**
Structural Grade: **2**
O&M Grade: **0**
Clock Start/From: **9**
Clock To:
1st Value:
2nd Value:
Value Percent:
Continuous Index:
Within 8" of Joint: **YES**
Remarks:

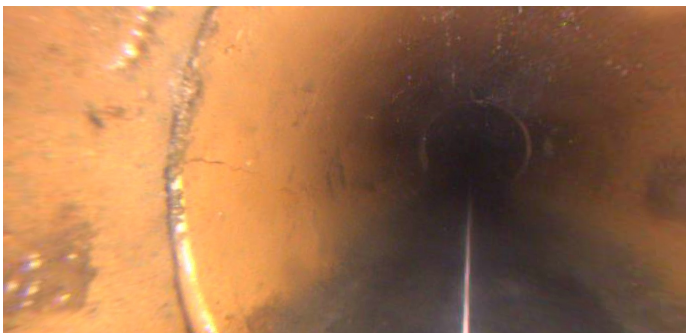
Code: **FL**
Description: **Fracture Longitudinal**

Distance (ft): **113.4**
Structural Grade: **3**
O&M Grade: **0**
Clock Start/From: **3**
Clock To:
1st Value:
2nd Value:
Value Percent:
Continuous Index:
Within 8" of Joint: **YES**
Remarks:

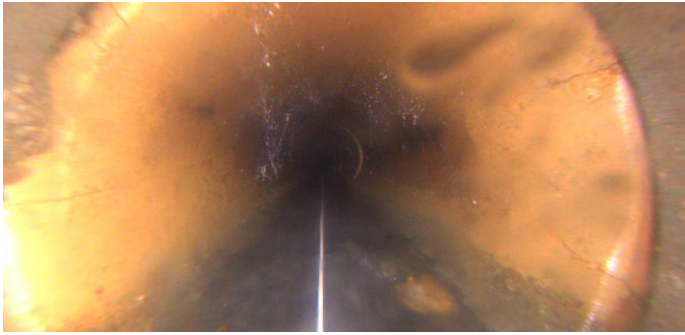
Code: **FM**
Description: **Fracture Multiple**

Distance (ft): **117.7**
Structural Grade: **4**
O&M Grade: **0**
Clock Start/From: **8**
Clock To: **4**
1st Value:
2nd Value:
Value Percent:
Continuous Index:
Within 8" of Joint: **YES**
Remarks:

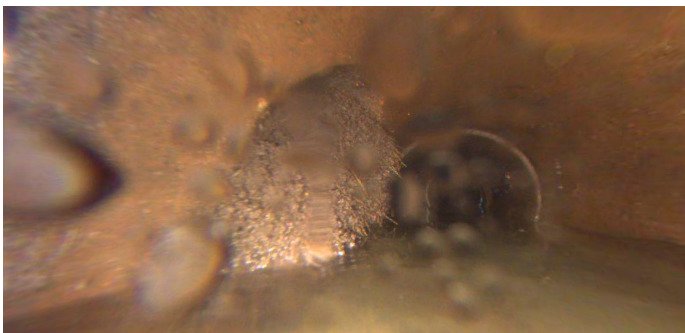
Code: **TFD**
Description: **Tap Factory Defective**

Distance (ft): **124.7**
Structural Grade: **0**
O&M Grade: **2**
Clock Start/From: **9**
Clock To:
1st Value: **4.000**
2nd Value:
Value Percent:
Continuous Index:
Within 8" of Joint:
Remarks: **ROOTS**

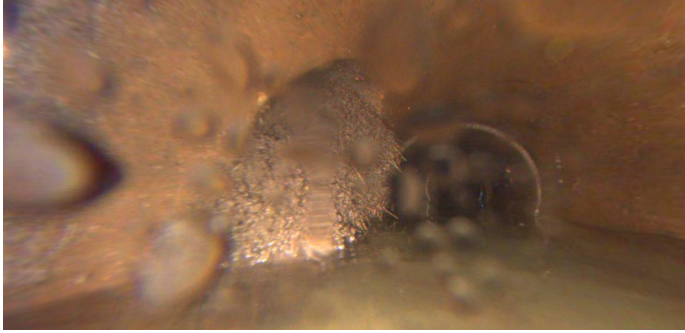
Code: **RML**
Description: **Roots Medium Lateral**

Distance (ft): **124.7**
Structural Grade: **0**
O&M Grade: **3**
Clock Start/From: **8**
Clock To: **10**
1st Value:
2nd Value:
Value Percent: **10.000**
Continuous Index:
Within 8" of Joint: **NO**
Remarks:

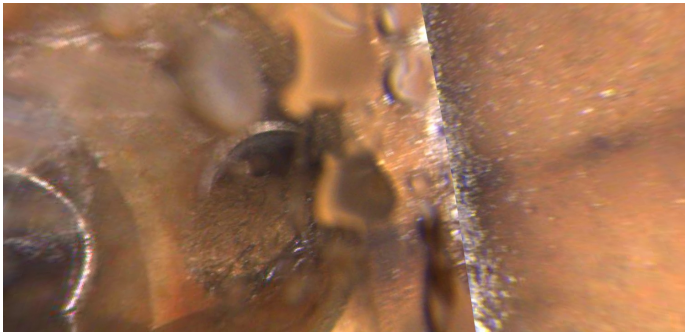
Code: **TF**
Description: **Tap Factory**

Distance (ft): **126.9**
Structural Grade: **0**
O&M Grade: **0**
Clock Start/From: **3**
Clock To:
1st Value: **4.000**
2nd Value:
Value Percent:
Continuous Index:
Within 8" of Joint:
Remarks:

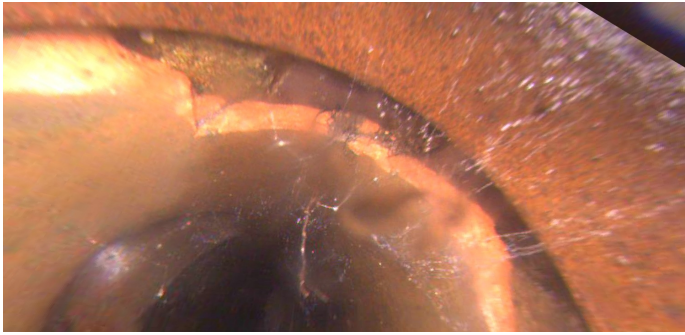
Code: **B**
Description: **Broken**

Distance (ft): **128.4**
Structural Grade: **5**
O&M Grade: **0**
Clock Start/From: **9**
Clock To: **1**
1st Value:
2nd Value:
Value Percent:
Continuous Index:
Within 8" of Joint: **YES**
Remarks:

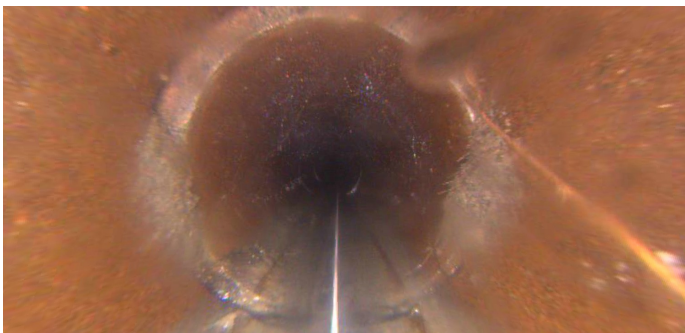
Code: **RMJ**
Description: **Roots Medium Joint**

Distance (ft): **134.8**
Structural Grade: **0**
O&M Grade: **3**
Clock Start/From: **8**
Clock To: **4**
1st Value:
2nd Value:
Value Percent: **5.000**
Continuous Index:
Within 8" of Joint: **YES**
Remarks:

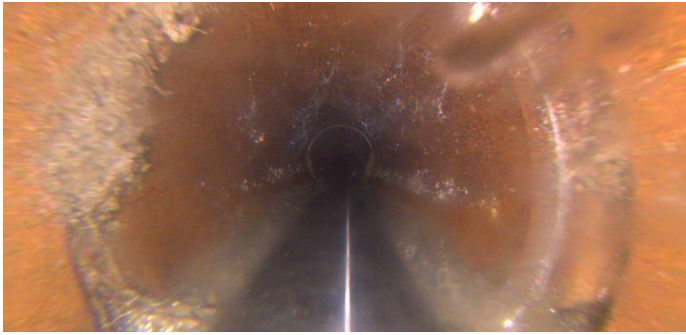
Code: **RMJ**
Description: **Roots Medium Joint**

Distance (ft): **136.7**
Structural Grade: **0**
O&M Grade: **3**
Clock Start/From: **8**
Clock To: **4**
1st Value:
2nd Value:
Value Percent: **5.000**
Continuous Index:
Within 8" of Joint: **YES**
Remarks:

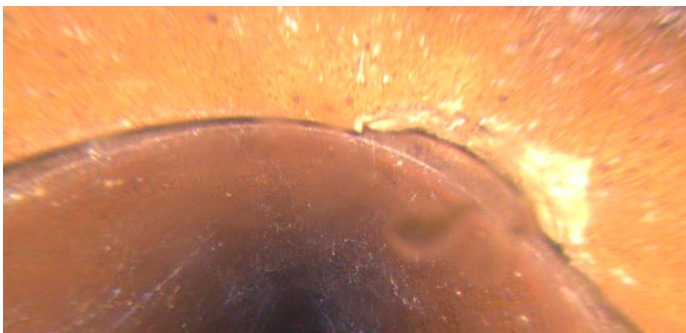
Code: **SSS**
Description: **Surface Spalling**

Distance (ft): **153.1**
Structural Grade: **2**
O&M Grade: **0**
Clock Start/From: **11**
Clock To: **12**
1st Value:
2nd Value:
Value Percent:
Continuous Index:
Within 8" of Joint: **YES**
Remarks:

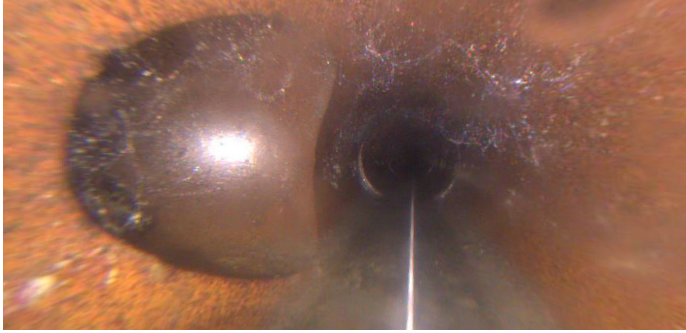
Code: **TF**
Description: **Tap Factory**

Distance (ft): **168.9**
Structural Grade: **0**
O&M Grade: **0**
Clock Start/From: **3**
Clock To:
1st Value: **4.000**
2nd Value:
Value Percent:
Continuous Index:
Within 8" of Joint:
Remarks:

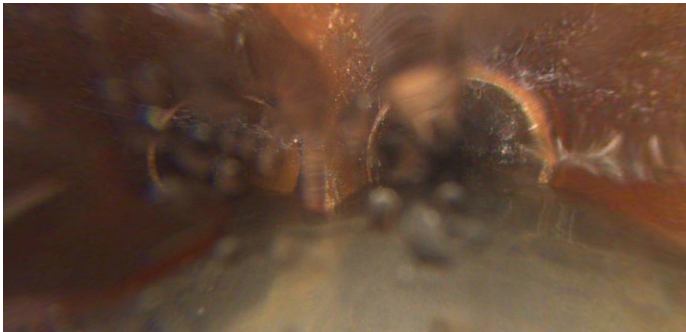
Code: **TFA**
Description: **Tap Factory Active**

Distance (ft): **170.4**
Structural Grade: **0**
O&M Grade: **0**
Clock Start/From: **9**
Clock To:
1st Value: **4.000**
2nd Value:
Value Percent:
Continuous Index:
Within 8" of Joint:
Remarks:

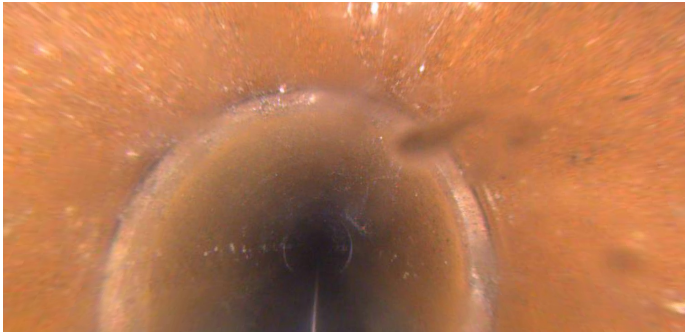
Code: **CM**
Description: **Crack Multiple**

Distance (ft): **192.3**
Structural Grade: **3**
O&M Grade: **0**
Clock Start/From: **8**
Clock To: **4**
1st Value:
2nd Value:
Value Percent:
Continuous Index:
Within 8" of Joint: **YES**
Remarks:

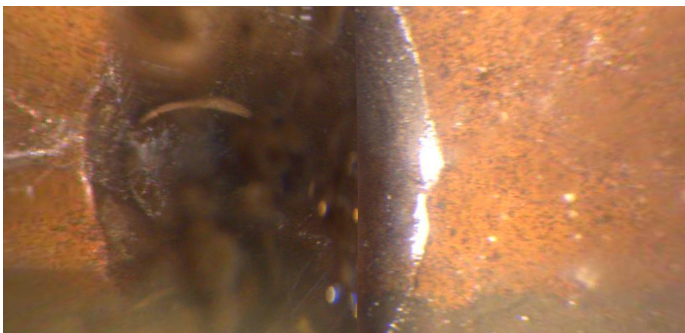
Code: **TFA**
Description: **Tap Factory Active**

Distance (ft): **209.4**
Structural Grade: **0**
O&M Grade: **0**
Clock Start/From: **3**
Clock To:
1st Value: **4.000**
2nd Value:
Value Percent:
Continuous Index:
Within 8" of Joint:
Remarks:

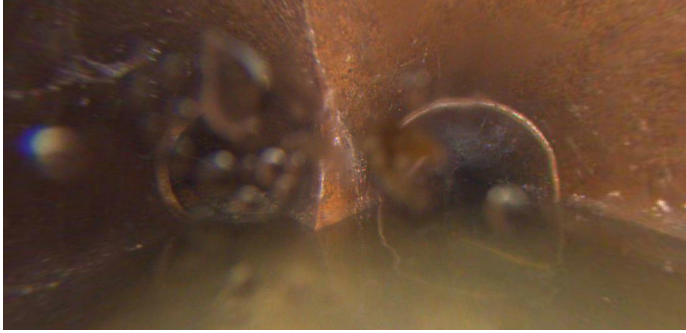
Code: **TFA**
Description: **Tap Factory Active**

Distance (ft): **211.6**
Structural Grade: **0**
O&M Grade: **0**
Clock Start/From: **9**
Clock To:
1st Value: **4.000**
2nd Value:
Value Percent:
Continuous Index:
Within 8" of Joint:
Remarks:

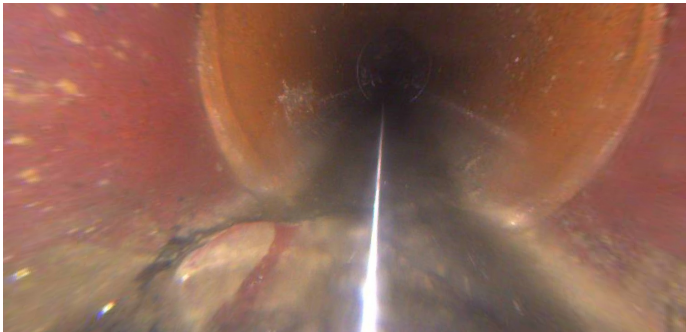
Code: **OBM**
Description: **Obstacle Pipe Material**

Distance (ft): **233.6**
Structural Grade: **0**
O&M Grade: **2**
Clock Start/From: **4**
Clock To: **5**
1st Value:
2nd Value:
Value Percent: **5.000**
Continuous Index:
Within 8" of Joint: **NO**
Remarks:

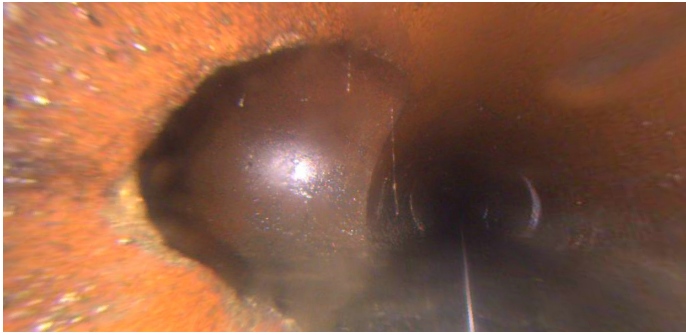
Code: **TFA**
Description: **Tap Factory Active**

Distance (ft): **251.5**
Structural Grade: **0**
O&M Grade: **0**
Clock Start/From: **3**
Clock To:
1st Value: **4.000**
2nd Value:
Value Percent:
Continuous Index:
Within 8" of Joint: **NO**
Remarks:

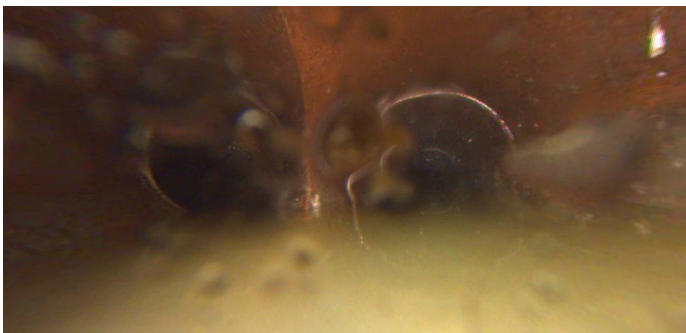
Code: **TFA**
Description: **Tap Factory Active**

Distance (ft): **252.9**
Structural Grade: **0**
O&M Grade: **0**
Clock Start/From: **9**
Clock To:
1st Value: **4.000**
2nd Value:
Value Percent:
Continuous Index:
Within 8" of Joint:
Remarks:

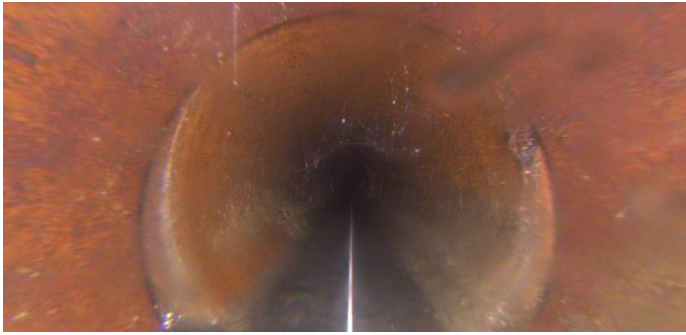
Code: **RFJ**
Description: **Roots Fine Joint**

Distance (ft): **256.3**
Structural Grade: **0**
O&M Grade: **1**
Clock Start/From: **10**
Clock To:
1st Value:
2nd Value:
Value Percent:
Continuous Index:
Within 8" of Joint: **YES**
Remarks:

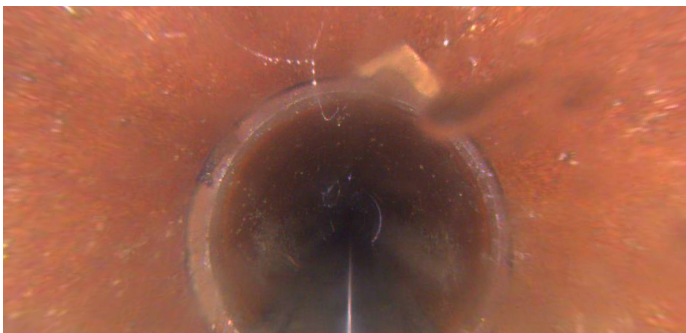
Code: **SSS**
Description: **Surface Spalling**

Distance (ft): **260.6**
Structural Grade: **2**
O&M Grade: **0**
Clock Start/From: **12**
Clock To:
1st Value:
2nd Value:
Value Percent:
Continuous Index:
Within 8" of Joint: **YES**
Remarks:

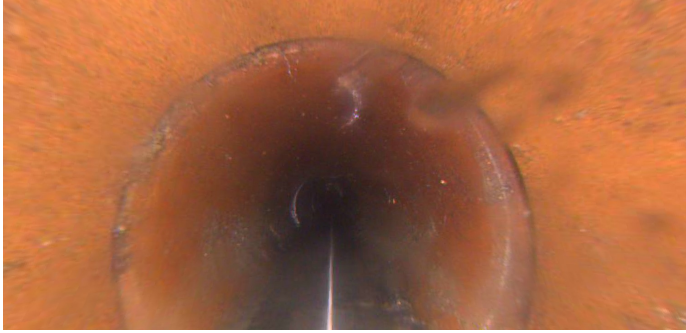
Code: **RFJ**
Description: **Roots Fine Joint**

Distance (ft): **266.7**
Structural Grade: **0**
O&M Grade: **1**
Clock Start/From: **8**
Clock To: **4**
1st Value:
2nd Value:
Value Percent:
Continuous Index:
Within 8" of Joint: **YES**
Remarks:

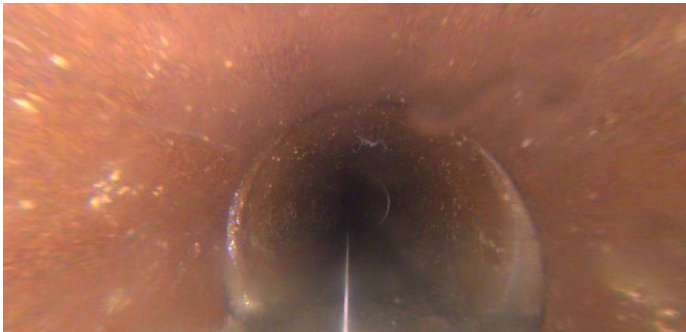
Code: **JOM**
Description: **Joint Offset Medium**

Distance (ft): **271.0**
Structural Grade: **1**
O&M Grade: **0**
Clock Start/From:
Clock To:
1st Value:
2nd Value:
Value Percent:
Continuous Index:
Within 8" of Joint: **NO**
Remarks:

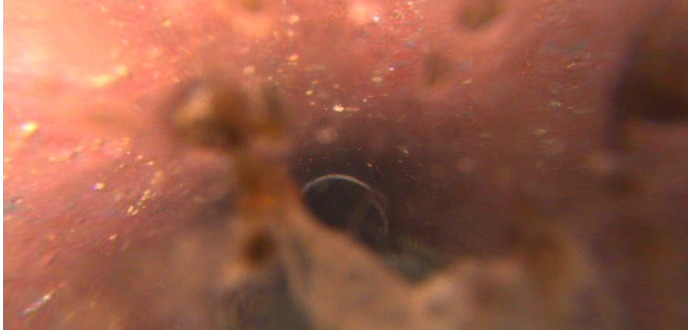
Code:	MSA
Description:	Abandoned Survey
Distance (ft):	275.6
Structural Grade:	0
O&M Grade:	0
Clock Start/From:	
Clock To:	
1st Value:	
2nd Value:	
Value Percent:	
Continuous Index:	
Within 8" of Joint:	NO
Remarks:	DEBRIS UNDER WATER
