Profile/Photo Observation Report

Date:	04/09/2018	Weather:		Coding:	PACP 6.0
Pipe Length (ft):	283.5	Owner:	NA	Pre Clean:	Not Known
P.O.#:		Surveyor:	Jen Costello	PSR:	P-707-021-080
Customer:		Clean Date:	01/01/1900	Shape:	C

Street:	Capitol	Flow Control:	Not Controlled
City:	Hobart, IN	Year Renewed:	
Location:	Light Highway	Tape/Media #:	
Purpose:	Maintenance Related	Dia/Height:	8"
Use:	Sanitary	Material:	PVC
Drain Area:	NA	Lining:	Cured in Place
Category:	NA		
Comment:	debris at 274'. flow incorrect.		
Location Details:		Direction of Survey:	Downstream
US MH:	M-707-080	DS MH:	M-707-021
		Total Length Surveyed (ft):	275.6

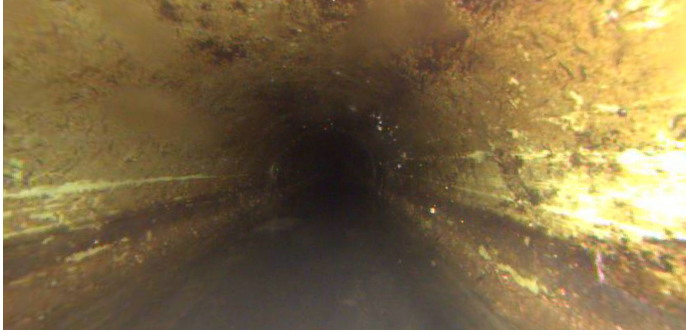
Code: **AMH**
Description: **Manhole**

Distance (ft): **.0**
Structural Grade: **0**
O&M Grade: **0**
Clock Start/From:
Clock To:
1st Value:
2nd Value:
Value Percent:
Continuous Index:
Within 8" of Joint: **NO**
Remarks: **M-707-080**

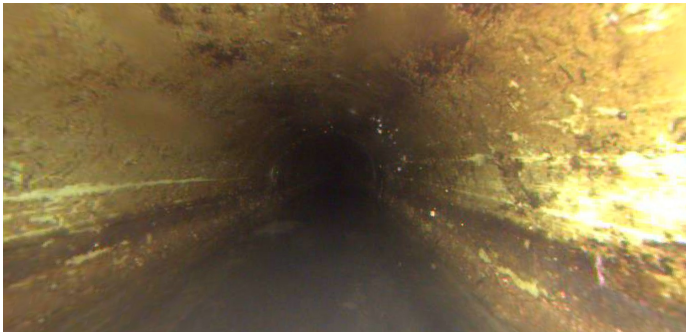
Code: **MWL**
Description: **Water Level**

Distance (ft): **.0**
Structural Grade: **0**
O&M Grade: **0**
Clock Start/From:
Clock To:
1st Value:
2nd Value:
Value Percent: **20.000**
Continuous Index:
Within 8" of Joint: **NO**
Remarks:

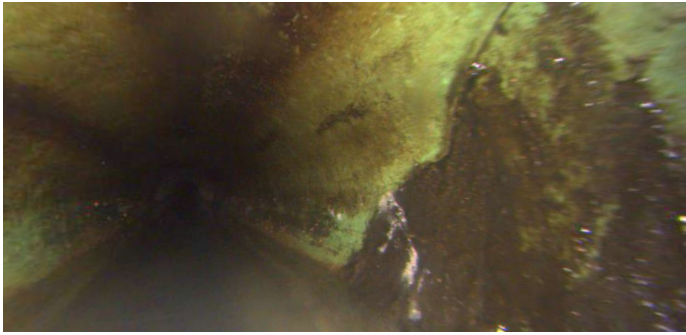
Code: **FS**
Description: **Fracture Spiral**

Distance (ft): **5.7**
Structural Grade: **3**
O&M Grade: **0**
Clock Start/From: **2**
Clock To: **4**
1st Value:
2nd Value:
Value Percent:
Continuous Index:
Within 8" of Joint:
Remarks:

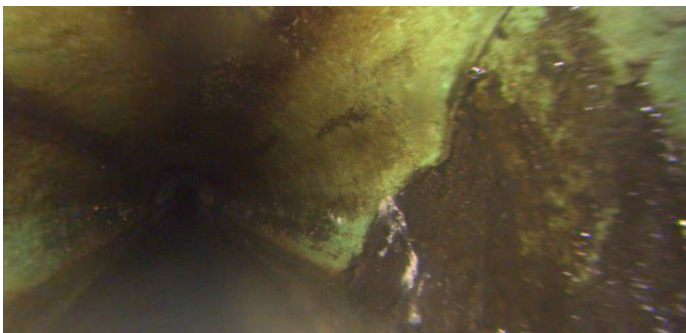
Code: **IW**
Description: **Infil Weeper**

Distance (ft): **5.7**
Structural Grade: **0**
O&M Grade: **2**
Clock Start/From: **1**
Clock To: **4**
1st Value:
2nd Value:
Value Percent:
Continuous Index:
Within 8" of Joint:
Remarks:

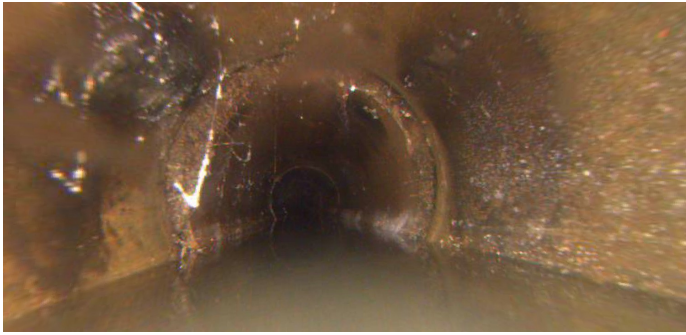
Code: **MMC**
Description: **Material Change**

Distance (ft): **24.7**
Structural Grade: **0**
O&M Grade: **0**
Clock Start/From:
Clock To:
1st Value:
2nd Value:
Value Percent:
Continuous Index:
Within 8" of Joint: **NO**
Remarks: **VCP**

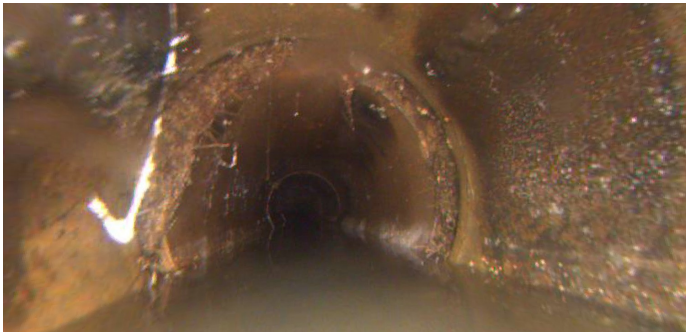
Code: **RFJ**
Description: **Roots Fine Joint**

Distance (ft): **24.9**
Structural Grade: **0**
O&M Grade: **1**
Clock Start/From: **8**
Clock To: **4**
1st Value:
2nd Value:
Value Percent:
Continuous Index:
Within 8" of Joint: **YES**
Remarks:

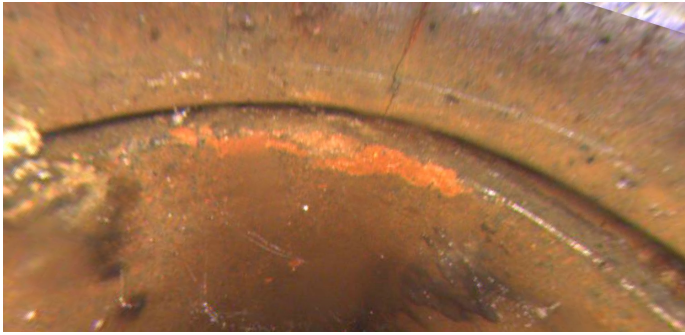
Code: **FL**
Description: **Fracture Longitudinal**

Distance (ft): **27.5**
Structural Grade: **3**
O&M Grade: **0**
Clock Start/From: **12**
Clock To:
1st Value:
2nd Value:
Value Percent:
Continuous Index:
Within 8" of Joint: **YES**
Remarks:

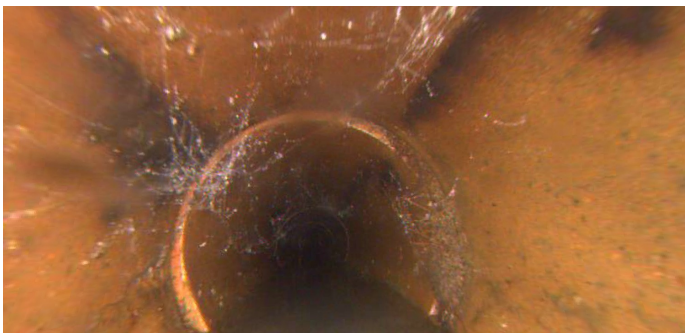
Code: **RFJ**
Description: **Roots Fine Joint**

Distance (ft): **29.1**
Structural Grade: **0**
O&M Grade: **1**
Clock Start/From: **8**
Clock To: **4**
1st Value:
2nd Value:
Value Percent:
Continuous Index:
Within 8" of Joint: **YES**
Remarks:

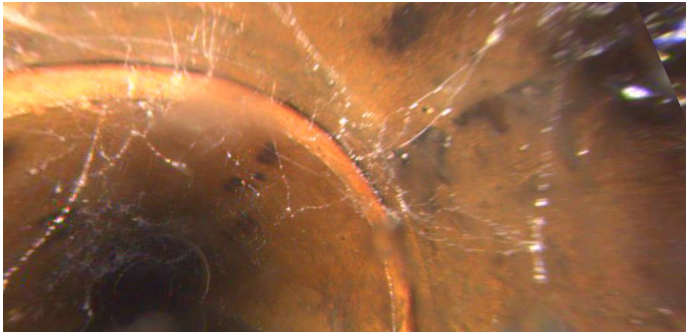
Code: **FL**
Description: **Fracture Longitudinal**

Distance (ft): **40.1**
Structural Grade: **3**
O&M Grade: **0**
Clock Start/From: **2**
Clock To:
1st Value:
2nd Value:
Value Percent:
Continuous Index:
Within 8" of Joint: **YES**
Remarks:

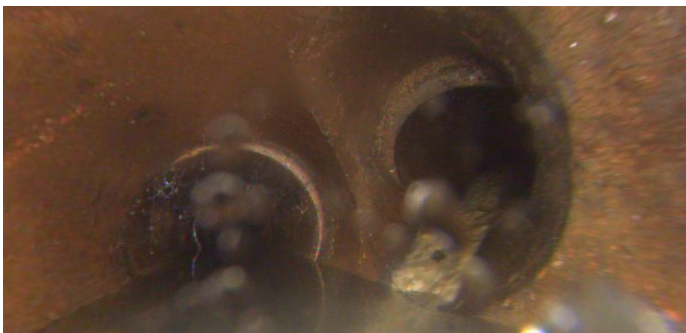
Code: **TFA**
Description: **Tap Factory Active**

Distance (ft): **56.4**
Structural Grade: **0**
O&M Grade: **0**
Clock Start/From: **3**
Clock To:
1st Value: **4.000**
2nd Value:
Value Percent:
Continuous Index:
Within 8" of Joint:
Remarks:

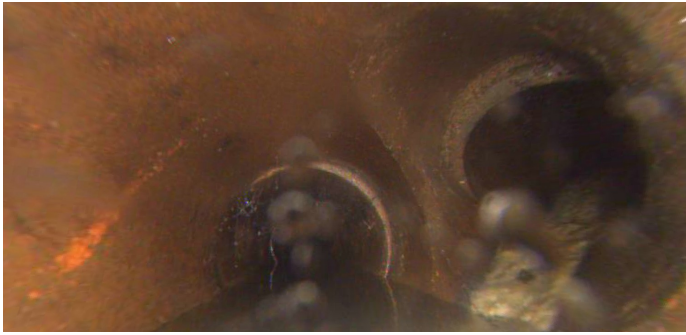
Code: **SSS**
Description: **Surface Spalling**

Distance (ft): **56.4**
Structural Grade: **2**
O&M Grade: **0**
Clock Start/From: **9**
Clock To: **10**
1st Value:
2nd Value:
Value Percent:
Continuous Index:
Within 8" of Joint:
Remarks:

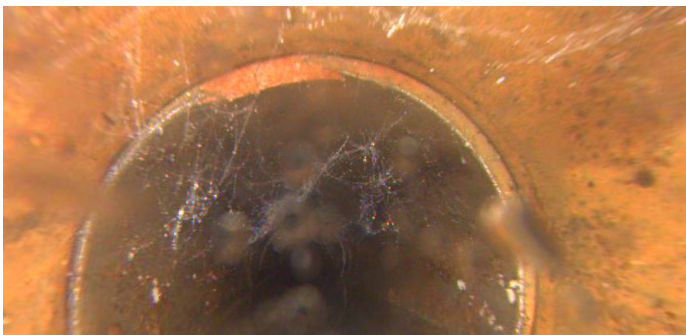
Code: **SSS**
Description: **Surface Spalling**

Distance (ft): **70.0**
Structural Grade: **2**
O&M Grade: **0**
Clock Start/From: **12**
Clock To:
1st Value:
2nd Value:
Value Percent:
Continuous Index:
Within 8" of Joint: **YES**
Remarks:

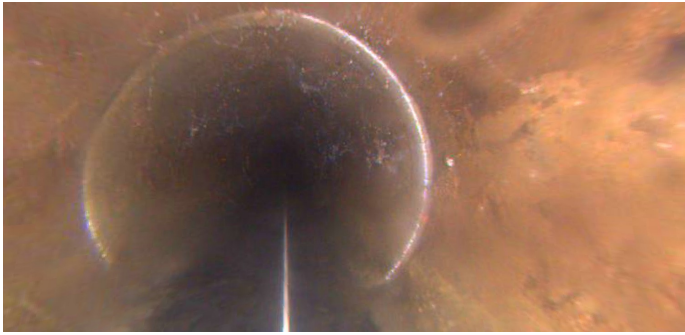
Code: **MGO**
Description: **General Observation**

Distance (ft): **88.1**
Structural Grade: **0**
O&M Grade: **0**
Clock Start/From:
Clock To:
1st Value:
2nd Value:
Value Percent:
Continuous Index:
Within 8" of Joint: **NO**
Remarks: **REAR CAMERA**

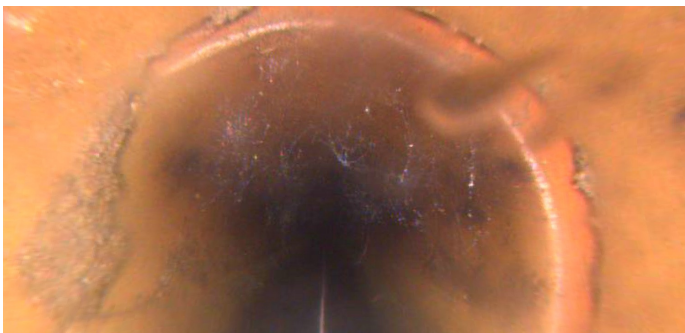
Code: **DAZ**
Description: **Deposits Attached Other**

Distance (ft): **111.4**
Structural Grade: **0**
O&M Grade: **2**
Clock Start/From: **2**
Clock To: **3**
1st Value:
2nd Value:
Value Percent: **5.000**
Continuous Index:
Within 8" of Joint: **YES**
Remarks:

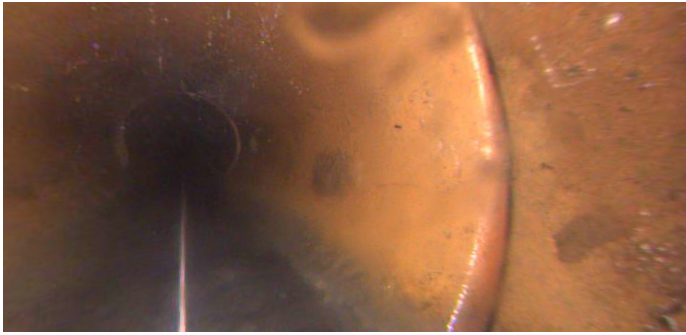
Code: **CL**
Description: **Crack Longitudinal**

Distance (ft): **113.4**
Structural Grade: **2**
O&M Grade: **0**
Clock Start/From: **9**
Clock To:
1st Value:
2nd Value:
Value Percent:
Continuous Index:
Within 8" of Joint: **YES**
Remarks:

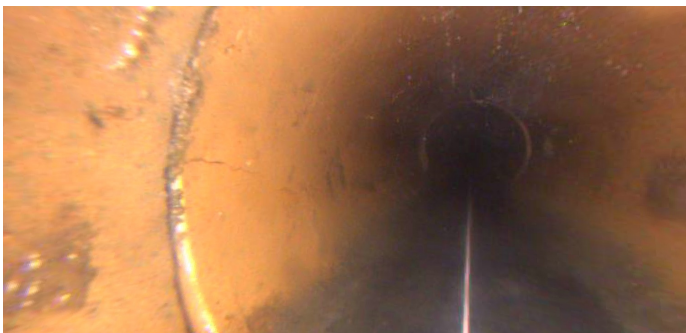
Code: **FL**
Description: **Fracture Longitudinal**

Distance (ft): **113.4**
Structural Grade: **3**
O&M Grade: **0**
Clock Start/From: **3**
Clock To:
1st Value:
2nd Value:
Value Percent:
Continuous Index:
Within 8" of Joint: **YES**
Remarks:

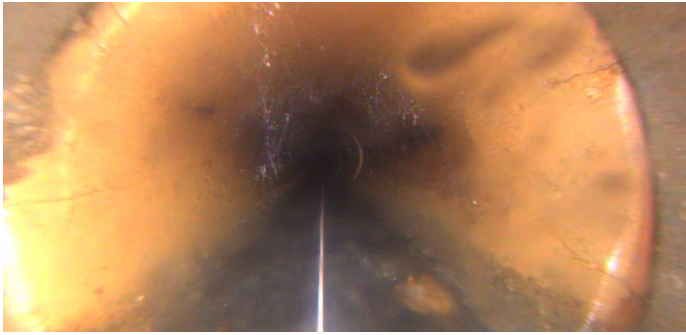
Code: **FM**
Description: **Fracture Multiple**

Distance (ft): **117.7**
Structural Grade: **4**
O&M Grade: **0**
Clock Start/From: **8**
Clock To: **4**
1st Value:
2nd Value:
Value Percent:
Continuous Index:
Within 8" of Joint: **YES**
Remarks:

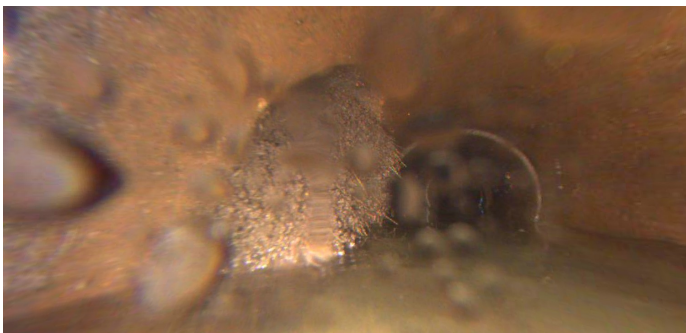
Code: **TFD**
Description: **Tap Factory Defective**

Distance (ft): **124.7**
Structural Grade: **0**
O&M Grade: **2**
Clock Start/From: **9**
Clock To:
1st Value: **4.000**
2nd Value:
Value Percent:
Continuous Index:
Within 8" of Joint:
Remarks: **ROOTS**

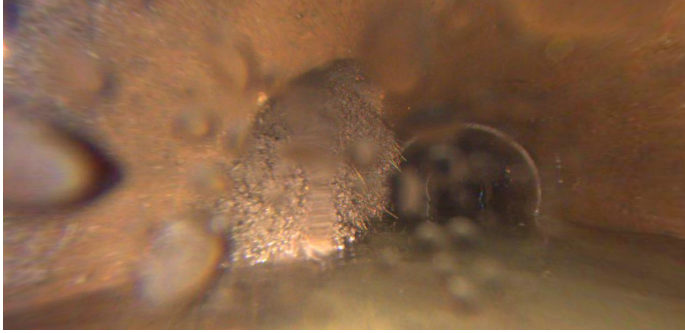
Code: **RML**
Description: **Roots Medium Lateral**

Distance (ft): **124.7**
Structural Grade: **0**
O&M Grade: **3**
Clock Start/From: **8**
Clock To: **10**
1st Value:
2nd Value:
Value Percent: **10.000**
Continuous Index:
Within 8" of Joint: **NO**
Remarks:

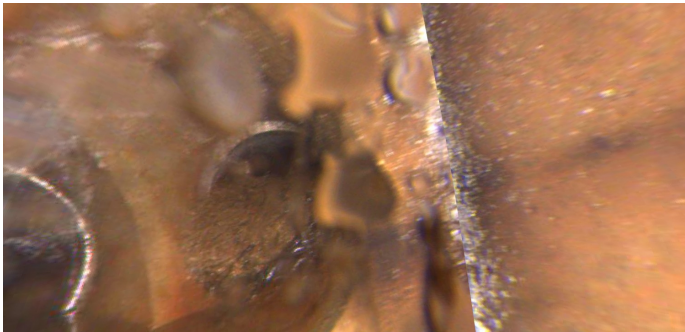
Code: **TF**
Description: **Tap Factory**

Distance (ft): **126.9**
Structural Grade: **0**
O&M Grade: **0**
Clock Start/From: **3**
Clock To:
1st Value: **4.000**
2nd Value:
Value Percent:
Continuous Index:
Within 8" of Joint:
Remarks:

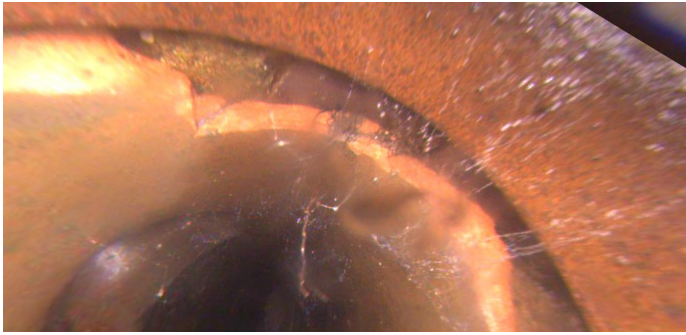
Code: **B**
Description: **Broken**

Distance (ft): **128.4**
Structural Grade: **5**
O&M Grade: **0**
Clock Start/From: **9**
Clock To: **1**
1st Value:
2nd Value:
Value Percent:
Continuous Index:
Within 8" of Joint: **YES**
Remarks:

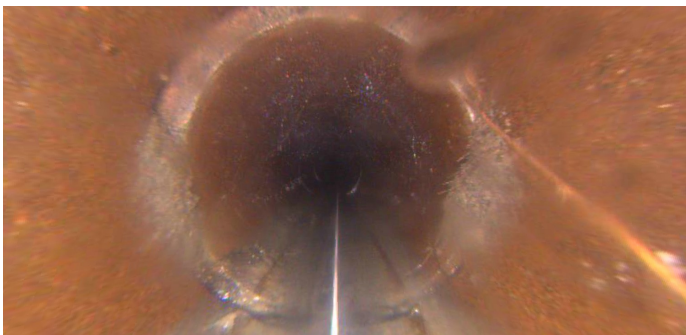
Code: **RMJ**
Description: **Roots Medium Joint**

Distance (ft): **134.8**
Structural Grade: **0**
O&M Grade: **3**
Clock Start/From: **8**
Clock To: **4**
1st Value:
2nd Value:
Value Percent: **5.000**
Continuous Index:
Within 8" of Joint: **YES**
Remarks:

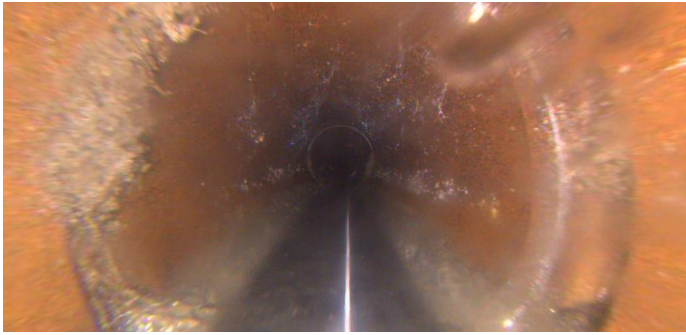
Code: **RMJ**
Description: **Roots Medium Joint**

Distance (ft): **136.7**
Structural Grade: **0**
O&M Grade: **3**
Clock Start/From: **8**
Clock To: **4**
1st Value:
2nd Value:
Value Percent: **5.000**
Continuous Index:
Within 8" of Joint: **YES**
Remarks:

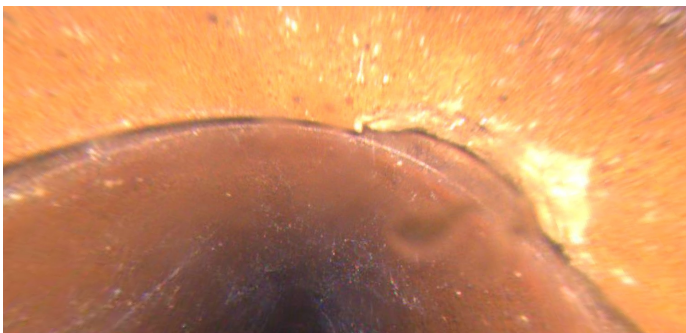
Code: **SSS**
Description: **Surface Spalling**

Distance (ft): **153.1**
Structural Grade: **2**
O&M Grade: **0**
Clock Start/From: **11**
Clock To: **12**
1st Value:
2nd Value:
Value Percent:
Continuous Index:
Within 8" of Joint: **YES**
Remarks:

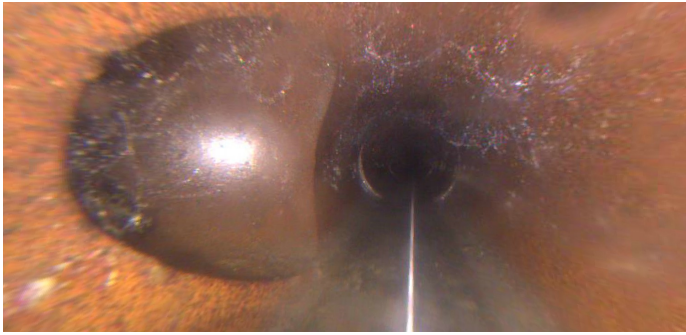
Code: **TF**
Description: **Tap Factory**

Distance (ft): **168.9**
Structural Grade: **0**
O&M Grade: **0**
Clock Start/From: **3**
Clock To:
1st Value: **4.000**
2nd Value:
Value Percent:
Continuous Index:
Within 8" of Joint:
Remarks:

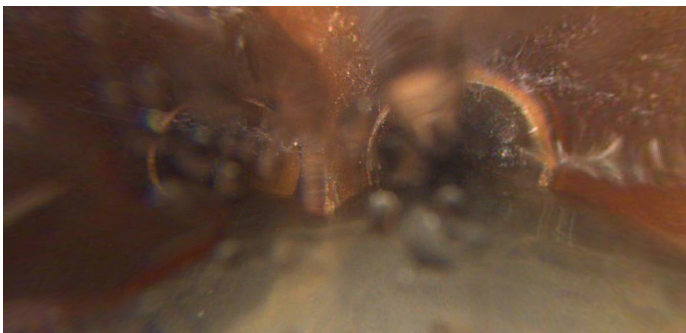
Code: **TFA**
Description: **Tap Factory Active**

Distance (ft): **170.4**
Structural Grade: **0**
O&M Grade: **0**
Clock Start/From: **9**
Clock To:
1st Value: **4.000**
2nd Value:
Value Percent:
Continuous Index:
Within 8" of Joint:
Remarks:

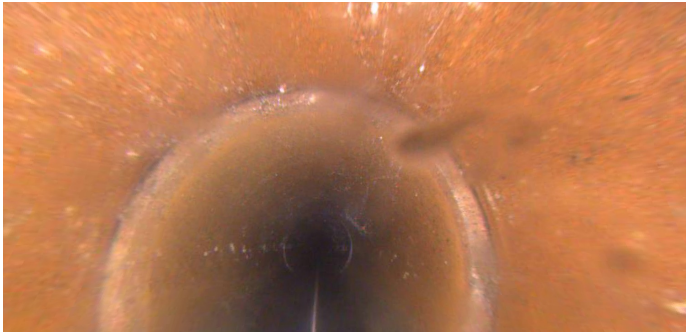
Code: **CM**
Description: **Crack Multiple**

Distance (ft): **192.3**
Structural Grade: **3**
O&M Grade: **0**
Clock Start/From: **8**
Clock To: **4**
1st Value:
2nd Value:
Value Percent:
Continuous Index:
Within 8" of Joint: **YES**
Remarks:

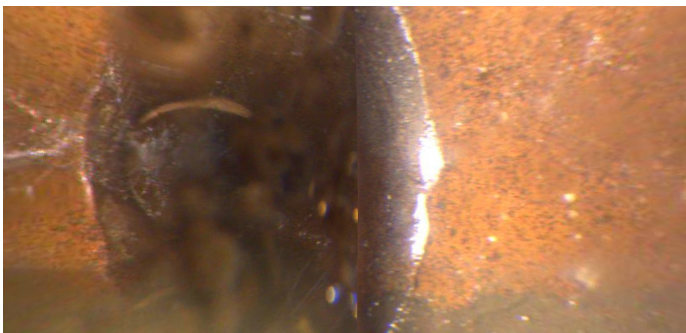
Code: **TFA**
Description: **Tap Factory Active**

Distance (ft): **209.4**
Structural Grade: **0**
O&M Grade: **0**
Clock Start/From: **3**
Clock To:
1st Value: **4.000**
2nd Value:
Value Percent:
Continuous Index:
Within 8" of Joint:
Remarks:

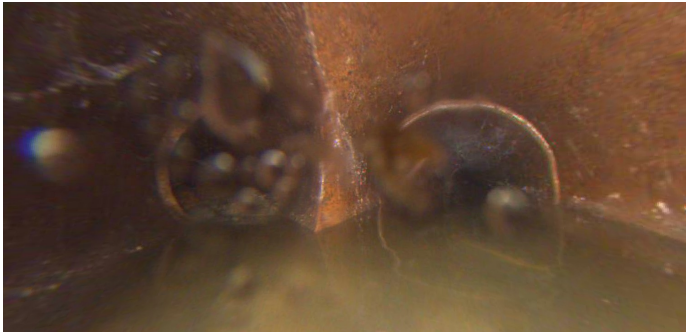
Code: **TFA**
Description: **Tap Factory Active**

Distance (ft): **211.6**
Structural Grade: **0**
O&M Grade: **0**
Clock Start/From: **9**
Clock To:
1st Value: **4.000**
2nd Value:
Value Percent:
Continuous Index:
Within 8" of Joint:
Remarks:

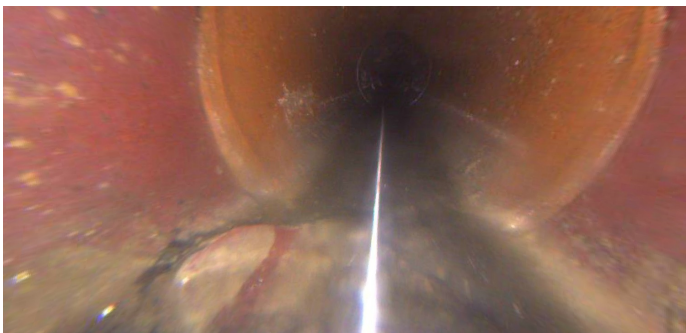
Code: **OBM**
Description: **Obstacle Pipe Material**

Distance (ft): **233.6**
Structural Grade: **0**
O&M Grade: **2**
Clock Start/From: **4**
Clock To: **5**
1st Value:
2nd Value:
Value Percent: **5.000**
Continuous Index:
Within 8" of Joint: **NO**
Remarks:

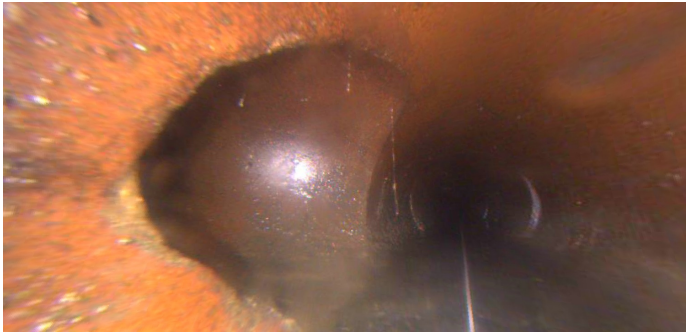
Code: **TFA**
Description: **Tap Factory Active**

Distance (ft): **251.5**
Structural Grade: **0**
O&M Grade: **0**
Clock Start/From: **3**
Clock To:
1st Value: **4.000**
2nd Value:
Value Percent:
Continuous Index:
Within 8" of Joint: **NO**
Remarks:

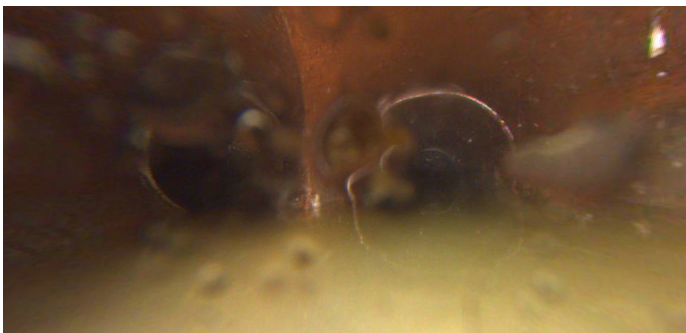
Code: **TFA**
Description: **Tap Factory Active**

Distance (ft): **252.9**
Structural Grade: **0**
O&M Grade: **0**
Clock Start/From: **9**
Clock To:
1st Value: **4.000**
2nd Value:
Value Percent:
Continuous Index:
Within 8" of Joint:
Remarks:

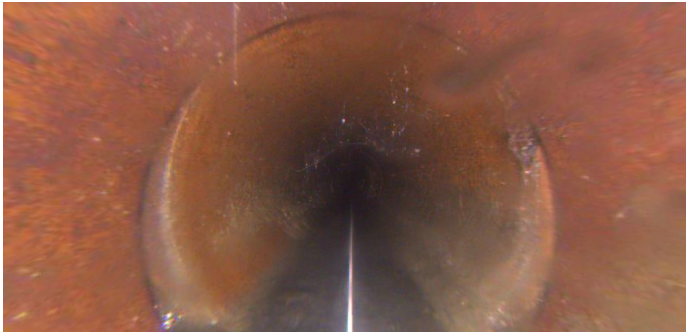
Code: **RFJ**
Description: **Roots Fine Joint**

Distance (ft): **256.3**
Structural Grade: **0**
O&M Grade: **1**
Clock Start/From: **10**
Clock To:
1st Value:
2nd Value:
Value Percent:
Continuous Index:
Within 8" of Joint: **YES**
Remarks:

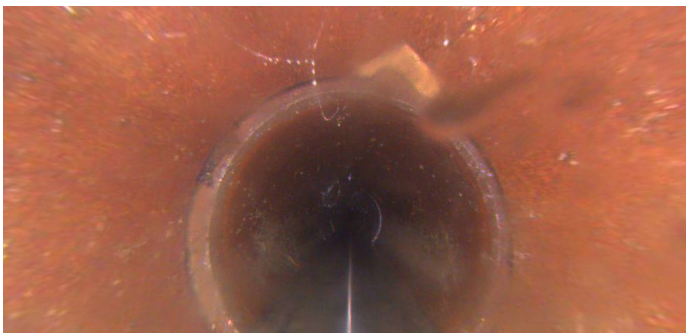
Code: **SSS**
Description: **Surface Spalling**

Distance (ft): **260.6**
Structural Grade: **2**
O&M Grade: **0**
Clock Start/From: **12**
Clock To:
1st Value:
2nd Value:
Value Percent:
Continuous Index:
Within 8" of Joint: **YES**
Remarks:

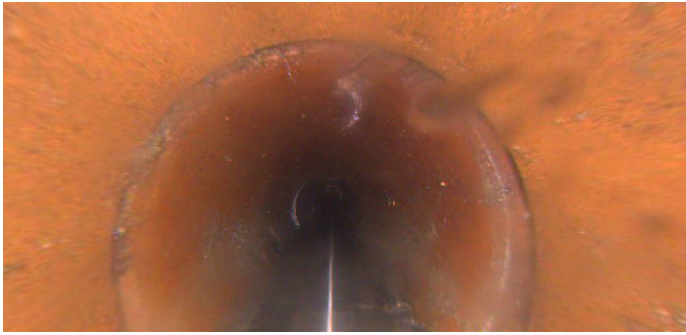
Code: **RFJ**
Description: **Roots Fine Joint**

Distance (ft): **266.7**
Structural Grade: **0**
O&M Grade: **1**
Clock Start/From: **8**
Clock To: **4**
1st Value:
2nd Value:
Value Percent:
Continuous Index:
Within 8" of Joint: **YES**
Remarks:

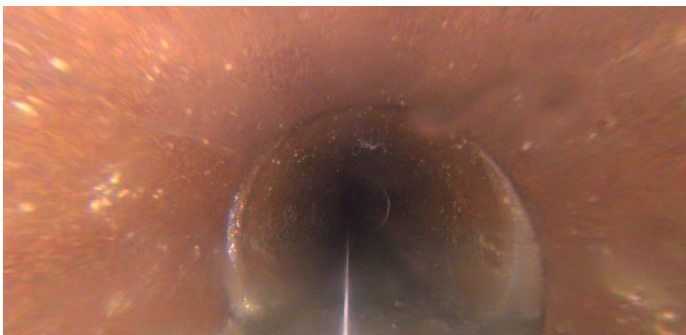
Code: **JOM**
Description: **Joint Offset Medium**

Distance (ft): **271.0**
Structural Grade: **1**
O&M Grade: **0**
Clock Start/From:
Clock To:
1st Value:
2nd Value:
Value Percent:
Continuous Index:
Within 8" of Joint: **NO**
Remarks:

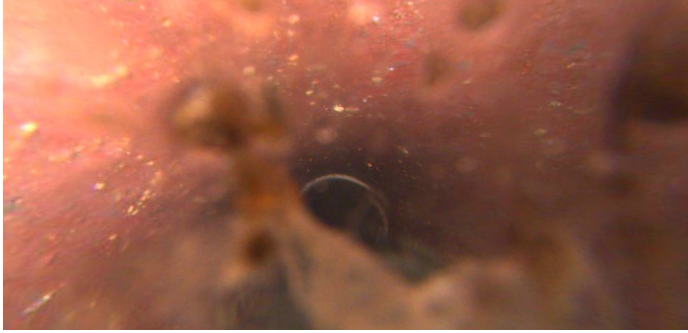
Code:	MSA
Description:	Abandoned Survey
Distance (ft):	275.6
Structural Grade:	0
O&M Grade:	0
Clock Start/From:	
Clock To:	
1st Value:	
2nd Value:	
Value Percent:	
Continuous Index:	
Within 8" of Joint:	NO
Remarks:	DEBRIS UNDER WATER
