## Profile/Photo Observation Report

Date:	<b>03/30/2018</b>	Weather:		Coding:	<b>PACP 6.0</b>
Pipe Length (ft):	<b>211.4</b>	Owner:	<b>NA</b>	Pre Clean:	<b>Not Known</b>
P.O.#:		Surveyor:	<b>Jen Costello</b>	PSR:	<b>P-707-035-081</b>
Customer:		Clean Date:	<b>01/01/1900</b>	Shape:	<b>C</b>

Street:	<b>State</b>	Flow Control:	<b>Not Controlled</b>
City:	<b>Hobart, IN</b>	Year Renewed:	
Location:	<b>Light Highway</b>	Tape/Media #:	
Purpose:	<b>Maintenance Related</b>	Dia/Height:	<b>12"</b>
Use:	<b>Sanitary</b>	Material:	<b>VCP</b>
Drain Area:	<b>NA</b>	Lining:	<b>Cured in Place</b>
Category:	<b>NA</b>		
Comment:	<b>Flow direction wrong.</b>

Location Details:		Direction of Survey:	<b>Upstream</b>
US MH:	<b>M-707-081</b>	DS MH:	<b>M-707-035</b>
		Total Length Surveyed (ft):	<b>164.1</b>

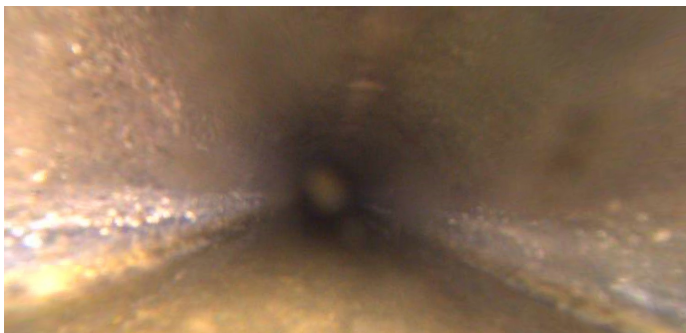
Code: **AMH**  
Description: **Manhole**

Distance (ft): **.0**  
Structural Grade: **0**  
O&M Grade: **0**  
Clock Start/From:  
Clock To:  
1st Value:  
2nd Value:  
Value Percent:  
Continuous Index:  
Within 8" of Joint: **NO**  
Remarks: **M-707-035**

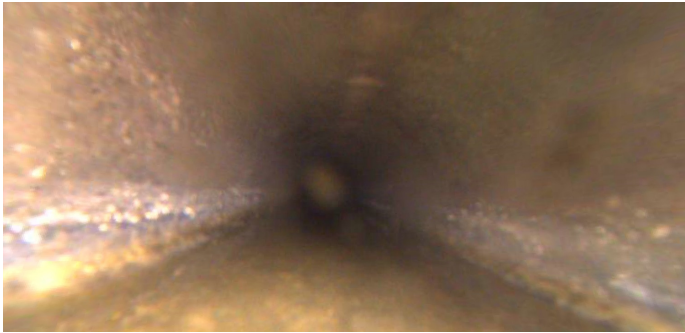
Code:	<b>MWL</b>
Description:	<b>Water Level</b>

Distance (ft):	<b>.0</b>
Structural Grade:	<b>0</b>
O&M Grade:	<b>0</b>
Clock Start/From:	
Clock To:	
1st Value:	
2nd Value:	
Value Percent:	<b>20.000</b>
Continuous Index:	
Within 8" of Joint:	<b>NO</b>
Remarks:

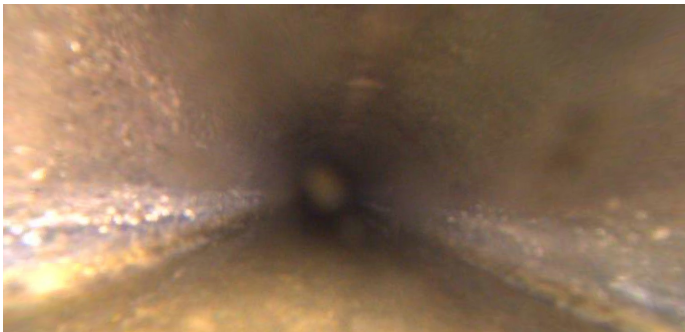
Code:	<b>DAGS</b>
Description:	<b>Deposits Attached Grease</b>

Distance (ft):	<b>.0</b>
Structural Grade:	<b>0</b>
O&M Grade:	<b>2</b>
Clock Start/From:	<b>8</b>
Clock To:	<b>4</b>
1st Value:	
2nd Value:	
Value Percent:	<b>5.000</b>
Continuous Index:	<b>S01</b>
Within 8" of Joint:	<b>NO</b>
Remarks:

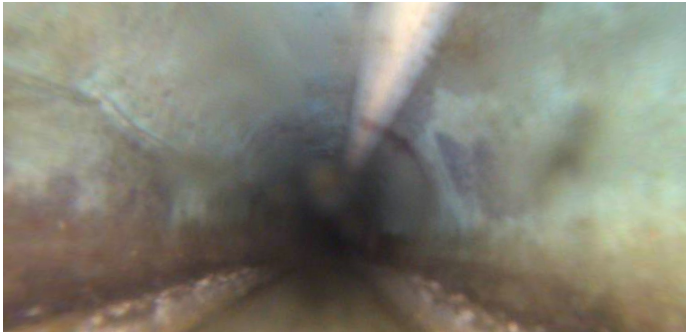
Code: **LFW**  
Description: **Lining Failure Wrinkled**

Distance (ft): **18.2**  
Structural Grade: **3**  
O&M Grade: **0**  
Clock Start/From: **10**  
Clock To:  
1st Value:  
2nd Value:  
Value Percent:  
Continuous Index: **S02**  
Within 8" of Joint: **NO**  
Remarks:

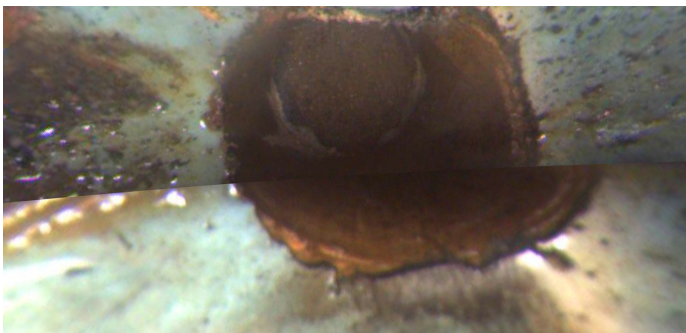
Code: **TB**  
Description: **Tap Break-in**

Distance (ft): **31.5**  
Structural Grade: **0**  
O&M Grade: **0**  
Clock Start/From: **12**  
Clock To:  
1st Value: **4.000**  
2nd Value:  
Value Percent:  
Continuous Index:  
Within 8" of Joint:  
Remarks:

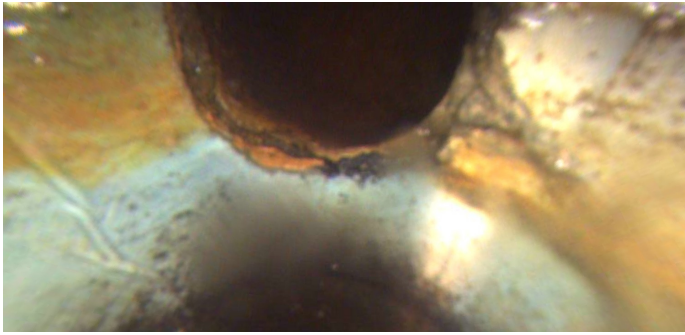
Code: **TB**  
Description: **Tap Break-in**

Distance (ft): **35.7**  
Structural Grade: **0**  
O&M Grade: **0**  
Clock Start/From: **12**  
Clock To:  
1st Value: **4.000**  
2nd Value:  
Value Percent:  
Continuous Index:  
Within 8" of Joint:  
Remarks:

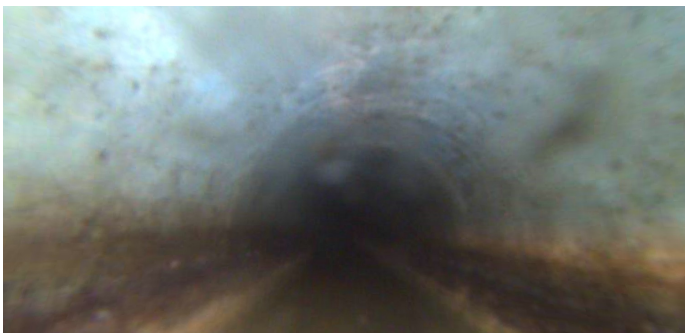
Code: **LFW**  
Description: **Lining Failure Wrinkled**

Distance (ft): **55.8**  
Structural Grade: **3**  
O&M Grade: **0**  
Clock Start/From: **10**  
Clock To:  
1st Value:  
2nd Value:  
Value Percent:  
Continuous Index: **F02**  
Within 8" of Joint: **NO**  
Remarks:

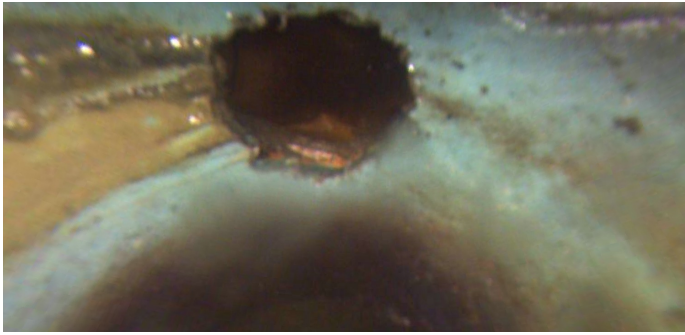
Code: **TBA**  
Description: **Tap Break-in Active**

Distance (ft): **74.4**  
Structural Grade: **0**  
O&M Grade: **0**  
Clock Start/From: **12**  
Clock To:  
1st Value: **4.000**  
2nd Value:  
Value Percent:  
Continuous Index:  
Within 8" of Joint:  
Remarks:

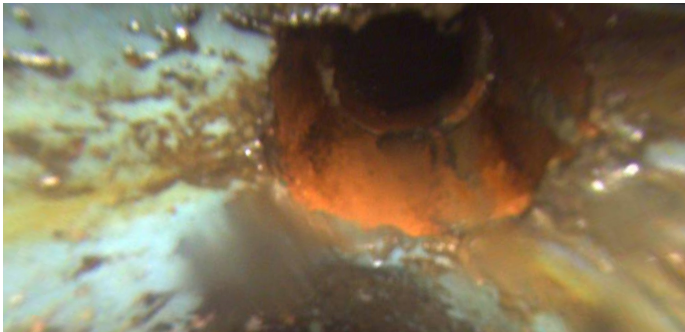
Code: **TB**  
Description: **Tap Break-in**

Distance (ft): **124.9**  
Structural Grade: **0**  
O&M Grade: **0**  
Clock Start/From: **12**  
Clock To:  
1st Value: **4.000**  
2nd Value:  
Value Percent:  
Continuous Index:  
Within 8" of Joint:  
Remarks:

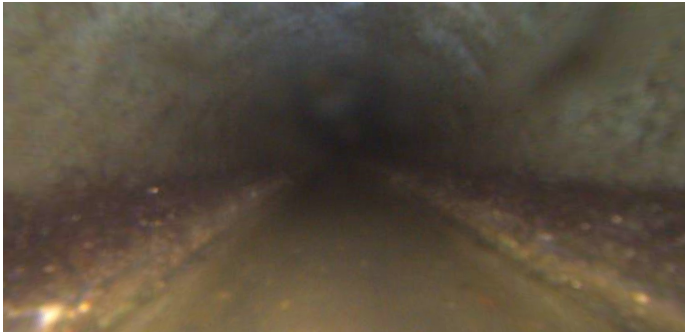
Code: **DAGS**  
Description: **Deposits Attached Grease**

Distance (ft): **164.1**  
Structural Grade: **0**  
O&M Grade: **2**  
Clock Start/From: **8**  
Clock To: **4**  
1st Value:  
2nd Value:  
Value Percent: **5.000**  
Continuous Index: **F01**  
Within 8" of Joint: **NO**  
Remarks:

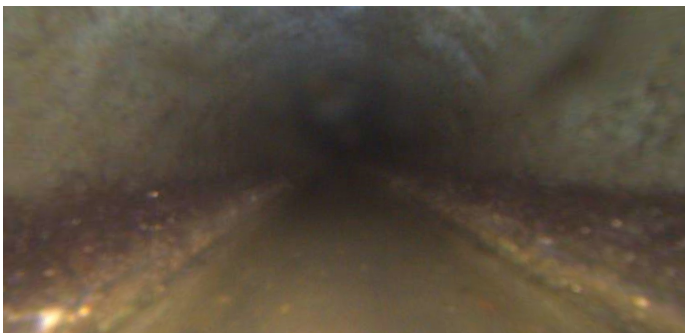
Code: **MSA**  
Description: **Abandoned Survey**

Distance (ft): **164.1**  
Structural Grade: **0**  
O&M Grade: **0**  
Clock Start/From:  
Clock To:  
1st Value:  
2nd Value:  
Value Percent:  
Continuous Index:  
Within 8" of Joint: **NO**  
Remarks: **unknown**
