Profile/Photo Observation Report

Street:	STATE ST	Flow Control:	Not Controlled
City:	Hobart, IN	Year Renewed:	
Location:	Light Highway	Tape/Media #:	
Purpose:	Maintenance Related	Dia/Height:	12"
Use:	Sanitary	Material:	VCP
Drain Area:	NA	Lining:	Cured in Place
Category:	NA		
Comment:	Flow direction wrong. Reverse setup.		
Location Details:		Direction of Survey:	Downstream
US MH:	M-707-081	DS MH:	M-707-035
		Total Length Surveyed (ft):	29.5

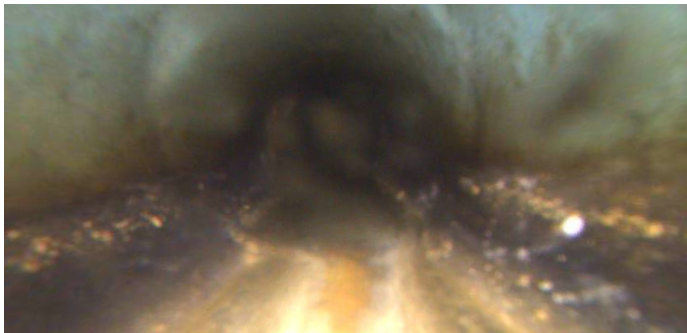
Code: **AMH**
 Description: **Manhole**
 Distance (ft): **.0**
 Structural Grade: **0**
 O&M Grade: **0**
 Clock Start/From:
 Clock To:
 1st Value:
 2nd Value:
 Value Percent:
 Continuous Index:
 Within 8" of Joint: **NO**
 Remarks: **M-707-081**

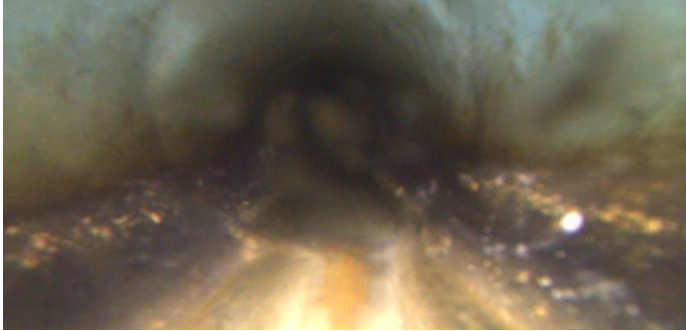
Code: **MWL**
Description: **Water Level**

Distance (ft): **.0**
Structural Grade: **0**
O&M Grade: **0**
Clock Start/From:
Clock To:
1st Value:
2nd Value:
Value Percent: **5.000**
Continuous Index:
Within 8" of Joint: **NO**
Remarks:

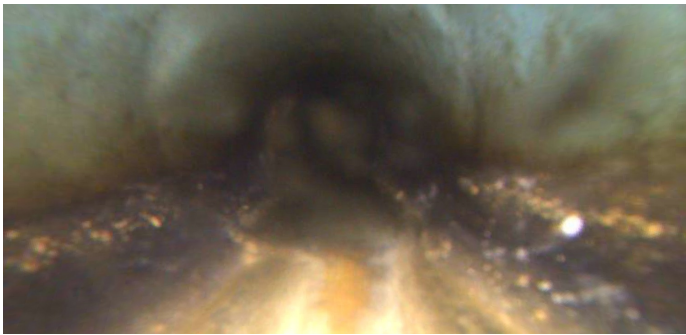
Code: **DAGS**
Description: **Deposits Attached Grease**

Distance (ft): **.0**
Structural Grade: **0**
O&M Grade: **2**
Clock Start/From: **7**
Clock To: **5**
1st Value:
2nd Value:
Value Percent: **5.000**
Continuous Index: **S01**
Within 8" of Joint: **NO**
Remarks:

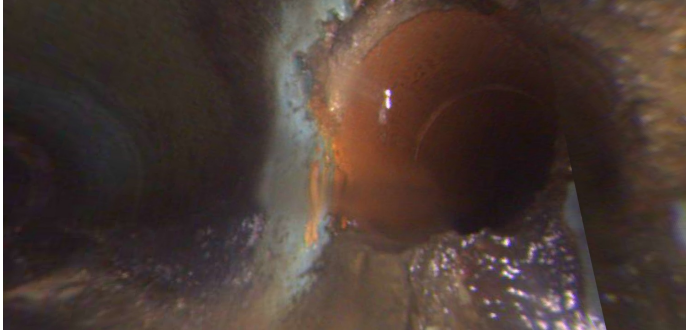
Code: **TBA**
Description: **Tap Break-in Active**

Distance (ft): **3.3**
Structural Grade: **0**
O&M Grade: **0**
Clock Start/From: **9**
Clock To:
1st Value: **4.000**
2nd Value:
Value Percent:
Continuous Index:
Within 8" of Joint:
Remarks:

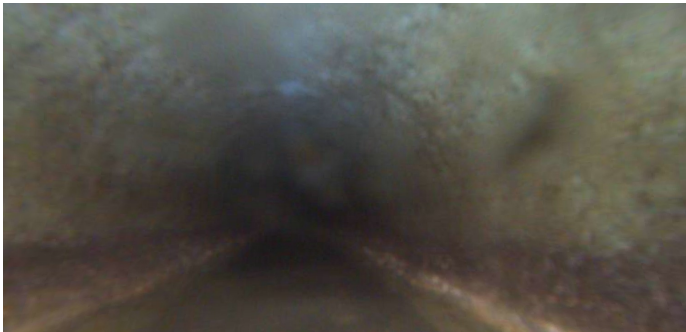
Code: **MSA**
Description: **Abandoned Survey**

Distance (ft): **29.5**
Structural Grade: **0**
O&M Grade: **0**
Clock Start/From:
Clock To:
1st Value:
2nd Value:
Value Percent:
Continuous Index:
Within 8" of Joint: **NO**
Remarks: **debris under water**

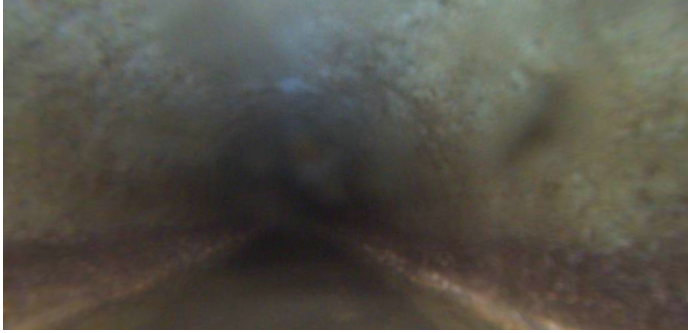
Code:	DAGS
Description:	Deposits Attached Grease
Distance (ft):	29.5
Structural Grade:	0
O&M Grade:	2
Clock Start/From:	7
Clock To:	5
1st Value:	
2nd Value:	
Value Percent:	5.000
Continuous Index:	F01
Within 8" of Joint:	NO
Remarks:
