## Profile/Photo Observation Report

Date:	<b>03/30/2018</b>	Weather:		Coding:	<b>PACP 6.0</b>
Pipe Length (ft):	<b>211.4</b>	Owner:	<b>NA</b>	Pre Clean:	<b>Not Known</b>
P.O.#:		Surveyor:	<b>Jen Costello</b>	PSR:	<b>P-707-035-081</b>
Customer:		Clean Date:	<b>01/01/1900</b>	Shape:	<b>C</b>

Street:	<b>State</b>	Flow Control:	<b>Not Controlled</b>
City:	<b>Hobart, IN</b>	Year Renewed:	
Location:	<b>Light Highway</b>	Tape/Media #:	
Purpose:	<b>Maintenance Related</b>	Dia/Height:	<b>12"</b>
Use:	<b>Sanitary</b>	Material:	<b>VCP</b>
Drain Area:	<b>NA</b>	Lining:	<b>Cured in Place</b>
Category:	<b>NA</b>		
Comment:	<b>Flow direction wrong. Reverse setup.</b>		
Location Details:		Direction of Survey:	<b>Downstream</b>
US MH:	<b>M-707-081</b>	DS MH:	<b>M-707-035</b>
		Total Length Surveyed (ft):	<b>29.5</b>

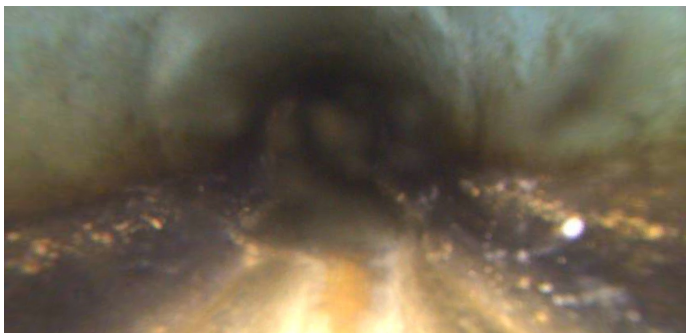
Code: **AMH**  
Description: **Manhole**

Distance (ft): **.0**  
Structural Grade: **0**  
O&M Grade: **0**  
Clock Start/From:  
Clock To:  
1st Value:  
2nd Value:  
Value Percent:  
Continuous Index:  
Within 8" of Joint: **NO**  
Remarks: **M-707-081**

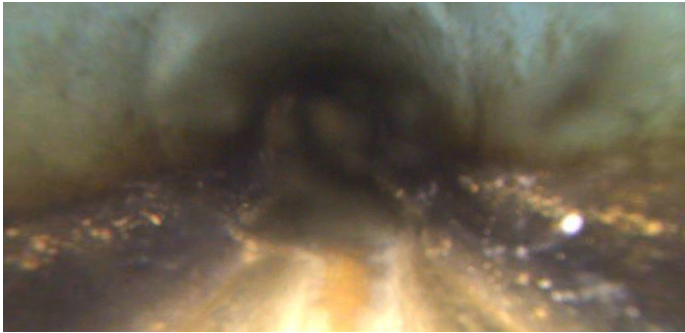
Code:	<b>MWL</b>
Description:	<b>Water Level</b>

Distance (ft):	<b>.0</b>
Structural Grade:	<b>0</b>
O&M Grade:	<b>0</b>
Clock Start/From:	
Clock To:	
1st Value:	
2nd Value:	
Value Percent:	<b>5.000</b>
Continuous Index:	
Within 8" of Joint:	<b>NO</b>
Remarks:

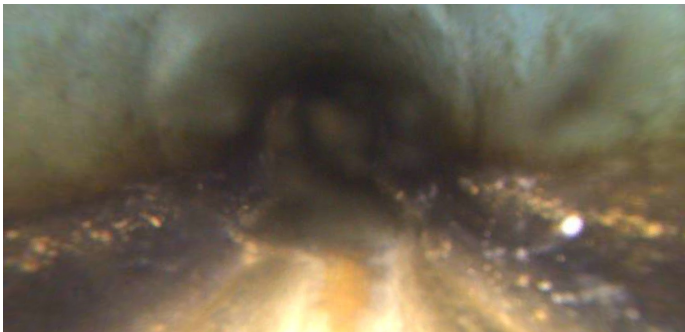
Code:	<b>DAGS</b>
Description:	<b>Deposits Attached Grease</b>

Distance (ft):	<b>.0</b>
Structural Grade:	<b>0</b>
O&M Grade:	<b>2</b>
Clock Start/From:	<b>7</b>
Clock To:	<b>5</b>
1st Value:	
2nd Value:	
Value Percent:	<b>5.000</b>
Continuous Index:	<b>S01</b>
Within 8" of Joint:	<b>NO</b>
Remarks:

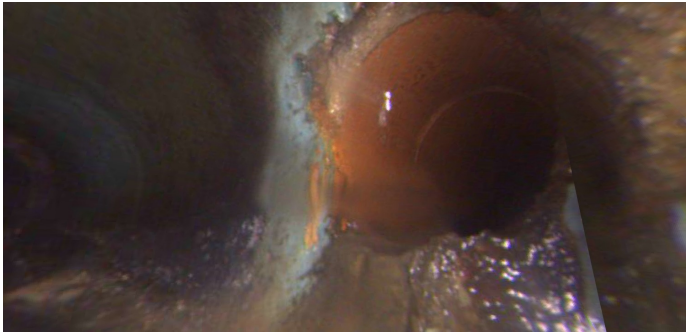
Code: **TBA**  
Description: **Tap Break-in Active**

Distance (ft): **3.3**  
Structural Grade: **0**  
O&M Grade: **0**  
Clock Start/From: **9**  
Clock To:  
1st Value: **4.000**  
2nd Value:  
Value Percent:  
Continuous Index:  
Within 8" of Joint:  
Remarks:

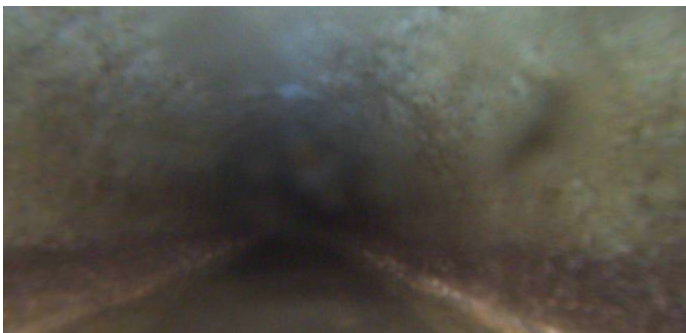
Code: **MSA**  
Description: **Abandoned Survey**

Distance (ft): **29.5**  
Structural Grade: **0**  
O&M Grade: **0**  
Clock Start/From:  
Clock To:  
1st Value:  
2nd Value:  
Value Percent:  
Continuous Index:  
Within 8" of Joint: **NO**  
Remarks: **debris under water**

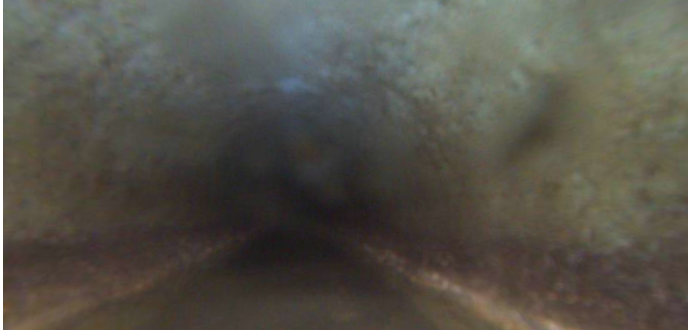
Code:	<b>DAGS</b>
Description:	<b>Deposits Attached Grease</b>
Distance (ft):	<b>29.5</b>
Structural Grade:	<b>0</b>
O&M Grade:	<b>2</b>
Clock Start/From:	<b>7</b>
Clock To:	<b>5</b>
1st Value:	
2nd Value:	
Value Percent:	<b>5.000</b>
Continuous Index:	<b>F01</b>
Within 8" of Joint:	<b>NO</b>
Remarks:
