Profile/Photo Observation Report

Street:	Lincoln	Flow Control:	Not Controlled
City:	Hobart, IN	Year Renewed:	
Location:	Light Highway	Tape/Media #:	
Purpose:	Maintenance Related	Dia/Height:	8"
Use:	Sanitary	Material:	PVC
Drain Area:	NA	Lining:	
Category:	NA		
Comment:	Flow direction wrong. Reverse setup.

Location Details:		Direction of Survey:	Upstream
US MH:	M-708-002	DS MH:	M-708-001
		Total Length Surveyed (ft):	380.4

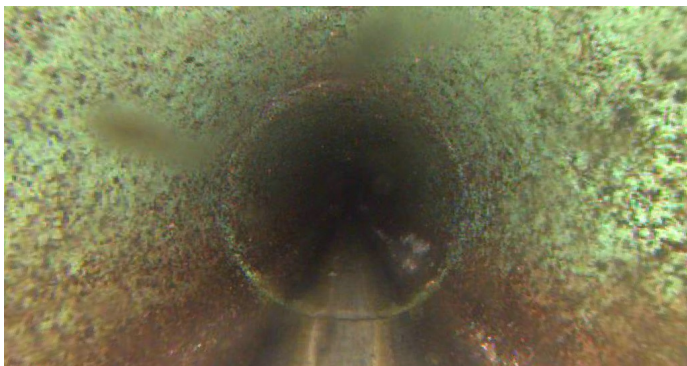
Code: **AMH**
 Description: **Manhole**

Distance (ft): **.0**
 Structural Grade: **0**
 O&M Grade: **0**
 Clock Start/From:
 Clock To:
 1st Value:
 2nd Value:
 Value Percent:
 Continuous Index:
 Within 8" of Joint: **NO**
 Remarks: **M-708-001**

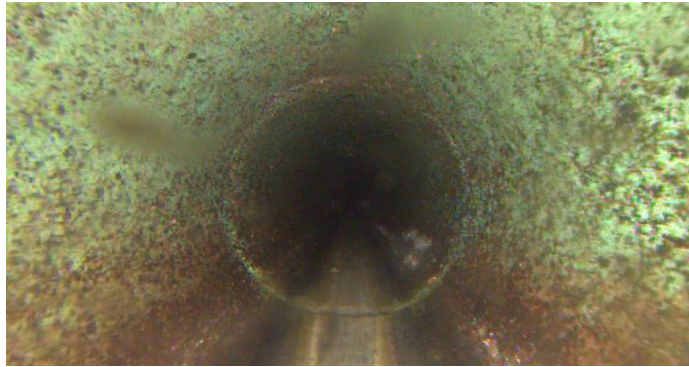
Code: **MWL**
Description: **Water Level**

Distance (ft): **.0**
Structural Grade: **0**
O&M Grade: **0**
Clock Start/From:
Clock To:
1st Value:
2nd Value:
Value Percent: **10.000**
Continuous Index:
Within 8" of Joint: **NO**
Remarks:

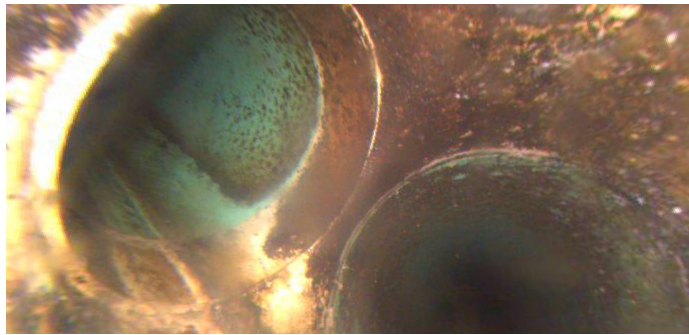
Code: **TF**
Description: **Tap Factory**

Distance (ft): **50.4**
Structural Grade: **0**
O&M Grade: **0**
Clock Start/From: **2**
Clock To:
1st Value: **4.000**
2nd Value:
Value Percent:
Continuous Index:
Within 8" of Joint:
Remarks:

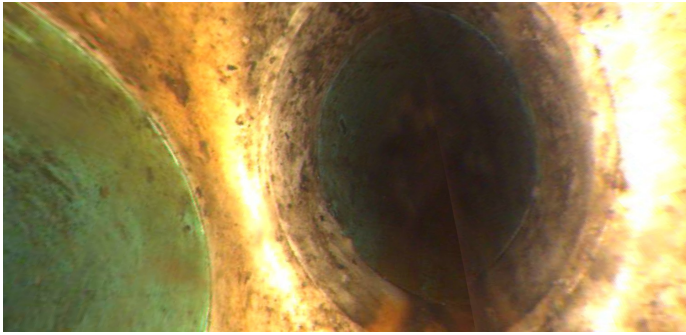
Code: **TF**
Description: **Tap Factory**

Distance (ft): **113.9**
Structural Grade: **0**
O&M Grade: **0**
Clock Start/From: **2**
Clock To:
1st Value: **4.000**
2nd Value:
Value Percent:
Continuous Index:
Within 8" of Joint:
Remarks:

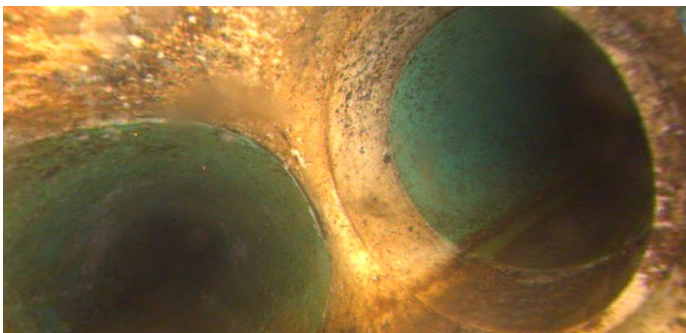
Code: **TF**
Description: **Tap Factory**

Distance (ft): **149.8**
Structural Grade: **0**
O&M Grade: **0**
Clock Start/From: **3**
Clock To:
1st Value: **4.000**
2nd Value:
Value Percent:
Continuous Index:
Within 8" of Joint:
Remarks:

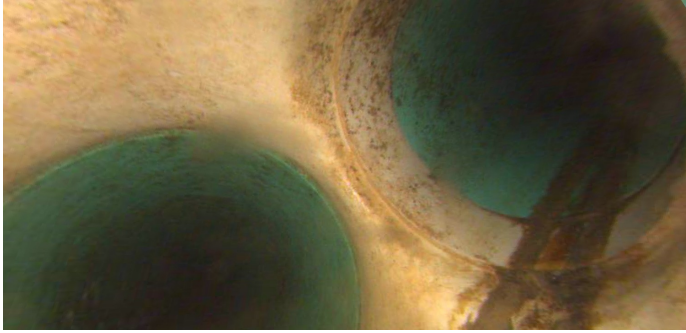
Code: **TF**
Description: **Tap Factory**

Distance (ft): **184.7**
Structural Grade: **0**
O&M Grade: **0**
Clock Start/From: **2**
Clock To:
1st Value: **4.000**
2nd Value:
Value Percent:
Continuous Index:
Within 8" of Joint:
Remarks:

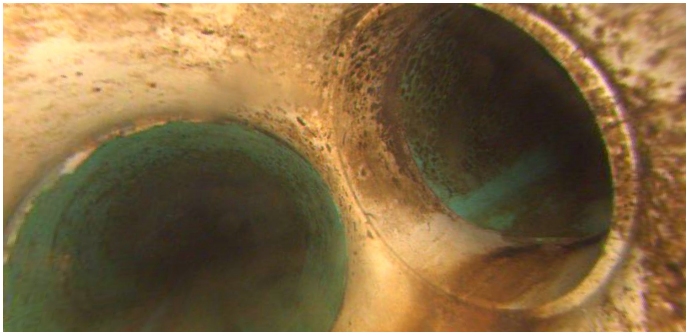
Code: **TF**
Description: **Tap Factory**

Distance (ft): **255.1**
Structural Grade: **0**
O&M Grade: **0**
Clock Start/From: **2**
Clock To:
1st Value: **4.000**
2nd Value:
Value Percent:
Continuous Index:
Within 8" of Joint:
Remarks:

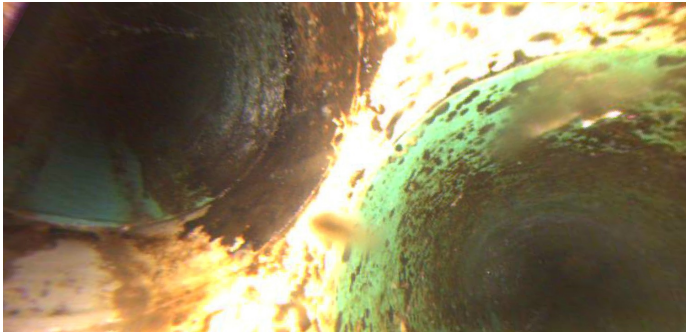
Code: **TF**
Description: **Tap Factory**

Distance (ft): **263.6**
Structural Grade: **0**
O&M Grade: **0**
Clock Start/From: **10**
Clock To:
1st Value: **4.000**
2nd Value:
Value Percent:
Continuous Index:
Within 8" of Joint:
Remarks:

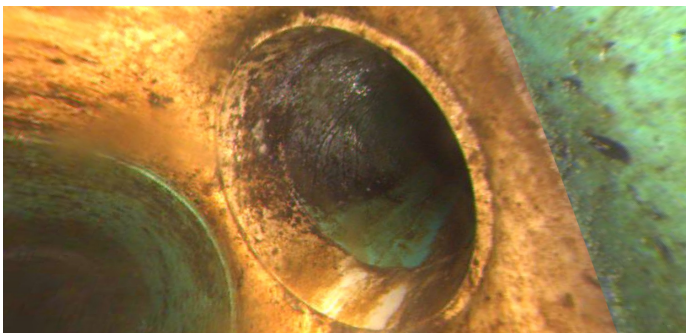
Code: **TF**
Description: **Tap Factory**

Distance (ft): **298.3**
Structural Grade: **0**
O&M Grade: **0**
Clock Start/From: **2**
Clock To:
1st Value: **4.000**
2nd Value:
Value Percent:
Continuous Index:
Within 8" of Joint:
Remarks:

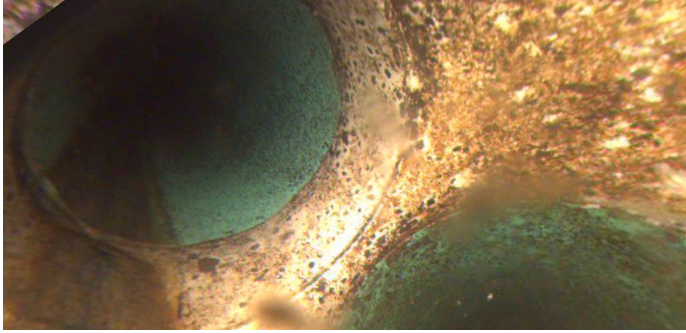
Code: **TF**
Description: **Tap Factory**

Distance (ft): **346.2**
Structural Grade: **0**
O&M Grade: **0**
Clock Start/From: **10**
Clock To:
1st Value: **4.000**
2nd Value:
Value Percent:
Continuous Index:
Within 8" of Joint:
Remarks:

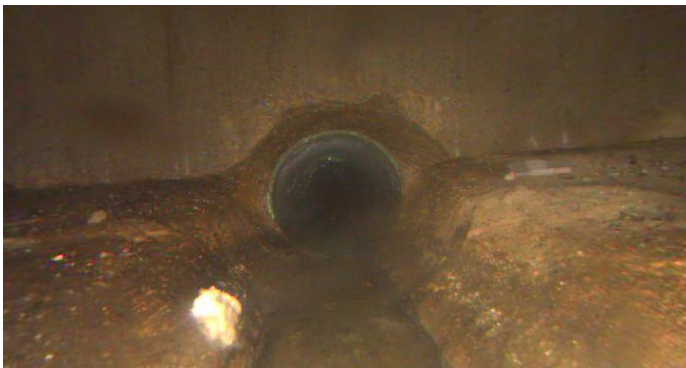
Code: **AMH**
Description: **Manhole**

Distance (ft): **380.4**
Structural Grade: **0**
O&M Grade: **0**
Clock Start/From:
Clock To:
1st Value:
2nd Value:
Value Percent:
Continuous Index:
Within 8" of Joint: **NO**
Remarks: **M-708-002**
