Profile/Photo Observation Report

Date:	03/29/2018	Weather:		Coding:	PACP 6.0
Pipe Length (ft):	355.1	Owner:	NA	Pre Clean:	Not Known
P.O.#:		Surveyor:	Jen Costello	PSR:	P-708-001-002
Customer:		Clean Date:	01/01/1900	Shape:	C

Street:	LINCOLN ST	Flow Control:	Not Controlled
City:	Hobart, IN	Year Renewed:	
Location:	Light Highway	Tape/Media #:	
Purpose:	Maintenance Related	Dia/Height:	12"
Use:	Sanitary	Material:	PVC
Drain Area:	NA	Lining:	
Category:	NA		
Comment:	Debris at 203'.

Location Details:		Direction of Survey:	Downstream
US MH:	M-708-002	DS MH:	M-708-001
		Total Length Surveyed (ft):	204.8

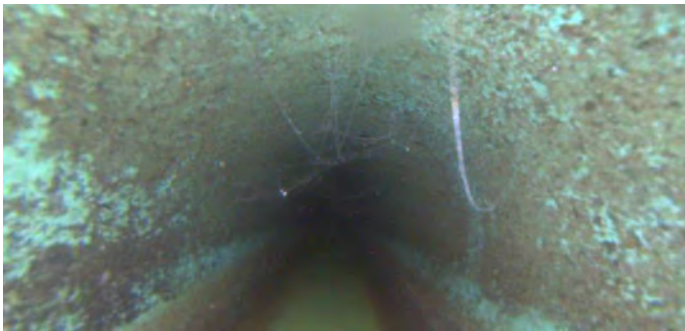
Code: **AMH**
Description: **Manhole**

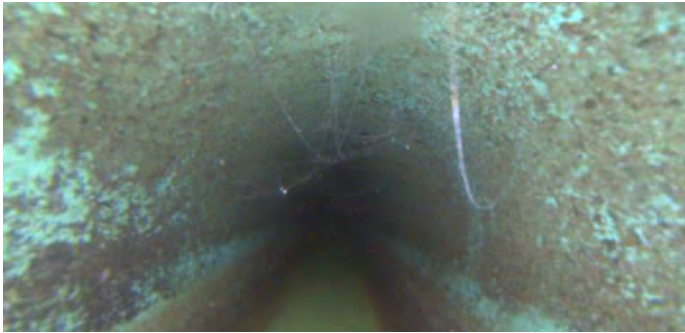
Code:	MWL
Description:	Water Level

Distance (ft):	.0
Structural Grade:	0
O&M Grade:	0
Clock Start/From:	
Clock To:	
1st Value:	
2nd Value:	
Value Percent:	5.000
Continuous Index:	
Within 8" of Joint:	NO
Remarks:

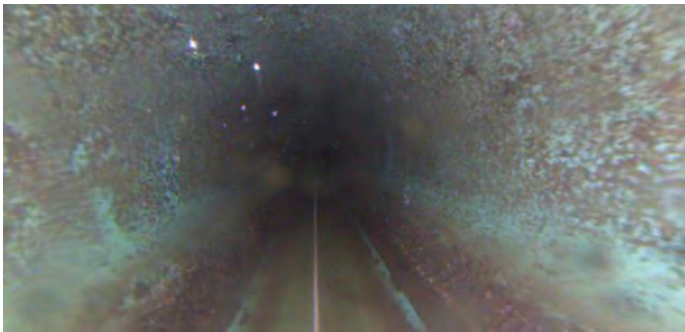
Code:	MGO
Description:	General Observation

Distance (ft):	8.9
Structural Grade:	0
O&M Grade:	0
Clock Start/From:	
Clock To:	
1st Value:	
2nd Value:	
Value Percent:	
Continuous Index:	
Within 8" of Joint:	NO
Remarks:	rear camera

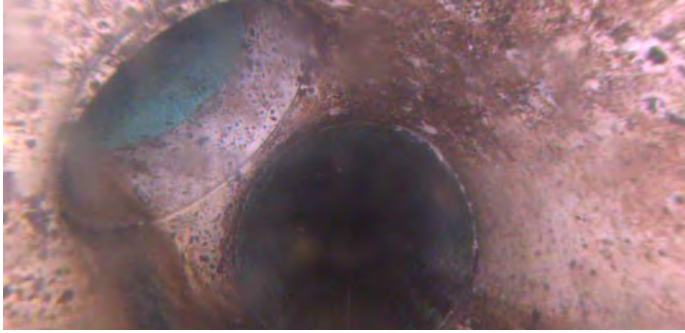
Code: **TF**
Description: **Tap Factory**

Distance (ft): **28.8**
Structural Grade: **0**
O&M Grade: **0**
Clock Start/From: **2**
Clock To:
1st Value: **4.000**
2nd Value:
Value Percent:
Continuous Index:
Within 8" of Joint:
Remarks:

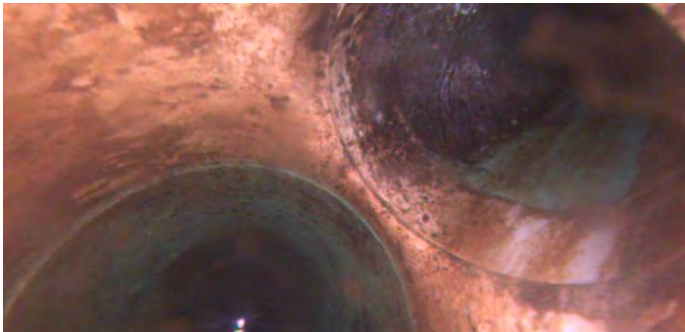
Code: **TF**
Description: **Tap Factory**

Distance (ft): **71.3**
Structural Grade: **0**
O&M Grade: **0**
Clock Start/From: **10**
Clock To:
1st Value: **4.000**
2nd Value:
Value Percent:
Continuous Index:
Within 8" of Joint:
Remarks:

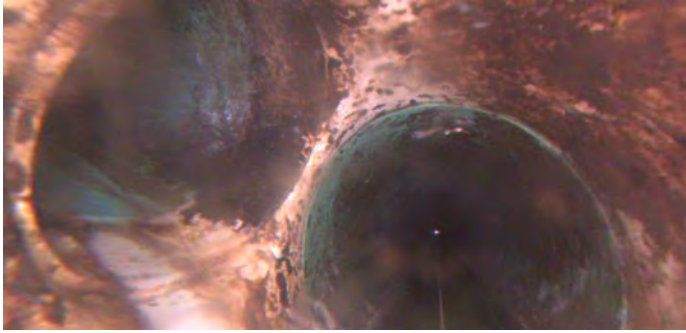
Code: **TF**
Description: **Tap Factory**

Distance (ft): **102.6**
Structural Grade: **0**
O&M Grade: **0**
Clock Start/From: **2**
Clock To:
1st Value: **4.000**
2nd Value:
Value Percent:
Continuous Index:
Within 8" of Joint:
Remarks:

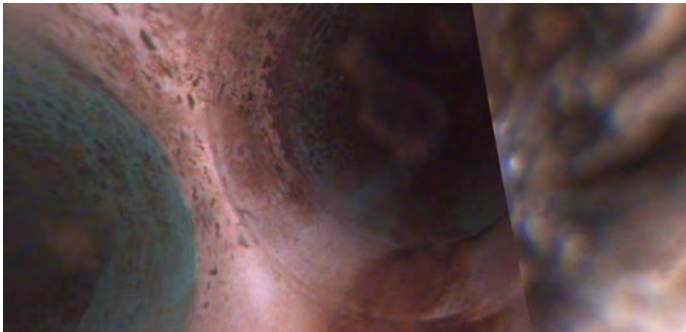
Code: **TF**
Description: **Tap Factory**

Distance (ft): **109.8**
Structural Grade: **0**
O&M Grade: **0**
Clock Start/From: **10**
Clock To:
1st Value: **4.000**
2nd Value:
Value Percent:
Continuous Index:
Within 8" of Joint:
Remarks:

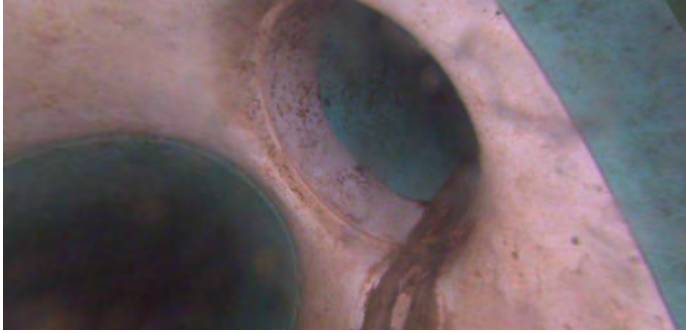
Code: **TF**
Description: **Tap Factory**

Distance (ft): **173.1**
Structural Grade: **0**
O&M Grade: **0**
Clock Start/From: **10**
Clock To:
1st Value: **4.000**
2nd Value:
Value Percent:
Continuous Index:
Within 8" of Joint:
Remarks:

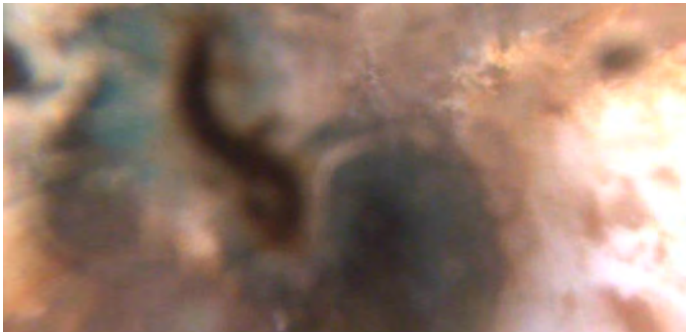
Code: **TF**
Description: **Tap Factory**

Distance (ft): **203.5**
Structural Grade: **0**
O&M Grade: **0**
Clock Start/From: **10**
Clock To:
1st Value: **4.000**
2nd Value:
Value Percent:
Continuous Index:
Within 8" of Joint:
Remarks:
