Profile/Photo Observation Report

Date:	03/29/2018	Weather:		Coding:	PACP 6.0
Pipe Length (ft):	303.1	Owner:	NA	Pre Clean:	Not Known
P.O.#:		Surveyor:	Jen Costello	PSR:	P-708-002-003
Customer:		Clean Date:	01/01/1900	Shape:	C

Street:	LINCOLN ST	Flow Control:	Not Controlled
City:	Hobart, IN	Year Renewed:	
Location:	Light Highway	Tape/Media #:	
Purpose:	Maintenance Related	Dia/Height:	12"
Use:	Sanitary	Material:	PVC
Drain Area:	NA	Lining:	
Category:	NA		
Comment:	Flow direction wrong.

Location Details:		Direction of Survey:	Upstream
US MH:	M-708-003	DS MH:	M-708-002
		Total Length Surveyed (ft):	330.1

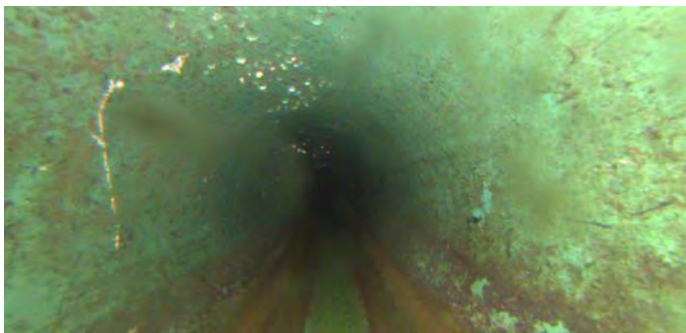
Code: **AMH**
Description: **Manhole**

Distance (ft): **.0**
Structural Grade: **0**
O&M Grade: **0**
Clock Start/From:
Clock To:
1st Value:
2nd Value:
Value Percent:
Continuous Index:
Within 8" of Joint: **NO**
Remarks: **M-708-002**

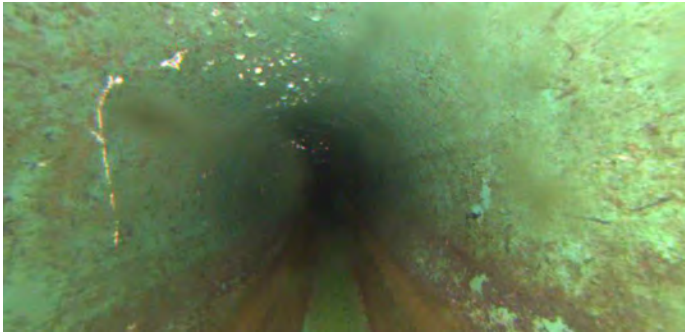
Code:	MWL
Description:	Water Level

Distance (ft):	.0
Structural Grade:	0
O&M Grade:	0
Clock Start/From:	
Clock To:	
1st Value:	
2nd Value:	
Value Percent:	5.000
Continuous Index:	
Within 8" of Joint:	NO
Remarks:

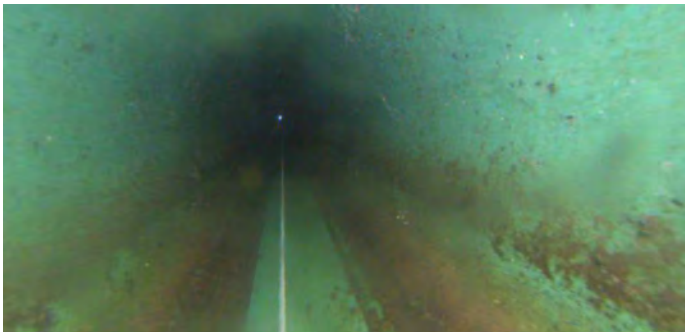
Code:	MGO
Description:	General Observation

Distance (ft):	23.1
Structural Grade:	0
O&M Grade:	0
Clock Start/From:	
Clock To:	
1st Value:	
2nd Value:	
Value Percent:	
Continuous Index:	
Within 8" of Joint:	NO
Remarks:	rear camera

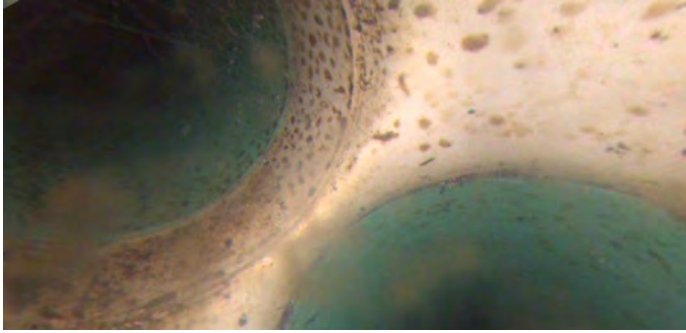
Code: **TF**
Description: **Tap Factory**

Distance (ft): **42.9**
Structural Grade: **0**
O&M Grade: **0**
Clock Start/From: **2**
Clock To:
1st Value: **4.000**
2nd Value:
Value Percent:
Continuous Index:
Within 8" of Joint:
Remarks:

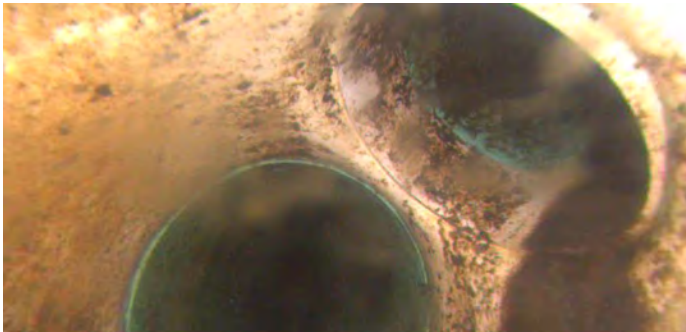
Code: **TFA**
Description: **Tap Factory Active**

Distance (ft): **63.1**
Structural Grade: **0**
O&M Grade: **0**
Clock Start/From: **11**
Clock To:
1st Value: **4.000**
2nd Value:
Value Percent:
Continuous Index:
Within 8" of Joint:
Remarks:

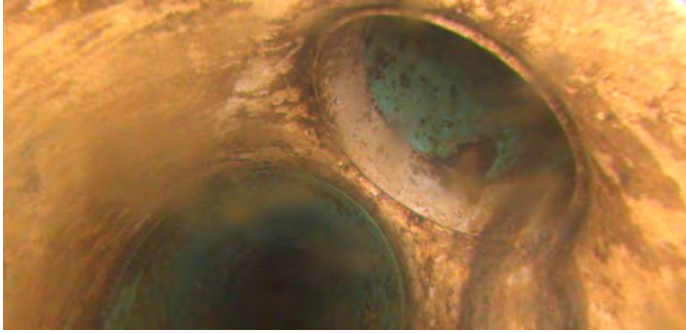
Code: **TF**
Description: **Tap Factory**

Distance (ft): **76.5**
Structural Grade: **0**
O&M Grade: **0**
Clock Start/From: **10**
Clock To:
1st Value: **4.000**
2nd Value:
Value Percent:
Continuous Index:
Within 8" of Joint:
Remarks:

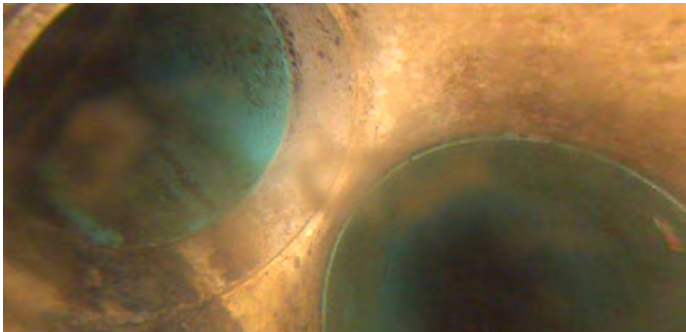
Code: **TF**
Description: **Tap Factory**

Distance (ft): **90.7**
Structural Grade: **0**
O&M Grade: **0**
Clock Start/From: **2**
Clock To:
1st Value: **4.000**
2nd Value:
Value Percent:
Continuous Index:
Within 8" of Joint:
Remarks:

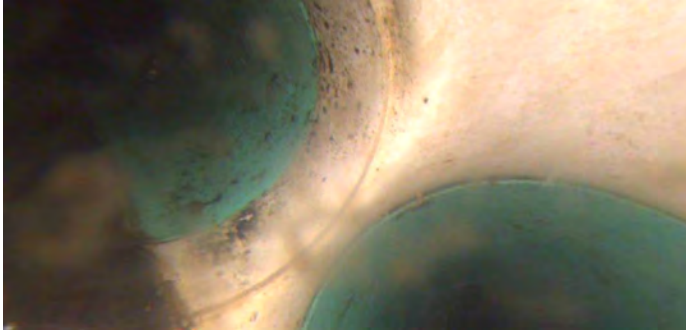
Code: **TF**
Description: **Tap Factory**

Distance (ft): **174.9**
Structural Grade: **0**
O&M Grade: **0**
Clock Start/From: **1**
Clock To:
1st Value: **4.000**
2nd Value:
Value Percent:
Continuous Index:
Within 8" of Joint:
Remarks:

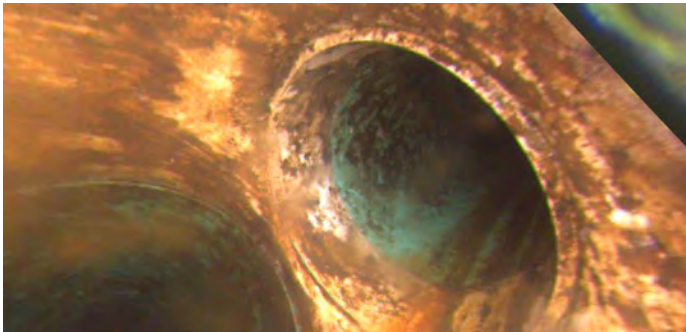
Code: **TF**
Description: **Tap Factory**

Distance (ft): **253.7**
Structural Grade: **0**
O&M Grade: **0**
Clock Start/From: **10**
Clock To:
1st Value: **4.000**
2nd Value:
Value Percent:
Continuous Index:
Within 8" of Joint:
Remarks:

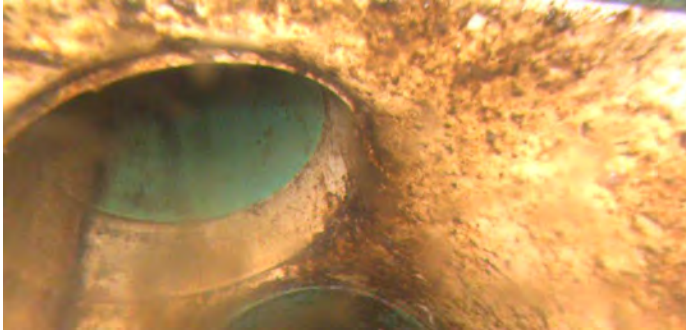
Code: **TF**
Description: **Tap Factory**

Distance (ft): **270.6**
Structural Grade: **0**
O&M Grade: **0**
Clock Start/From: **1**
Clock To:
1st Value: **4.000**
2nd Value:
Value Percent:
Continuous Index:
Within 8" of Joint:
Remarks:
