Profile/Photo Observation Report

Date:	03/29/2018	Weather:		Coding:	PACP 6.0
Pipe Length (ft):	303.1	Owner:	NA	Pre Clean:	Not Known
P.O.#:		Surveyor:	Jen Costello	PSR:	P-708-002-003
Customer:		Clean Date:	01/01/1900	Shape:	C

Street:	Lincoln	Flow Control:	Not Controlled
City:	Hobart, IN	Year Renewed:	
Location:	Light Highway	Tape/Media #:	
Purpose:	Maintenance Related	Dia/Height:	12"
Use:	Sanitary	Material:	PVC
Drain Area:	NA	Lining:	
Category:	NA		
Comment:	Flow direction wrong.

Location Details:		Direction of Survey:	Upstream
US MH:	M-708-003	DS MH:	M-708-002
		Total Length Surveyed (ft):	330.1

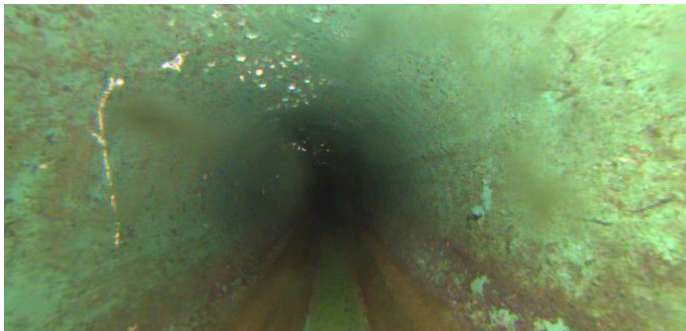
Code: **AMH**
Description: **Manhole**

Distance (ft): **.0**
Structural Grade: **0**
O&M Grade: **0**
Clock Start/From:
Clock To:
1st Value:
2nd Value:
Value Percent:
Continuous Index:
Within 8" of Joint: **NO**
Remarks: **M-708-002**

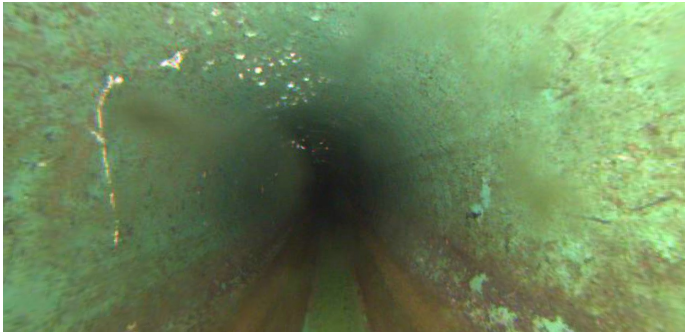
Code:	MWL
Description:	Water Level

Distance (ft):	.0
Structural Grade:	0
O&M Grade:	0
Clock Start/From:	
Clock To:	
1st Value:	
2nd Value:	
Value Percent:	5.000
Continuous Index:	
Within 8" of Joint:	NO
Remarks:

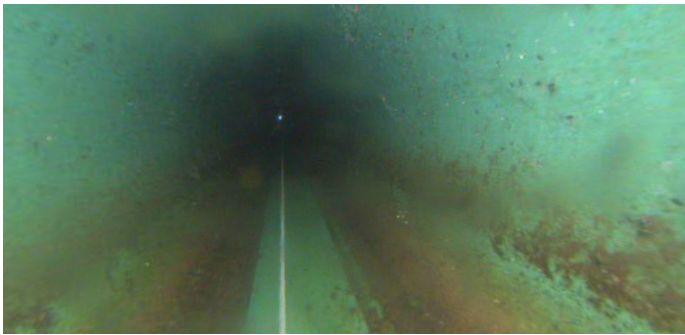
Code:	MGO
Description:	General Observation

Distance (ft):	23.1
Structural Grade:	0
O&M Grade:	0
Clock Start/From:	
Clock To:	
1st Value:	
2nd Value:	
Value Percent:	
Continuous Index:	
Within 8" of Joint:	NO
Remarks:	rear camera

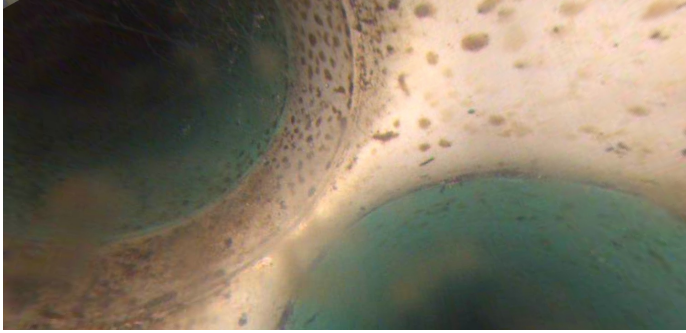
Code: **TF**
Description: **Tap Factory**

Distance (ft): **42.9**
Structural Grade: **0**
O&M Grade: **0**
Clock Start/From: **2**
Clock To:
1st Value: **4.000**
2nd Value:
Value Percent:
Continuous Index:
Within 8" of Joint:
Remarks:

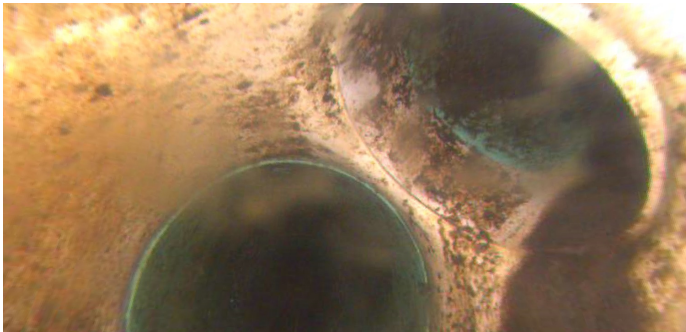
Code: **TFA**
Description: **Tap Factory Active**

Distance (ft): **63.1**
Structural Grade: **0**
O&M Grade: **0**
Clock Start/From: **11**
Clock To:
1st Value: **4.000**
2nd Value:
Value Percent:
Continuous Index:
Within 8" of Joint:
Remarks:

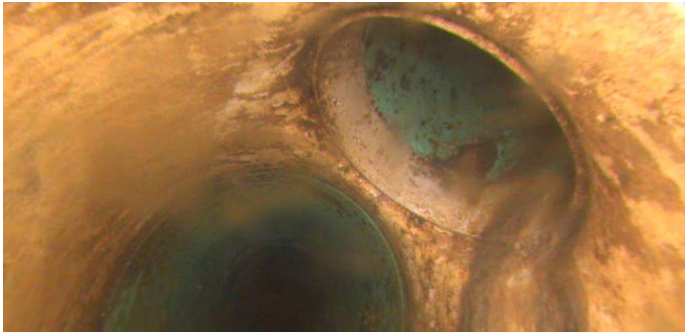
Code: **TF**
Description: **Tap Factory**

Distance (ft): **76.5**
Structural Grade: **0**
O&M Grade: **0**
Clock Start/From: **10**
Clock To:
1st Value: **4.000**
2nd Value:
Value Percent:
Continuous Index:
Within 8" of Joint:
Remarks:

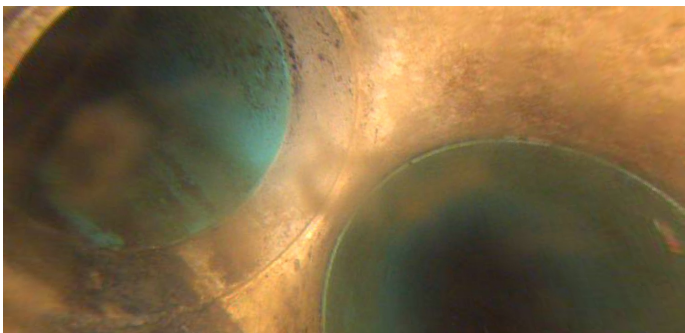
Code: **TF**
Description: **Tap Factory**

Distance (ft): **90.7**
Structural Grade: **0**
O&M Grade: **0**
Clock Start/From: **2**
Clock To:
1st Value: **4.000**
2nd Value:
Value Percent:
Continuous Index:
Within 8" of Joint:
Remarks:

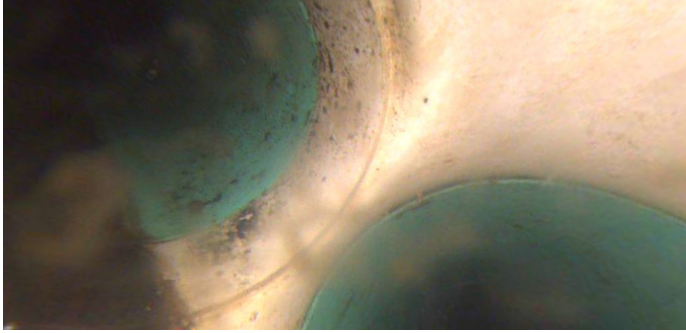
Code: **TF**
Description: **Tap Factory**

Distance (ft): **174.9**
Structural Grade: **0**
O&M Grade: **0**
Clock Start/From: **1**
Clock To:
1st Value: **4.000**
2nd Value:
Value Percent:
Continuous Index:
Within 8" of Joint:
Remarks:

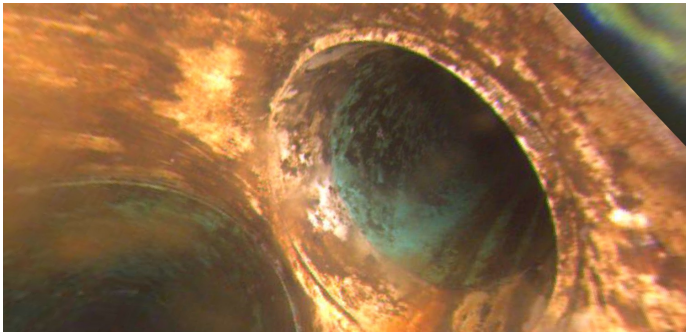
Code: **TF**
Description: **Tap Factory**

Distance (ft): **253.7**
Structural Grade: **0**
O&M Grade: **0**
Clock Start/From: **10**
Clock To:
1st Value: **4.000**
2nd Value:
Value Percent:
Continuous Index:
Within 8" of Joint:
Remarks:

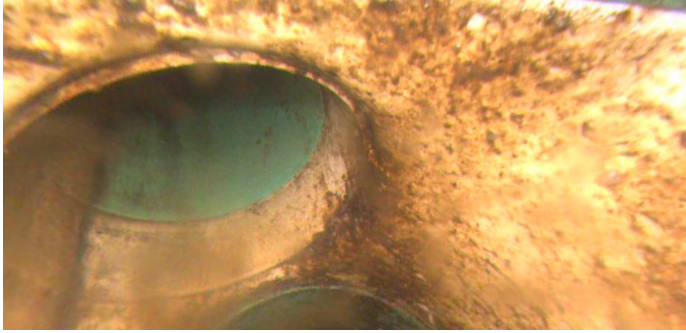
Code: **TF**
Description: **Tap Factory**

Distance (ft): **270.6**
Structural Grade: **0**
O&M Grade: **0**
Clock Start/From: **1**
Clock To:
1st Value: **4.000**
2nd Value:
Value Percent:
Continuous Index:
Within 8" of Joint:
Remarks:

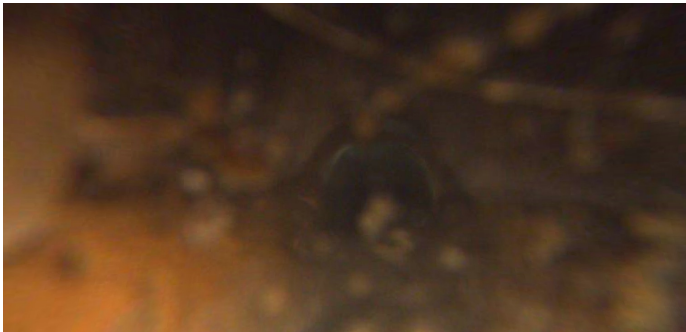
Code: **AMH**
Description: **Manhole**

Distance (ft): **330.1**
Structural Grade: **0**
O&M Grade: **0**
Clock Start/From:
Clock To:
1st Value:
2nd Value:
Value Percent:
Continuous Index:
Within 8" of Joint: **NO**
Remarks: **M-708-003**
