## Profile/Photo Observation Report

Date:	<b>03/29/2018</b>	Weather:		Coding:	<b>PACP 6.0</b>
Pipe Length (ft):	<b>340.2</b>	Owner:	<b>NA</b>	Pre Clean:	<b>Not Known</b>
P.O.#:		Surveyor:	<b>Jen Costello</b>	PSR:	<b>P-708-003-004</b>
Customer:		Clean Date:	<b>01/01/1900</b>	Shape:	<b>C</b>

Street:	<b>LINCOLN ST</b>	Flow Control:	<b>Not Controlled</b>
City:	<b>Hobart, IN</b>	Year Renewed:	
Location:	<b>Light Highway</b>	Tape/Media #:	
Purpose:	<b>Maintenance Related</b>	Dia/Height:	<b>8"</b>
Use:	<b>Sanitary</b>	Material:	<b>PVC</b>
Drain Area:	<b>NA</b>	Lining:	
Category:	<b>NA</b>		
Comment:	<b>Flow direction wrong. Reverse setup. Tether issue at 203'. Reversal to middle of segment completed.</b>		
Location Details:		Direction of Survey:	<b>Upstream</b>
US MH:	<b>M-708-004</b>	DS MH:	<b>M-708-003</b>
		Total Length Surveyed (ft):	<b>203.2</b>

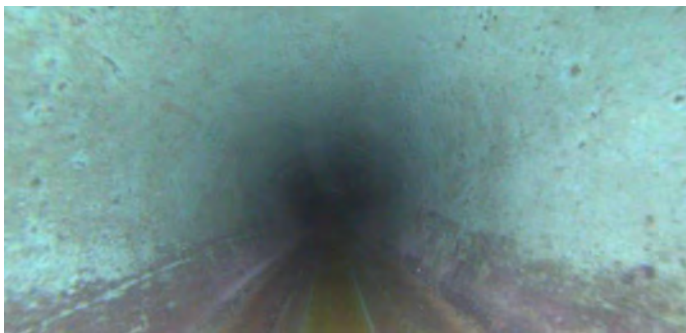
Code: **AMH**  
Description: **Manhole**

Distance (ft): **.0**  
Structural Grade: **0**  
O&M Grade: **0**  
Clock Start/From:  
Clock To:  
1st Value:  
2nd Value:  
Value Percent:  
Continuous Index:  
Within 8" of Joint: **NO**  
Remarks: **M-708-003**

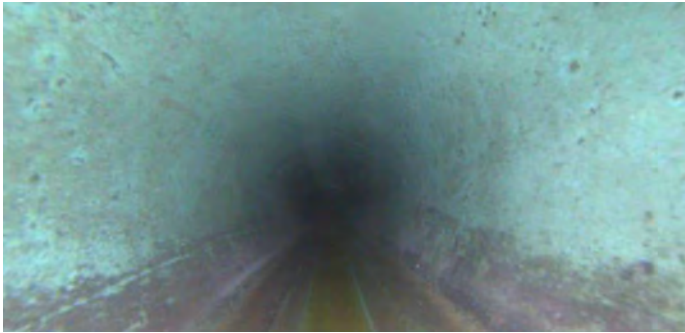
Code:	<b>MWL</b>
Description:	<b>Water Level</b>

Distance (ft):	<b>.0</b>
Structural Grade:	<b>0</b>
O&M Grade:	<b>0</b>
Clock Start/From:	
Clock To:	
1st Value:	
2nd Value:	
Value Percent:	<b>5.000</b>
Continuous Index:	
Within 8" of Joint:	<b>NO</b>
Remarks:

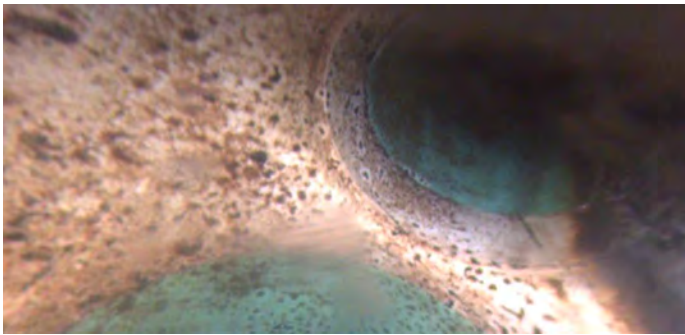
Code:	<b>TF</b>
Description:	<b>Tap Factory</b>

Distance (ft):	<b>6.5</b>
Structural Grade:	<b>0</b>
O&M Grade:	<b>0</b>
Clock Start/From:	<b>1</b>
Clock To:	
1st Value:	<b>4.000</b>
2nd Value:	
Value Percent:	
Continuous Index:	
Within 8" of Joint:	
Remarks:

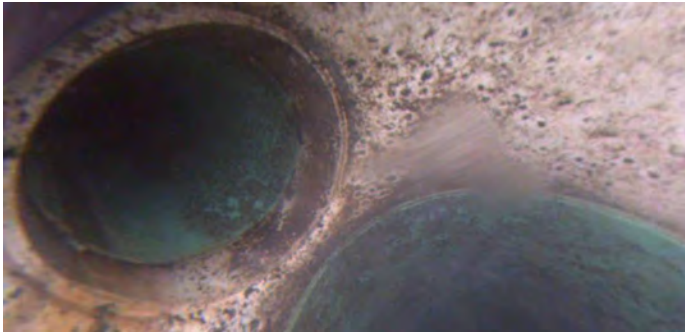
Code: **TF**  
Description: **Tap Factory**

Distance (ft): **10.1**  
Structural Grade: **0**  
O&M Grade: **0**  
Clock Start/From: **10**  
Clock To:  
1st Value: **4.000**  
2nd Value:  
Value Percent:  
Continuous Index:  
Within 8" of Joint:  
Remarks:

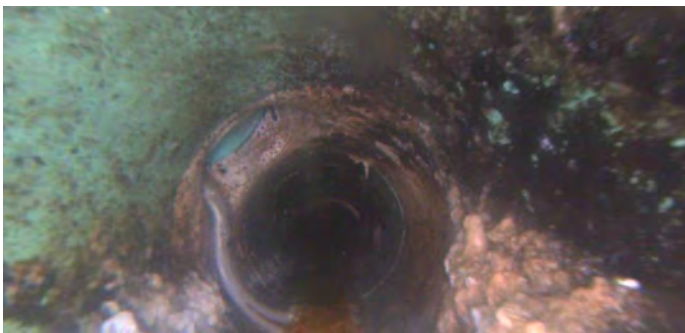
Code: **DAGS**  
Description: **Deposits Attached Grease**

Distance (ft): **18.0**  
Structural Grade: **0**  
O&M Grade: **2**  
Clock Start/From: **8**  
Clock To: **4**  
1st Value:  
2nd Value:  
Value Percent: **5.000**  
Continuous Index:  
Within 8" of Joint: **NO**  
Remarks:

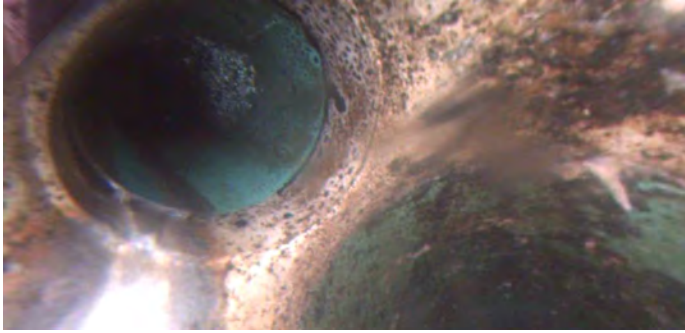
Code: **TF**  
Description: **Tap Factory**

Distance (ft): **18.9**  
Structural Grade: **0**  
O&M Grade: **0**  
Clock Start/From: **10**  
Clock To:  
1st Value: **4.000**  
2nd Value:  
Value Percent:  
Continuous Index:  
Within 8" of Joint:  
Remarks:

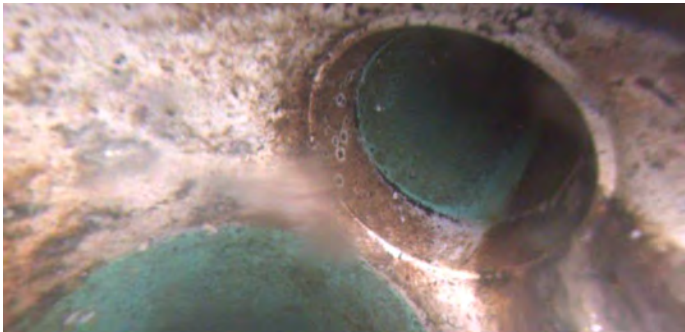
Code: **TF**  
Description: **Tap Factory**

Distance (ft): **21.1**  
Structural Grade: **0**  
O&M Grade: **0**  
Clock Start/From: **1**  
Clock To:  
1st Value: **4.000**  
2nd Value:  
Value Percent:  
Continuous Index:  
Within 8" of Joint:  
Remarks:

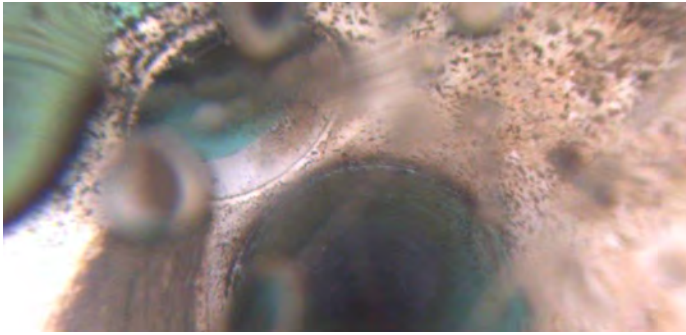
Code: **TF**  
Description: **Tap Factory**

Distance (ft): **85.7**  
Structural Grade: **0**  
O&M Grade: **0**  
Clock Start/From: **10**  
Clock To:  
1st Value: **4.000**  
2nd Value:  
Value Percent:  
Continuous Index:  
Within 8" of Joint:  
Remarks:

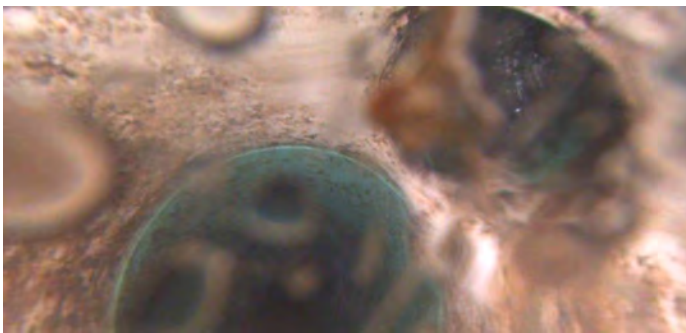
Code: **TF**  
Description: **Tap Factory**

Distance (ft): **117.8**  
Structural Grade: **0**  
O&M Grade: **0**  
Clock Start/From: **2**  
Clock To:  
1st Value: **4.000**  
2nd Value:  
Value Percent:  
Continuous Index:  
Within 8" of Joint:  
Remarks:

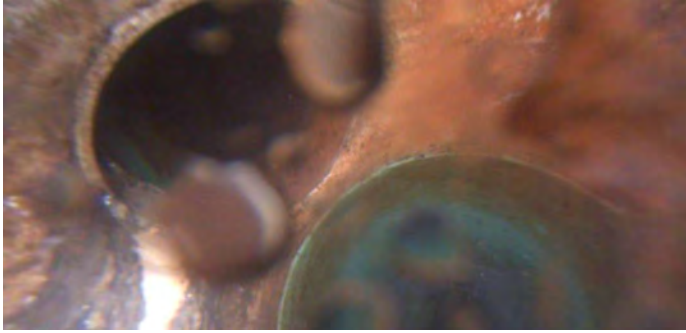
Code: **TF**  
Description: **Tap Factory**

Distance (ft): **184.9**  
Structural Grade: **0**  
O&M Grade: **0**  
Clock Start/From: **1**  
Clock To:  
1st Value: **4.000**  
2nd Value:  
Value Percent:  
Continuous Index:  
Within 8" of Joint:  
Remarks:

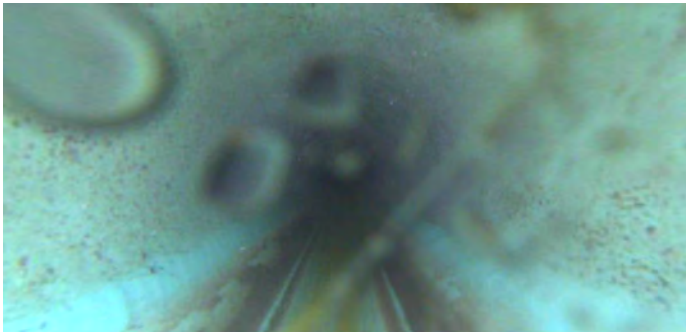
Code: **MSA**  
Description: **Abandoned Survey**

Distance (ft): **203.2**  
Structural Grade: **0**  
O&M Grade: **0**  
Clock Start/From:  
Clock To:  
1st Value:  
2nd Value:  
Value Percent:  
Continuous Index:  
Within 8" of Joint: **NO**  
Remarks: **unknown**
