Profile/Photo Observation Report

Date:	03/29/2018	Weather:		Coding:	PACP 6.0
Pipe Length (ft):	340.2	Owner:	NA	Pre Clean:	Not Known
P.O.#:		Surveyor:	Jen Costello	PSR:	P-708-003-004
Customer:		Clean Date:	01/01/1900	Shape:	C

Street:	Lincoln	Flow Control:	Not Controlled
City:	Hobart, IN	Year Renewed:	
Location:	Light Highway	Tape/Media #:	
Purpose:	Maintenance Related	Dia/Height:	8"
Use:	Sanitary	Material:	PVC
Drain Area:	NA	Lining:	
Category:	NA		
Comment:	Flow direction wrong. Reverse setup. Tether issue at 203'. Reversal to middle of segment completed.		
Location Details:		Direction of Survey:	Upstream
US MH:	M-708-004	DS MH:	M-708-003
		Total Length Surveyed (ft):	203.2

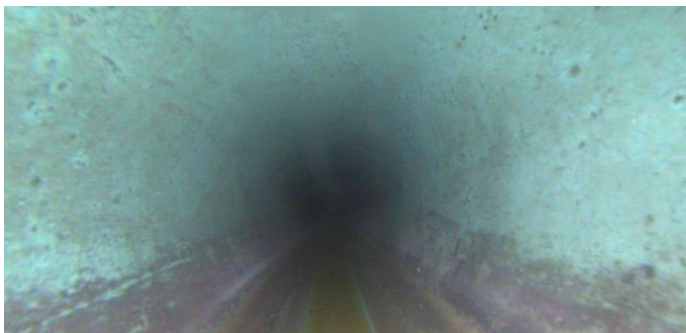
Code: **AMH**
Description: **Manhole**

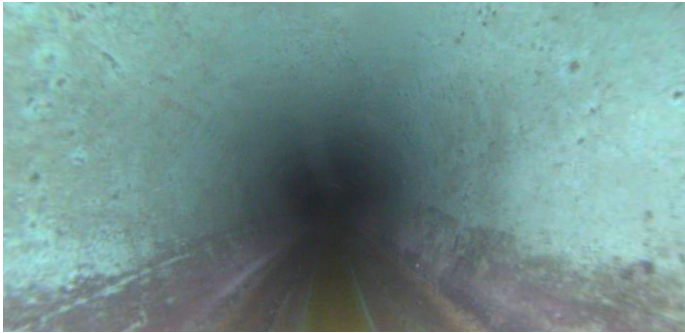
Code:	MWL
Description:	Water Level

Distance (ft):	.0
Structural Grade:	0
O&M Grade:	0
Clock Start/From:	
Clock To:	
1st Value:	
2nd Value:	
Value Percent:	5.000
Continuous Index:	
Within 8" of Joint:	NO
Remarks:

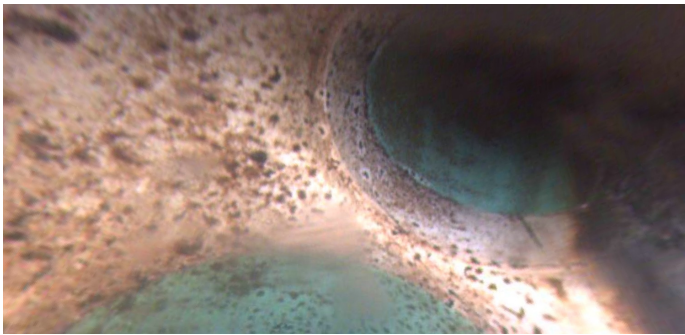
Code:	TF
Description:	Tap Factory

Distance (ft):	6.5
Structural Grade:	0
O&M Grade:	0
Clock Start/From:	1
Clock To:	
1st Value:	4.000
2nd Value:	
Value Percent:	
Continuous Index:	
Within 8" of Joint:	
Remarks:

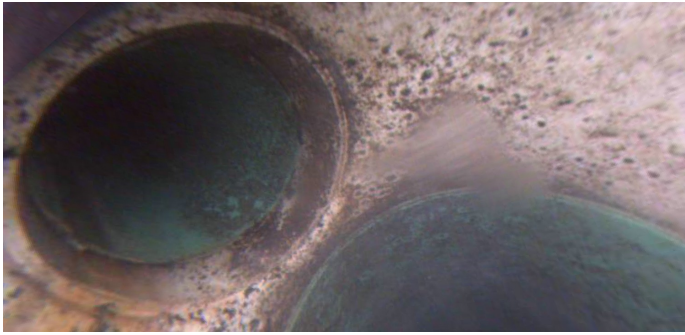
Code: **TF**
Description: **Tap Factory**

Distance (ft): **10.1**
Structural Grade: **0**
O&M Grade: **0**
Clock Start/From: **10**
Clock To:
1st Value: **4.000**
2nd Value:
Value Percent:
Continuous Index:
Within 8" of Joint:
Remarks:

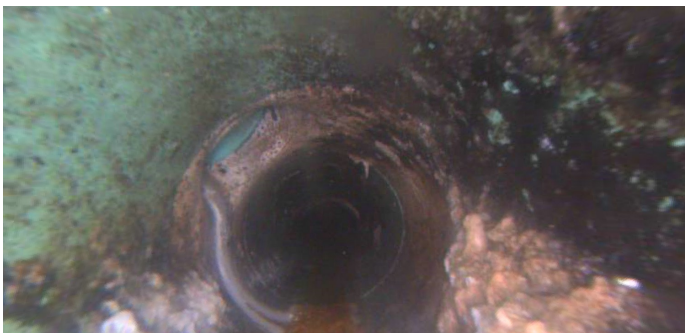
Code: **DAGS**
Description: **Deposits Attached Grease**

Distance (ft): **18.0**
Structural Grade: **0**
O&M Grade: **2**
Clock Start/From: **8**
Clock To: **4**
1st Value:
2nd Value:
Value Percent: **5.000**
Continuous Index:
Within 8" of Joint: **NO**
Remarks:

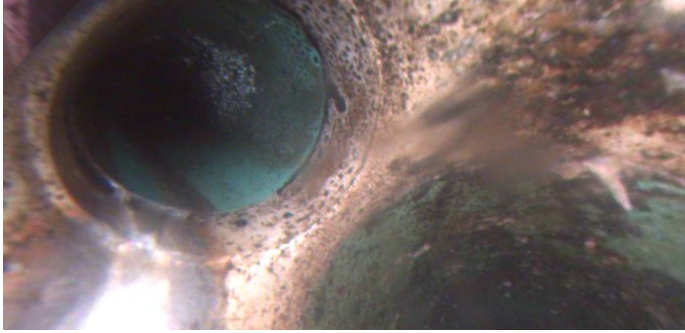
Code: **TF**
Description: **Tap Factory**

Distance (ft): **18.9**
Structural Grade: **0**
O&M Grade: **0**
Clock Start/From: **10**
Clock To:
1st Value: **4.000**
2nd Value:
Value Percent:
Continuous Index:
Within 8" of Joint:
Remarks:

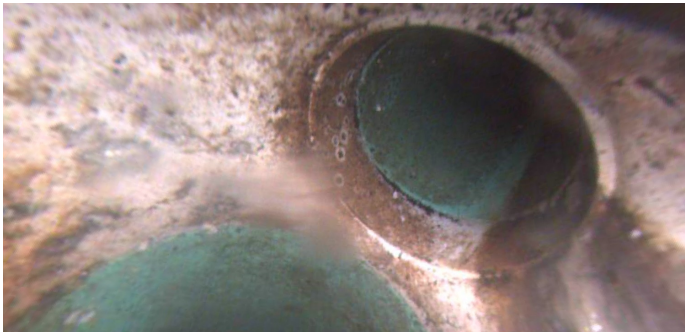
Code: **TF**
Description: **Tap Factory**

Distance (ft): **21.1**
Structural Grade: **0**
O&M Grade: **0**
Clock Start/From: **1**
Clock To:
1st Value: **4.000**
2nd Value:
Value Percent:
Continuous Index:
Within 8" of Joint:
Remarks:

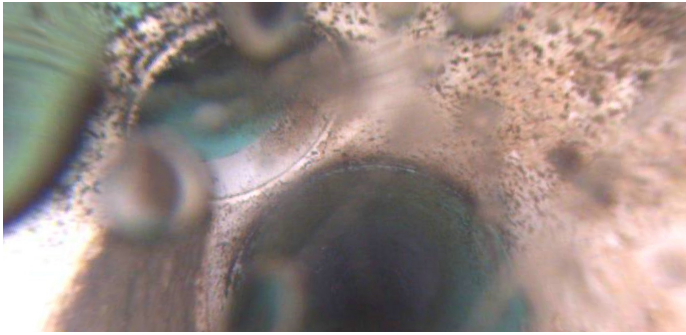
Code: **TF**
Description: **Tap Factory**

Distance (ft): **85.7**
Structural Grade: **0**
O&M Grade: **0**
Clock Start/From: **10**
Clock To:
1st Value: **4.000**
2nd Value:
Value Percent:
Continuous Index:
Within 8" of Joint:
Remarks:

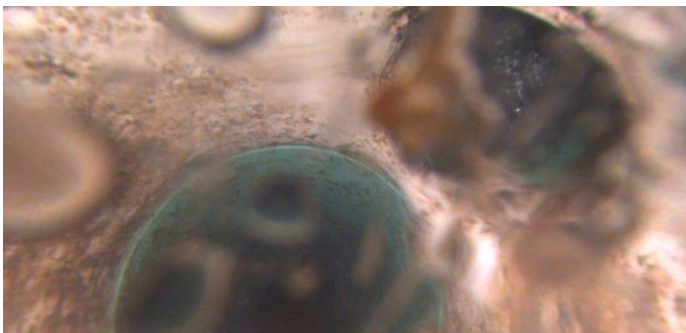
Code: **TF**
Description: **Tap Factory**

Distance (ft): **117.8**
Structural Grade: **0**
O&M Grade: **0**
Clock Start/From: **2**
Clock To:
1st Value: **4.000**
2nd Value:
Value Percent:
Continuous Index:
Within 8" of Joint:
Remarks:

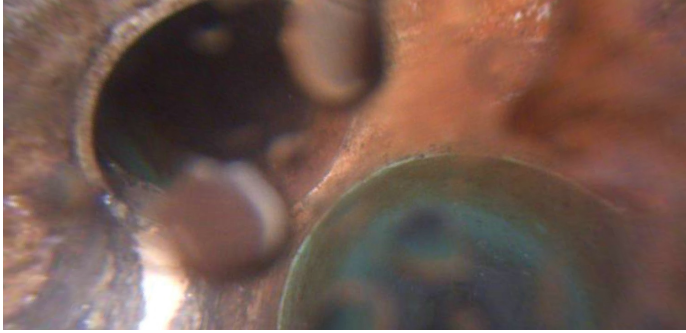
Code: **TF**
Description: **Tap Factory**

Distance (ft): **184.9**
Structural Grade: **0**
O&M Grade: **0**
Clock Start/From: **1**
Clock To:
1st Value: **4.000**
2nd Value:
Value Percent:
Continuous Index:
Within 8" of Joint:
Remarks:

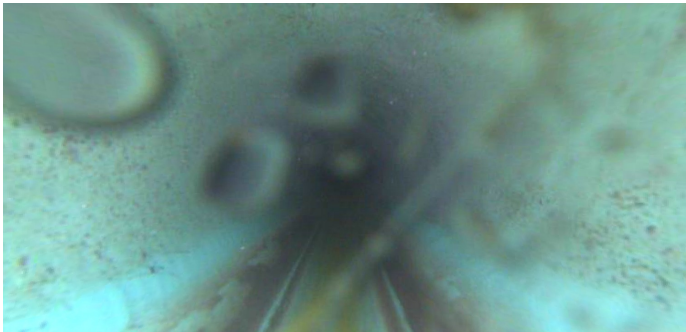
Code: **MSA**
Description: **Abandoned Survey**

Distance (ft): **203.2**
Structural Grade: **0**
O&M Grade: **0**
Clock Start/From:
Clock To:
1st Value:
2nd Value:
Value Percent:
Continuous Index:
Within 8" of Joint: **NO**
Remarks: **unknown**
