Profile/Photo Observation Report

Street:	LINCOLN ST	Flow Control:	Not Controlled
City:	Hobart, IN	Year Renewed:	
Location:	Light Highway	Tape/Media #:	
Purpose:	Maintenance Related	Dia/Height:	8"
Use:	Sanitary	Material:	PVC
Drain Area:	NA	Lining:	
Category:	NA		
Comment:	Flow direction wrong. Unknown reason for stop.		
Location Details:		Direction of Survey:	Downstream
US MH:	M-708-004	DS MH:	M-708-003
		Total Length Surveyed (ft):	202.7

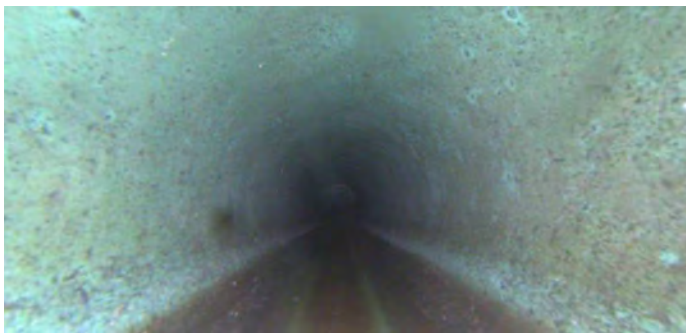
Code: **AMH**
Description: **Manhole**

Distance (ft): **.0**
Structural Grade: **0**
O&M Grade: **0**
Clock Start/From:
Clock To:
1st Value:
2nd Value:
Value Percent:
Continuous Index:
Within 8" of Joint: **NO**
Remarks: **M-708-004**

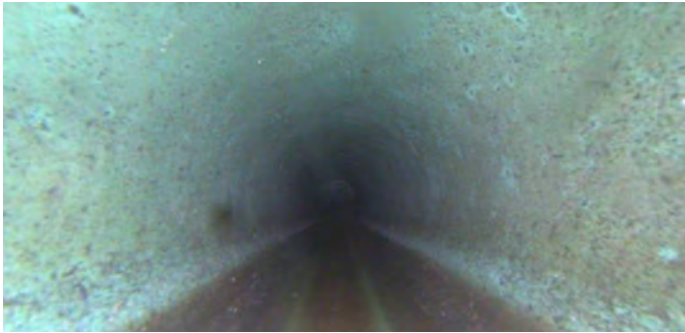
Code:	MWL
Description:	Water Level

Distance (ft):	.0
Structural Grade:	0
O&M Grade:	0
Clock Start/From:	
Clock To:	
1st Value:	
2nd Value:	
Value Percent:	5.000
Continuous Index:	
Within 8" of Joint:	NO
Remarks:

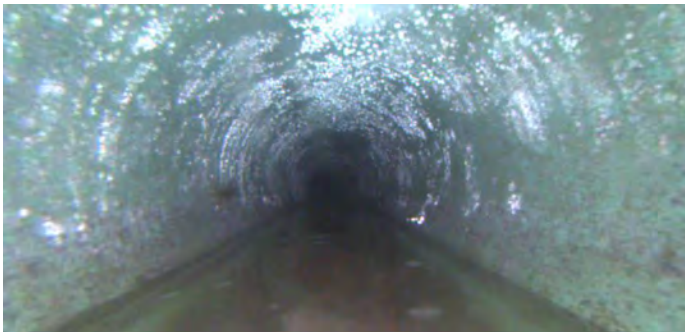
Code:	MWL
Description:	Water Level

Distance (ft):	19.6
Structural Grade:	0
O&M Grade:	0
Clock Start/From:	
Clock To:	
1st Value:	
2nd Value:	
Value Percent:	20.000
Continuous Index:	
Within 8" of Joint:	NO
Remarks:

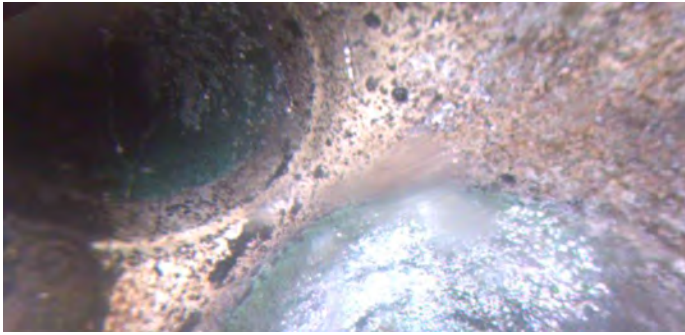
Code: **TF**
Description: **Tap Factory**

Distance (ft): **26.2**
Structural Grade: **0**
O&M Grade: **0**
Clock Start/From: **10**
Clock To:
1st Value: **4.000**
2nd Value:
Value Percent:
Continuous Index:
Within 8" of Joint:
Remarks:

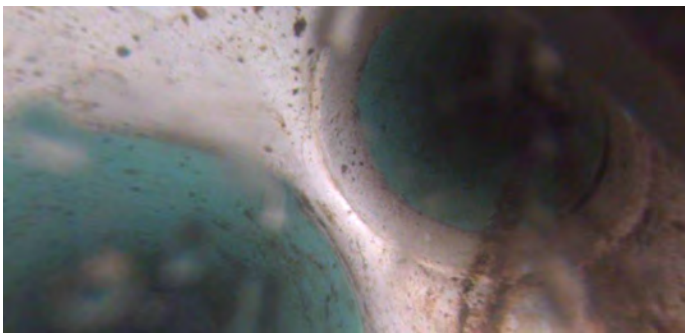
Code: **TF**
Description: **Tap Factory**

Distance (ft): **102.5**
Structural Grade: **0**
O&M Grade: **0**
Clock Start/From: **2**
Clock To:
1st Value: **4.000**
2nd Value:
Value Percent:
Continuous Index:
Within 8" of Joint:
Remarks:

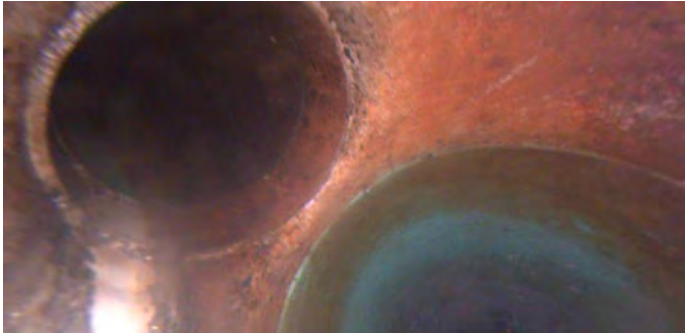
Code: **TF**
Description: **Tap Factory**

Distance (ft): **133.8**
Structural Grade: **0**
O&M Grade: **0**
Clock Start/From: **2**
Clock To:
1st Value: **4.000**
2nd Value:
Value Percent:
Continuous Index:
Within 8" of Joint:
Remarks:

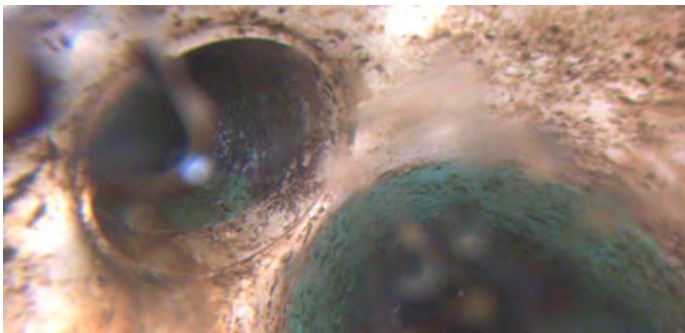
Code: **TF**
Description: **Tap Factory**

Distance (ft): **200.3**
Structural Grade: **0**
O&M Grade: **0**
Clock Start/From: **10**
Clock To:
1st Value: **4.000**
2nd Value:
Value Percent:
Continuous Index:
Within 8" of Joint:
Remarks:

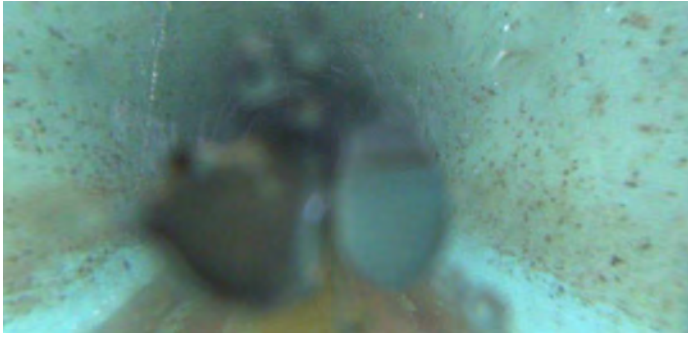
Code:	MSA
Description:	Abandoned Survey
Distance (ft):	202.7
Structural Grade:	0
O&M Grade:	0
Clock Start/From:	
Clock To:	
1st Value:	
2nd Value:	
Value Percent:	
Continuous Index:	
Within 8" of Joint:	NO
Remarks:	UNKNOWN
